Vacuum K-26 EOL

CLOSURE

**RICE OPERATING COMPANY
JUNCTION BOX FINAL REPORT**

Unit K, Section 26, T17S, R35E

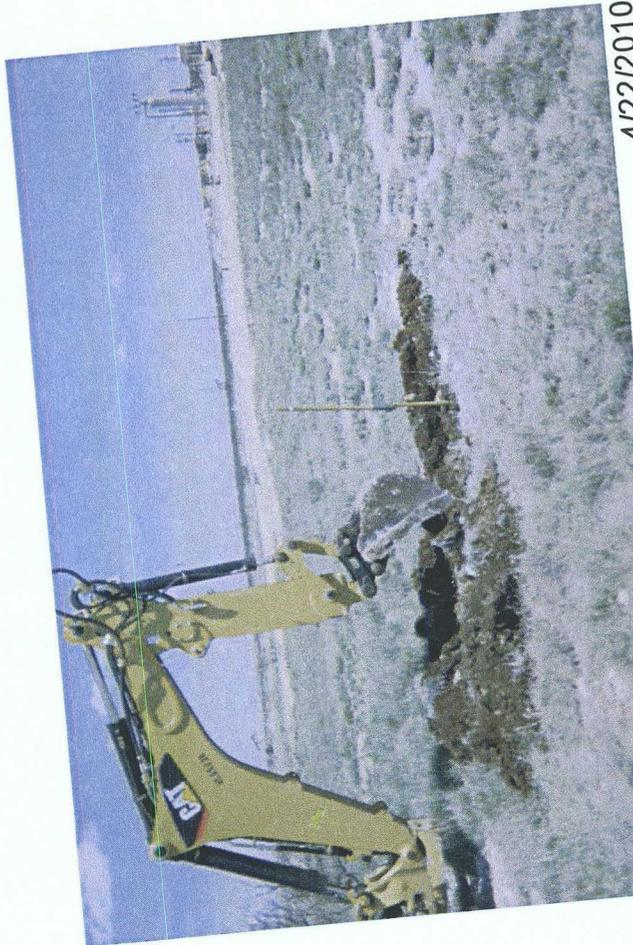
4/22/2010

Delineation trench being excavated

General Description of Remedial Action: This junction box was addressed during the Vacuum SWD System abandonment. After the former junction box was removed an investigation was conducted using a backhoe to collect soil sample at regular intervals creating a 7x3x5-ft deep excavation. Each sample was field tested for chlorides and organic vapors which yielded low concentrations similar to that of the background sample.

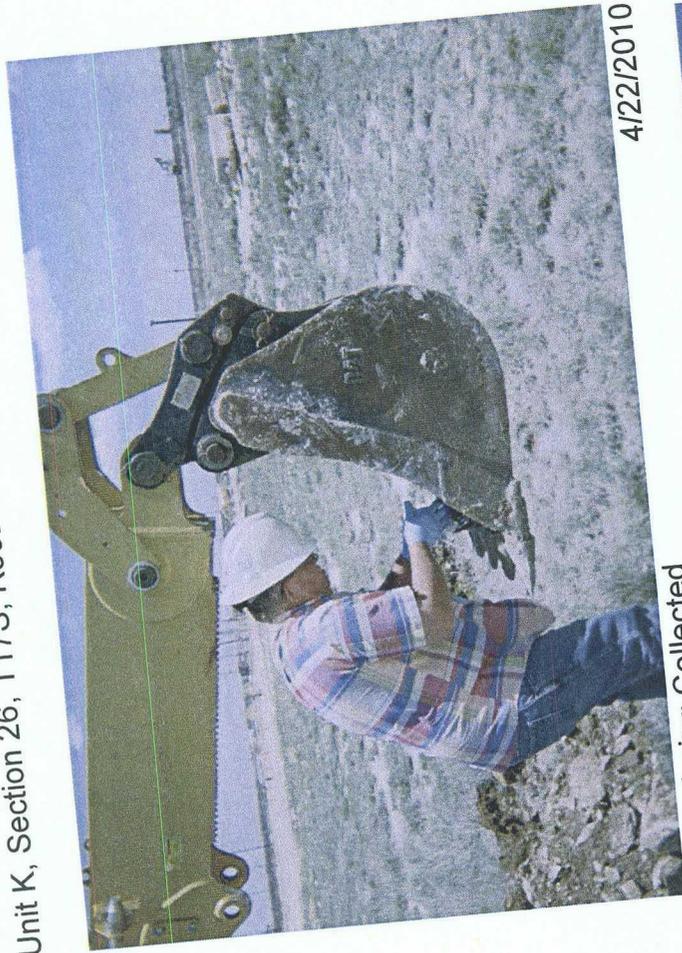
4/22/2010

Sample being Collected

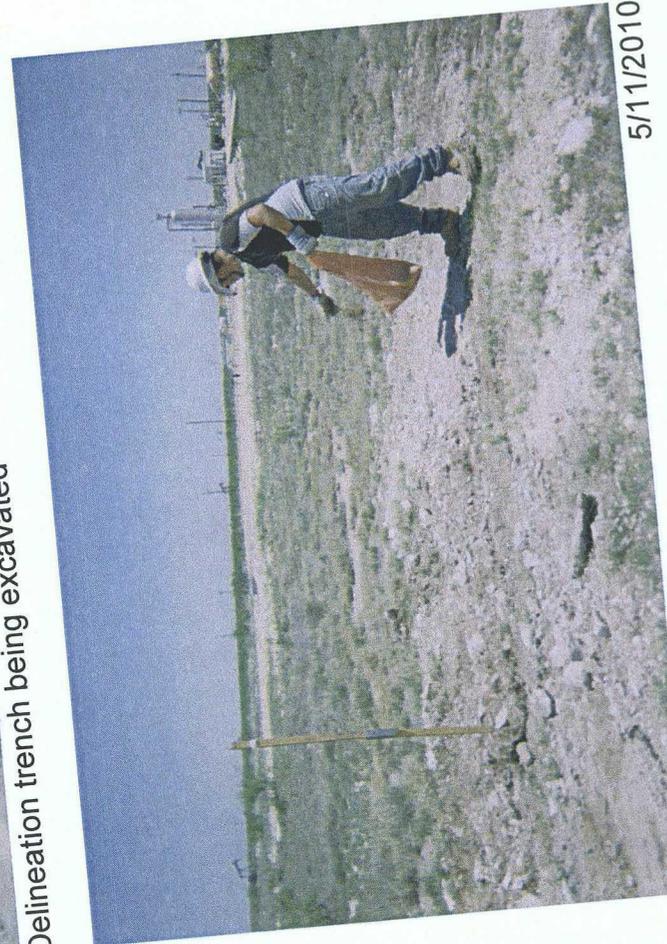
5/11/2010

Excavation being seeded

The excavated soil was returned to the excavation to ground surface and contoured to the surrounding area. On 5/11/2010, the site was seeded with a blend of native vegetation and is expected to return to a productive capacity at a normal rate.

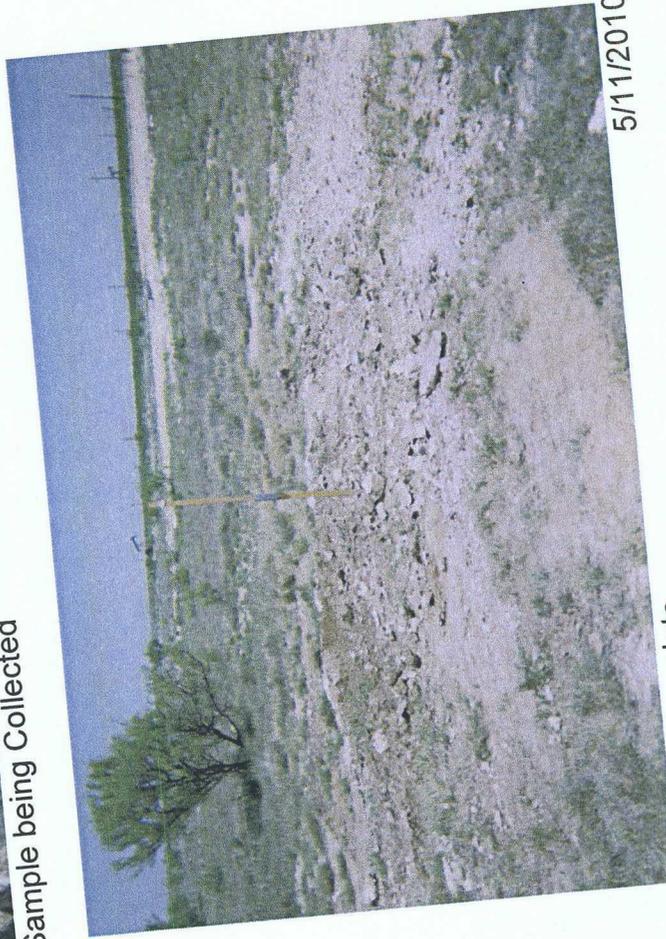
5/11/2010

Excavation complete

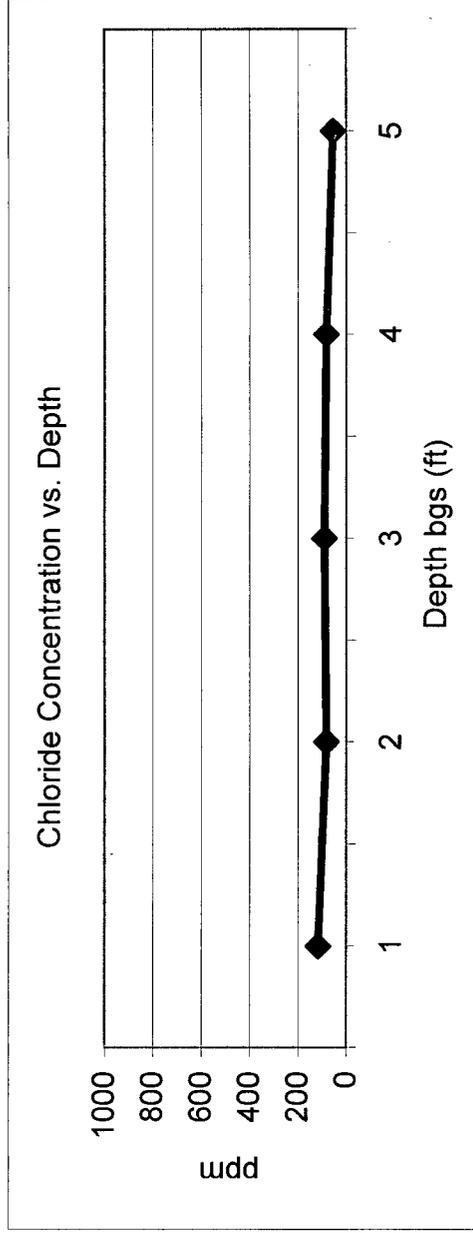
Vacuum K-26 EOL

Backhoe samples at the junction (source)

Depth bgs (ft)	[Cl ⁻] ppm
1	117
2	83
3	91
4	83
5	56

Groundwater = 50 ft
