**Vacuum K-30 EOL**

**CLOSURE**

RICE OPERATING COMPANY  
JUNCTION BOX FINAL REPORT

Unit K, Section 30, T17S, R35E

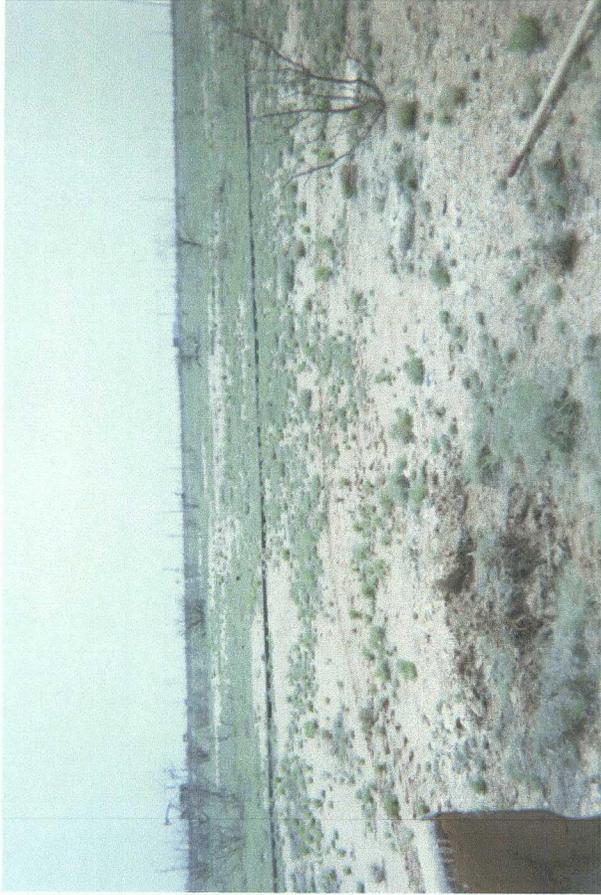
Site prior to delineation

4/19/2010

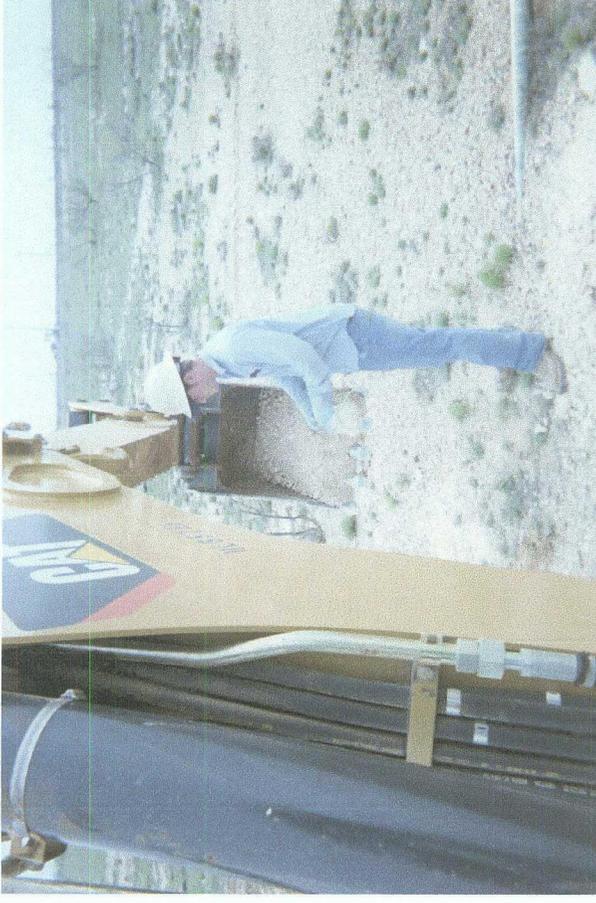
Collecting sample

4/19/2010

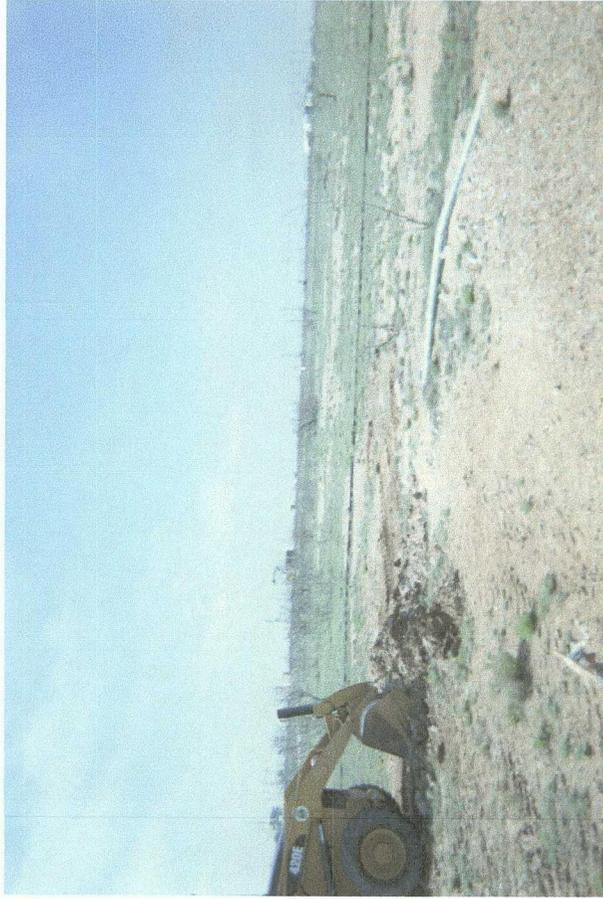
Backfilling excavation

4/20/2010

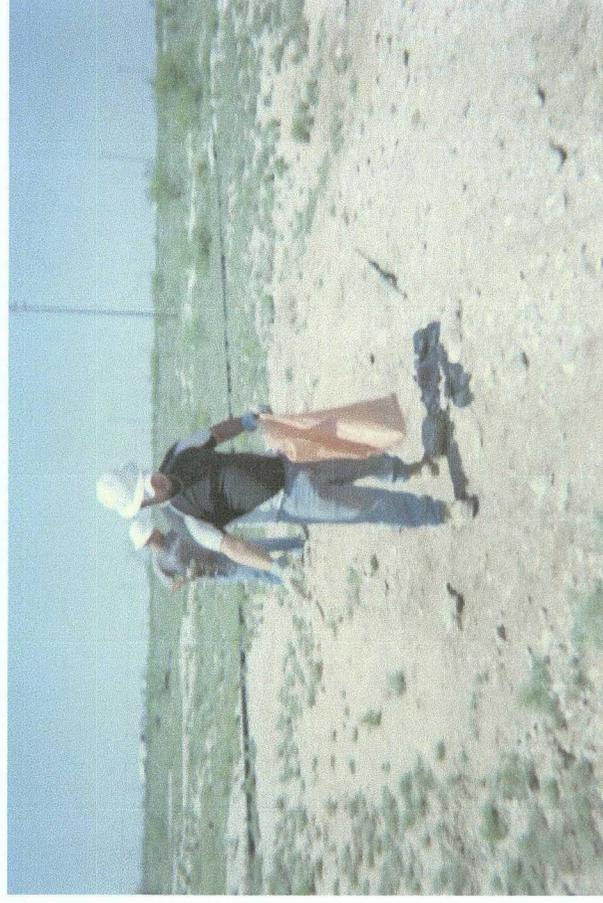
Seeding excavation

5/21/2010

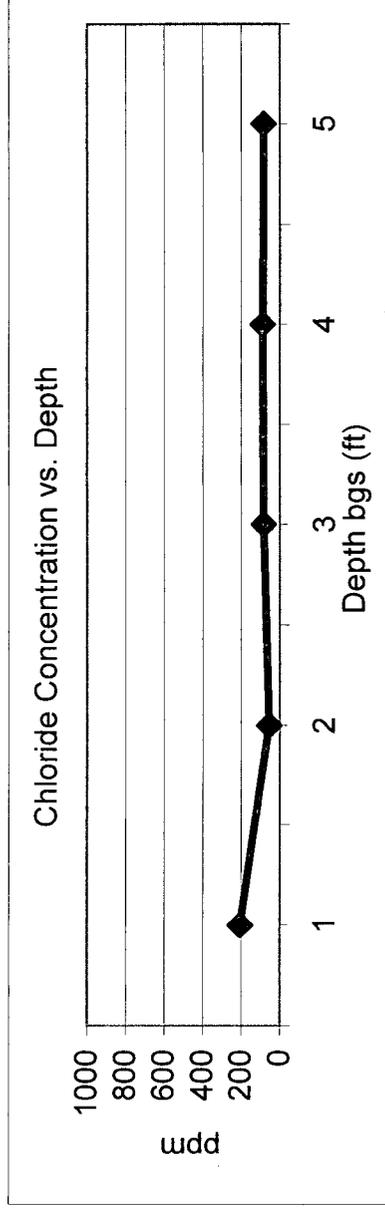
Backhoe samples at the junction (source)

Depth bgs (ft)	[Cl <sup>-</sup> ] ppm
1	208
2	56
3	85
4	89
5	84

Groundwater = 88 ft
