Vacuum B-5-1 EOL

CLOSURE

**RICE OPERATING COMPANY
JUNCTION BOX FINAL REPORT**

SWD SYSTEM	JUNCTION	UNIT	SECTION	TOWNSHIP	RANGE	COUNTY	BOX DIMENSIONS - FEET		
							Length	Width	Depth
Vacuum	B-5-1 EOL	B	5	18S	35E	Lea	Eliminated

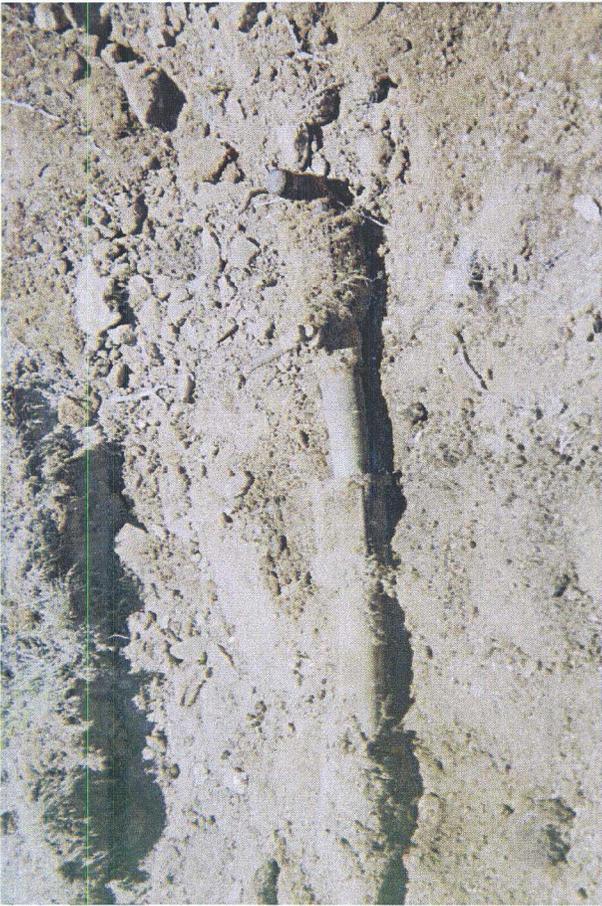
Site prior to delineation

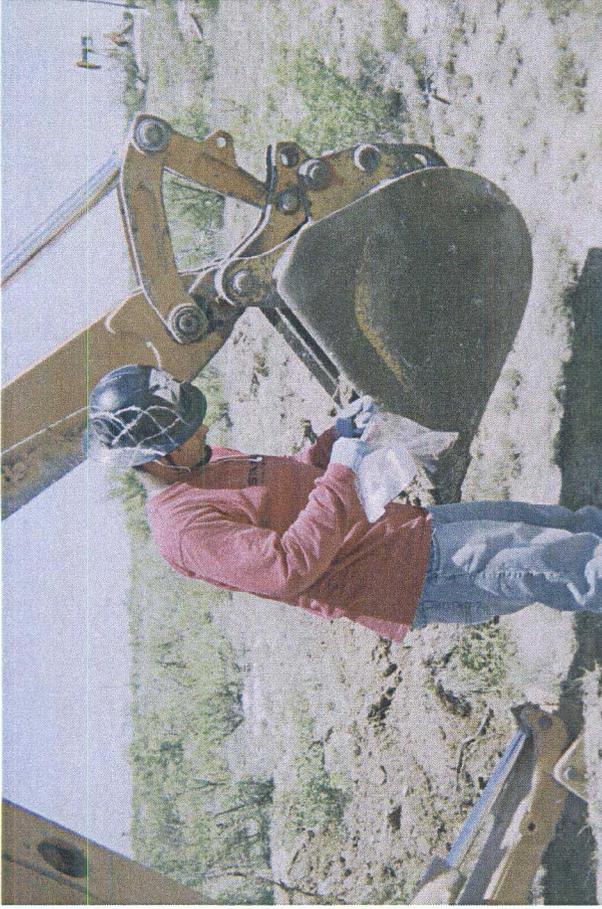
Collecting sample

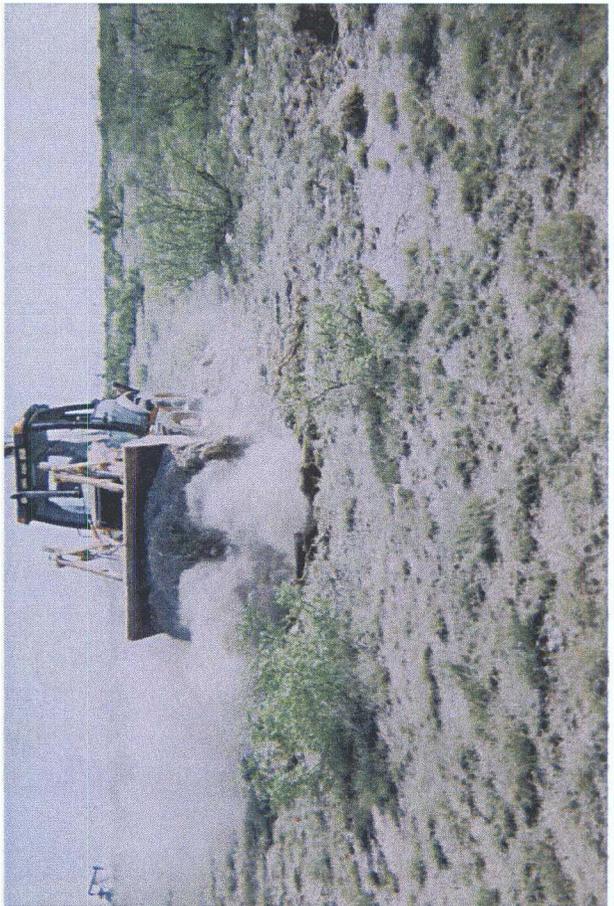
Backfilling excavation

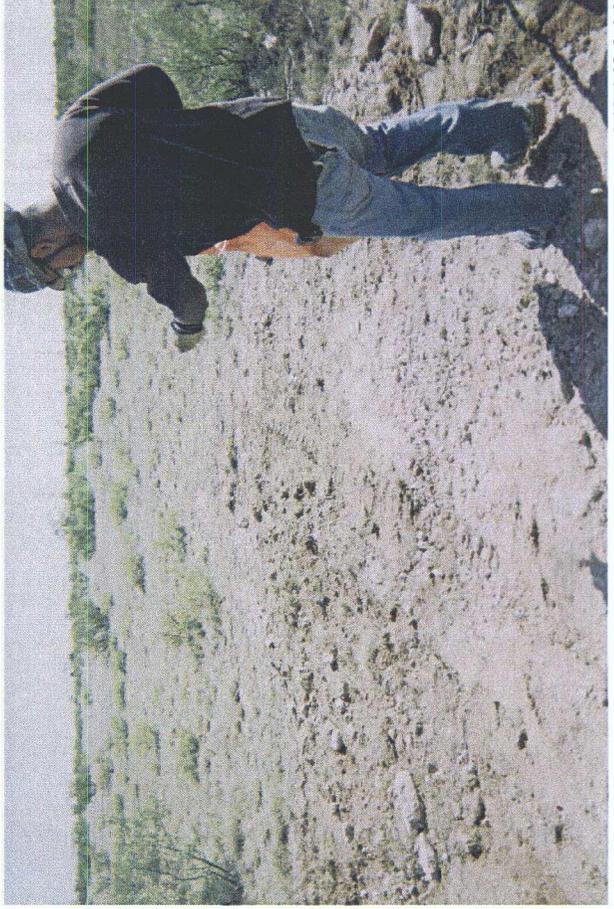
Seeding excavation

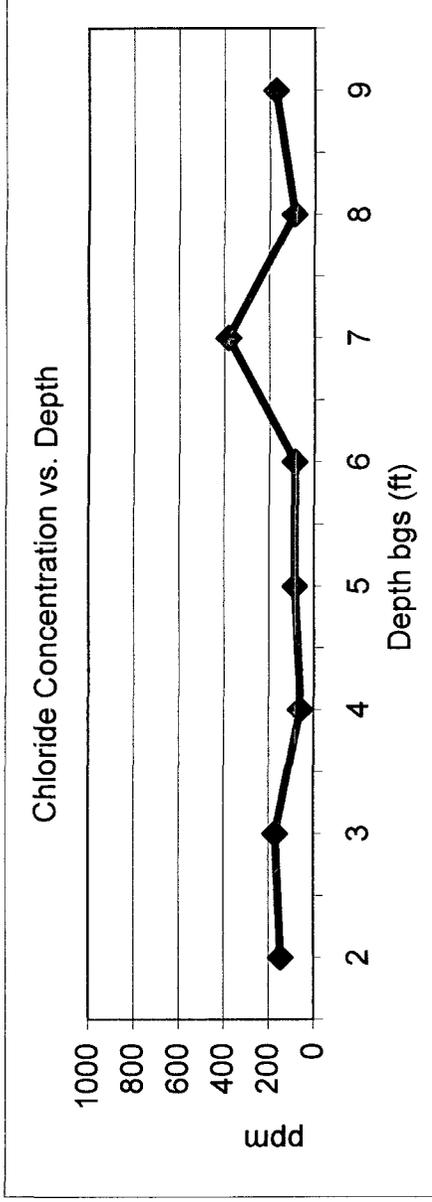
Backhoe samples at the junction (source)

Depth bgs (ft)	[Cl ⁻] ppm
2	146
3	170
4	59
5	85
6	86
7	382
8	90
9	172

Groundwater = 66 ft
