**RICE OPERATING COMPANY
JUNCTION BOX FINAL REPORT**

SWD SYSTEM	JUNCTION	UNIT	SECTION	TOWNSHIP	RANGE	COUNTY	BOX DIMENSIONS - FEET		
							Length	Width	Depth
Vacuum	K-33 EOL	K	33	17S	35E	Lea	Eliminated

Vacuum K-33 EOL

Unit K, Section 33, T17S, R35E

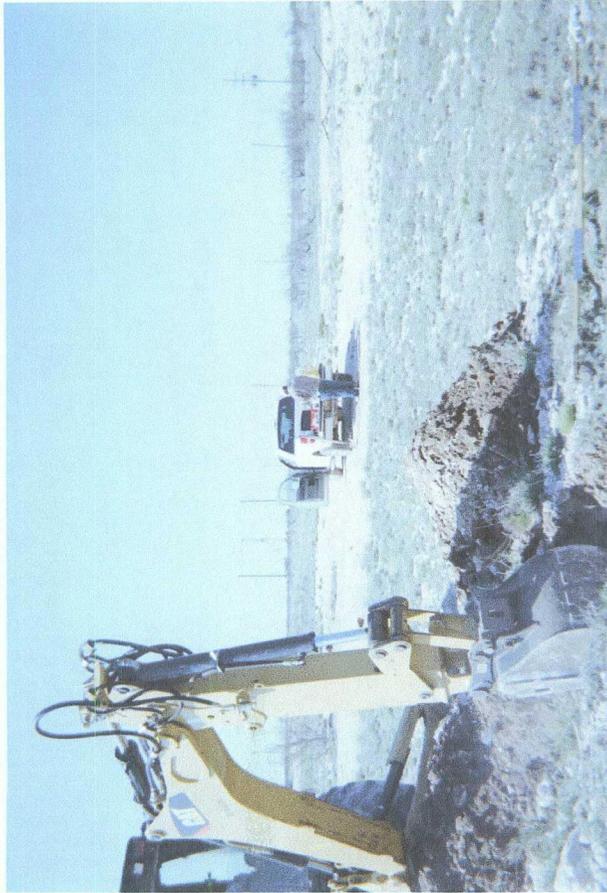
4/20/2010

Delineation trench being excavated

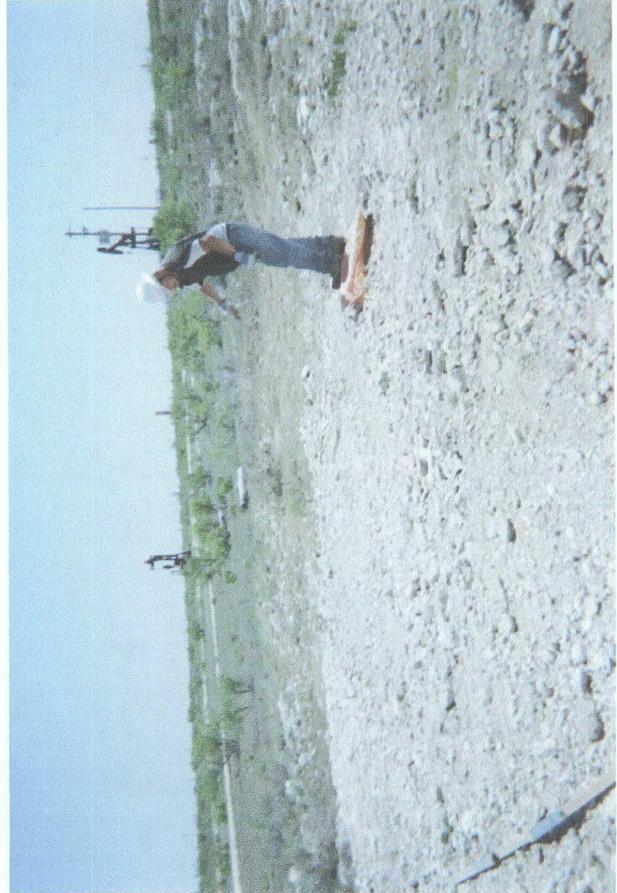
5/21/2010

Seeding excavation

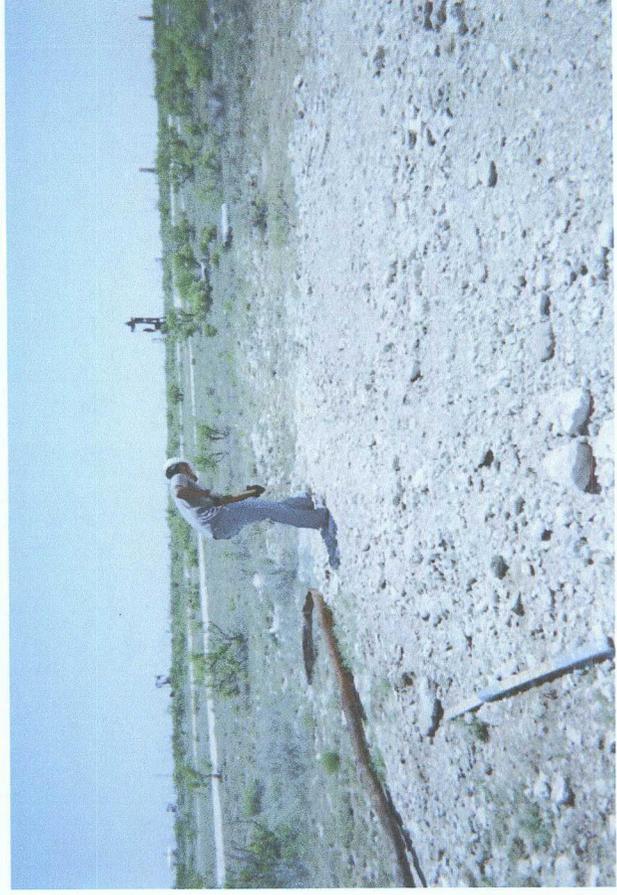
5/21/2010

Racking in seed
