Release Notification and Corrective Action N

May 2011

REMEDIATION SUMMARY & SITE CLOSURE PROPOSAL

**LEGACY RESERVES, LP
WA SIMPSON
Lea County, New Mexico
Unit Letter "I" (NE/SE), Section 3, Township 15 South, Range 37 East
Latitude 33° 02.632' North, Longitude 103° 10.987' West
NMOCD Reference #1RP-10-9-2609**

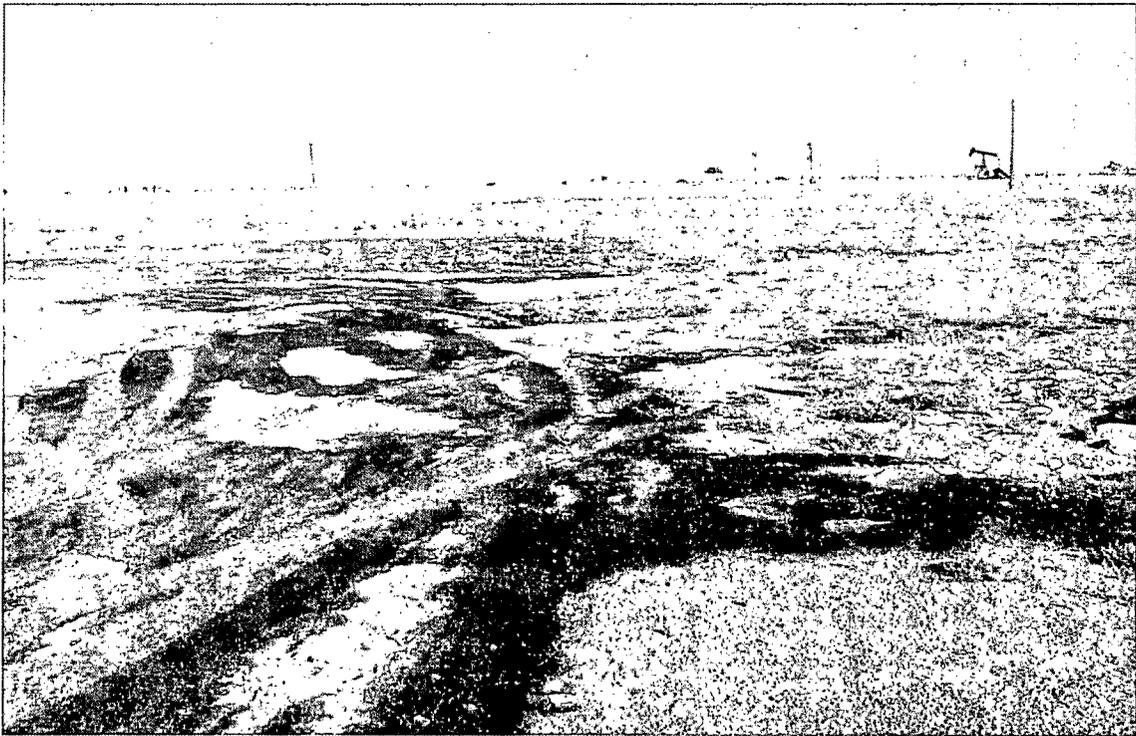
On April 14, 2011, a delineation trench (Trench 6) was excavated in the approximate center of the Southeast Pooling Area to a total depth of approximately ten (10) feet bgs. Soil samples were collected at selected intervals and field-screened with a chloride test kit.

Based on field tests and a visual inspection of the site, further investigation of the extent of hydrocarbon impact in the Southeast Pooling Area is warranted. Vertical delineation beyond ten (10) feet bgs is precluded by an impenetrable rock layer running underneath the Southeast Pooling Area. Horizontal delineation is precluded by an area of historical impact adjacent to the Southeast Pooling Area (Southeast Historical Area).

WA Simpson - Southeast Pooling Area & Southeast Historical Area (looking East)

- Soil borings will be drilled to delineate the vertical extent of impact in the Southeast Historical Area. Soil samples will be collected at five (5) foot drilling intervals and field screened using a PID and a chloride field test kit. Selected soil samples will be submitted to the laboratory for analysis of benzene, toluene, ethylbenzene, and xylenes (BTEX), total petroleum hydrocarbons (TPH), and/or chlorides using EPA methods SW-846 8021b, SW-846 8015M, and 300.1, respectively.

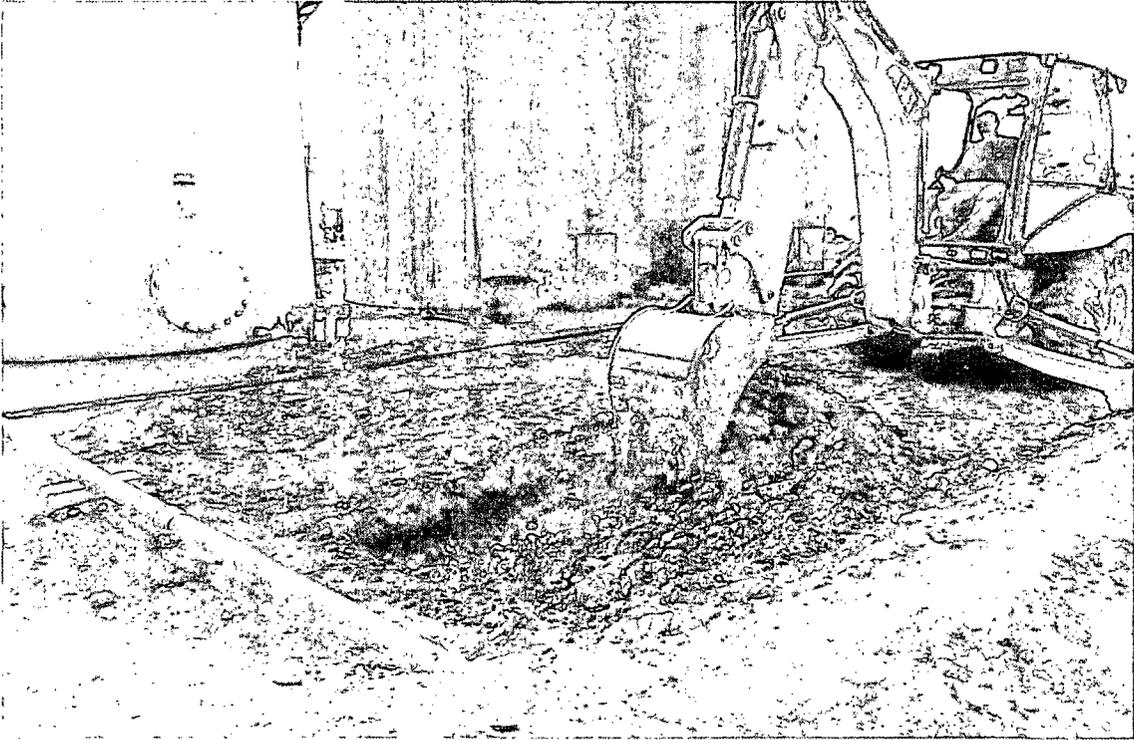
From September 10 to September 20, 2010, remediation activities proceeded at the site. Heavily impacted and visually stained soil was excavated from within the tank battery's containment berm and adjacent to an on-site water tank (Southwest Pooling Area). The excavated soil was stockpiled on-site, pending final disposition, and the containment berm was reconstructed.

WA Simpson - Tank Battery Excavation
