**Release Notification and Corrective Action**

**Cimarex Energy Company  
Pennzoil 36 State Com. #2  
Unit A Section 36, Township 19S, Range 33E  
Lea County, New Mexico**

**Closure Plan**

**December 29, 2010**

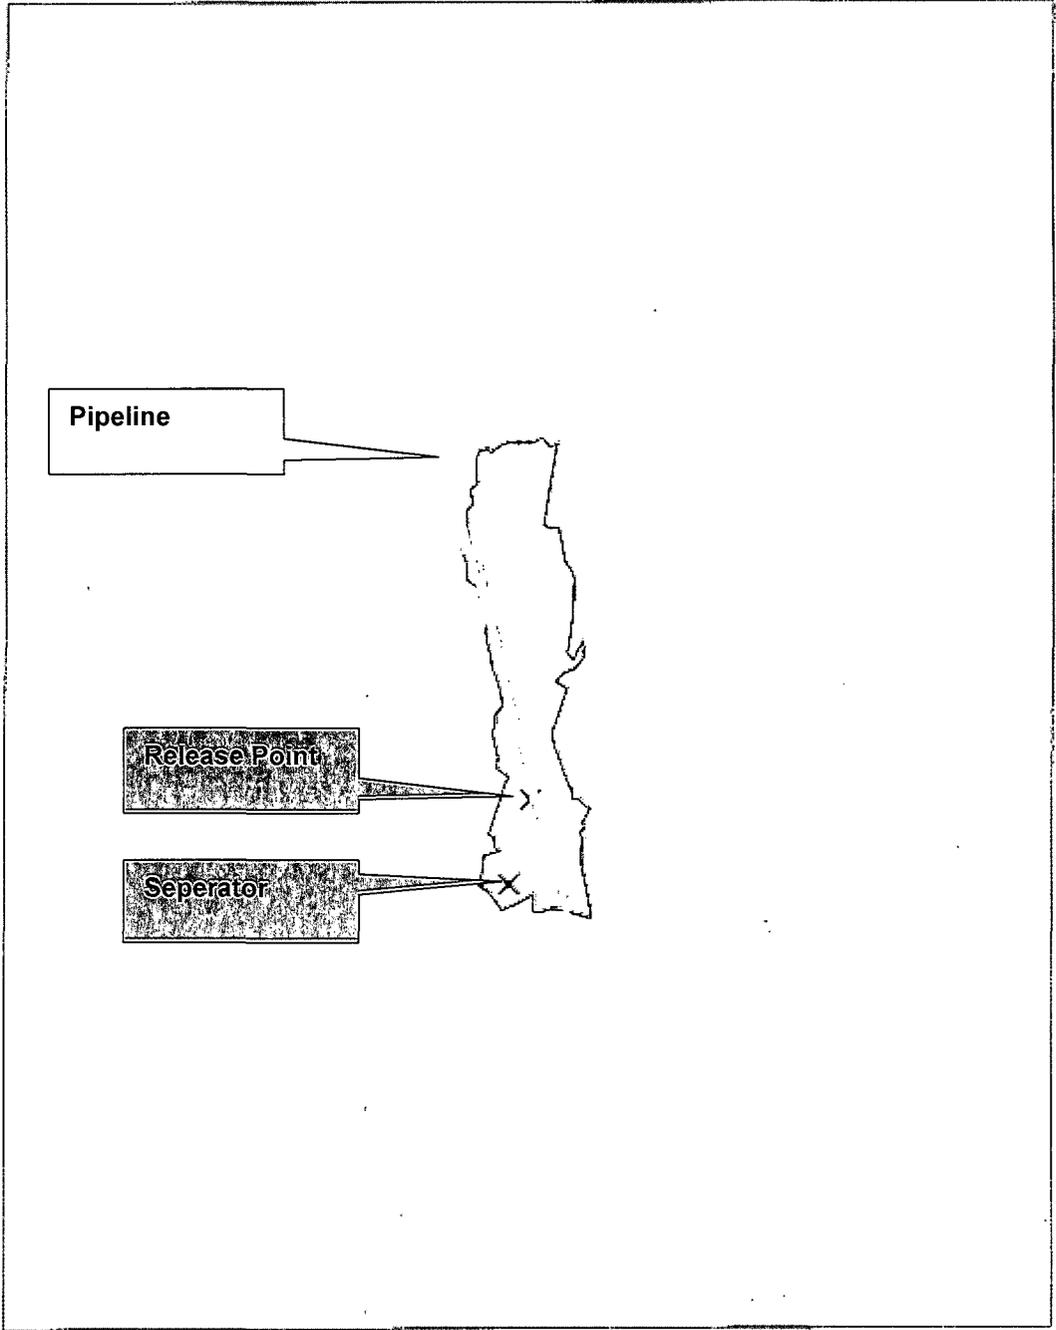
**Figure 2  
Site Map**

CIM-10-019: 2,520 sq ft

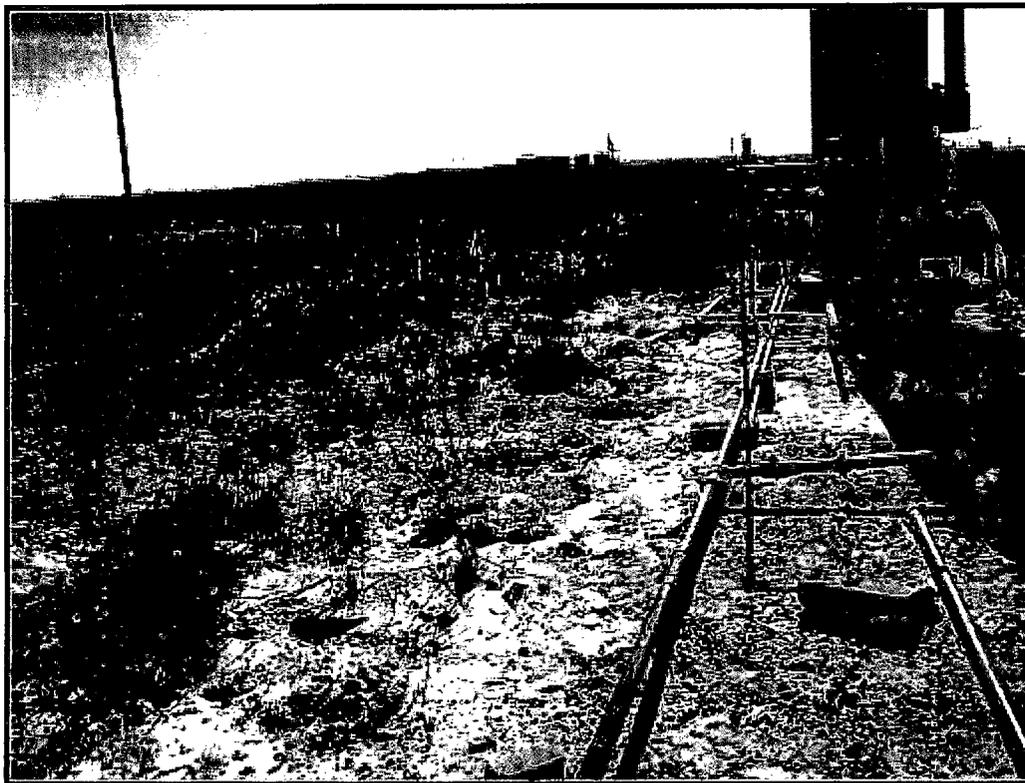
Release area facing south

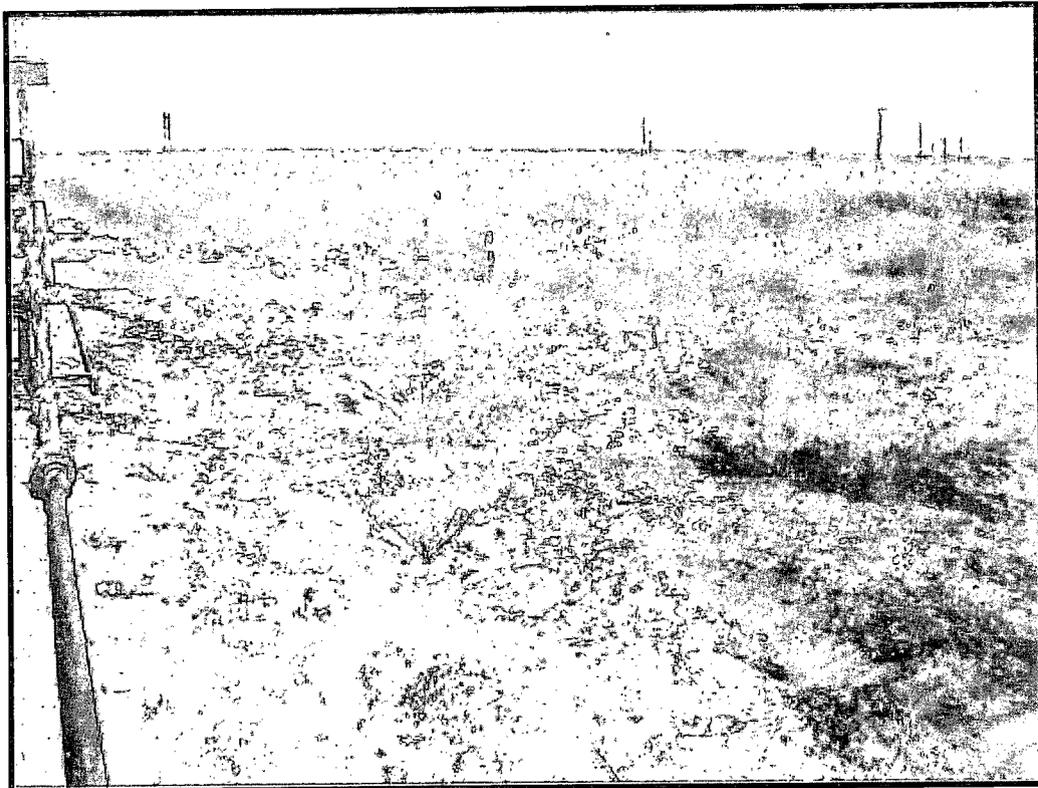
Release area facing northeast

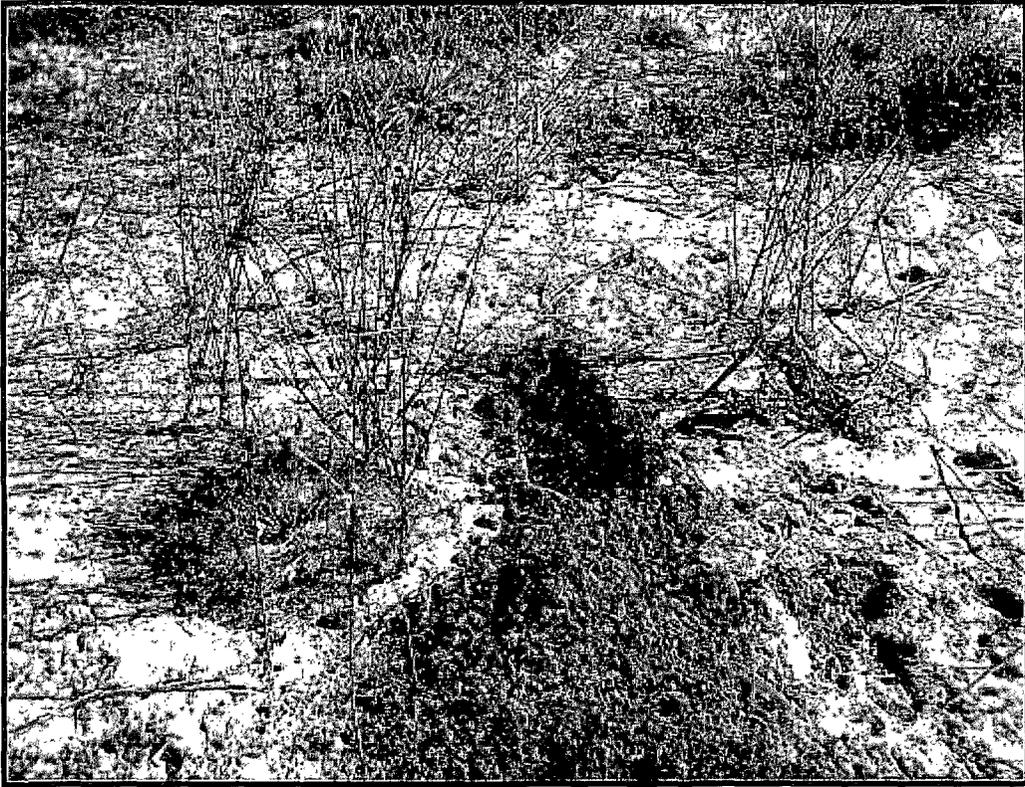
Release area with staining

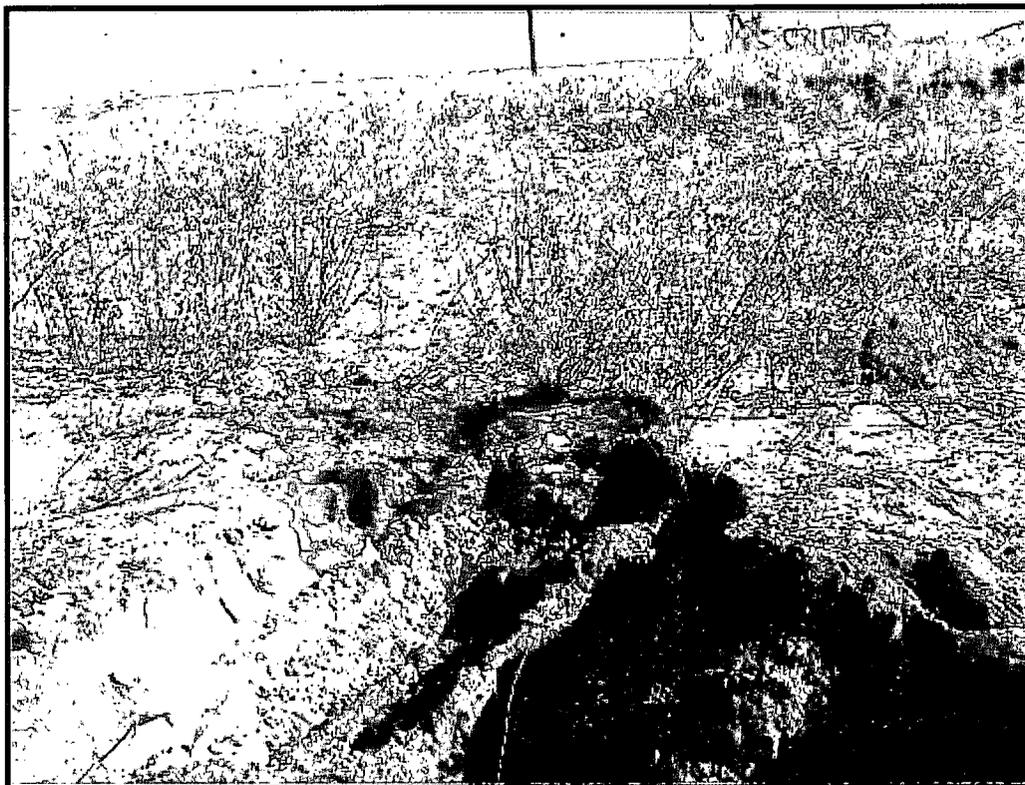
Release area with staining facing east

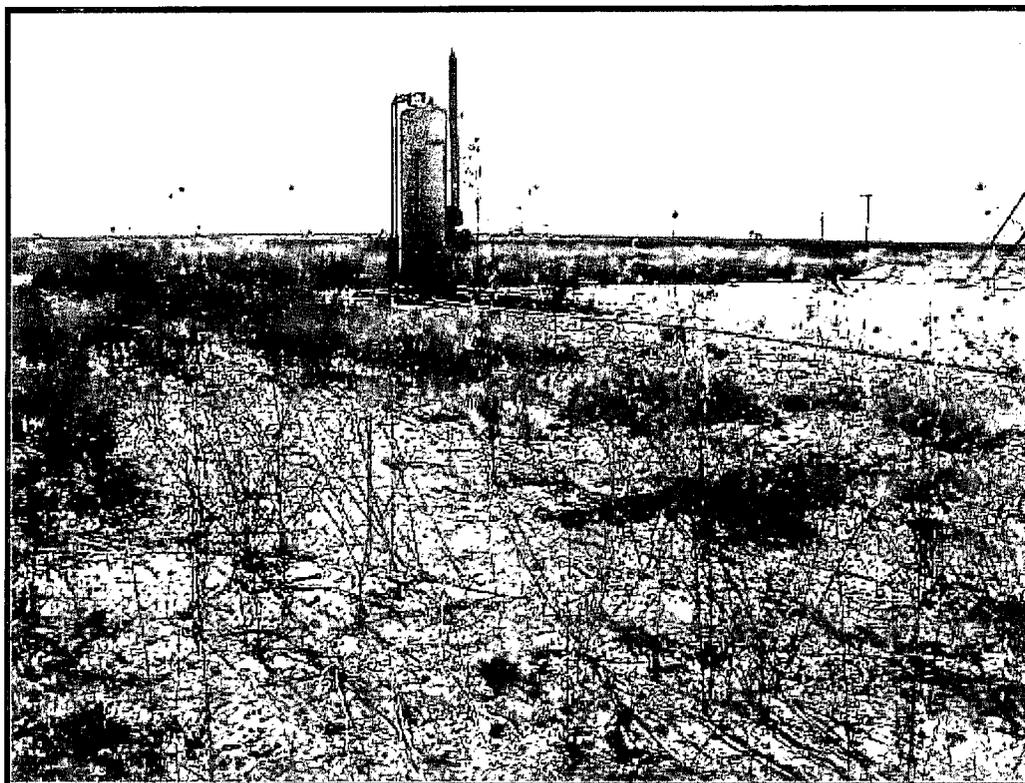
Release area facing southwest

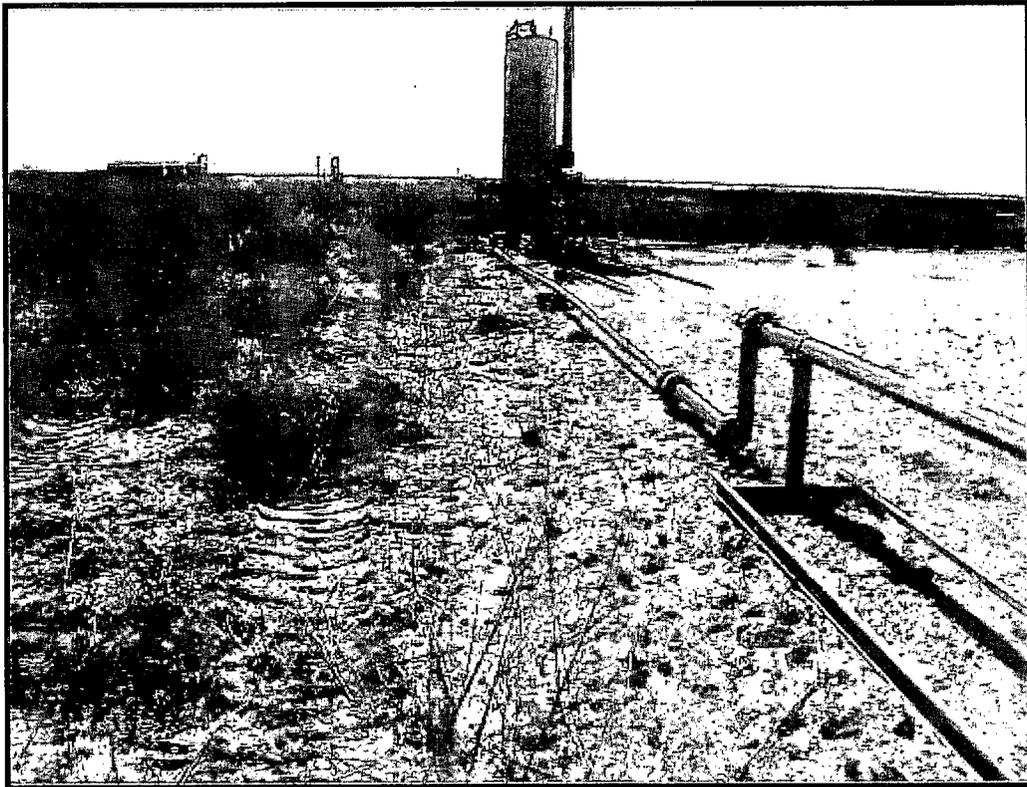
Release area facing south

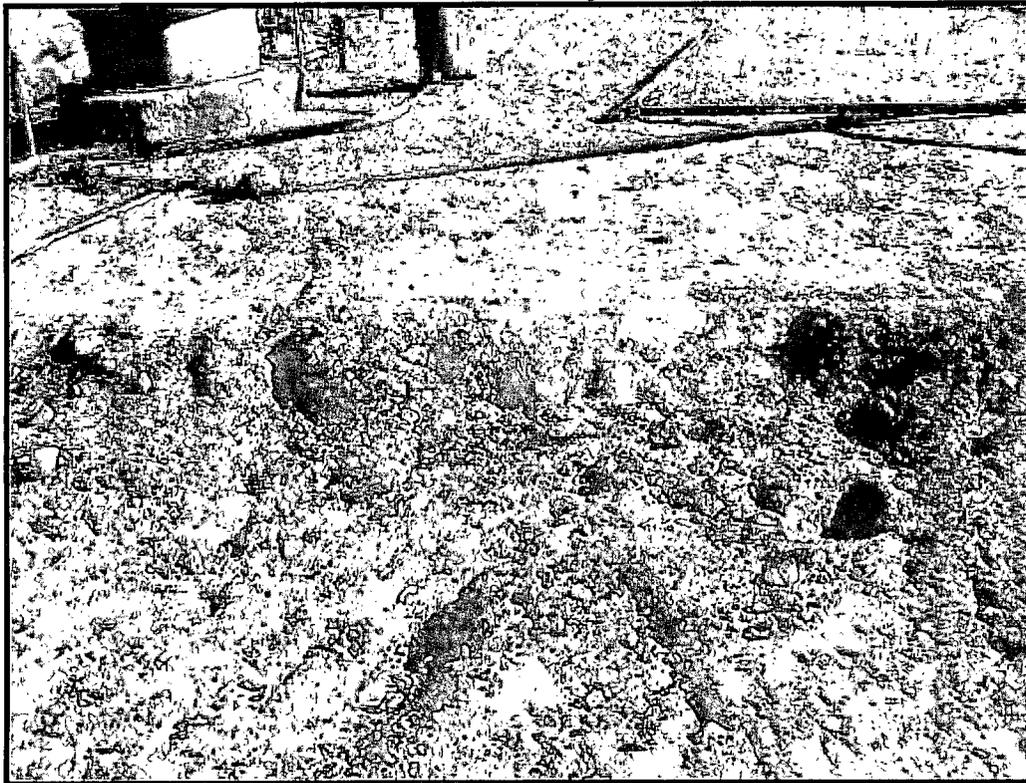
Release area excavated facing south

On December 20, 2010 Safety and Environmental Solutions, Inc. contracted Custom Welding to perform excavation at release area. The release area was excavated between depths of five (5) feet below grade surface (bgs) and six (6) feet below grade surface. Grab samples were retrieved at bottom of excavation and three (3) point composite samples were retrieved from east wall and west wall. Samples were then transported under Chain of Custody to Cardinal Laboratories in Hobbs, NM to be analyzed for Total Petroleum Hydrocarbons (EPA Method 418.1) Chlorides (EPA Method 4500B) and Benzene, Toluene, Ethyl Benzene, and Total Xylenes (BTEX EPA Method 8260B):

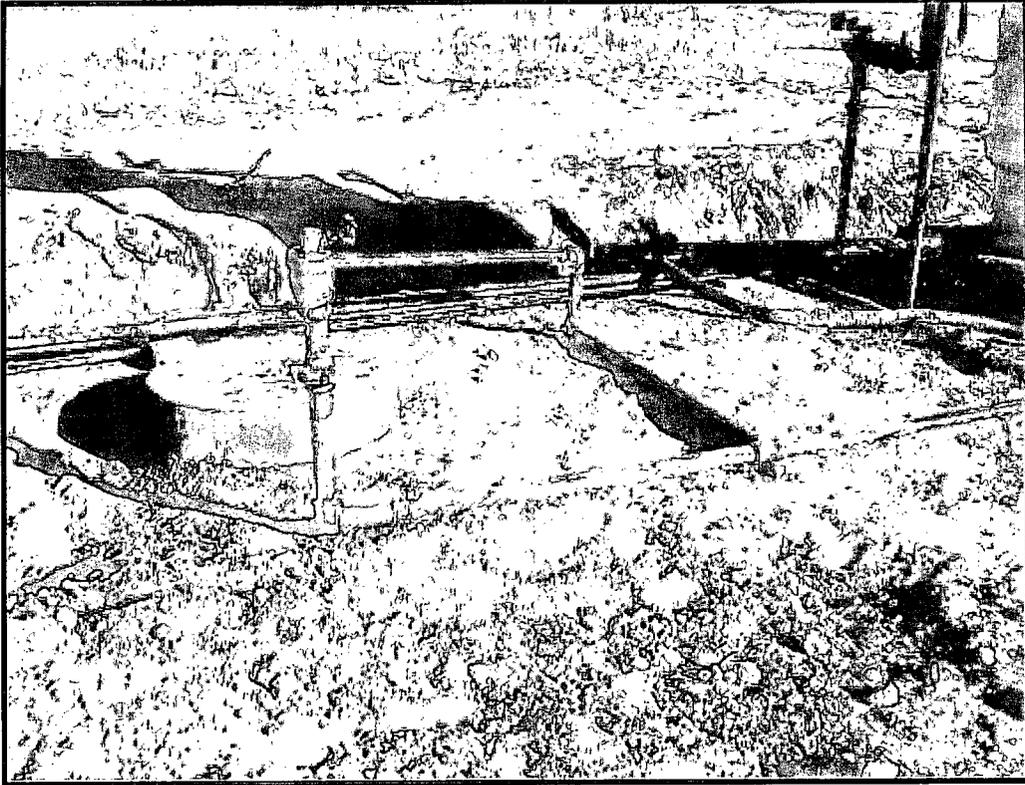
Release area excavated facing east

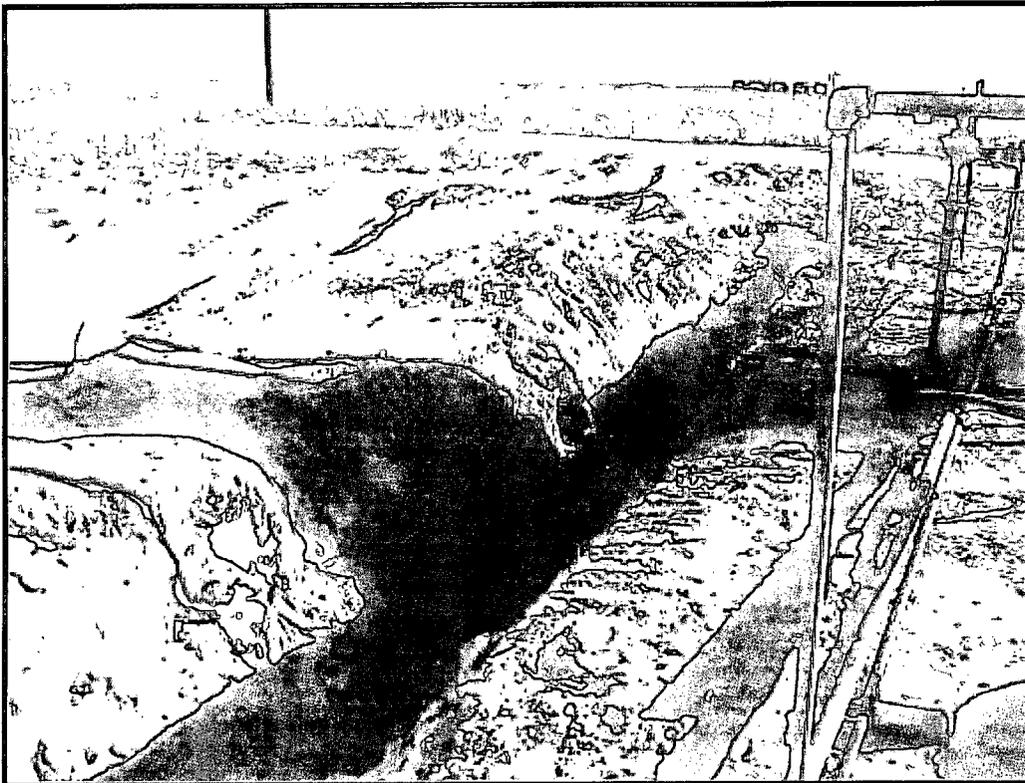
Release area excavated facing southeast

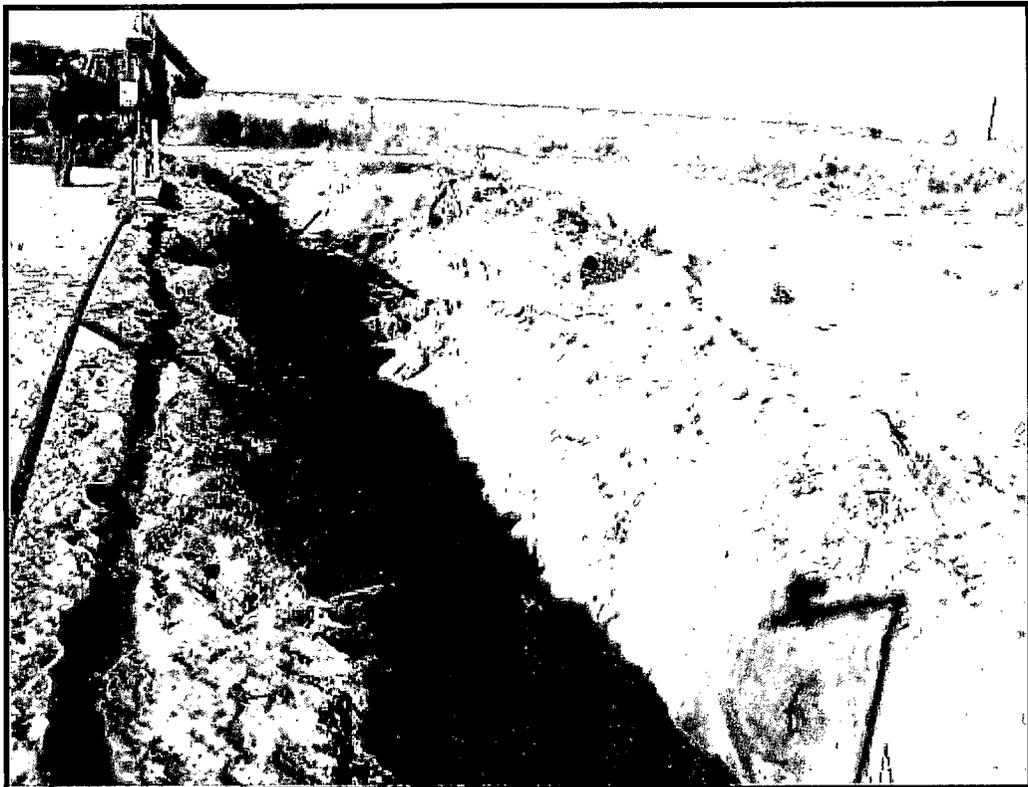
Release area excavated facing northeast

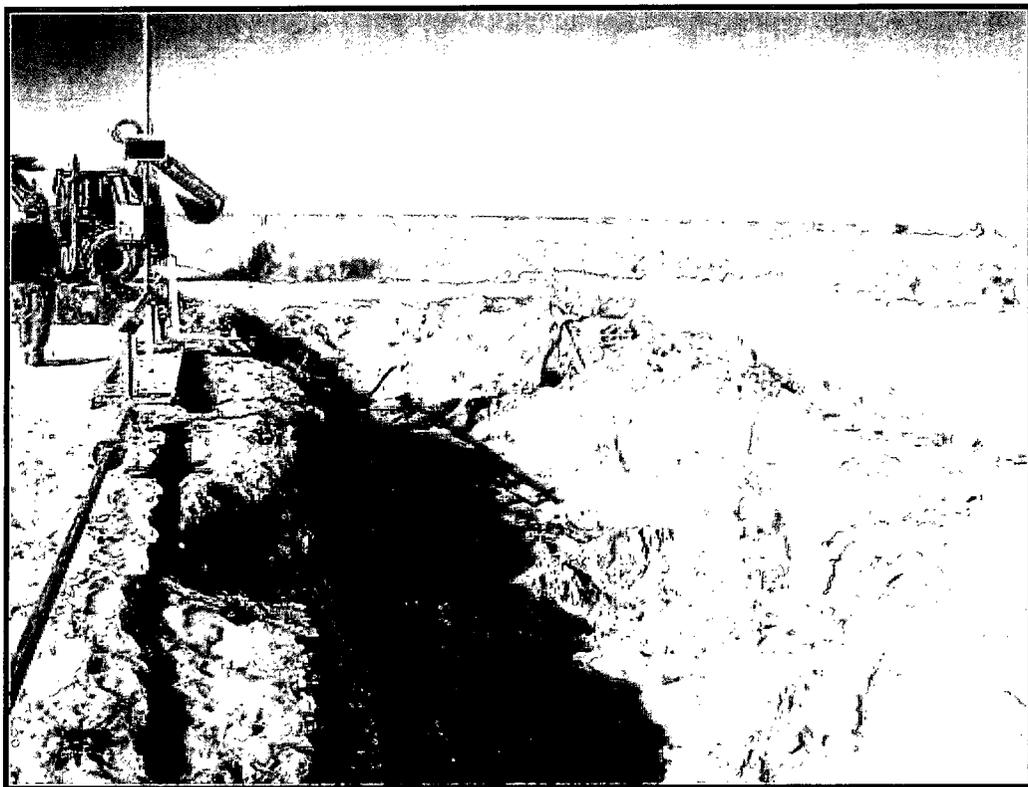
Release area excavated facing north

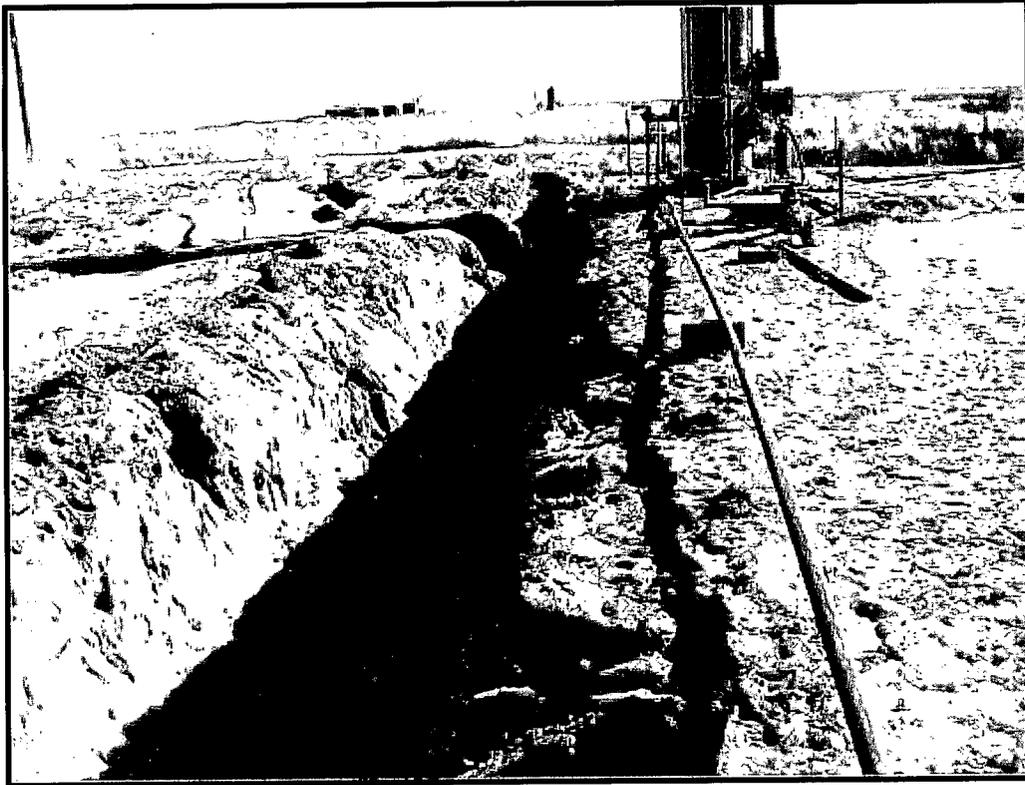
Release area excavated facing south

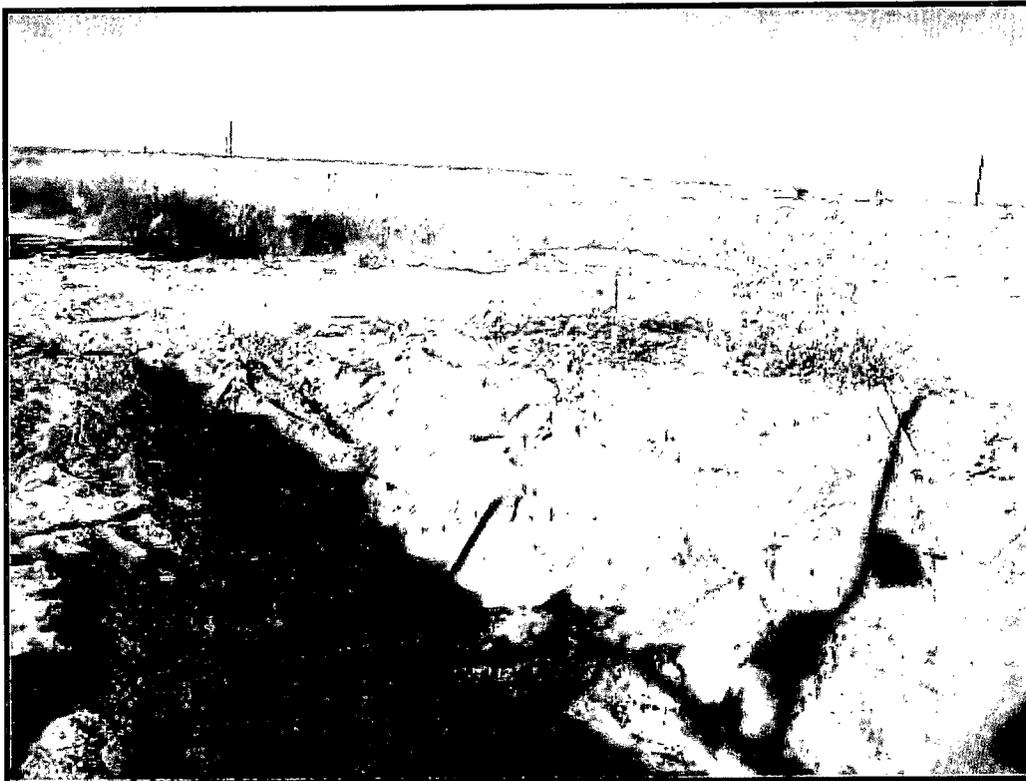
Release area excavated facing north

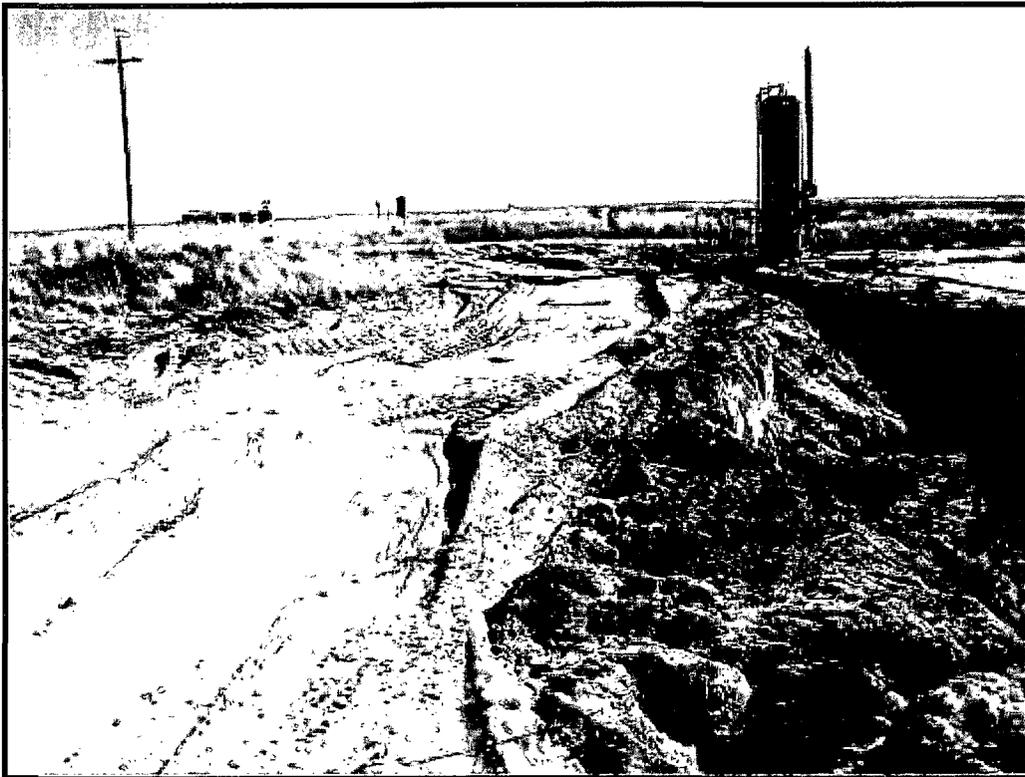
Release area surface facing south

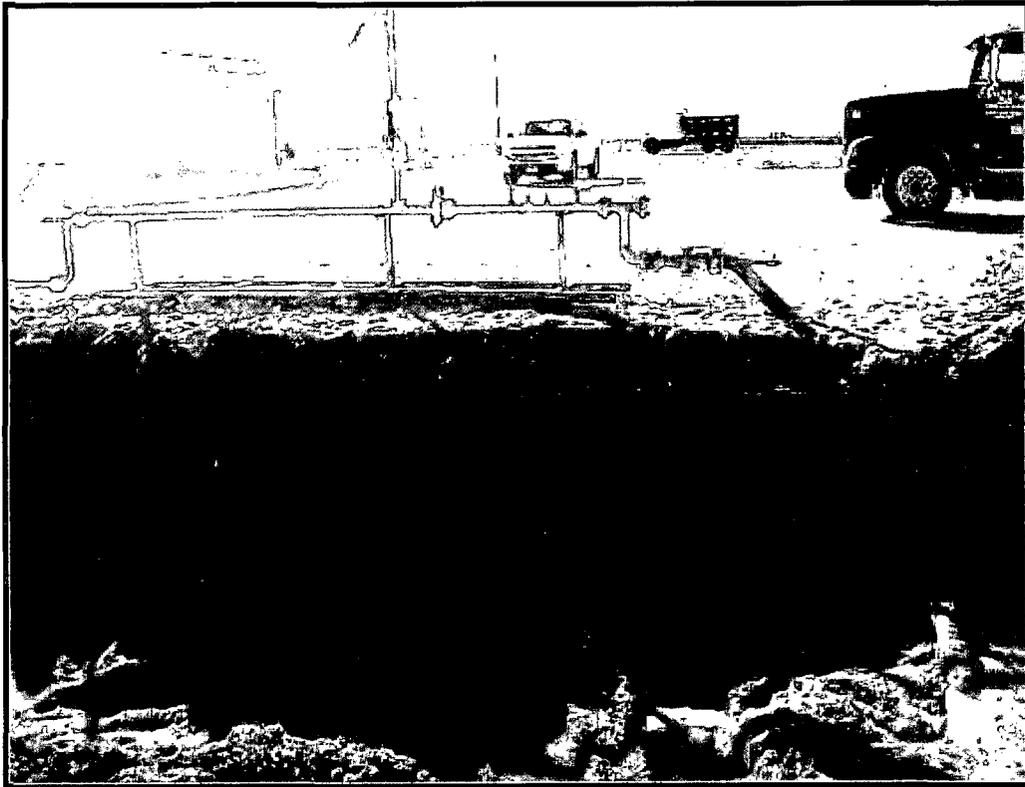
Release area excavated facing west

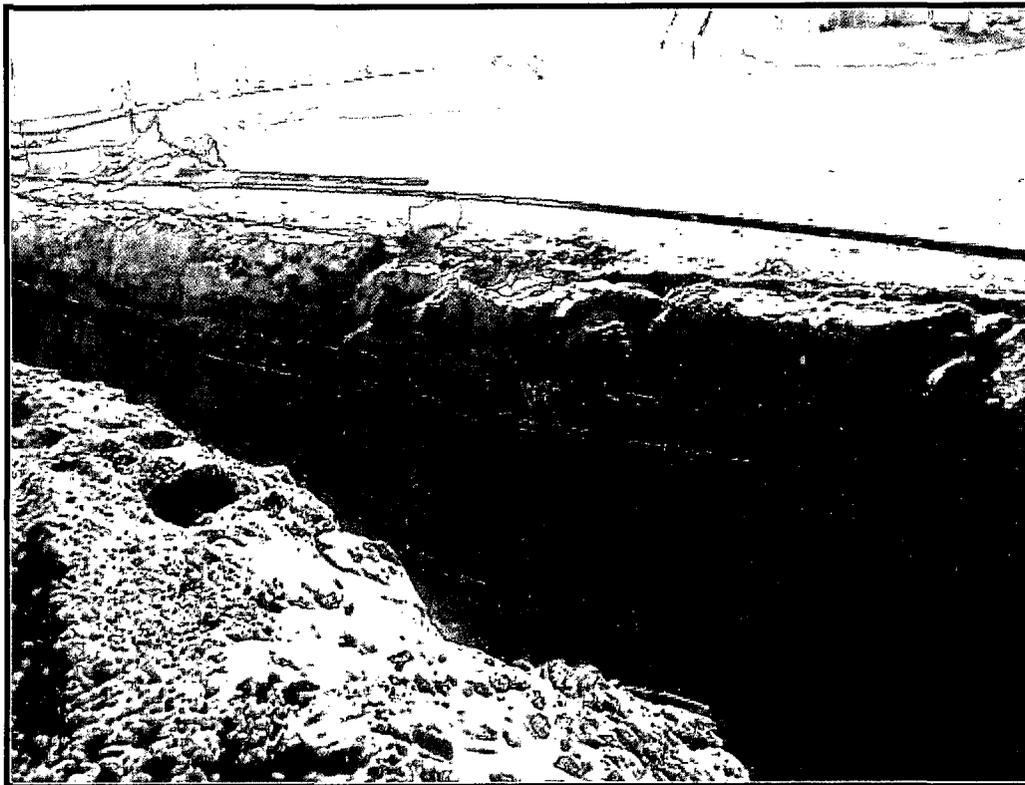
Release area excavated facing west

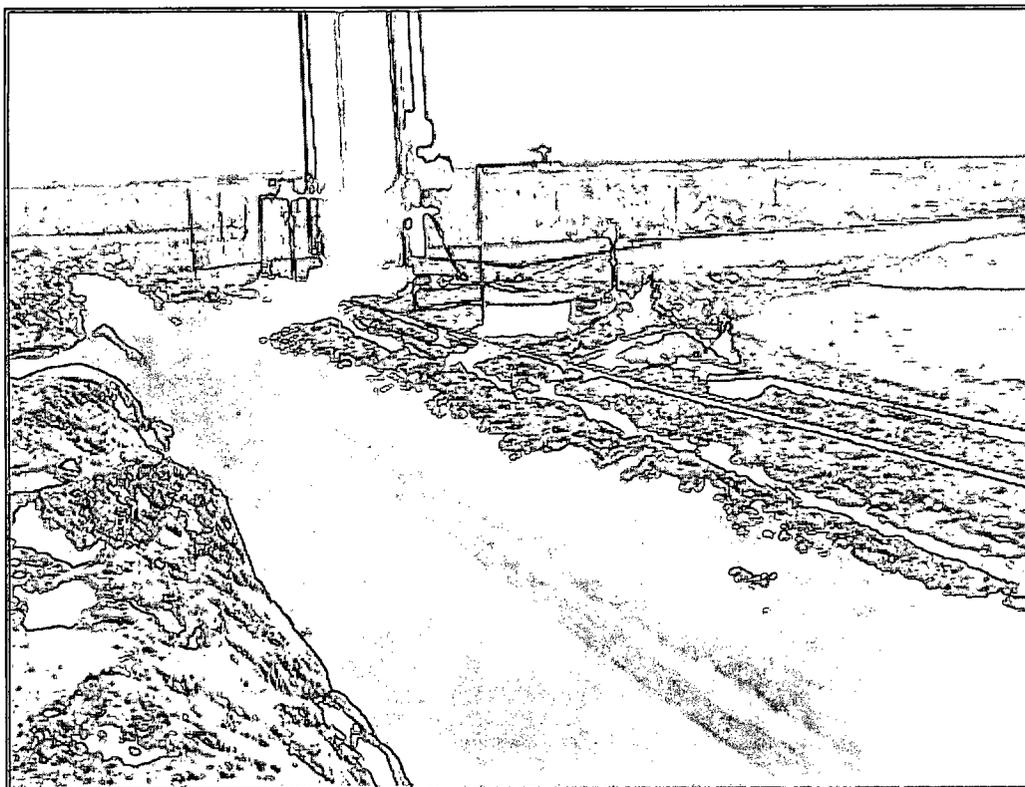
Release area excavated facing southwest
