**From:** Hansen, Edward J., EMNRD  
**Sent:** Monday, February 04, 2013 12:39 PM  
**To:** Hack Conder (hconder@riceswd.com)  
**Cc:** Leking, Geoffrey R, EMNRD; Laura Pena (lpena@riceswd.com); Katie Jones <kjones@riceswd.com> (kjones@riceswd.com); Scott Curtis (scurtis@riceswd.com)  
**Subject:** Remediation Plan (1R427-22) Termination - ROC EME F-11 Site

**RE: Termination Request  
for the Rice Operating Company's  
EME F-11 Site  
Unit Letter F, Section 11, T20S, R36E, NMPM, Lea County, New Mexico  
Remediation Plan (1R427-22) Termination**

RE: Termination Request  
EME F-11 (1R427-22): UL/F Sec. 11, T20S, R36E  
RICE Operating Company – Eunice Monument Eumont SWD System

**RICE OPERATING COMPANY  
JUNCTION BOX FINAL REPORT**

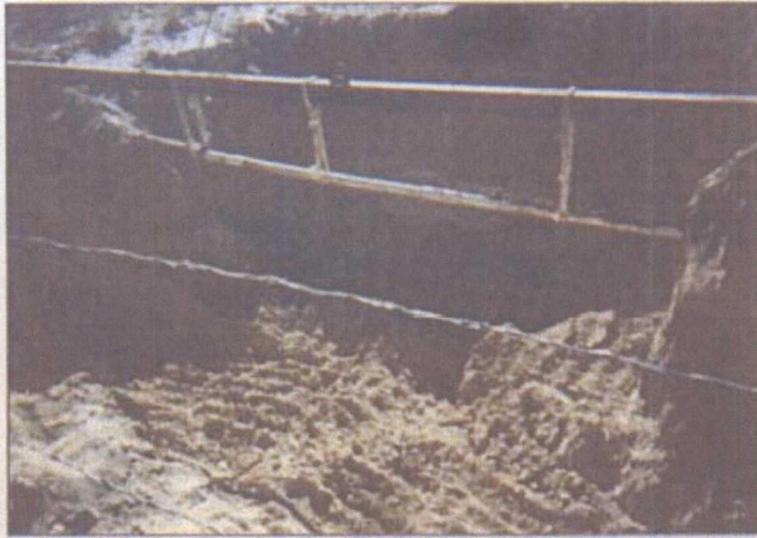
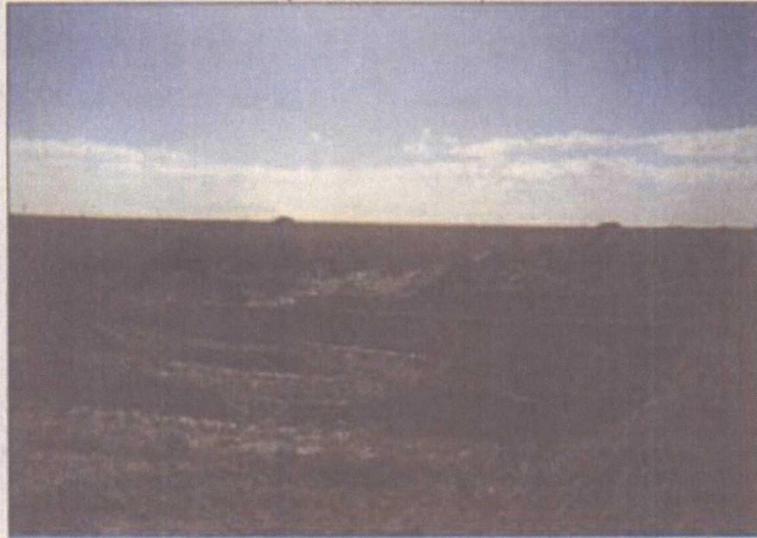
↓ Excavation ↑

**General Description of Remedial Action:** The box was located amongst sparsely vegetated sand dunes. The site was delineated vertically and laterally for TPH and chlorides, producing a 20' x 20' x 7' excavation. The excavated soil was landfarmed on location and then backfilled into the hole. The site was contoured to mimic the natural landscape. This site is no longer a junction so a box was not required. The disturbed surface was seeded with native vegetation and is expected to return to productive capacity at a normal rate. These activities are not detrimental to groundwater, livestock, or public health.

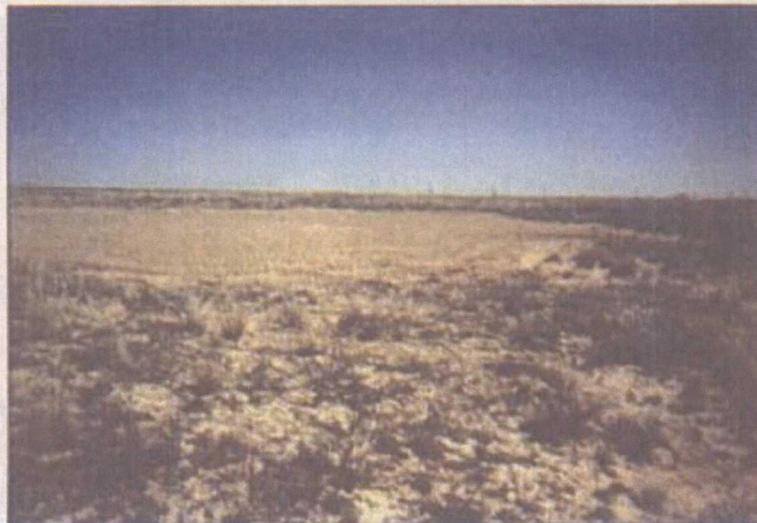
Backfilled

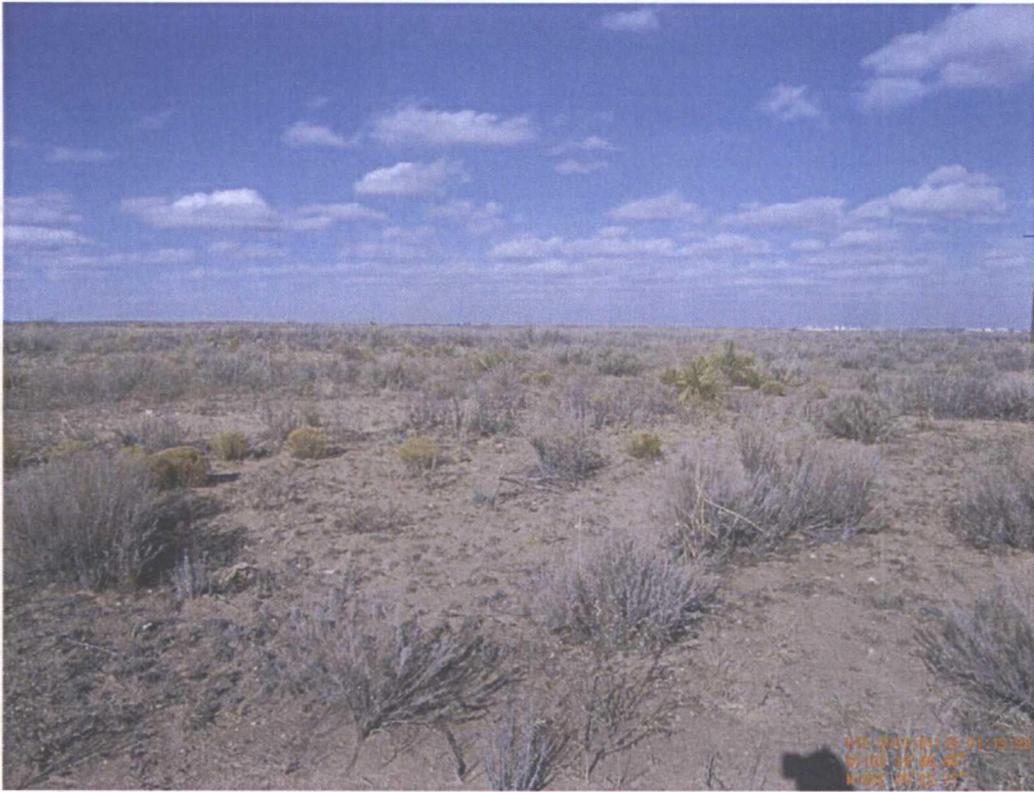
Facing North

1/15/2013

The junction box site location map, final report, photodocumentation, laboratory analysis and current photodocumentation are attached. Vegetation has rebounded at the site so no re-vegetation efforts are needed.

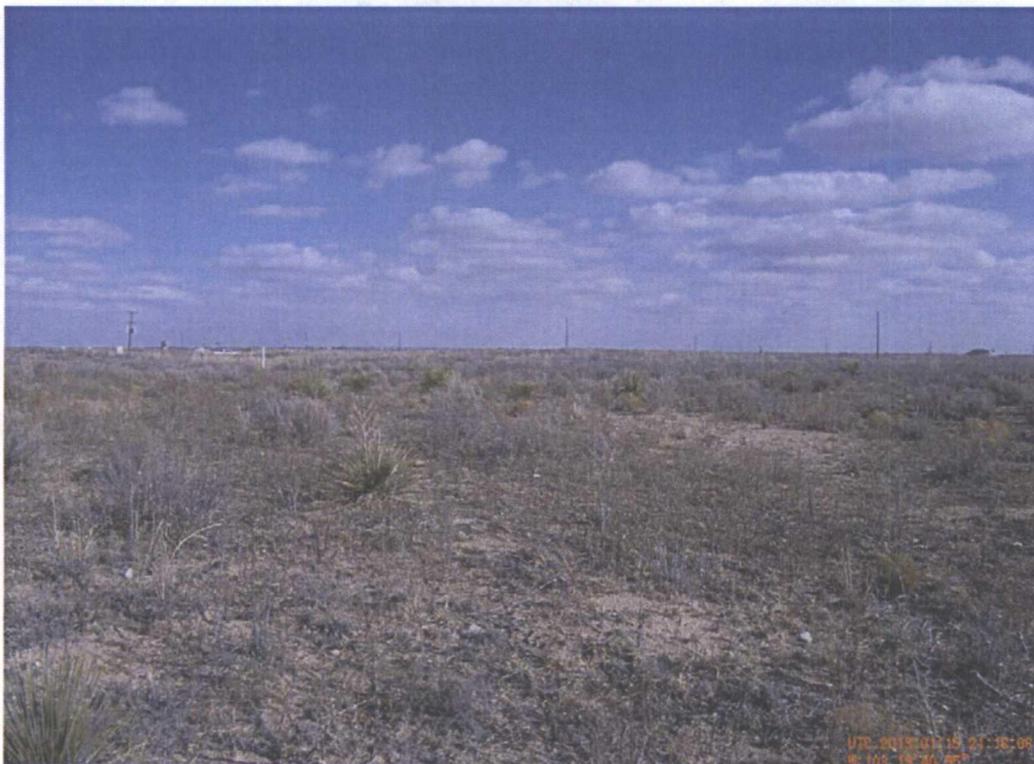
Facing East

1/15/2013
