NAVAJO REFINING COMPANY  
ARTESIA REFINERY, EDDY COUNTY, NEW MEXICO  
**2011 ANNUAL GROUNDWATER REPORT**

# PHASE SEPARATED HYDROCARBON THICKNESS ISOPLETHS (FEET) SECOND SEMIANNUAL EVENT 2011

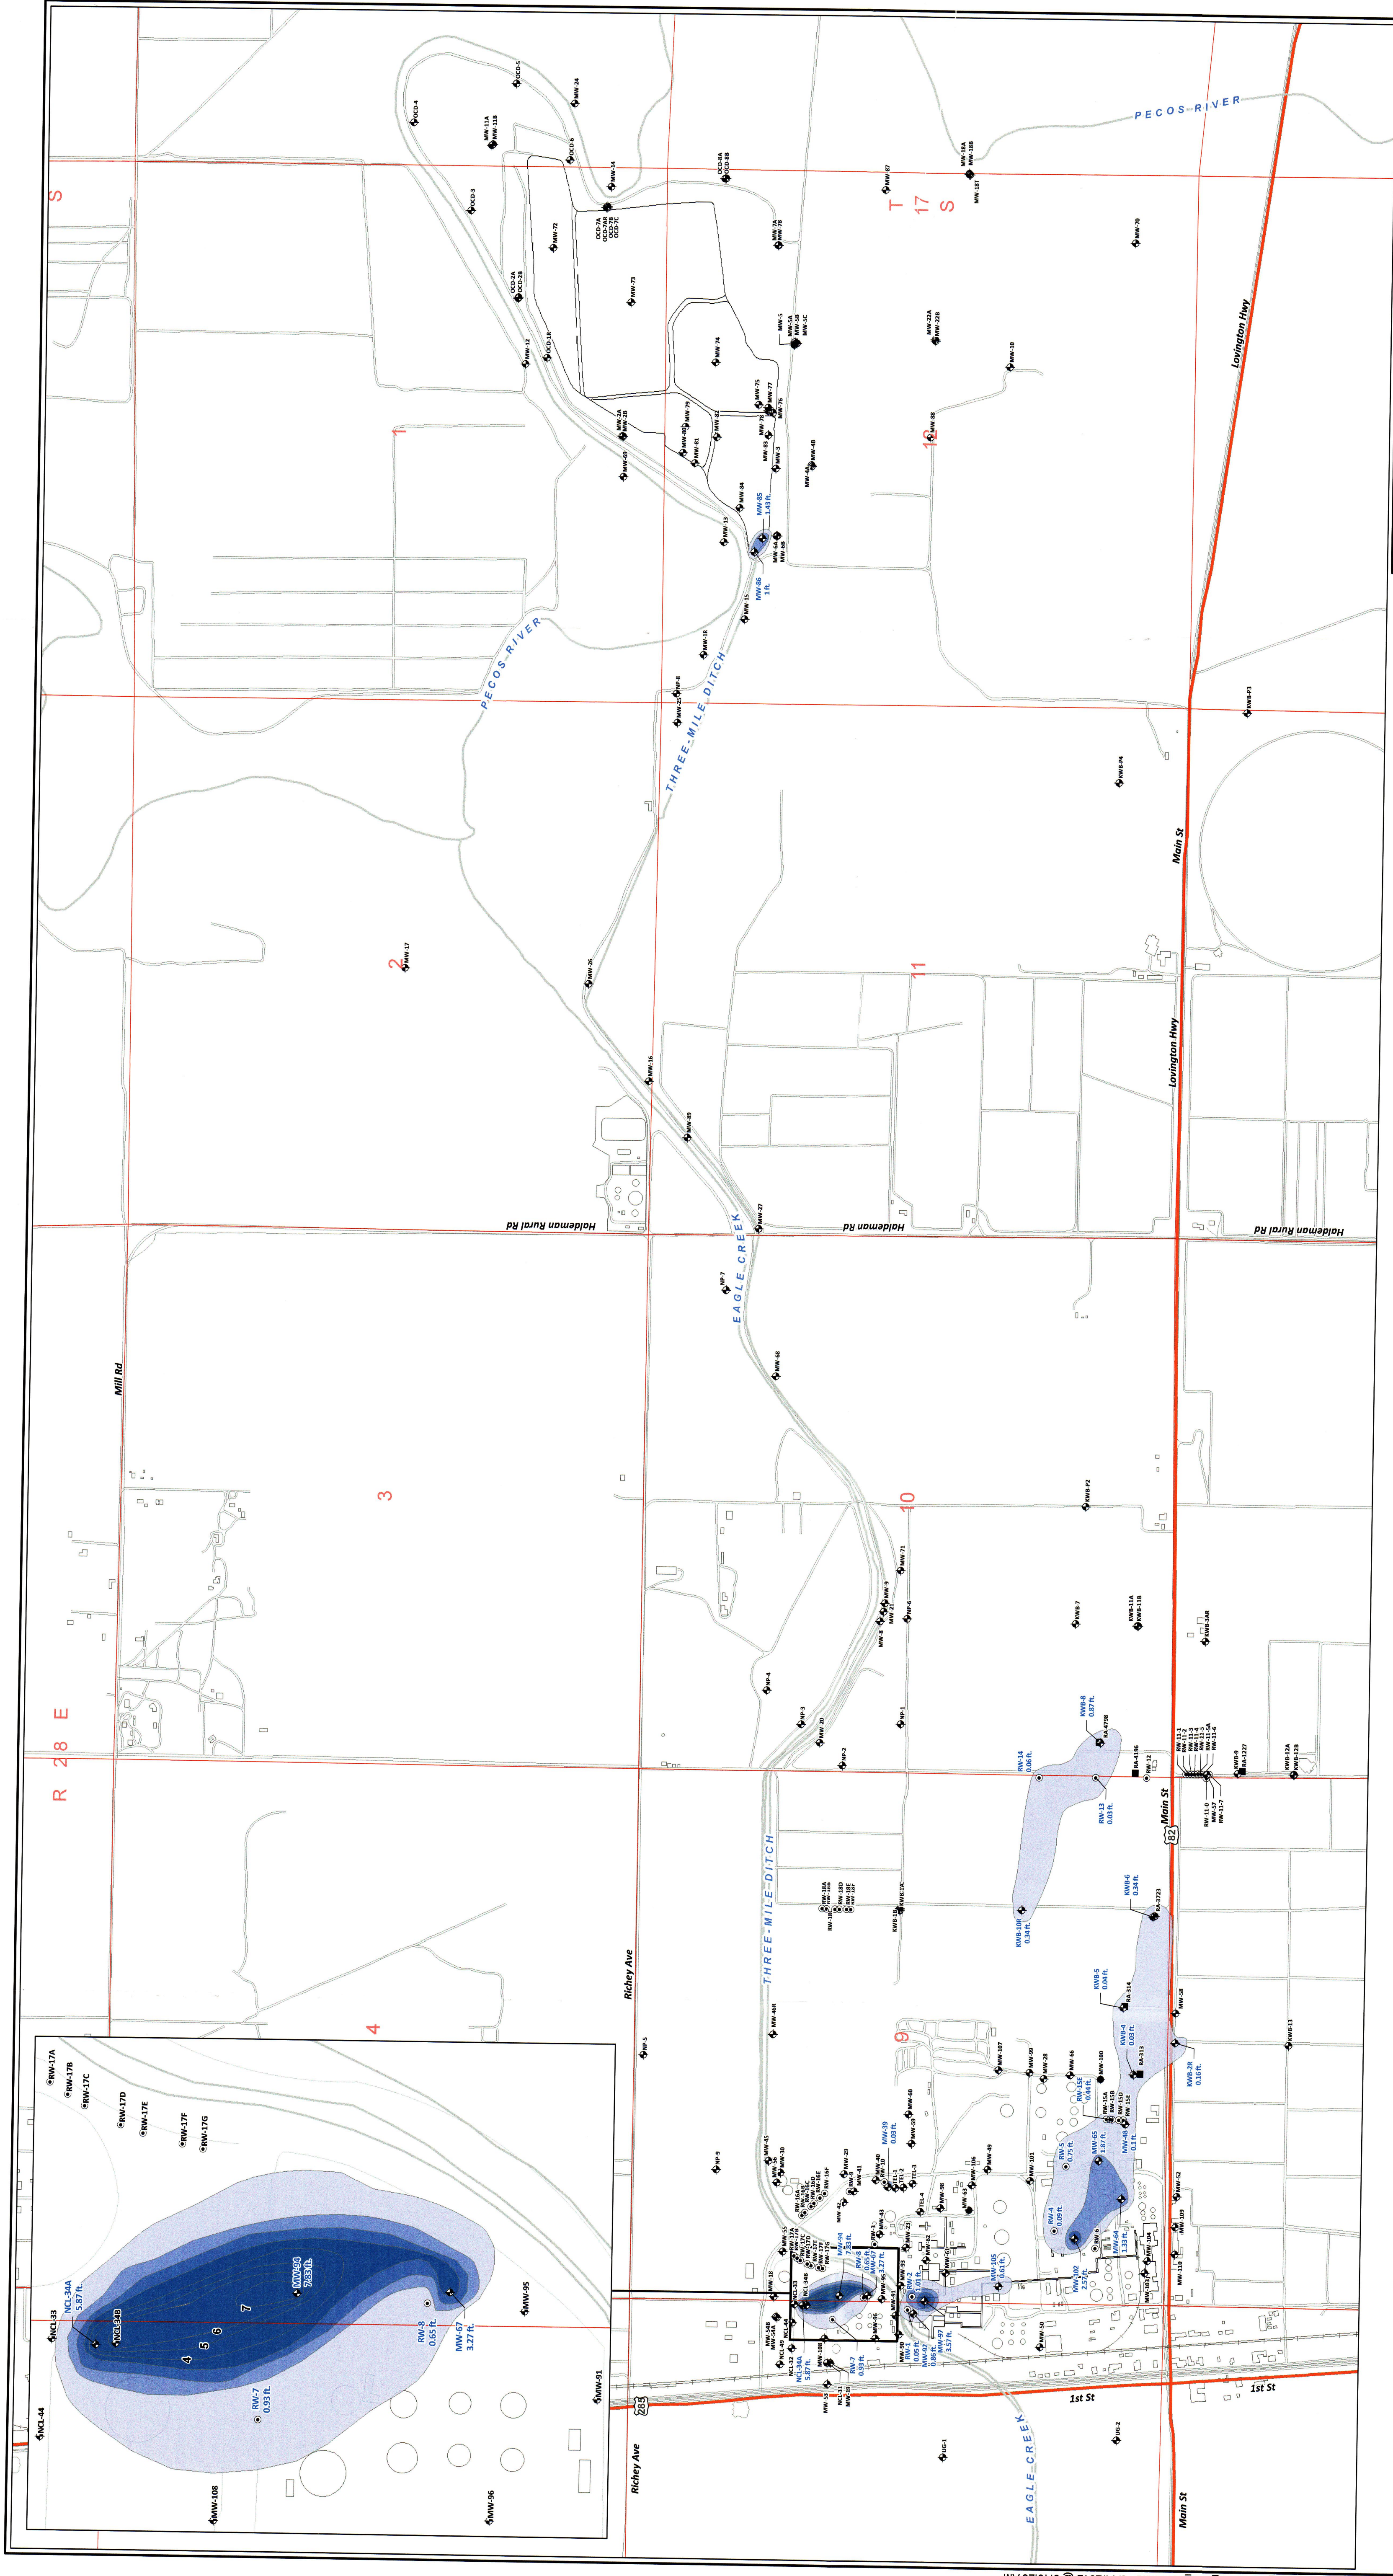
**FIGURE 8**

## PHASE SEPARATED HYDROCARBON THICKNESS
