**RE: Termination Request  
for the Rice Operating Company's  
EME Jct I-29-2 Site  
Unit Letter I, Section 29, T19S, R37E, NMPM, Lea County, New Mexico  
Remediation Plan (1R427-334) Termination**

RE: Termination Request  
EME Jct. I-29-2 (1R427-334): UL/I, Sec. 29, T19S, R37E  
RICE Operating Company – Eunice Monument Eumont SWD System

## EME Jct. I-29-2 (1R427-334)

**RICE OPERATING COMPANY  
JUNCTION BOX FINAL REPORT**

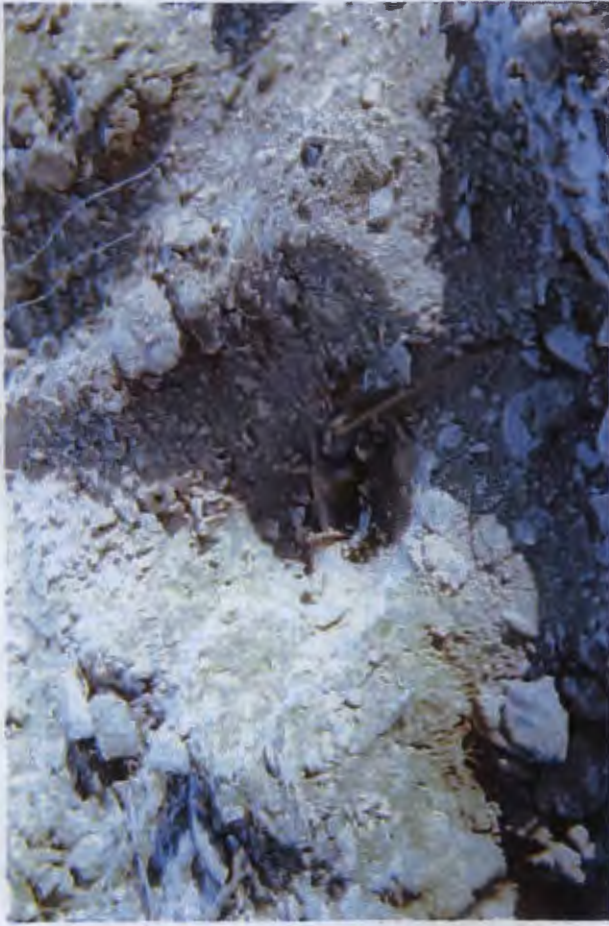
1/29/2010

Site prior to excavating

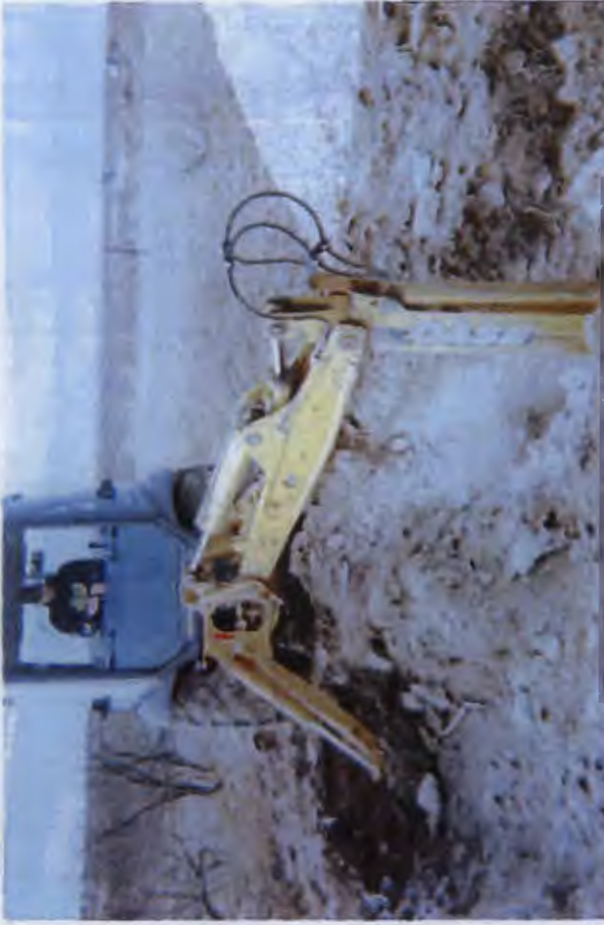
1/29/2010

Delineation trench being excavated

**General Description of Remedial Action:** This junction and line were eliminated under the pipeline replacement/upgrade program. After the former junction was removed, an investigation was conducted using a backhoe to collect soil samples at regular intervals. Chloride field tests were performed on each sample, which yielded low concentrations of chloride similar to that of the background sample. Organic vapors were measured using a PID, which also yielded low concentrations. The deepest sample, 10 ft BGS, was sent to a commercial laboratory for analysis, which confirmed low concentrations of chloride and organics. The excavated soil was returned to the excavation to ground surface and contoured to the surrounding area. On 2/05/2010, site was seeded with a blend of native vegetation and is expected to return to a productive capacity at a normal rate.

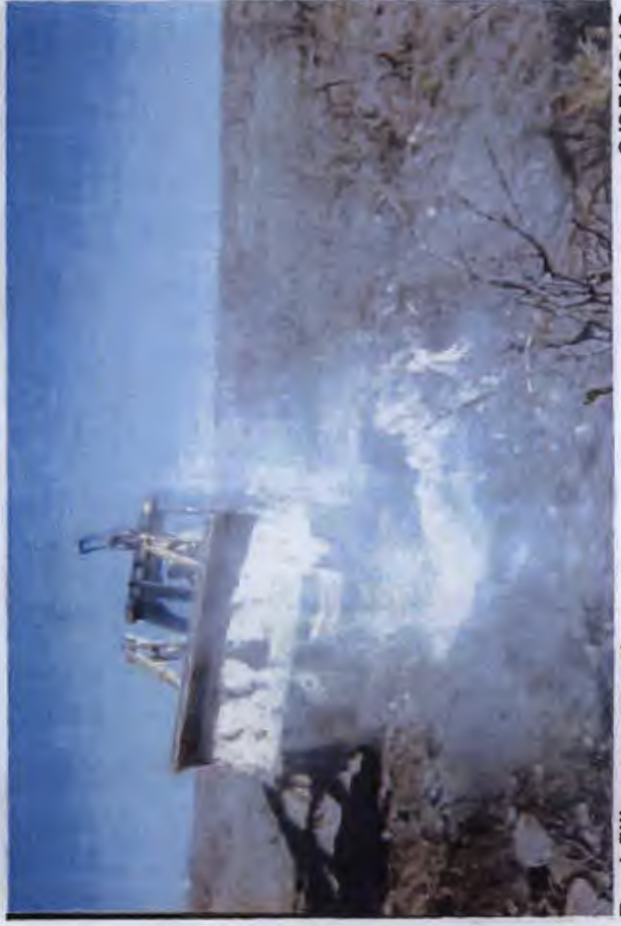
2/05/2010

Backfilling excavation

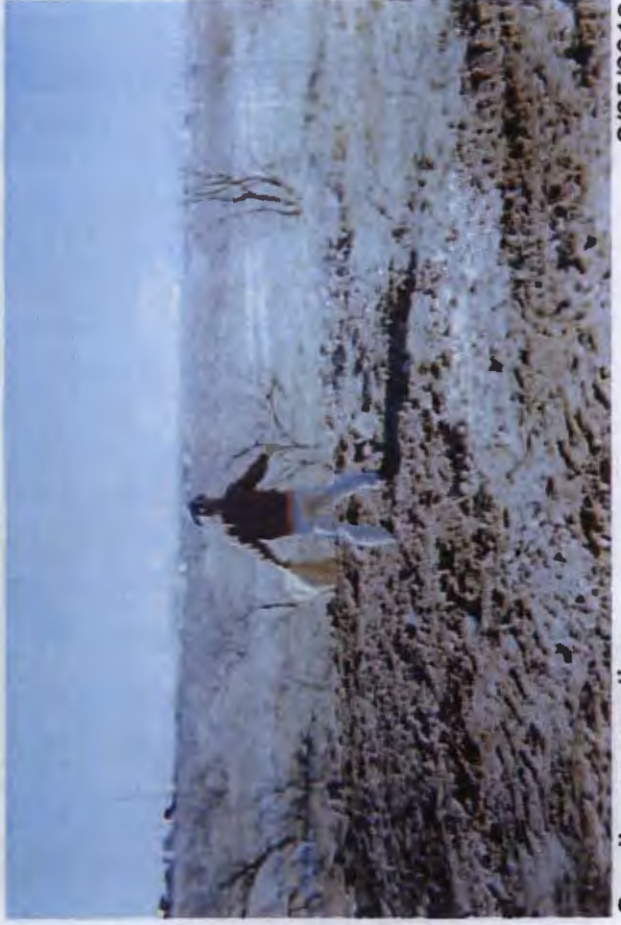
2/05/2010

Seeding excavation

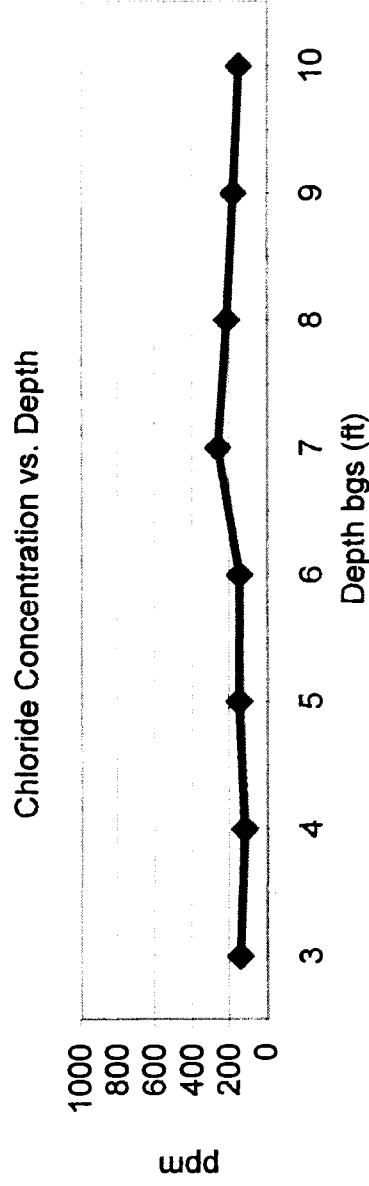
# EME Junction I-29-2

Backhoe samples at the junction (source)

Depth bgs (ft)	[Cl] ppm
3	140
4	116
5	145
6	143
7	260
8	211
9	178
10	148

Groundwater = 30 ft.

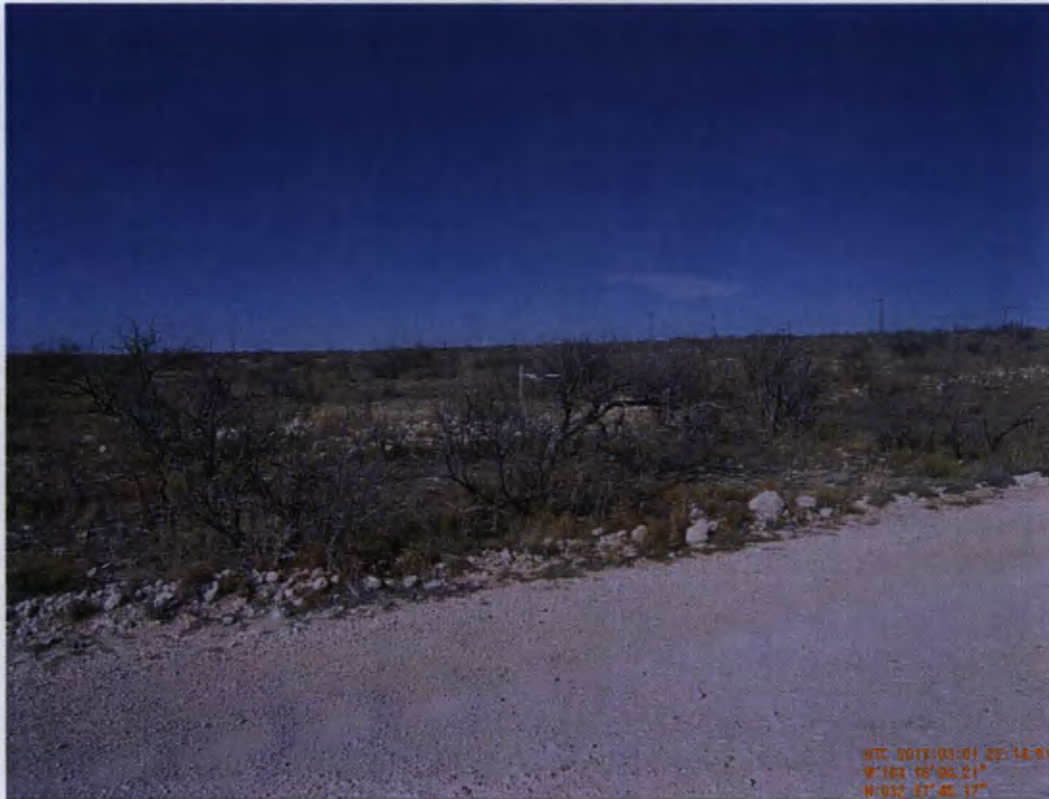
3/1/2013

In 2010, ROC initiated work on the former I-29-2 junction box. The site is located in UL/I, Sec. 29, T19S, R37E. NM OSE records indicate that groundwater would likely be encountered at a depth of approximately 30 +/- feet. The site was delineated using a backhoe to collect soil samples at regular intervals, creating a 5x3x10 ft deep excavation. Each sample was field titrated for chlorides and field screened using a PID for hydrocarbons, resulting in low concentrations of each. The 10 ft sample was sent to a commercial laboratory for analysis of chloride and TPH, resulting in a chloride concentration of 224 mg/kg, a gasoline range organics (GRO) concentration below detectable limits and a diesel range organics (DRO) concentration of 24.1 mg/kg. The excavated soil was returned to the excavation and contoured to the surrounding area. On 2/5/2010, the site was seeded with a blend of native vegetation. A junction box is no longer needed at the site. Vegetation has rebounded at the site, so no re-vegetation efforts are needed.

Facing north

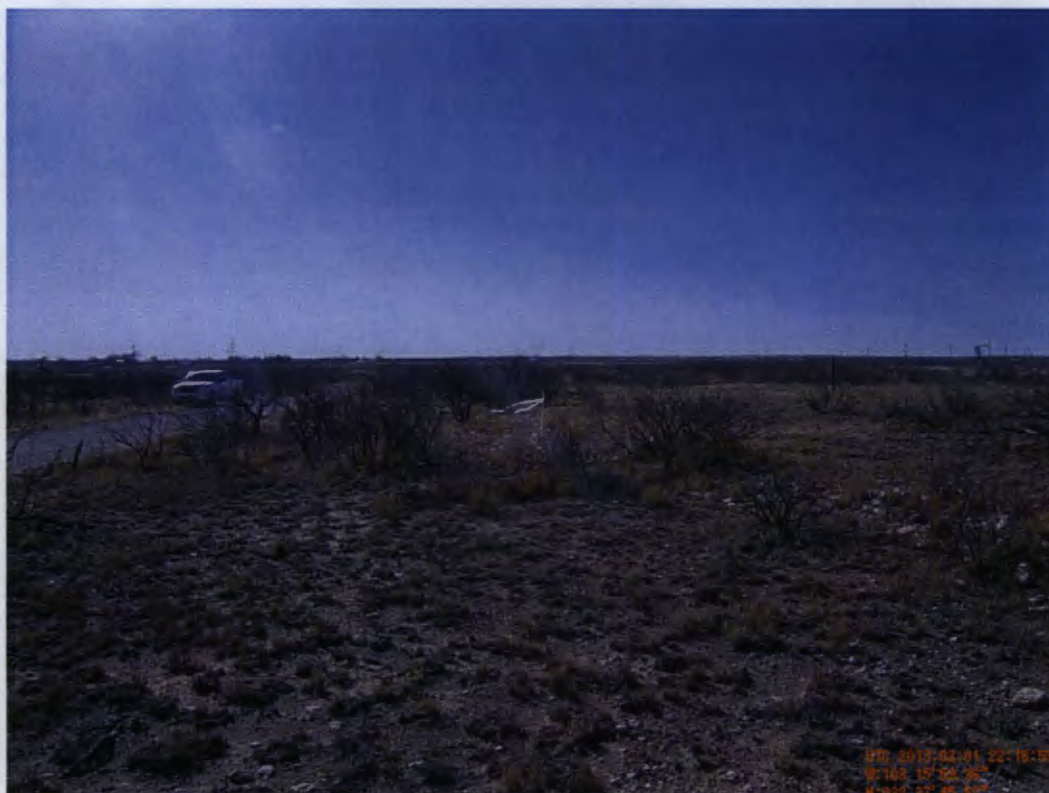
3/1/2013

Facing west
