AP - 104

BUCKEYE VACUUM FIELD UNIT SITE--2011 ANNUAL GROUNDWATER MONITORING REPORT

**SECTION 1--TOWNSHIP 18 SOUTH--RANGE 34 EAST
LEA COUNTY, NM**

SEPTEMBER 2012

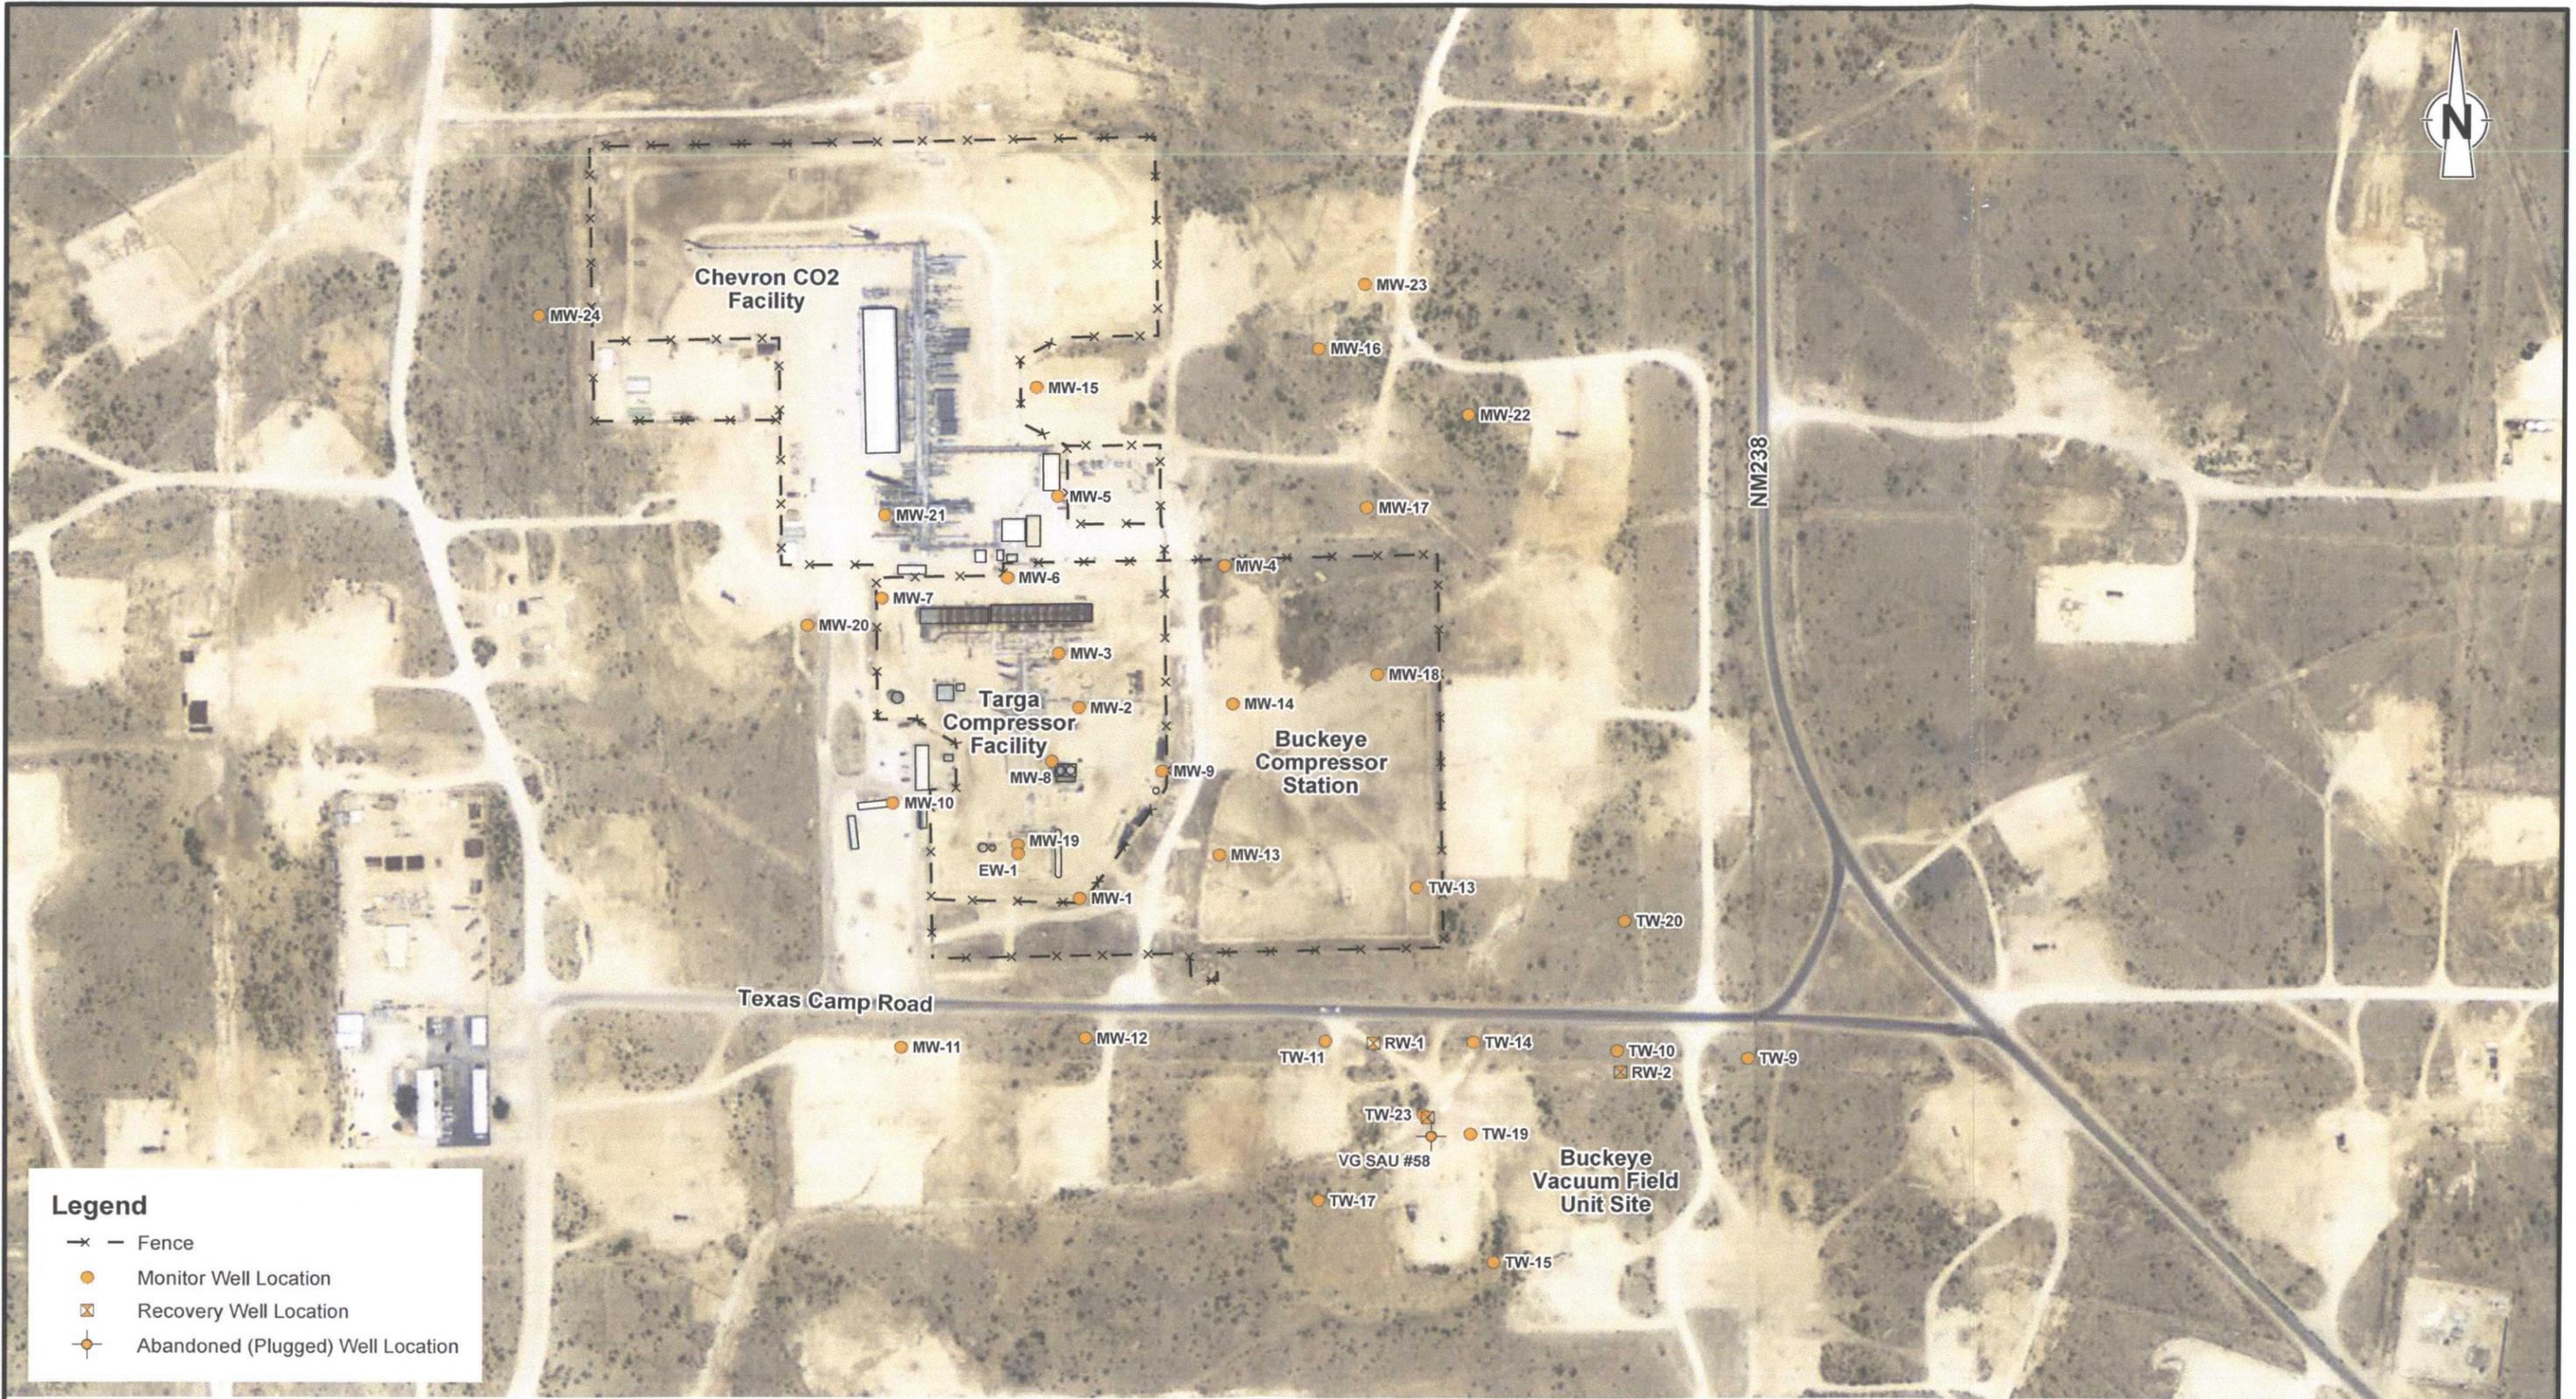
figure 2
 SITE DETAILS MAP
 BUCKEYE VACUUM FIELD UNIT SITE
 SECTION 1, T18S-R34E, LEA COUNTY, NEW MEXICO
 Chevron Environmental Management Company, Houston, Texas

The Buckeye Vacuum Field Unit Site includes 10 active monitor wells and three extraction wells. They are shown on FIGURE 2. Three monitor wells and one recovery well, TW-10, TW-13, TW-14, and RW-3, were both gauged and sampled during 2011. Groundwater at the site was monitored during two semi-annual events during 2011. The first took place on April 12. The second groundwater monitoring event was conducted on October 17 and 18.

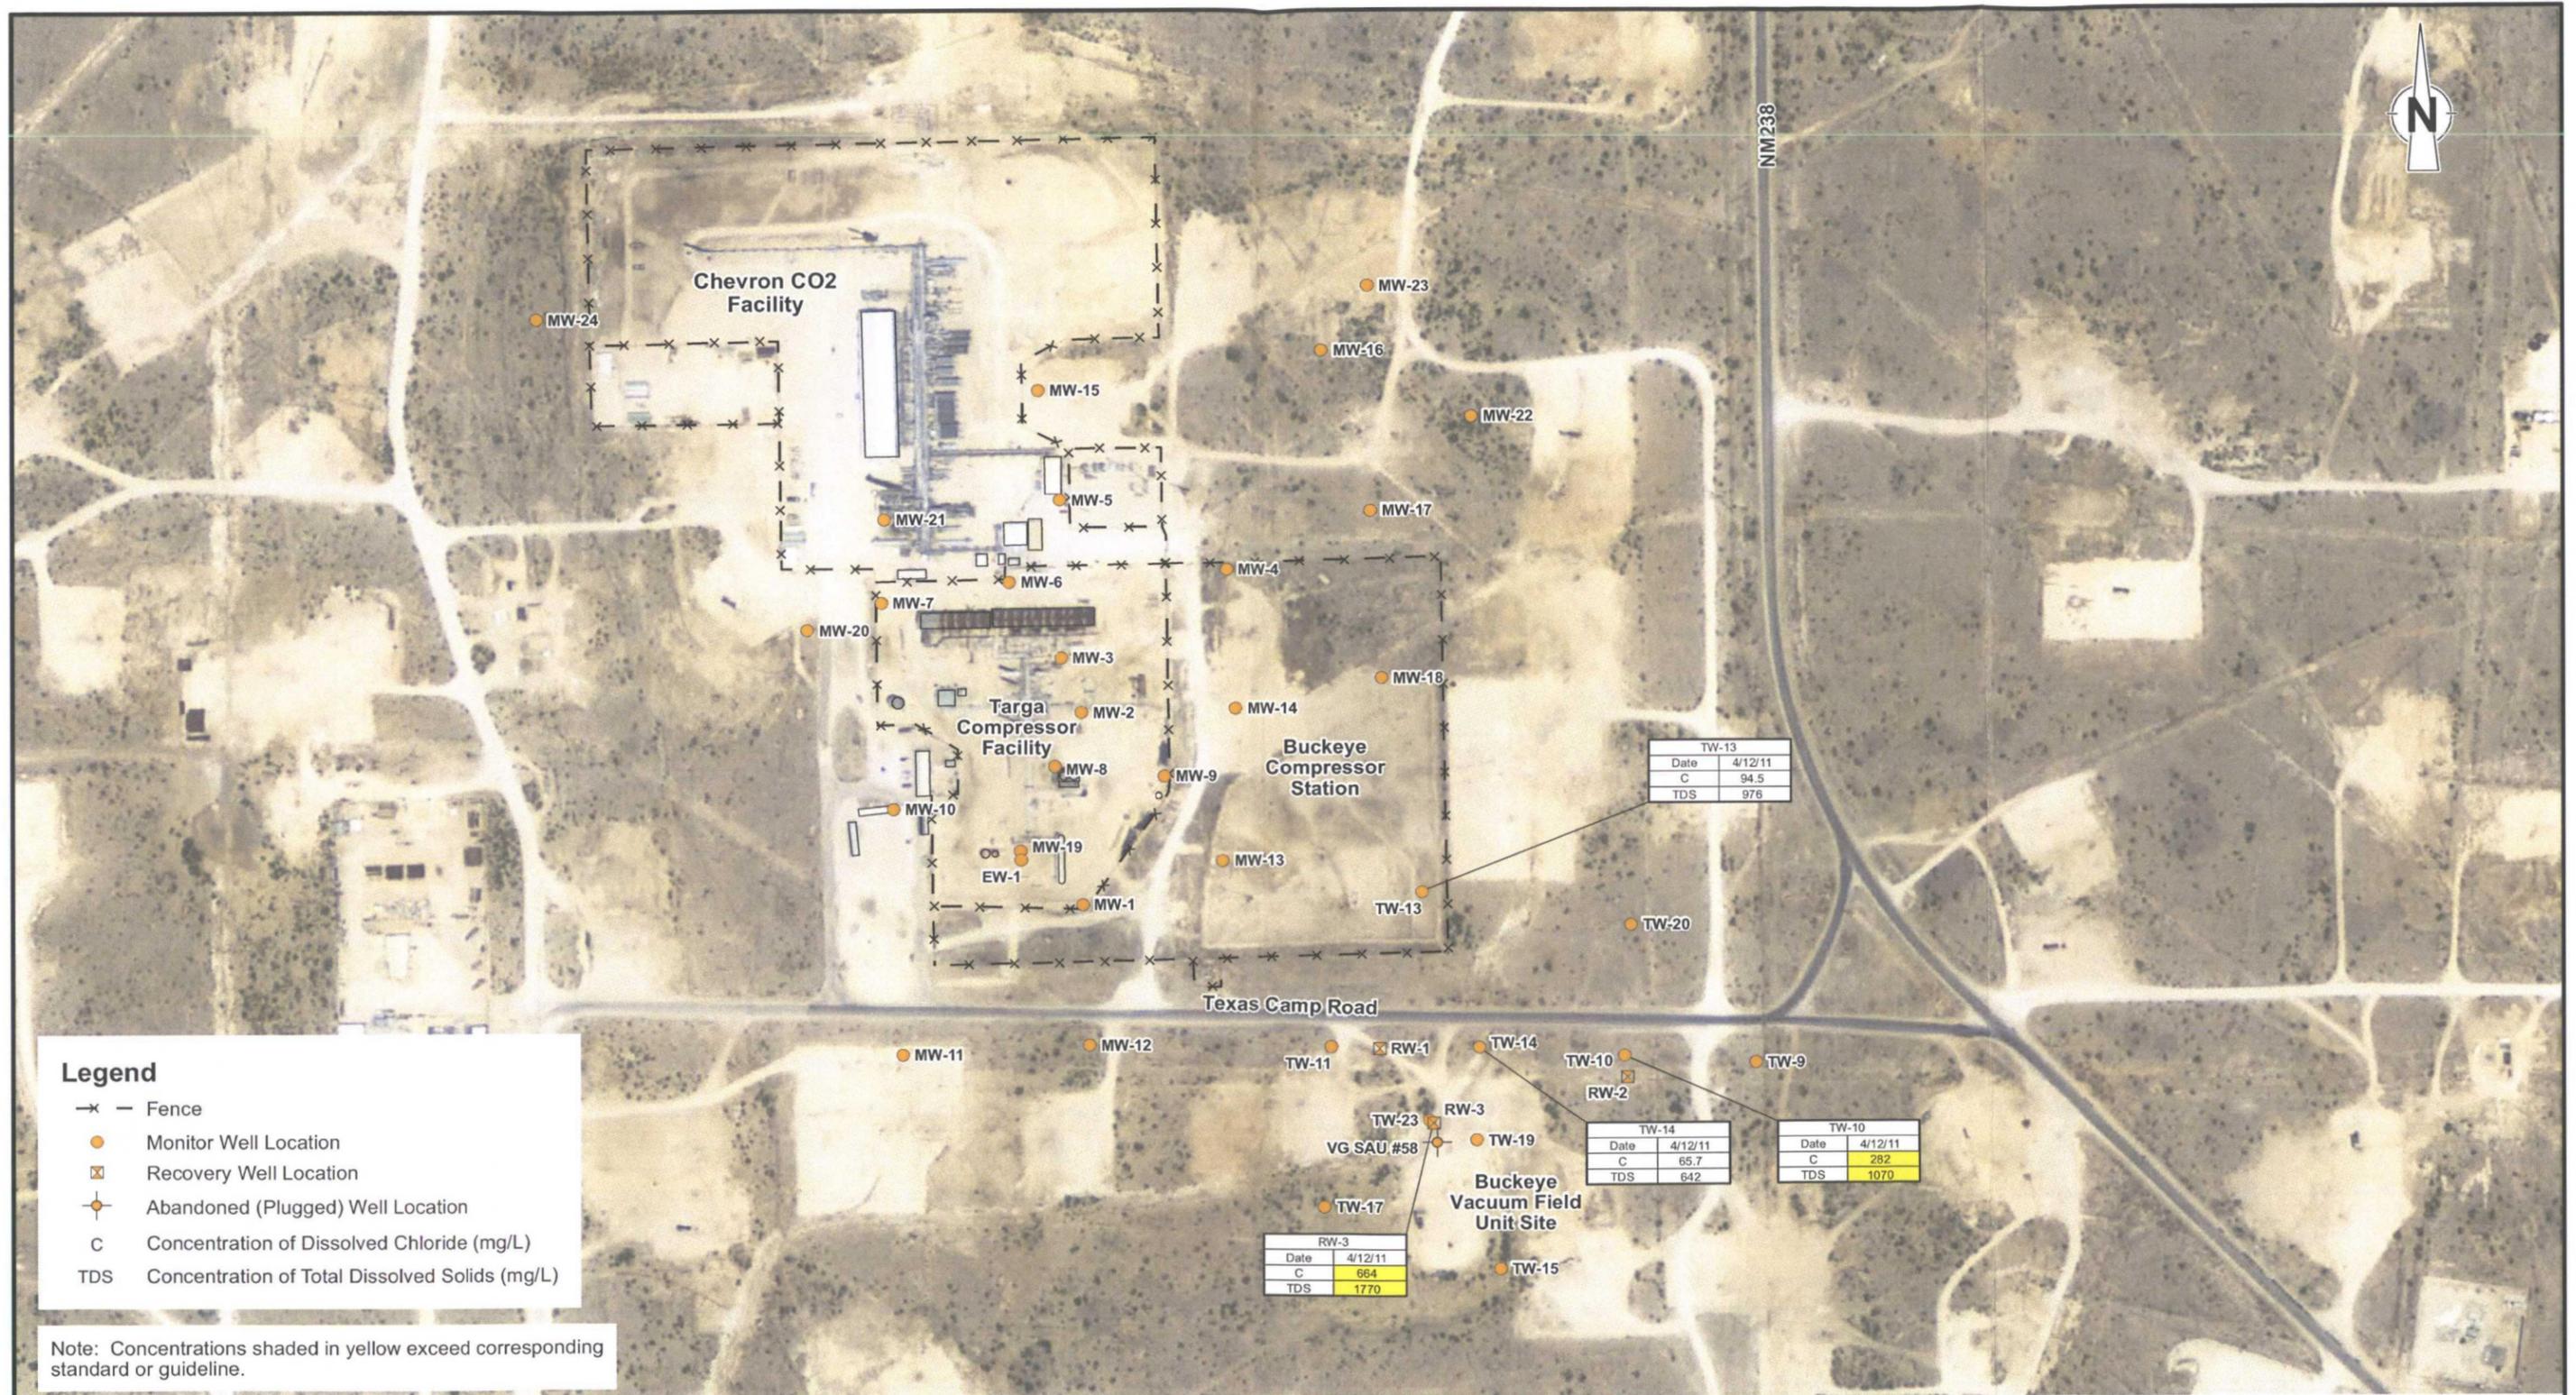
figure 5
 DISTRIBUTION OF DISSOLVED CHLORIDE AND TOTAL DISSOLVED SOLIDS - APRIL 12, 2011
 BUCKEYE VACUUM FIELD UNIT SITE
 SECTION 1, T18S-R34E, LEA COUNTY, NEW MEXICO
 Chevron Environmental Management Company, Houston, Texas

Trends of concentrations of chemicals of concern over time are shown in APPENDIX A. Copies of signed analytical reports and chains-of-custody are attached in APPENDIX B. Dissolved chloride was present in wells TW-10 and RW-3 in concentrations above the NMWQCC standard of 250 mg/L, during both monitoring events in 2011. The trend in TW-10 continued to be increasing during 2011, while that in RW-3 continued a decreasing trend during 2011. Dissolved chloride concentrations in TW-13 and TW-14 were below the NMWQCC standard during 2011. The trend in TW-13 was stable, while the trend in TW-14 was declining. Since dissolved chloride concentrations in TW-10 exceed the NMWQCC standard for chloride and data were not collected from TW-9 or TW-20 during 2011, delineation on the down-gradient side of chloride plume could not be demonstrated.

Total dissolved solids (TDS) were detected in concentrations exceeding the NMWQCC standard of 1000 mg/L in the samples collected from TW-10 and RW-3 during the first semi-annual monitoring event in April 2011; however, concentrations in both wells were below the standard during the second monitoring event; that is, both wells showed decreasing trends in 2011. Concentrations of TDS in TW-13 and TW-14 were below the standard in both monitoring events during 2011 and showed declining trends.

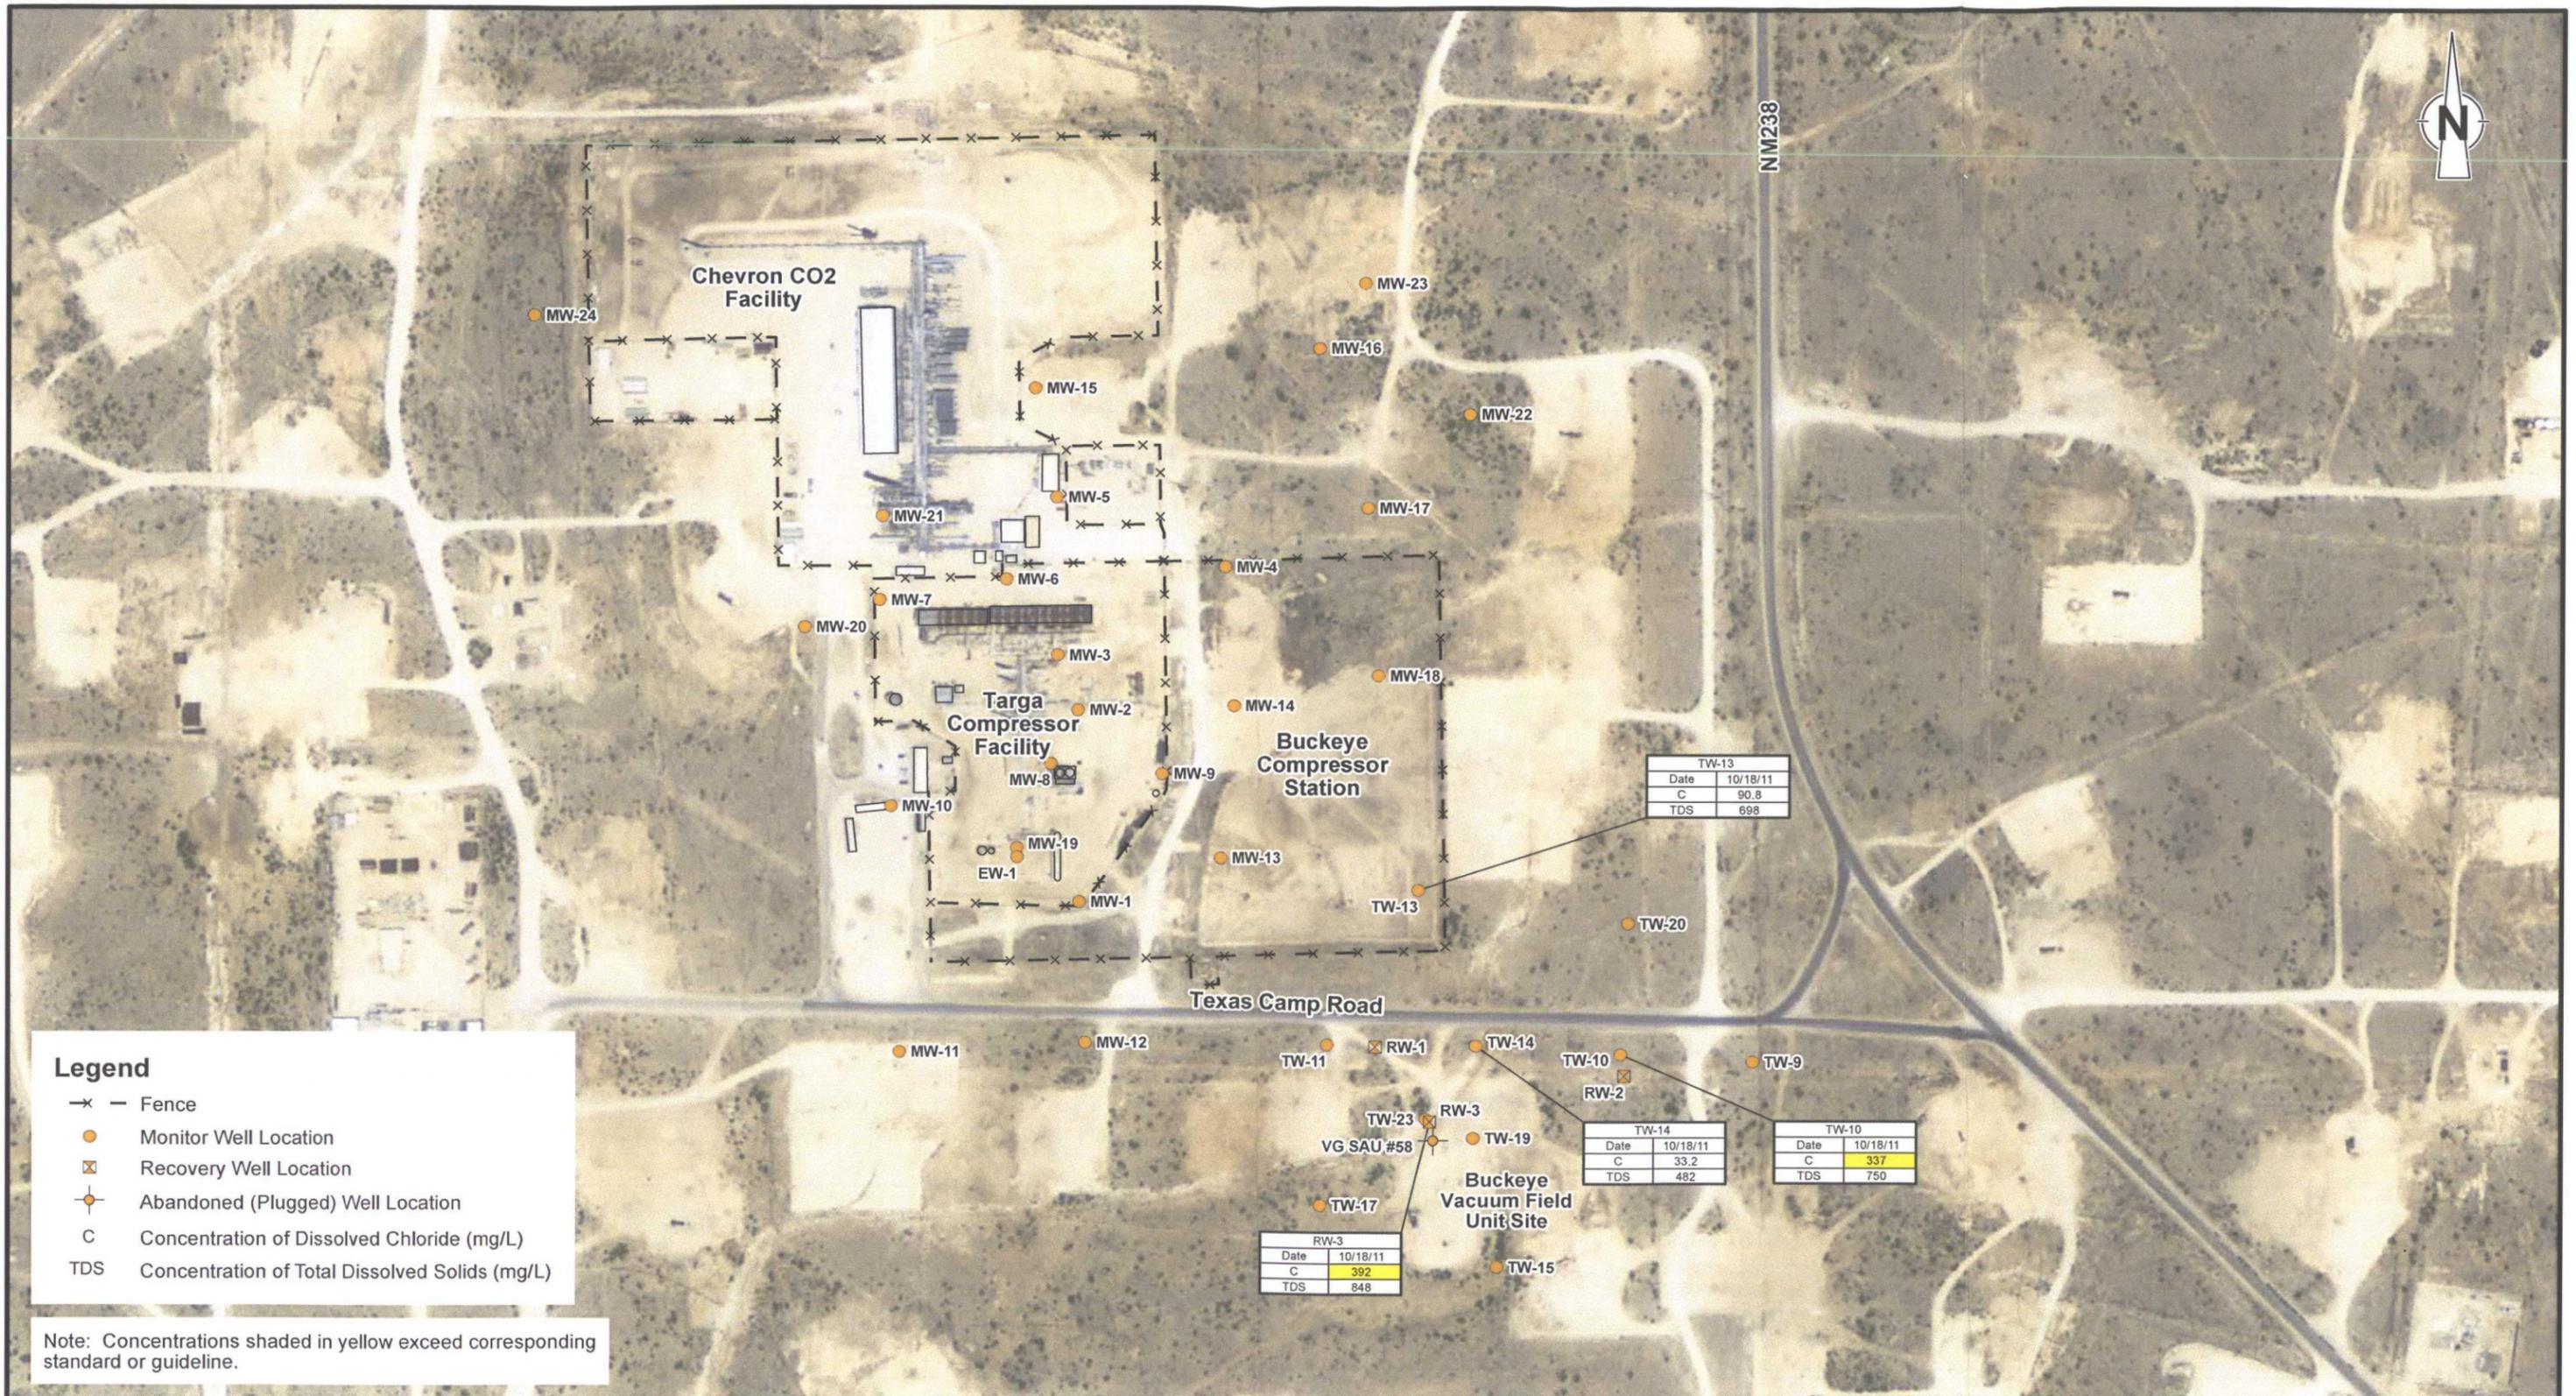
figure 6
 DISTRIBUTION OF DISSOLVED CHLORIDE AND TOTAL DISSOLVED SOLIDS - OCTOBER 18, 2011
 BUCKEYE VACUUM FIELD UNIT SITE
 SECTION 1, T18S-R34E, LEA COUNTY, NEW MEXICO
 Chevron Environmental Management Company, Houston, Texas

Samples of groundwater were collected from wells TW-10, TW-13, TW-14, and RW-3 during monitoring events in both April and October 2011. A cumulative table of all available results of analyses of groundwater samples collected at the Buckeye Vacuum Field Unit Site is shown in TABLE II. Chemicals of Concern (COCs) are shown in columns across the top of the table. Appropriate standards are shown below the names of analytes. Analytical results for the first monitoring event, April 12, 2011, are shown in map form on FIGURE 5. Analytical results of the second monitoring event, in October 2011, have been compiled in TABLE II and shown in map form on FIGURE 6.
