**RE: Termination Request
for the Rice Operating Company's
EME Jct N-14 Site
Unit Letter N, Section 14, T20S, R36E, NMPM, Lea County, New Mexico
Remediation Plan (1R427-343) Termination**

RE: Termination Request
EME Jct. N-14 (1R427-343): UL/N, Sec. 14, T20S, R36E
RICE Operating Company – Eunice Monument Eumont SWD System

**RICE OPERATING COMPANY
JUNCTION BOX FINAL REPORT**

EME Jct. N-14
Unit N, Section 14, T20S, R36E

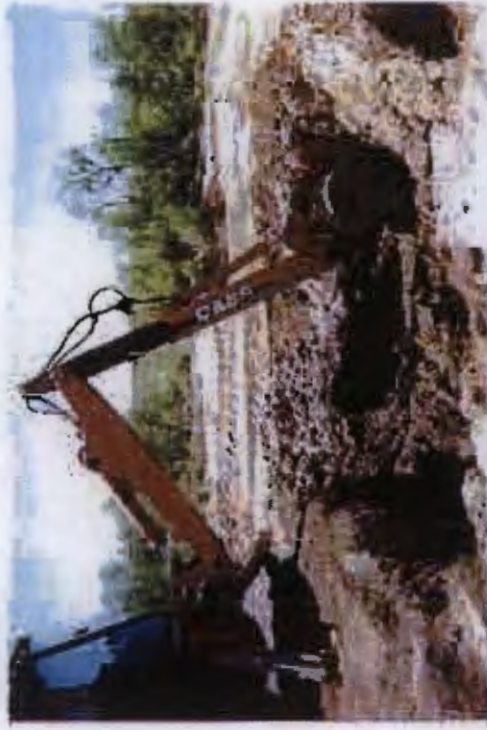
6/11/2010

Definition trench being excavated.

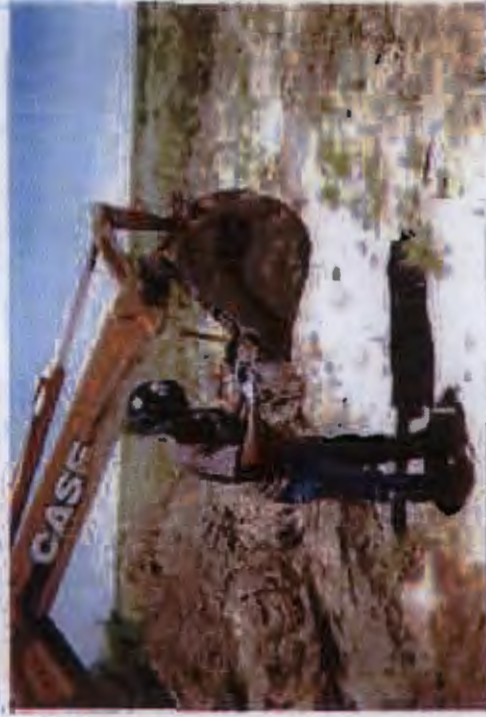
6/11/2010

Collecting samples

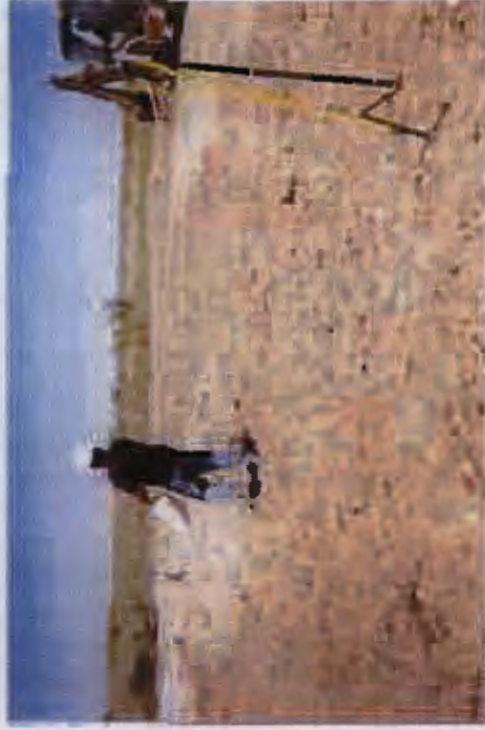
8/26/2010

Seeding site

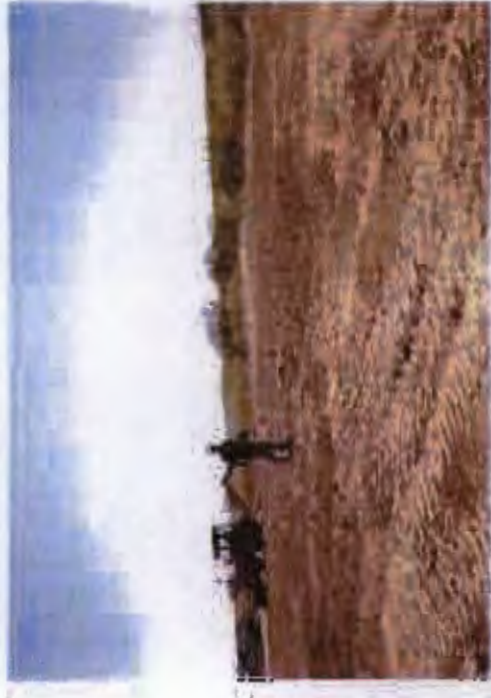
8/26/2010

Covering seed

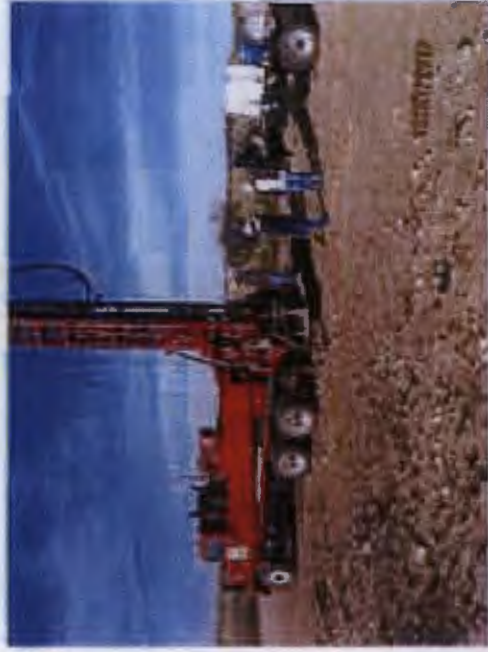
Soil bore

To further investigate the depth of the chloride and TPH presence, a soil boring was initiated on 10/27/2010 at 9 ft southwest of the former junction box. Each sample was field titrated for chlorides and field screened using a PID for hydrocarbons, resulting in low concentrations of both. The 15 ft and 24 ft samples were taken to a commercial laboratory for analysis of chloride and TPH, resulting in a 15 ft chloride concentration of 32 mg/kg and concentrations of GRO and DRO below detectable limits. The 24 ft sample resulted in a chloride concentration of 32 mg/kg and concentrations of GRO and DRO below detectable limits. The entire bore hole was plugged with bentonite to ground surface.

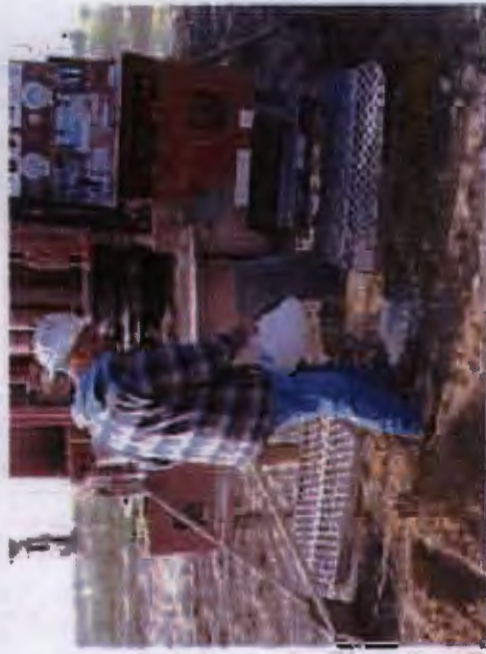
10/27/2010

Plugging soil bore

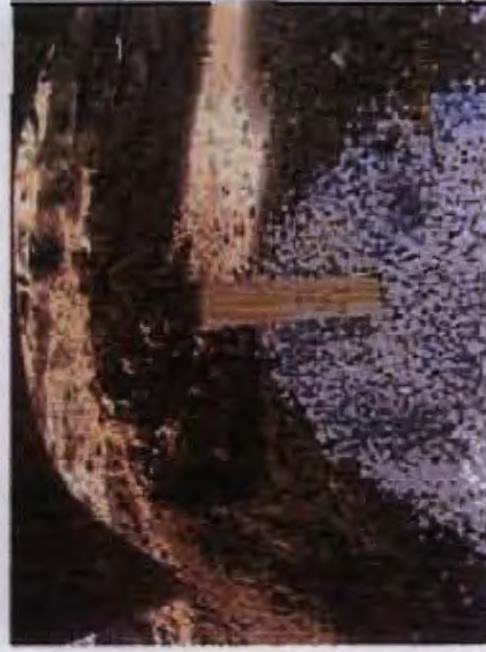
10/27-2010

Soil bore complete

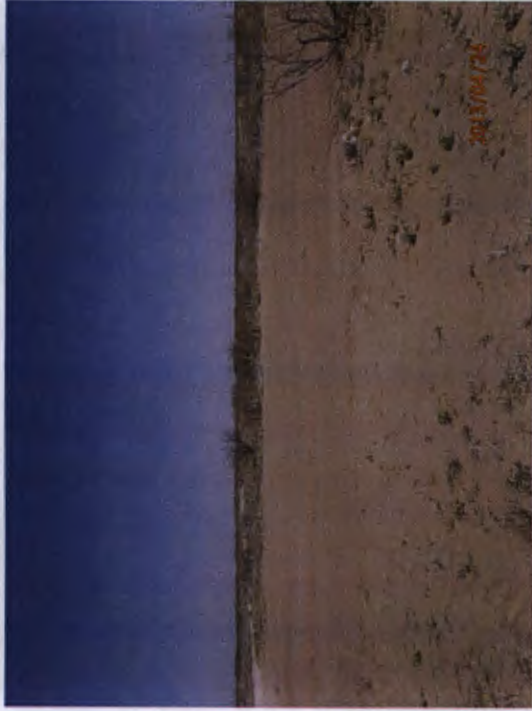
4/24/2013

Site prior to seeding, facing west

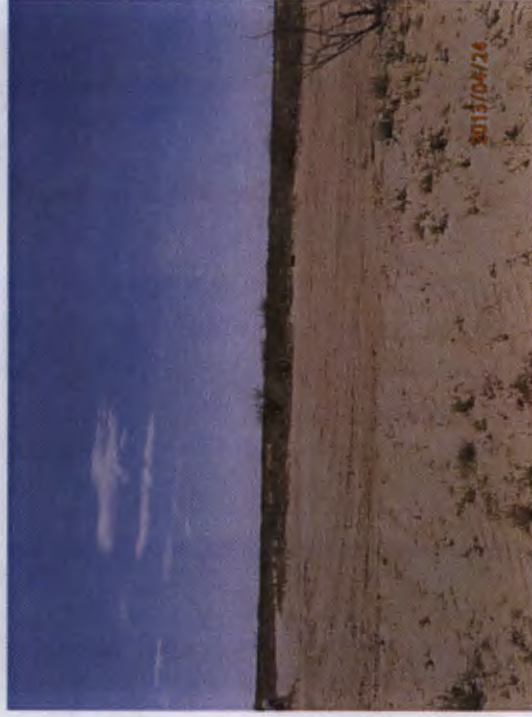
4/24/2013

Site completed, facing west
