From: Hansen, Edward J., EMNRD
Sent: Tuesday, June 04, 2013 4:32 PM
To: Hack Conder (hconder@riceswd.com)
Cc: Leking, Geoffrey R, EMNRD; Laura Pena (lpna@riceswd.com); Katie Jones <kjones@riceswd.com> (kjones@riceswd.com); Scott Curtis (scurtis@riceswd.com)
Subject: Remediation Plan (1R427-77) Termination - ROC EME M-9-5 Site

**RE: Termination Request
for the Rice Operating Company's
EME M-9-5 Site
Unit Letter M, Section 9, T20S, R37E, NMPM, Lea County, New Mexico
Remediation Plan (1R427-77) Termination**

RE: Termination Request
EME M-9-5 (1R427-77): UL/M, Sec. 9, T20S, R37E
RICE Operating Company – Eunice Monument Eumont SWD System

**RICE OPERATING COMPANY
JUNCTION BOX FINAL REPORT**

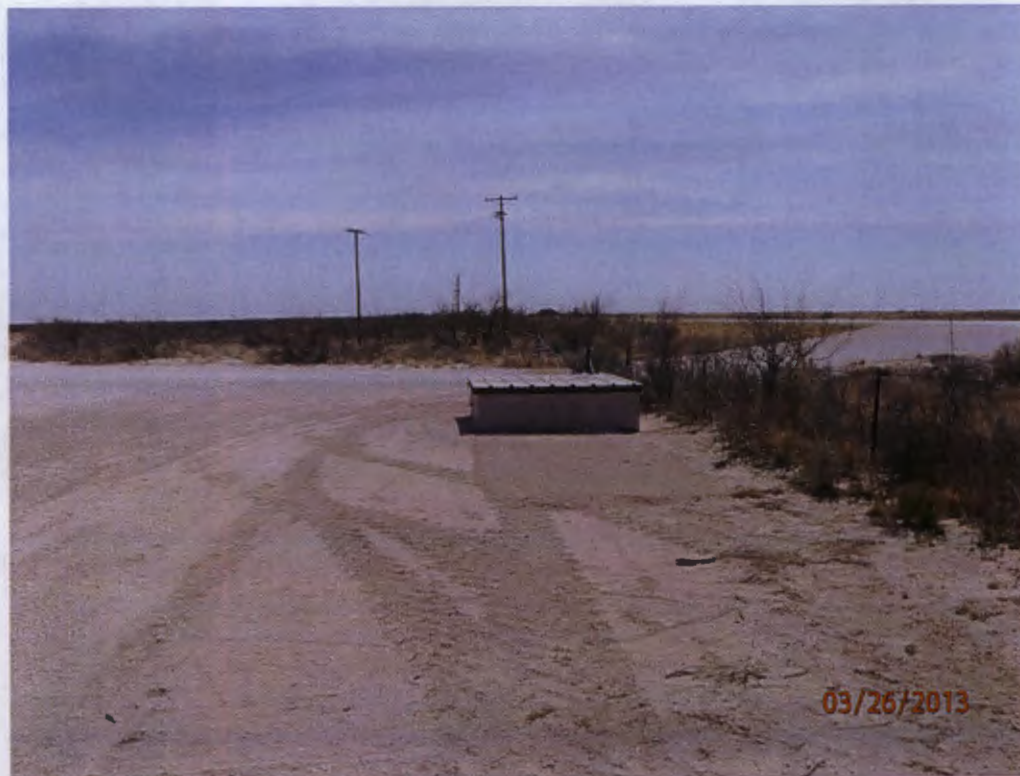
Facing south

3/26/2013

ground surface (BGS) where a compacted red-bed clay layer was installed and density tested. The clay layer will provide a barrier that will inhibit the downward migration of chlorides to groundwater. The excavation was backfilled with remediated soil to ground surface and contoured to the surrounding area. The remediated soil was tested in 3 ft lifts, resulting in low concentrations of chloride. A new, water-tight junction box was built over the same location within an active facility; therefore, seeding is not necessary.

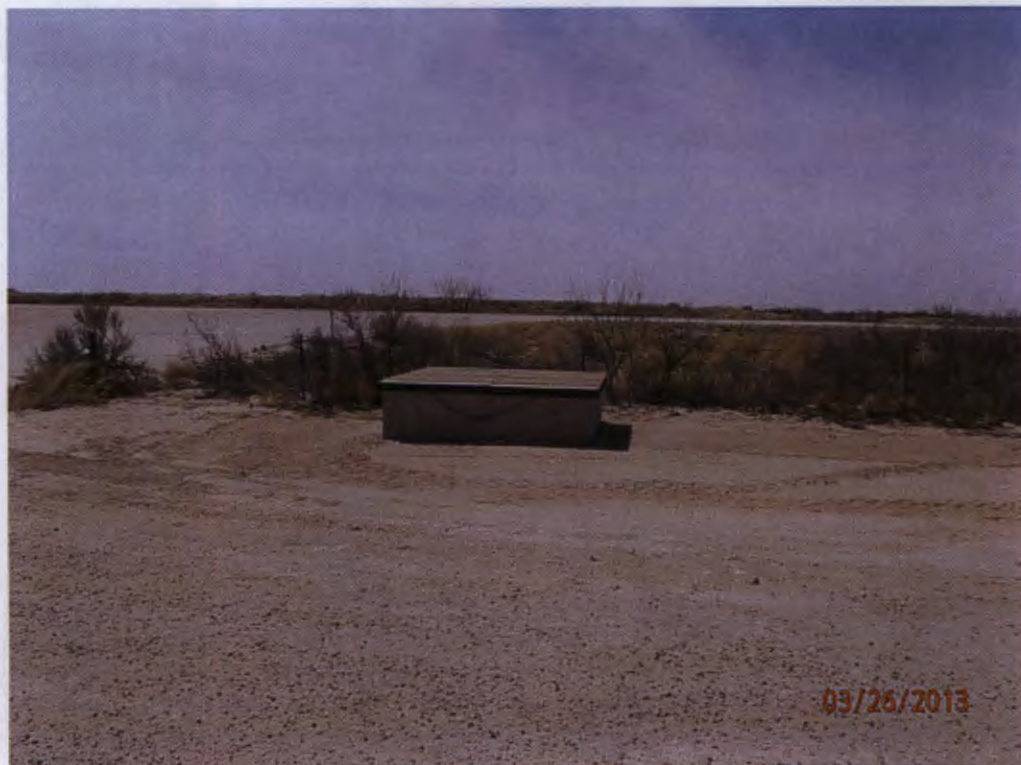
Facing west

3/26/2013
