RE: Corrective Action Plan (CAP) Report and Termination Request

Rice Operating Company – BD SWD System

BD B-16 (1R426-28): UL/B sec. 16 T22S R37E

Corrective Action Plan Report

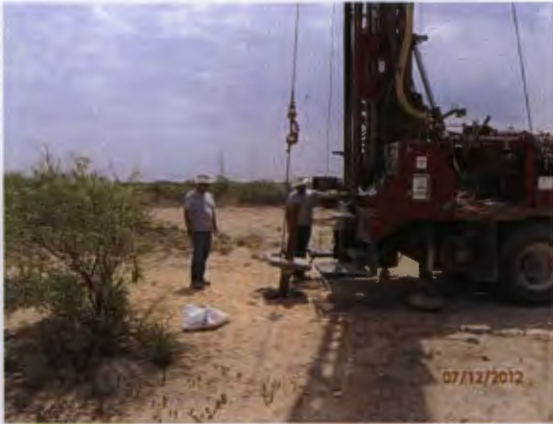
Pulling MW-1, facing south

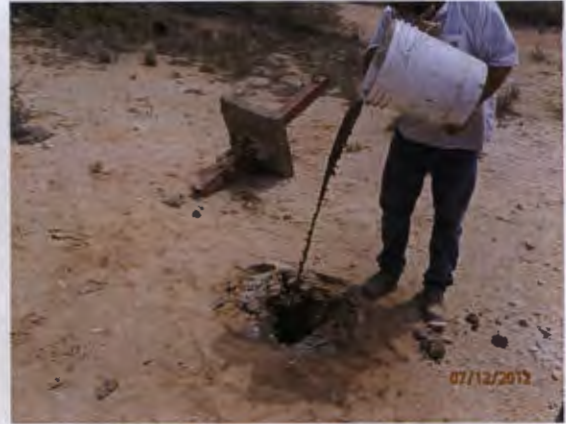
Plugging MW-1 with a 1-3% bentonite/concrete slurry with a 3 ft concrete cap, facing south
7/12/12

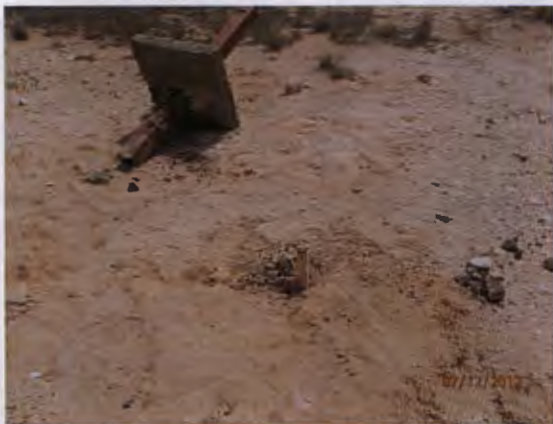
MW-1 plug and abandonment completed, facing south
7/12/12

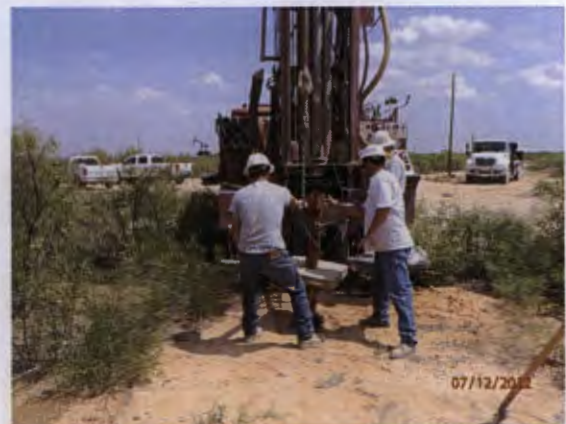
Pulling MW-2, facing south

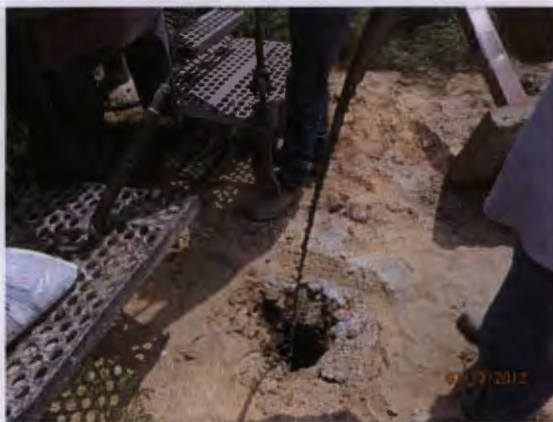
Plugging MW-2 with a 1-3% bentonite/concrete slurry with a 3 ft concrete cap, facing south
7/12/12

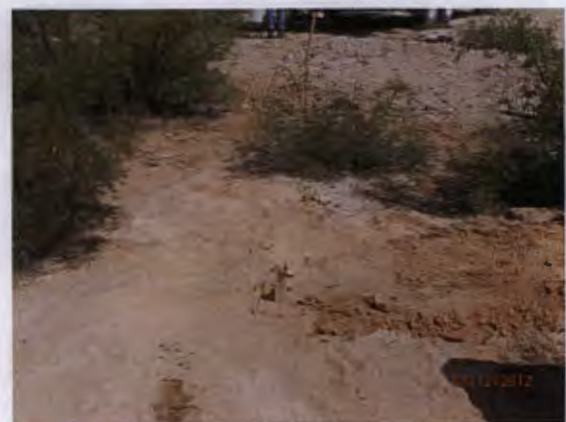
MW-2 plug and abandonment completed, facing south
7/12/12

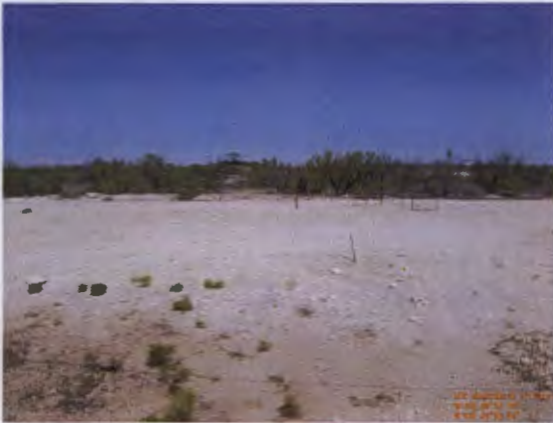
Site prior to excavation,
facing north 9/19/2012

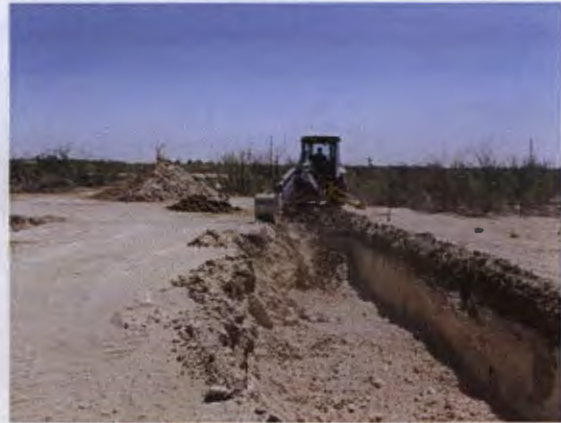
Excavating site,
facing east 4/18/2013

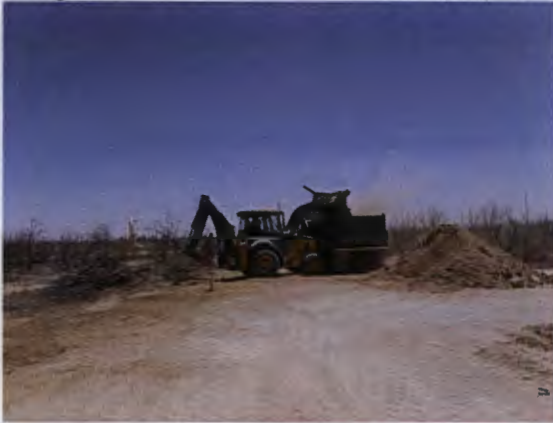
Exporting soil,
facing east 4/18/2013

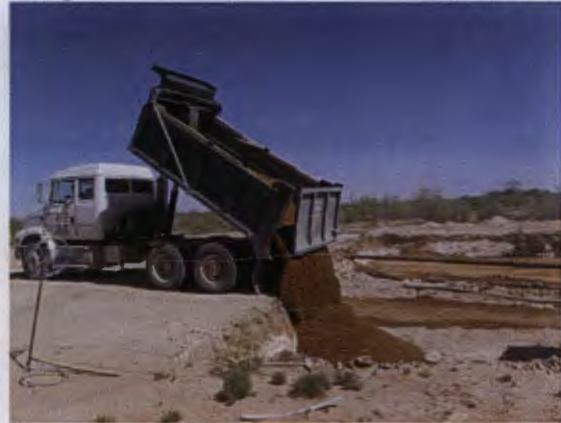
Importing blow sand,
facing north 4/29/2013

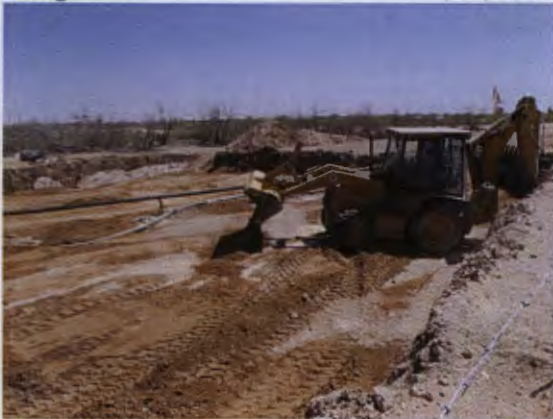
Installing 6" bottom sand pad,
facing northeast 4/29/2013

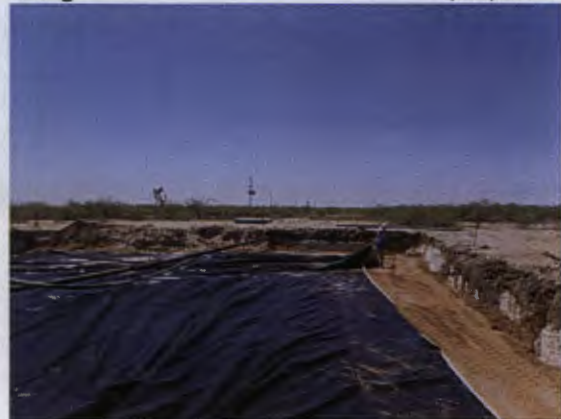
Installing 76'x77', 20-mil reinforced plastic liner
at 5' bgs, facing west 4/29/2013

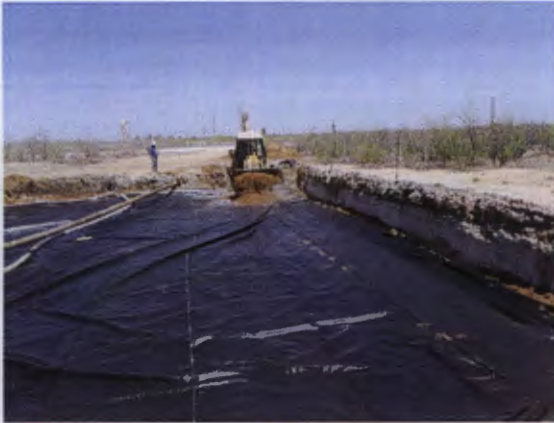
Installing a 1' sand pad above liner,
facing east 4/29/2013

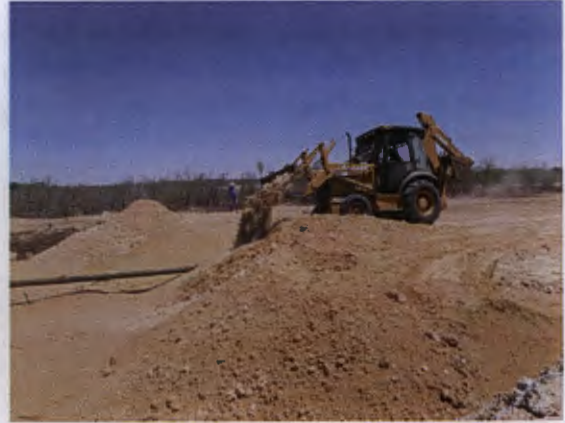
Backfilling site,
facing north 5/3/2013

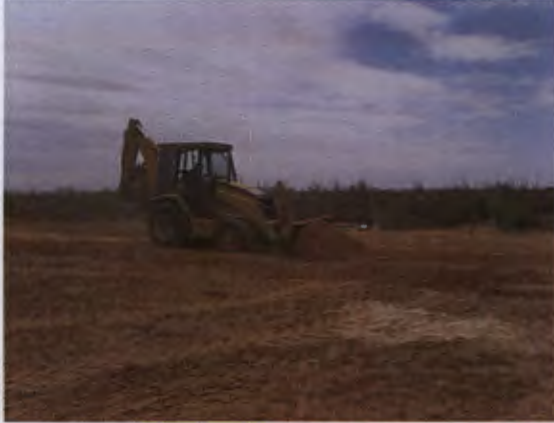
Backfilling site with top soil,
facing south 5/6/2013

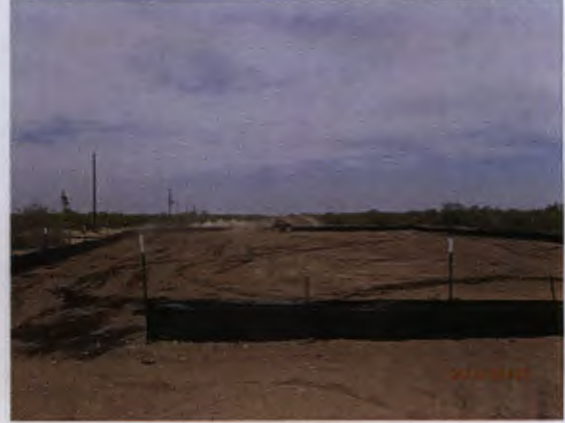
Spreading amendments,
facing west 5/28/2013

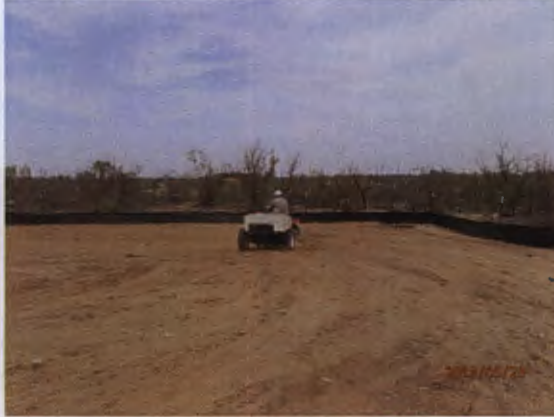
Spreading seed,
facing southwest 5/28/2013

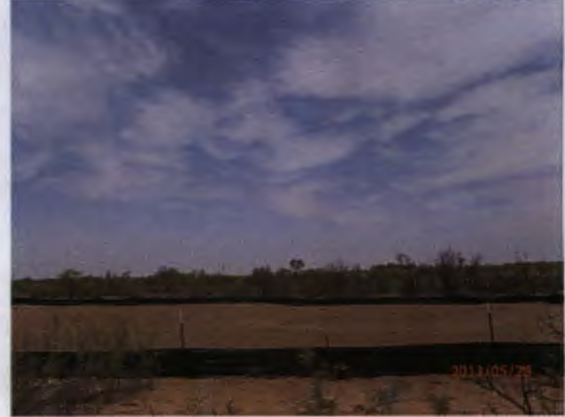
Site complete,
facing north 5/28/2013
