**RE: Termination Request
Rice Operating Company – BD SWD System
BD G-23 EOL (1R426-281): UL/G sec. 23 T22S R37E
(formerly BD B-23 EOL)**

- Figure 1 – Geographical Location Map
- Figure 2 – Site Location Map
- Figure 3 – MW Sampling Data
- Figure 4 – Soil Data Map
- Appendix A – Description of Hydrocarbon Substance in MW-1

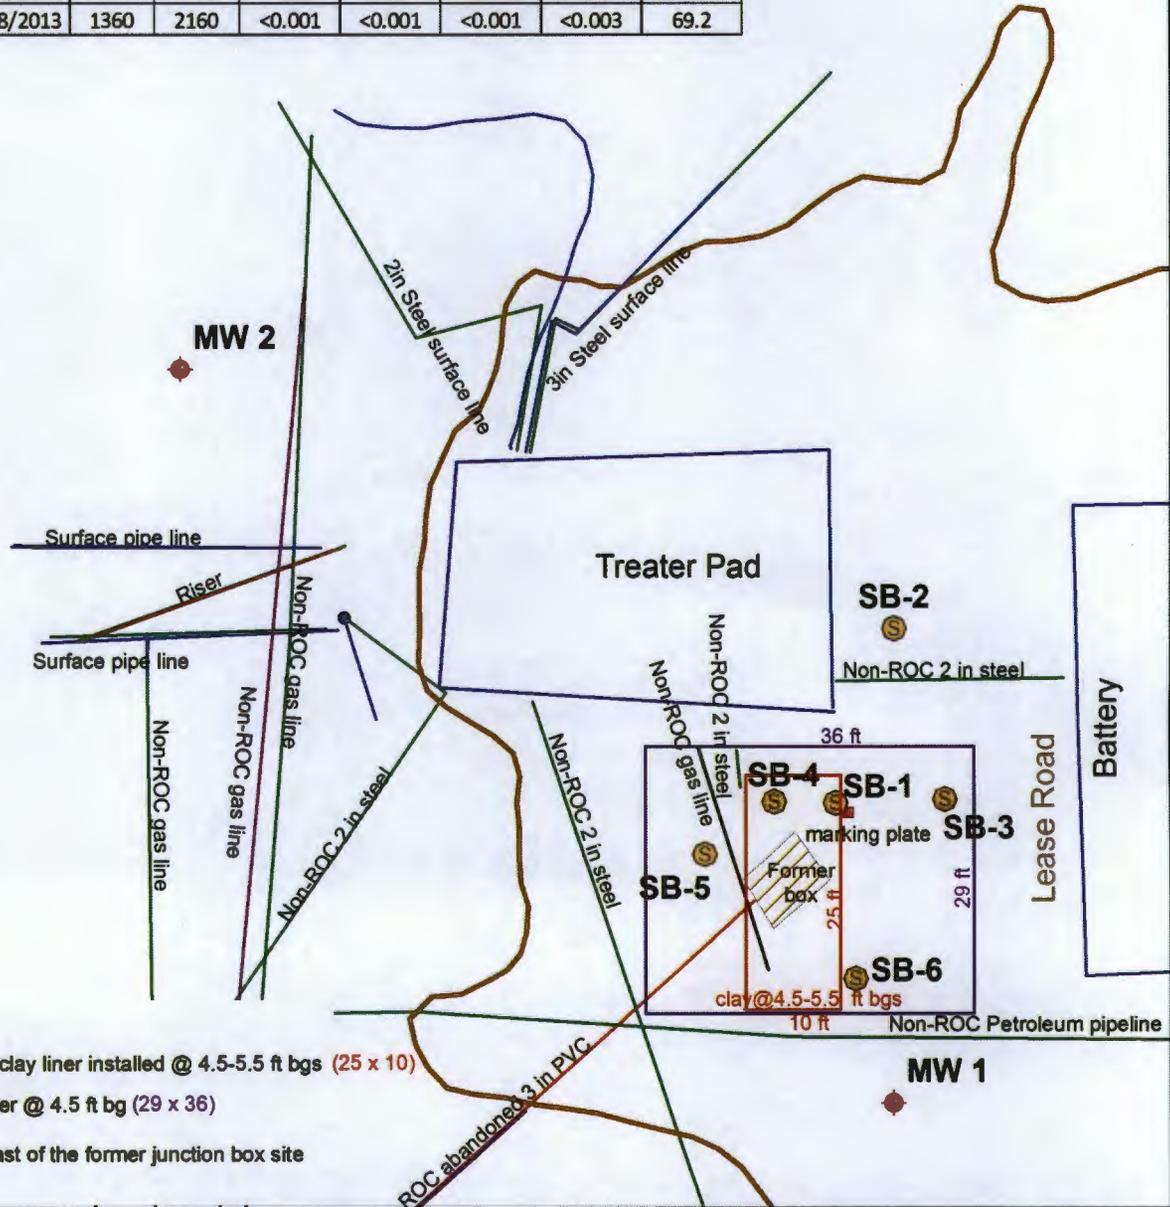
Figure 3

- Approximate location of clay liner installed @ 4.5-5.5 ft bgs (25 x 10)
- Approved 20-mil poly liner @ 4.5 ft bgs (29 x 36)

The marking plat is 10 ft northeast of the former junction box site
 DGW: 60 ft

MW-1 and MW-2 have been sampled quarterly since their installation (Figure 3). During their last sampling event on April 18th, 2013, MW-1, the source well, had a laboratory chloride reading of 820 mg/L, a TDS reading of 1690 mg/L and showed slight elevations in BTEX. MW-2, the up-gradient well, had a laboratory chloride reading of 1,360 mg/L, a TDS reading of 2,160 mg/L and a BTEX reading of non-detect. Based on the monitor well sampling data, it is evident that there is a non-ROC site contributing chloride to the groundwater, up-gradient of the G-23 EOL site.

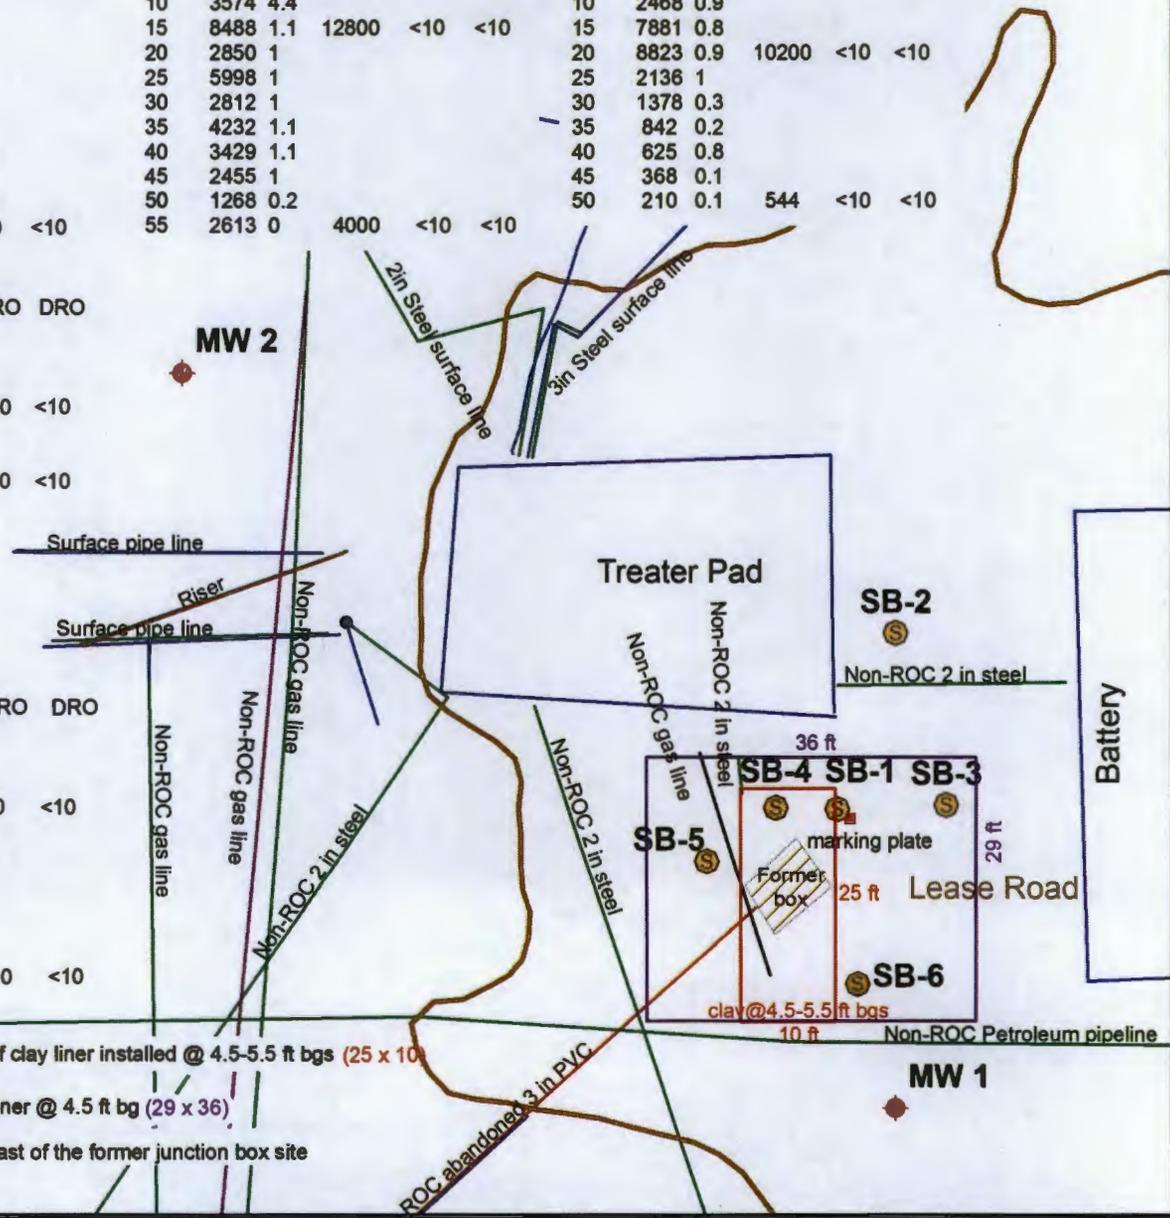
Figure 4

SB-1					
Depth	Cl-	PID	LAB Cl-	GRO	DRO
15	6687	23.7	8200	<10	<10
20	2839	9.3			
25	2181	3.6			
30	1749	1.7			
35	2294	0			
40	1055	0			
45	752	0			
50	570	0			
55	289	4.4	160	<10	<10

Approximate location of clay liner installed @ 4.5-5.5 ft bgs (25 x 10)
 Approved 20-mil poly liner @ 4.5 ft bg (29 x 36)
 The marking plat is 10 ft northeast of the former junction box site
 DGW: 60 ft

As part of the Investigation and Characterization Plan approved by NMOCD on May 19th, 2011, six soil bores (SB-1 through SB-6) were advanced through the former junction box site on May 23rd, 2011 and June 6th, 2011. RECS personnel field tested the soil for chlorides and screened in the field with a photo-ionization detector (PID). Representative samples from the bores were taken to a commercial laboratory for confirmation of chloride and hydrocarbon field numbers. All the soil bores had laboratory chloride values that decreased with depth.

A Further Investigation Report and Corrective Action Plan for Soils was submitted to NMOCD on March 16th, 2012 and approved on March 20th, 2012. As per the report, RECS began the excavation for liner installation on January 16th, 2013. The site was excavated to 29 ft x 36 ft to a depth of 4.5 ft bgs, uncovering the existing clay layer. A 20-mil reinforced poly liner was installed and properly seated at the base of the excavation. Clean, imported blow sand was used to backfill the site to 3 ft bgs and the final 3 ft was backfilled with clean, imported caliche. This site is located on a lease pad and seeding was not required.
