**HIP - \_\_122\_\_**

**Re: Hydrostatic Test Discharge Permit**  
**Permit: HIP-122**  
**Enterprise Products Operating, LLC**  
**Western Expansion Pipeline III, Segment 3**  
**Locations: Unit N of Section 27, Township 10 North, Range 8 East, NMPM,**  
**Santa Fe County, New Mexico**

**SUBJECT: DRAFT – Submittal of a Notice of Intent to Perform Hydrostatic Test  
WEP III – Segment 3  
Santa Fe County, New Mexico**

On behalf of Enterprise Products Operating LLC (Enterprise), Kleinfelder West, Inc. (Kleinfelder) is submitting this draft Notice of Intent (NOI) for a hydrostatic test to be conducted on Segment 3 of Enterprise's Western Expansion Pipeline III (WEP III).

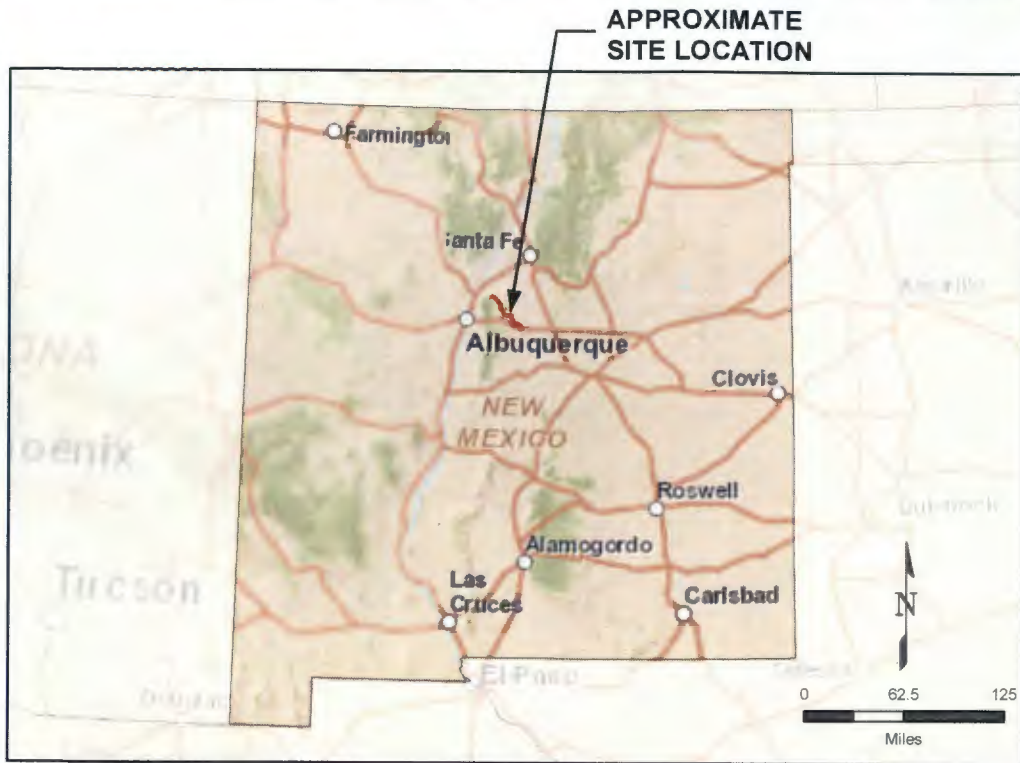
- Figure 1 – Regional map showing topography, the pipeline section undergoing testing, and the hydrostatic test water discharge location.
- Figure 2 – Site-specific map showing the hydrostatic test water discharge area.

- The Enterprise Western Expansion Pipeline (WEP) III line is a new, welded, steel pipeline. In Segment 3, most of the pipeline is 16-inch diameter, but some portions of the pipeline are 20-inch in diameter. Segment 3 of the WEP III pipeline is 34.0 miles or 179,400 feet long (Figure 1);

- The source water for the hydrostatic testing is the King Irrigation Well (King well). The location of the King well, POD number E 00321 S-14, is shown in Figures 1 and 2;

The location of the pipeline to be hydrostatically tested and the discharge location are shown on Figures 1 and 2.

- In the SE/4; SW/4; Section 27, T10N, R8E (Figure 1).
- The latitude and longitude coordinates are included in *Item b*.

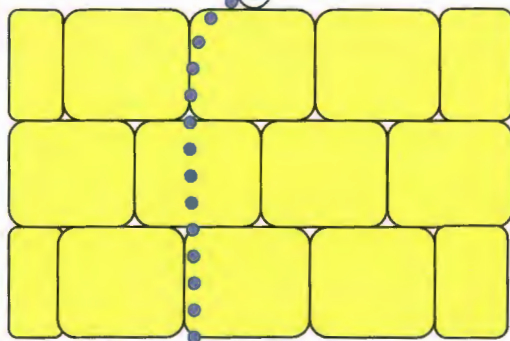
**Side View**

This system is designed to capture sediment and debris while allowing water to flow through. The size of the catch basin will be approximately 30x40 feet in size. This system is designed so that water will flow through the bales and filter out into the surrounding vegetation at a slow velocity. If too much water enters the catch basin, there is an overflow pipe to prevent the structure from collapse. Geotech fabric will be installed below the overflow to prevent erosion.

Non-woven geotextile fabric will be installed beneath the dissipation structure to prevent scouring. Hay bales will be used to control erosion as the water is discharged from the pipeline at a rate of approximately 1,500 gallons per minute (gpm) into the hydrostatic waste water dissipation and discharge system. A connector pipe is attached to the end of the pipeline and to a baffle "T" located within the dissipation structure. Pipeline water will gradually be released from the dissipation structure at a low flow rate onto the area described in *item g*. The dissipation and discharge structure will be built to maintain the proper flow rate to avoid scouring the landscape. Soil berms approximately four feet wide and three feet high will be placed south of the discharge area to prevent flow onto the road or properties to the south (Figure 2). A diagram and description of the hydrostatic waste water dissipation and discharge system is shown in Figure 3.

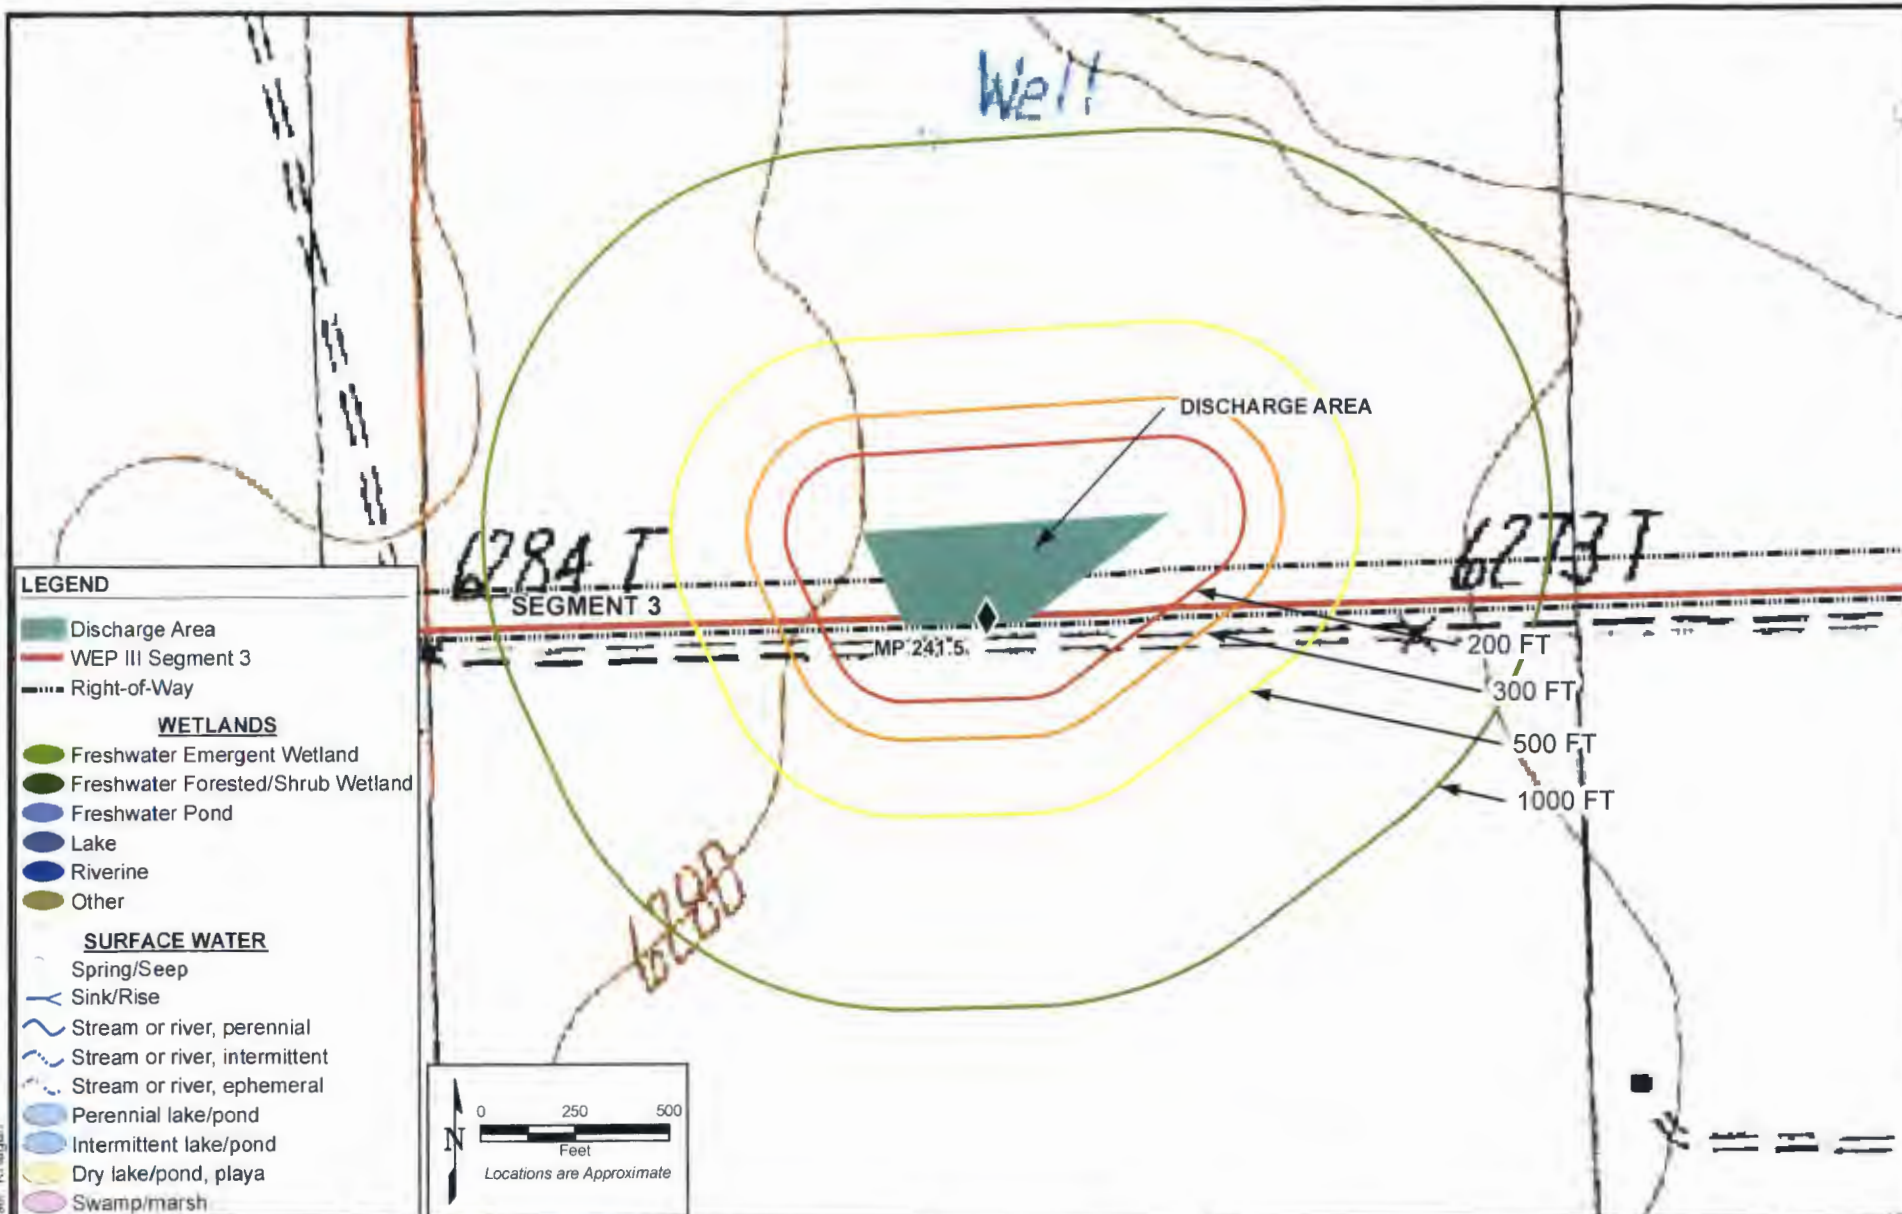
**SURFACE WATER AND WETLANDS NEAR  
DISCHARGE AREA, WEP III SEGMENT 3**

No watercourses; lakebeds, sinkholes, or playa lakes were observed within 200 feet of the discharge area during the site visit (Appendix A). A search of watercourses, lakebeds, sinkholes and playa lakes in the vicinity of the discharge area was completed by reviewing a topographic map and using the GIS database. None were indicated during the review. A copy of the topographic map is included in Appendix B, Figure B-1.

No springs were identified on the topographic map within 1,000 feet of the discharge area (Figure B-1, Appendix B) and no springs were observed during the site inspection (Appendix A).

No wetlands were observed during the site inspection (Appendix A). A topographic map provided by the U.S. Fish and Wildlife Service National Wetlands Inventory database was reviewed for wetlands in the vicinity of the site. Wetlands were not observed in or within 500 feet of the perimeter of the discharge area. A copy of the topographic map is included in Appendix B, Figure B-1.

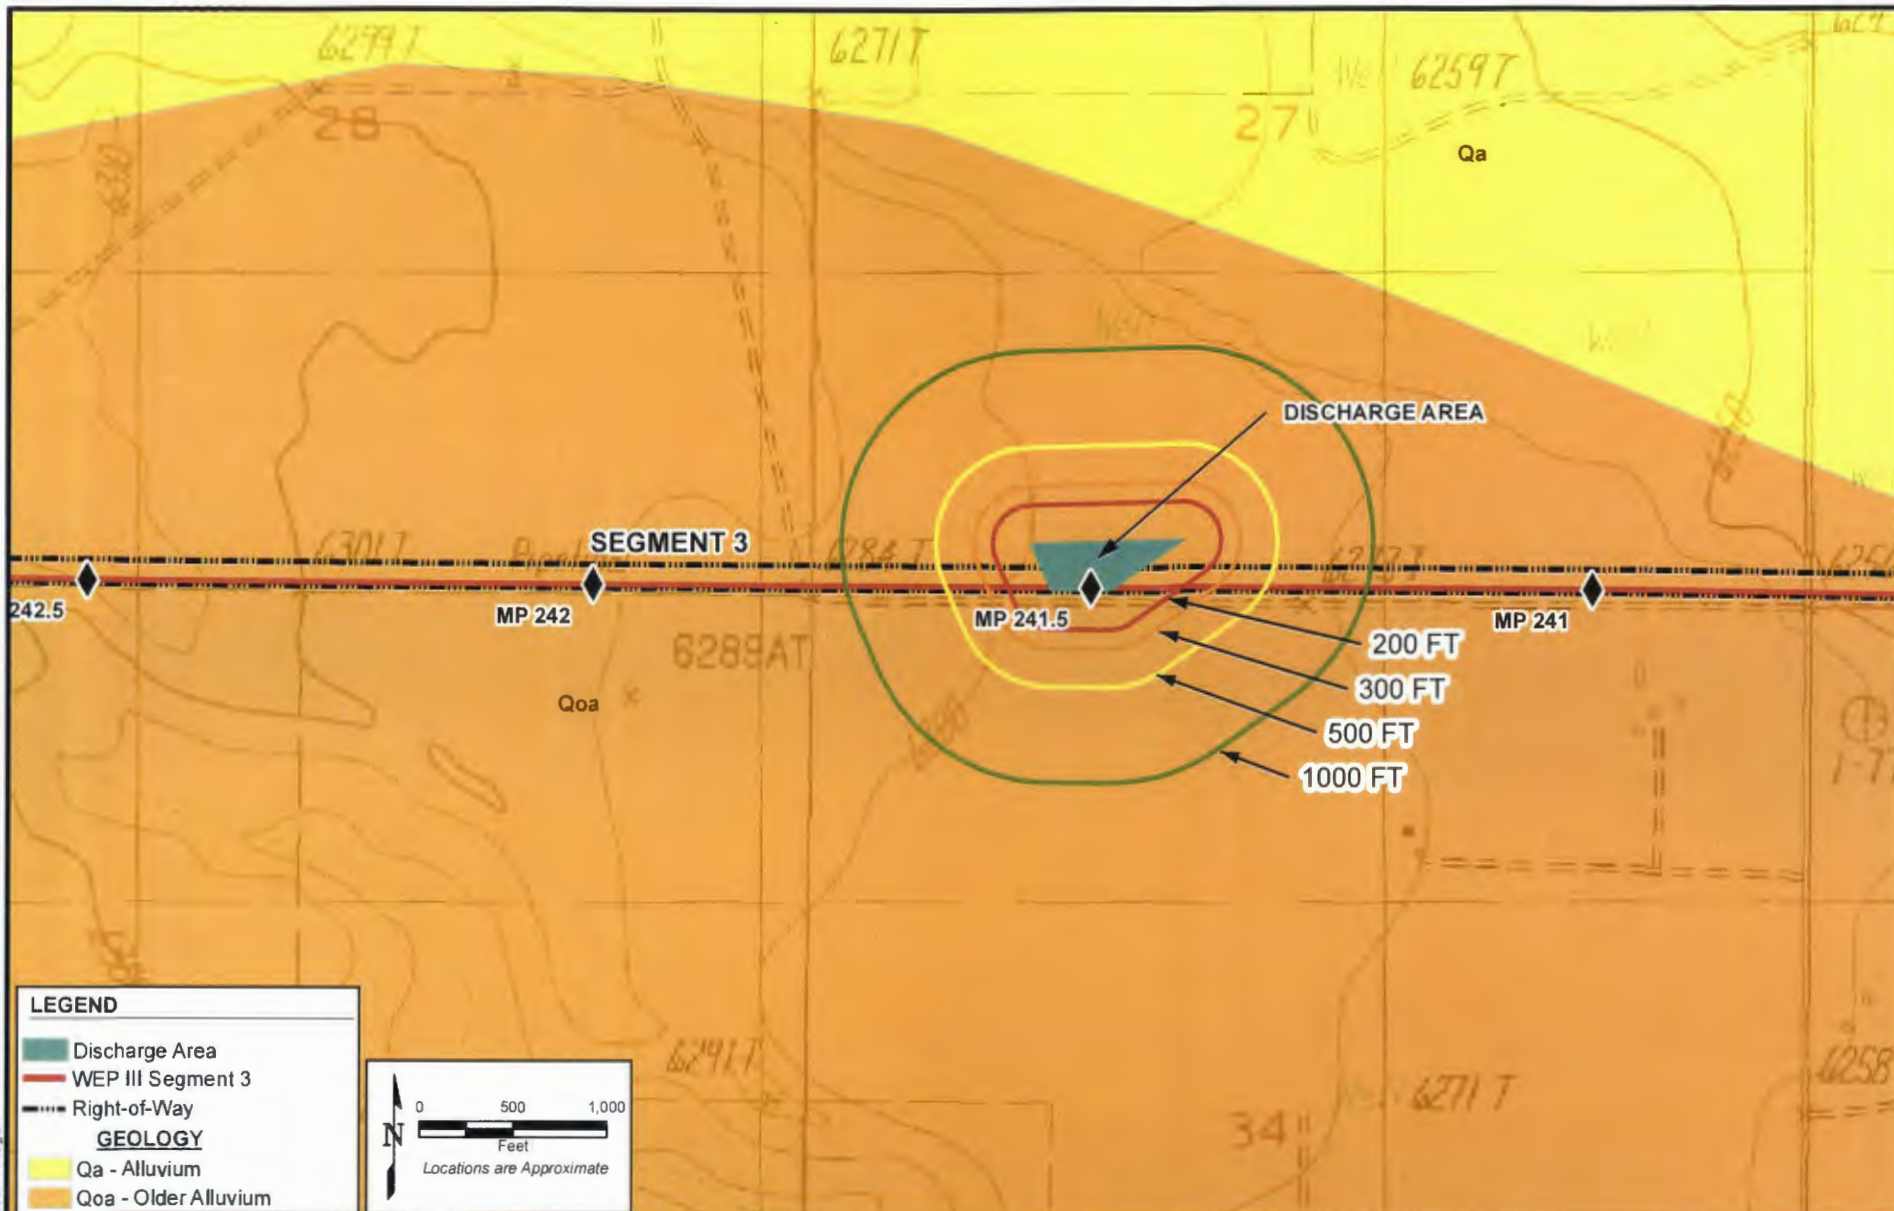
## GEOLOGY IN THE VICINITY OF THE DISCHARGE AREA, WEP III SEGMENT 3

- Discharge Area
- WEP III Segment 3
- Right-of-Way
- GEOLOGY**
- Qa - Alluvium
- Qoa - Older Alluvium

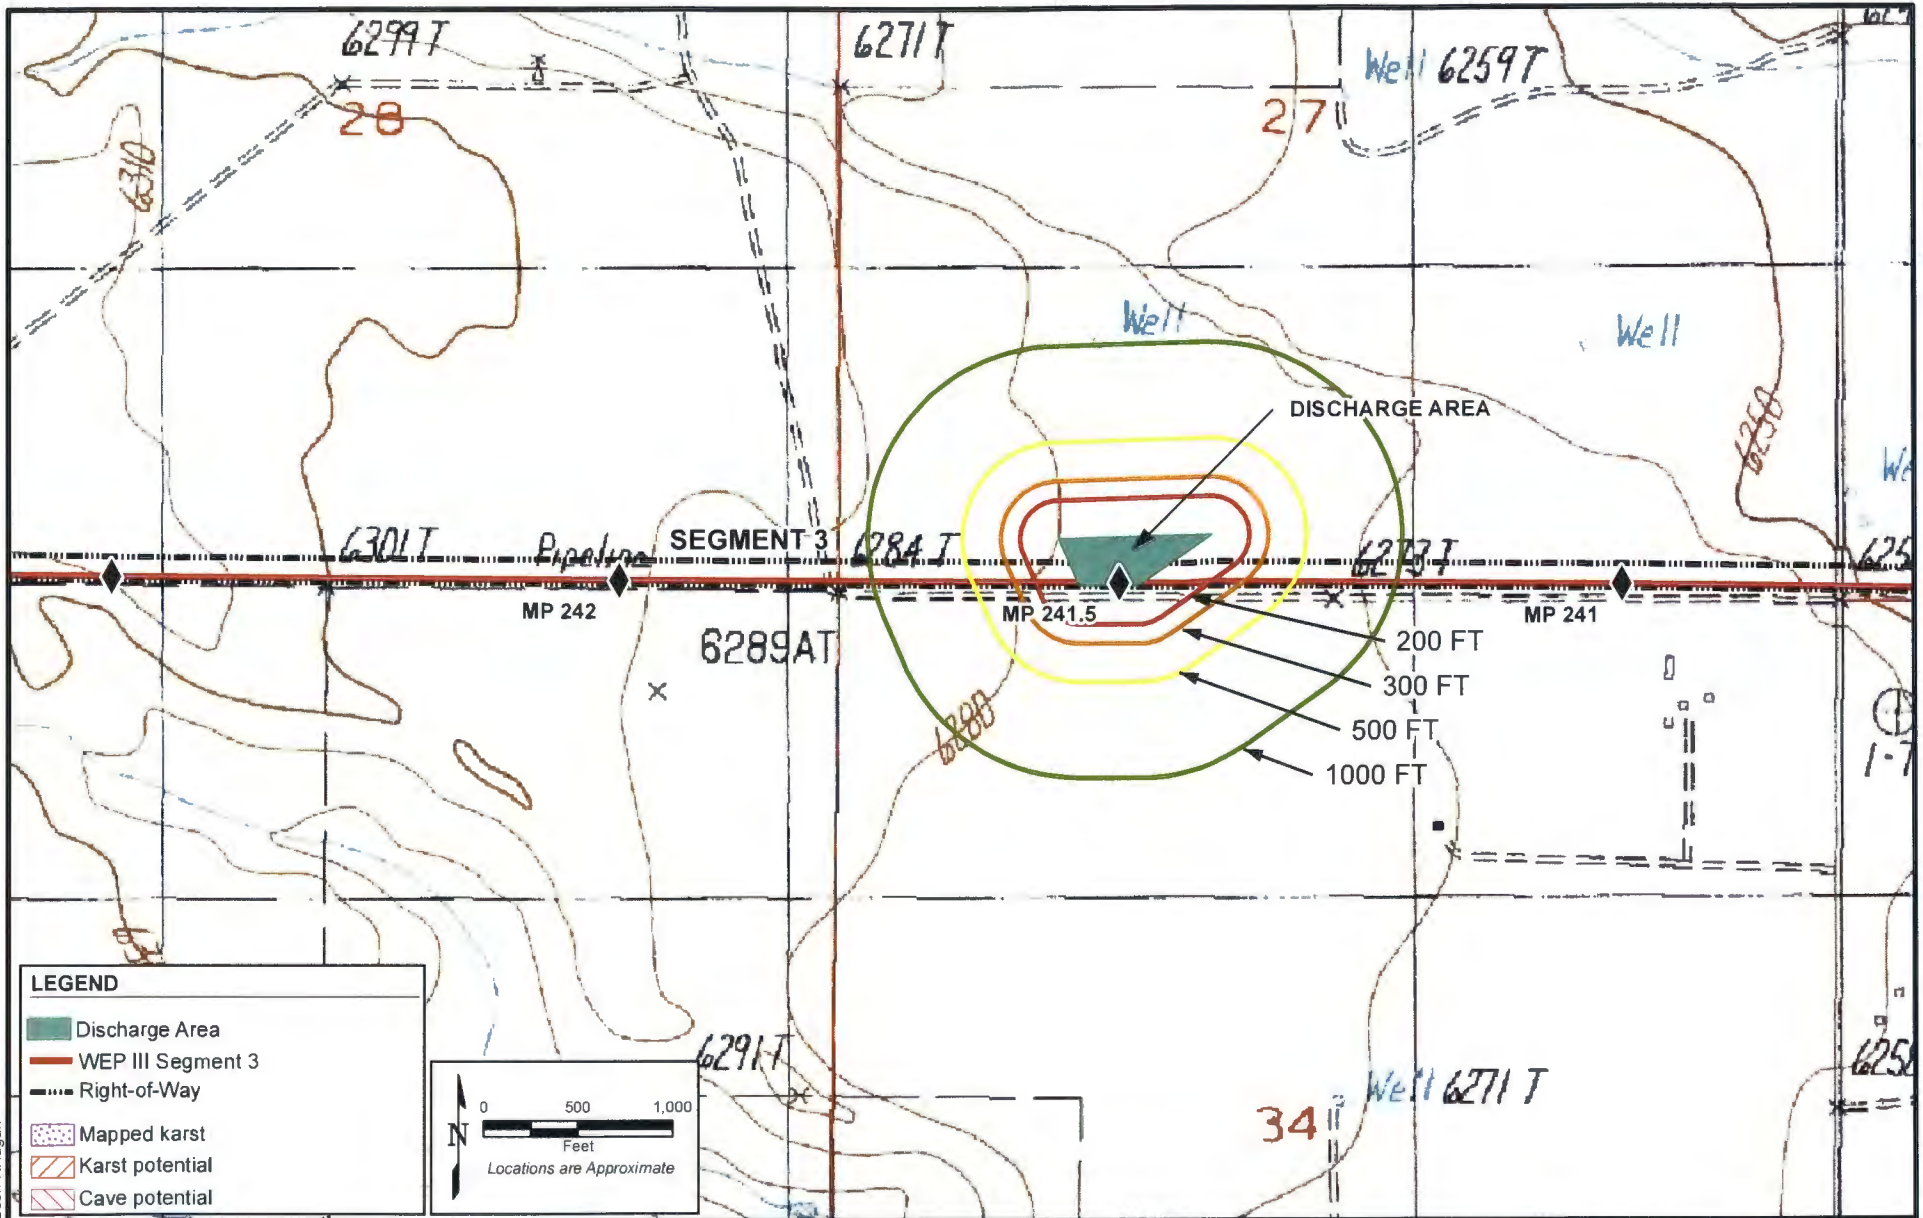
**KARST IN THE VICINITY OF THE DISCHARGE AREA, WEP III SEGMENT 3**  
ENTERPRISE PRODUCTS OPERATING LLC  
SANTA FE COUNTY, NEW MEXICO  
ORIGINATOR: K. HAGAN  
APPROVED BY: *ES 8-28-13*

- Discharge Area
- WEP III Segment 3
- Right-of-Way
- Mapped karst
- Karst potential
- Cave potential

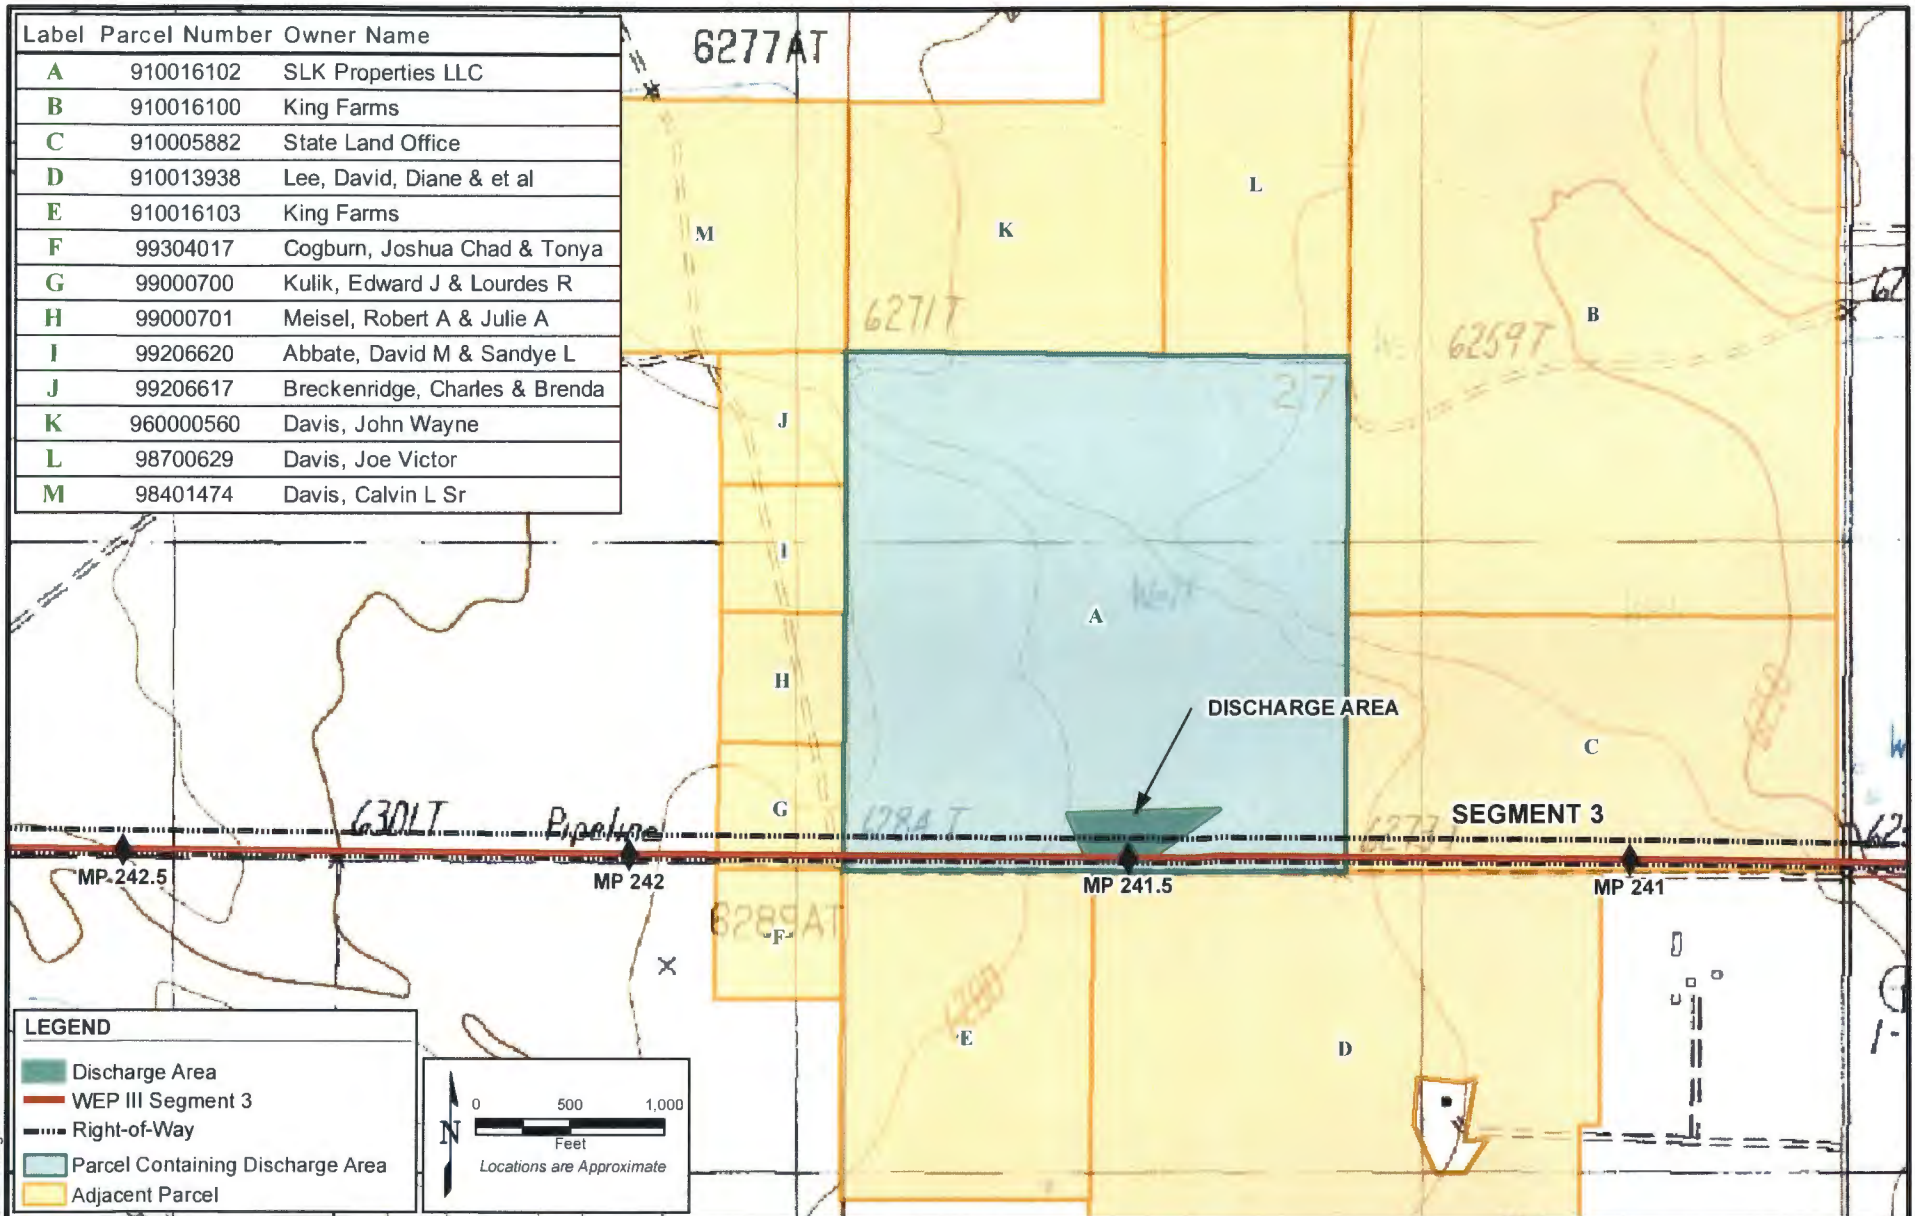
**LAND OWNERSHIP IN THE VICINITY OF THE  
DISCHARGE AREA, WEP III SEGMENT 3**

Label	Parcel Number	Owner Name
A	910016102	SLK Properties LLC
B	910016100	King Farms
C	910005882	State Land Office
D	910013938	Lee, David, Diane & et al
E	910016103	King Farms
F	99304017	Cogburn, Joshua Chad & Tonya
G	99000700	Kulik, Edward J & Lourdes R
H	99000701	Meisel, Robert A & Julie A
I	99206620	Abbate, David M & Sandye L
J	99206617	Breckenridge, Charles & Brenda
K	960000560	Davis, John Wayne
L	98700629	Davis, Joe Victor
M	98401474	Davis, Calvin L Sr

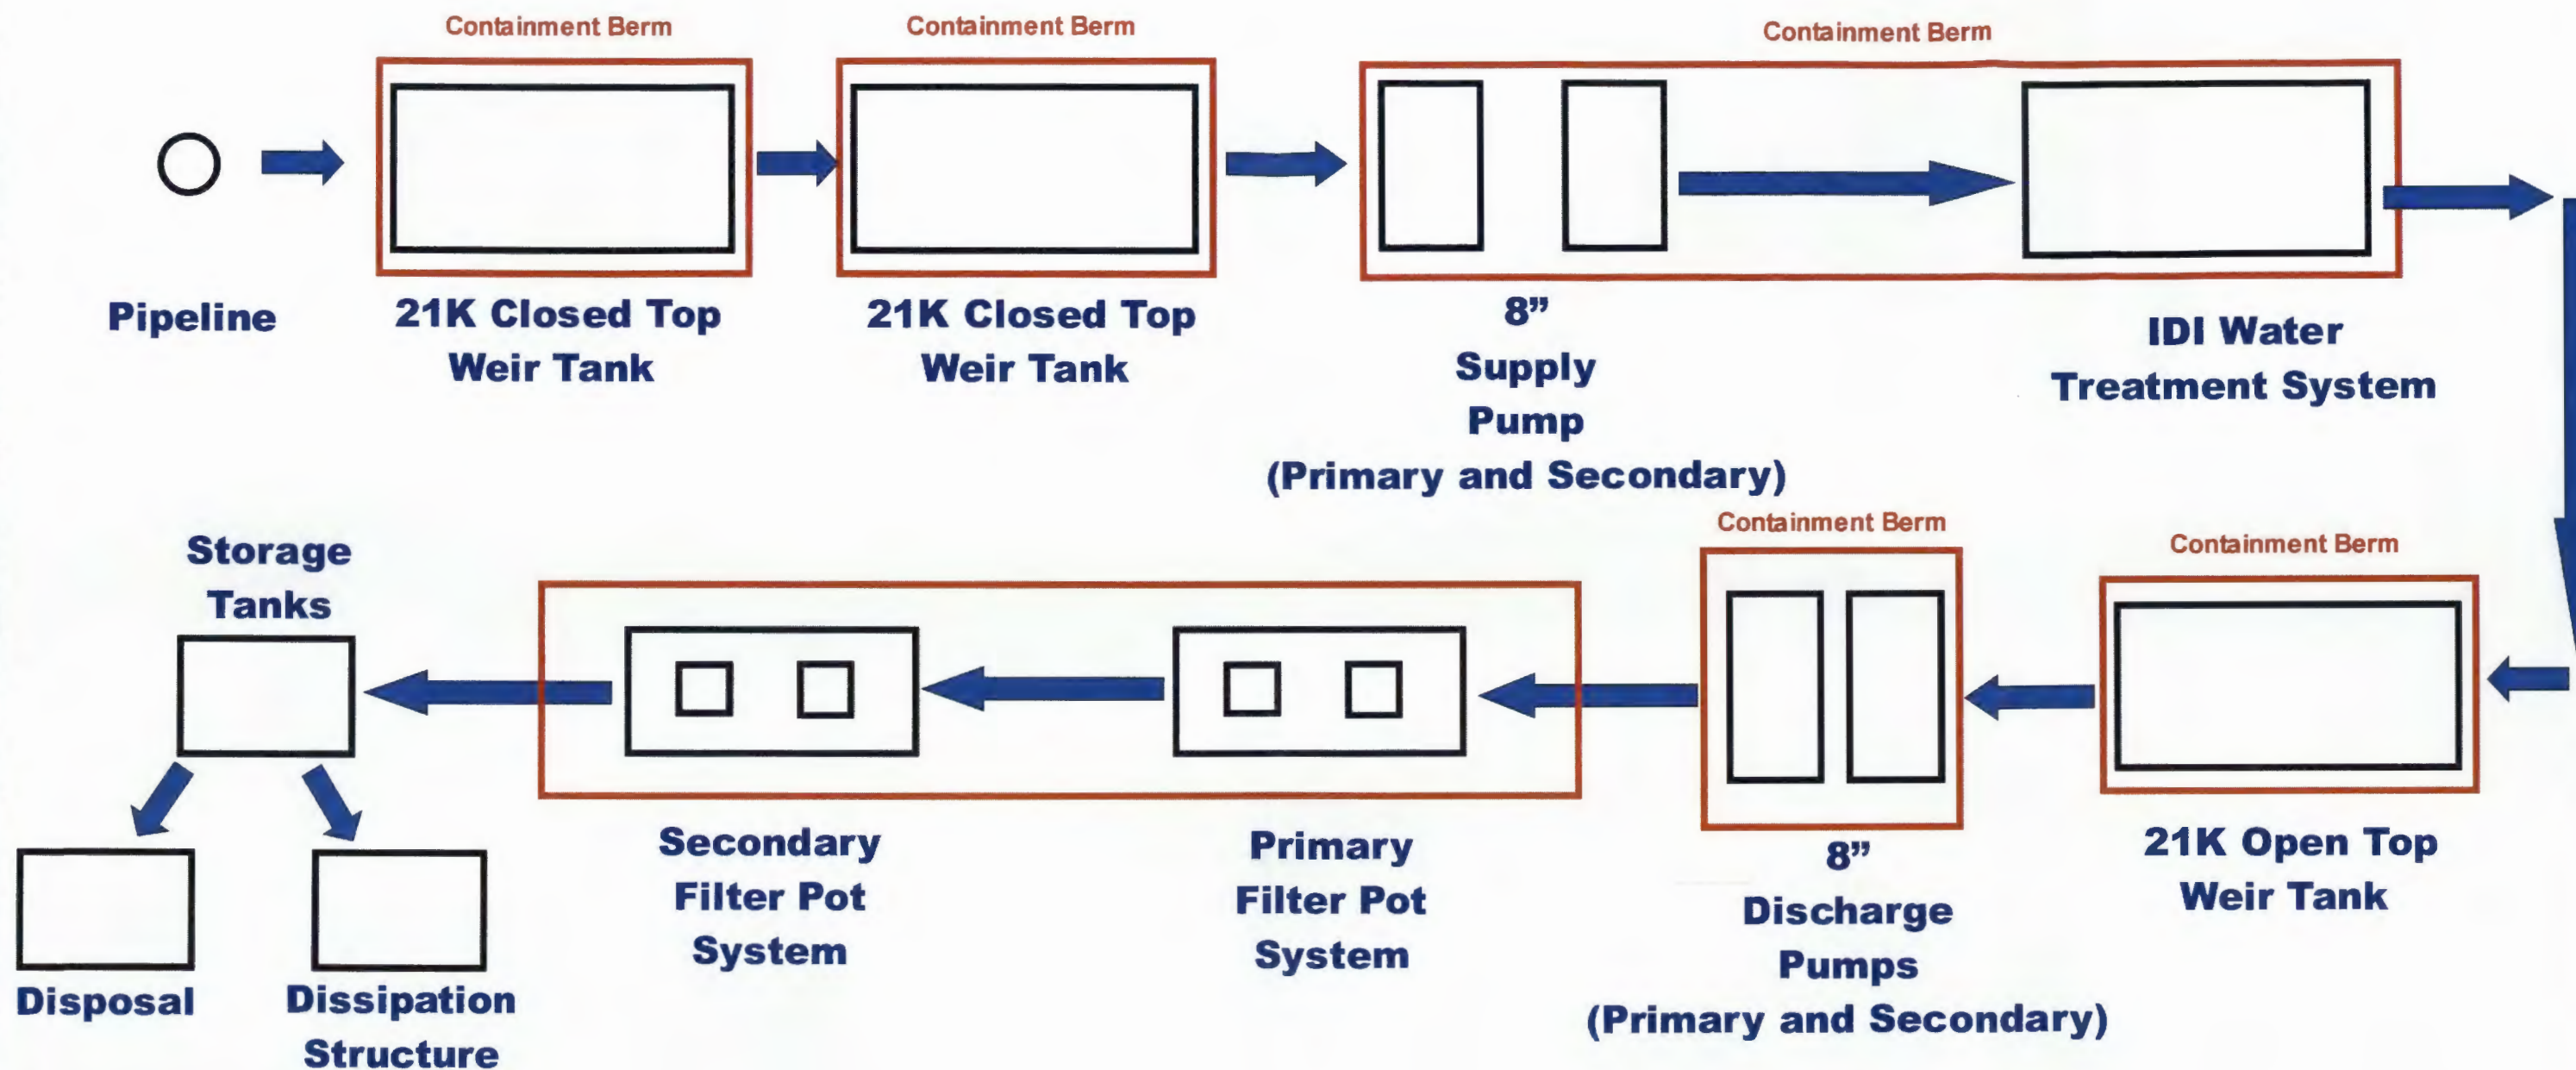
Source: IDI, Process Diagram, Hydrostatic Pipeline Water Filtration, Enterprise Products, dated 07/16/13.

If hydrostatic test water analytical results exceed the greater of the standards of NMAC 20.6.2.3103 or background levels for discharge, the test water will be treated using an electro-coagulation cleaning process and a separate filtering system. This process is described in Appendix G.
