**Unit Petroleum
Gourley Fed 3Q Drillpit**

**Annual Report
2013**

Annual Groundwater Monitoring Report

Gourley Federal #3 Well
Unit H, Section 28, T-22-S, R-28_E
Eddy County, New Mexico

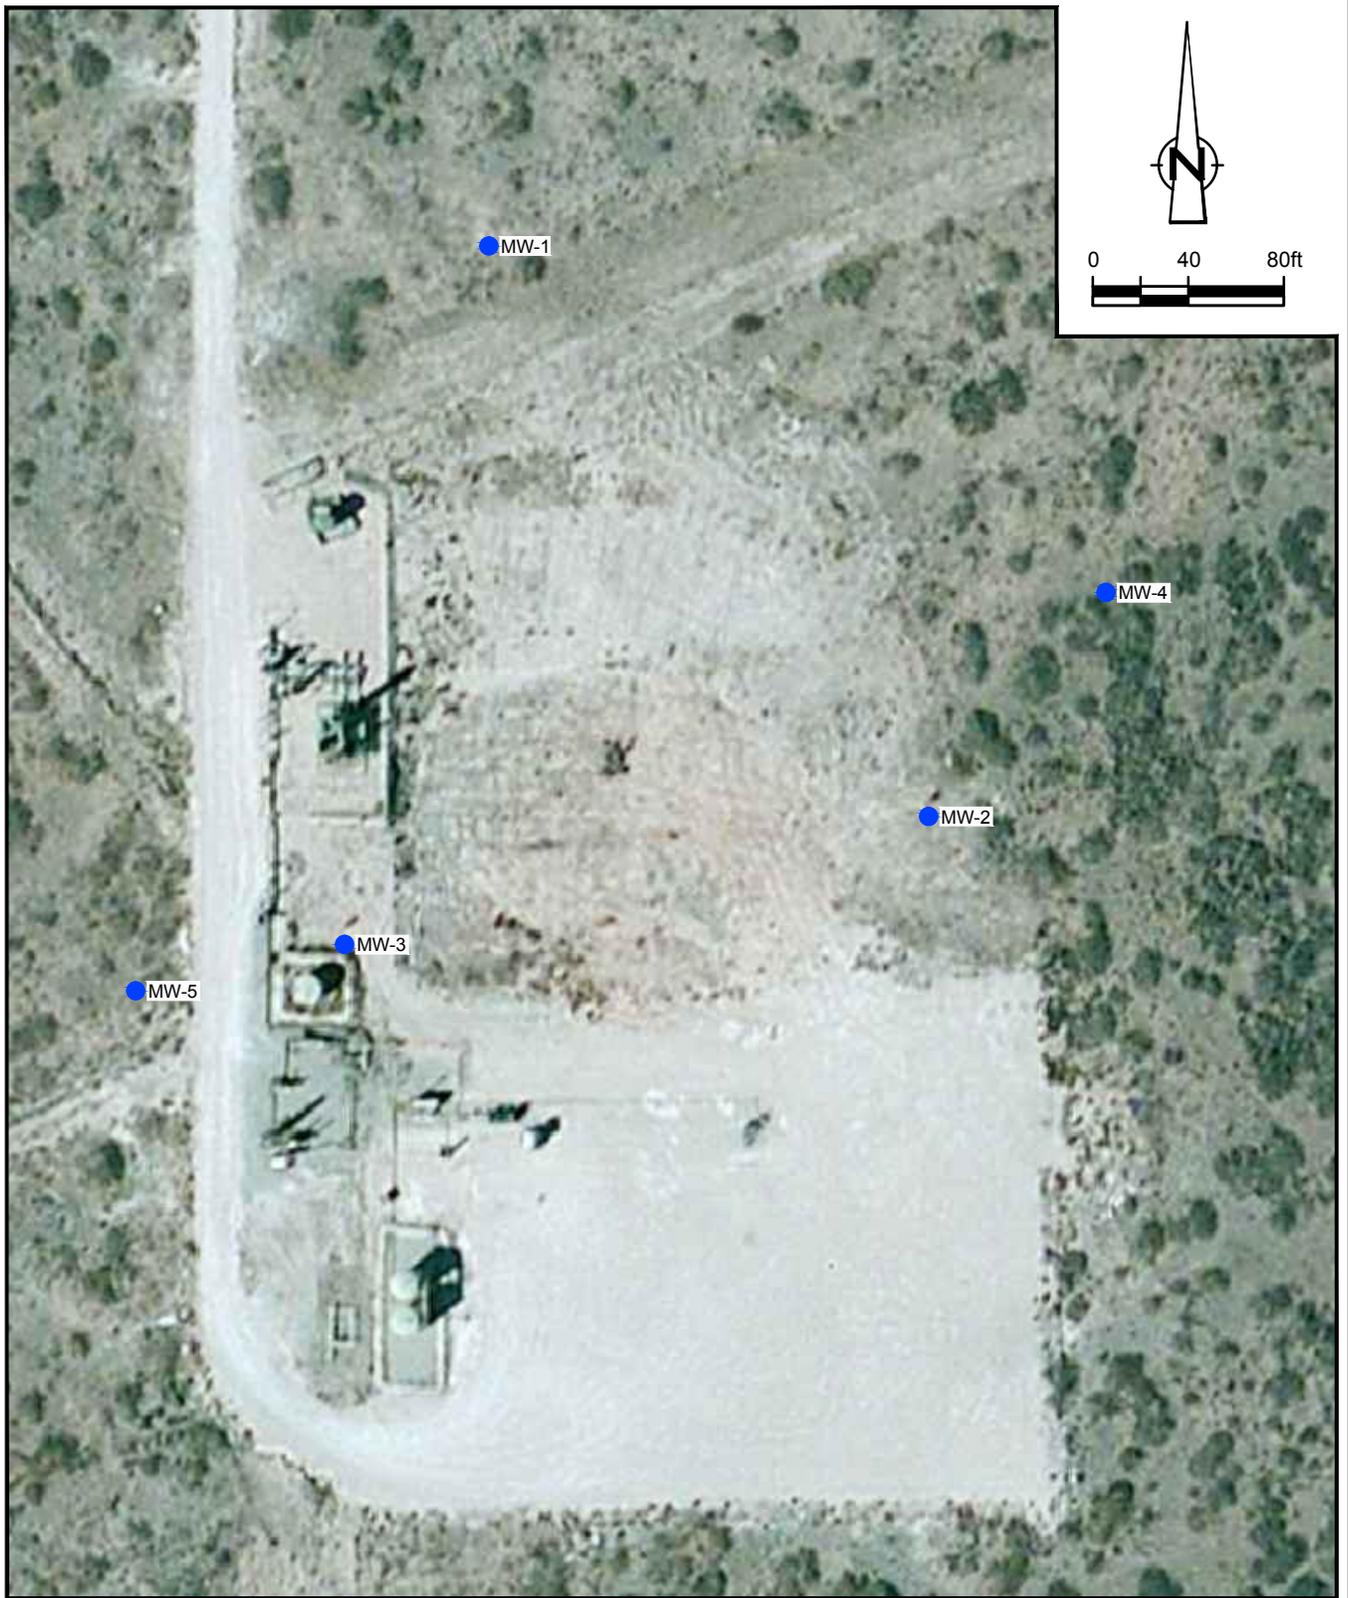
Figure 2
 SITE DETAIL MAP
 GOURLEY FEDERAL #3
 EDDY COUNTY, NEW MEXICO
Unit Petroleum Company

Monitoring Well Location

- Obtaining required monitor well permits, and coordinating with stakeholders.
- Installing two additional monitoring wells, one upgradient of MW-2 and one downgradient of MW-3 (**Figure 2**).
- Conducting six quarterly groundwater monitoring and sampling events.

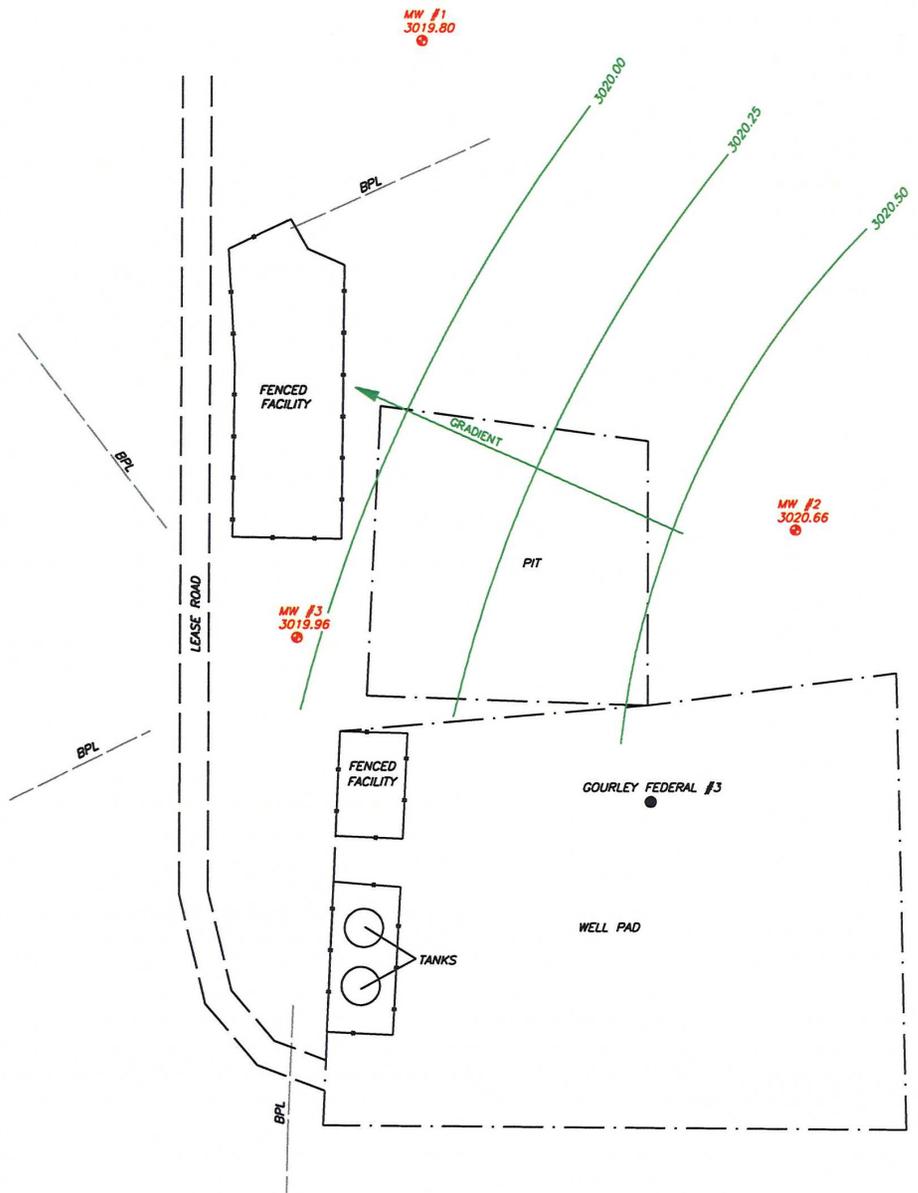
FIGURE NO. 3

GOURLEY FEDERAL #3
GROUNDWATER GRADIENT MAP
GAUGED ON 6/27/09

Prior to collection of groundwater samples, depth to groundwater in each well was measured using an oil/water interface probe (**Table 2**). Previous data collected by Tetra Tech indicated that the local groundwater gradient was to the west-northwest. A groundwater gradient map from Tetra Tech is included as **Figure 3**.

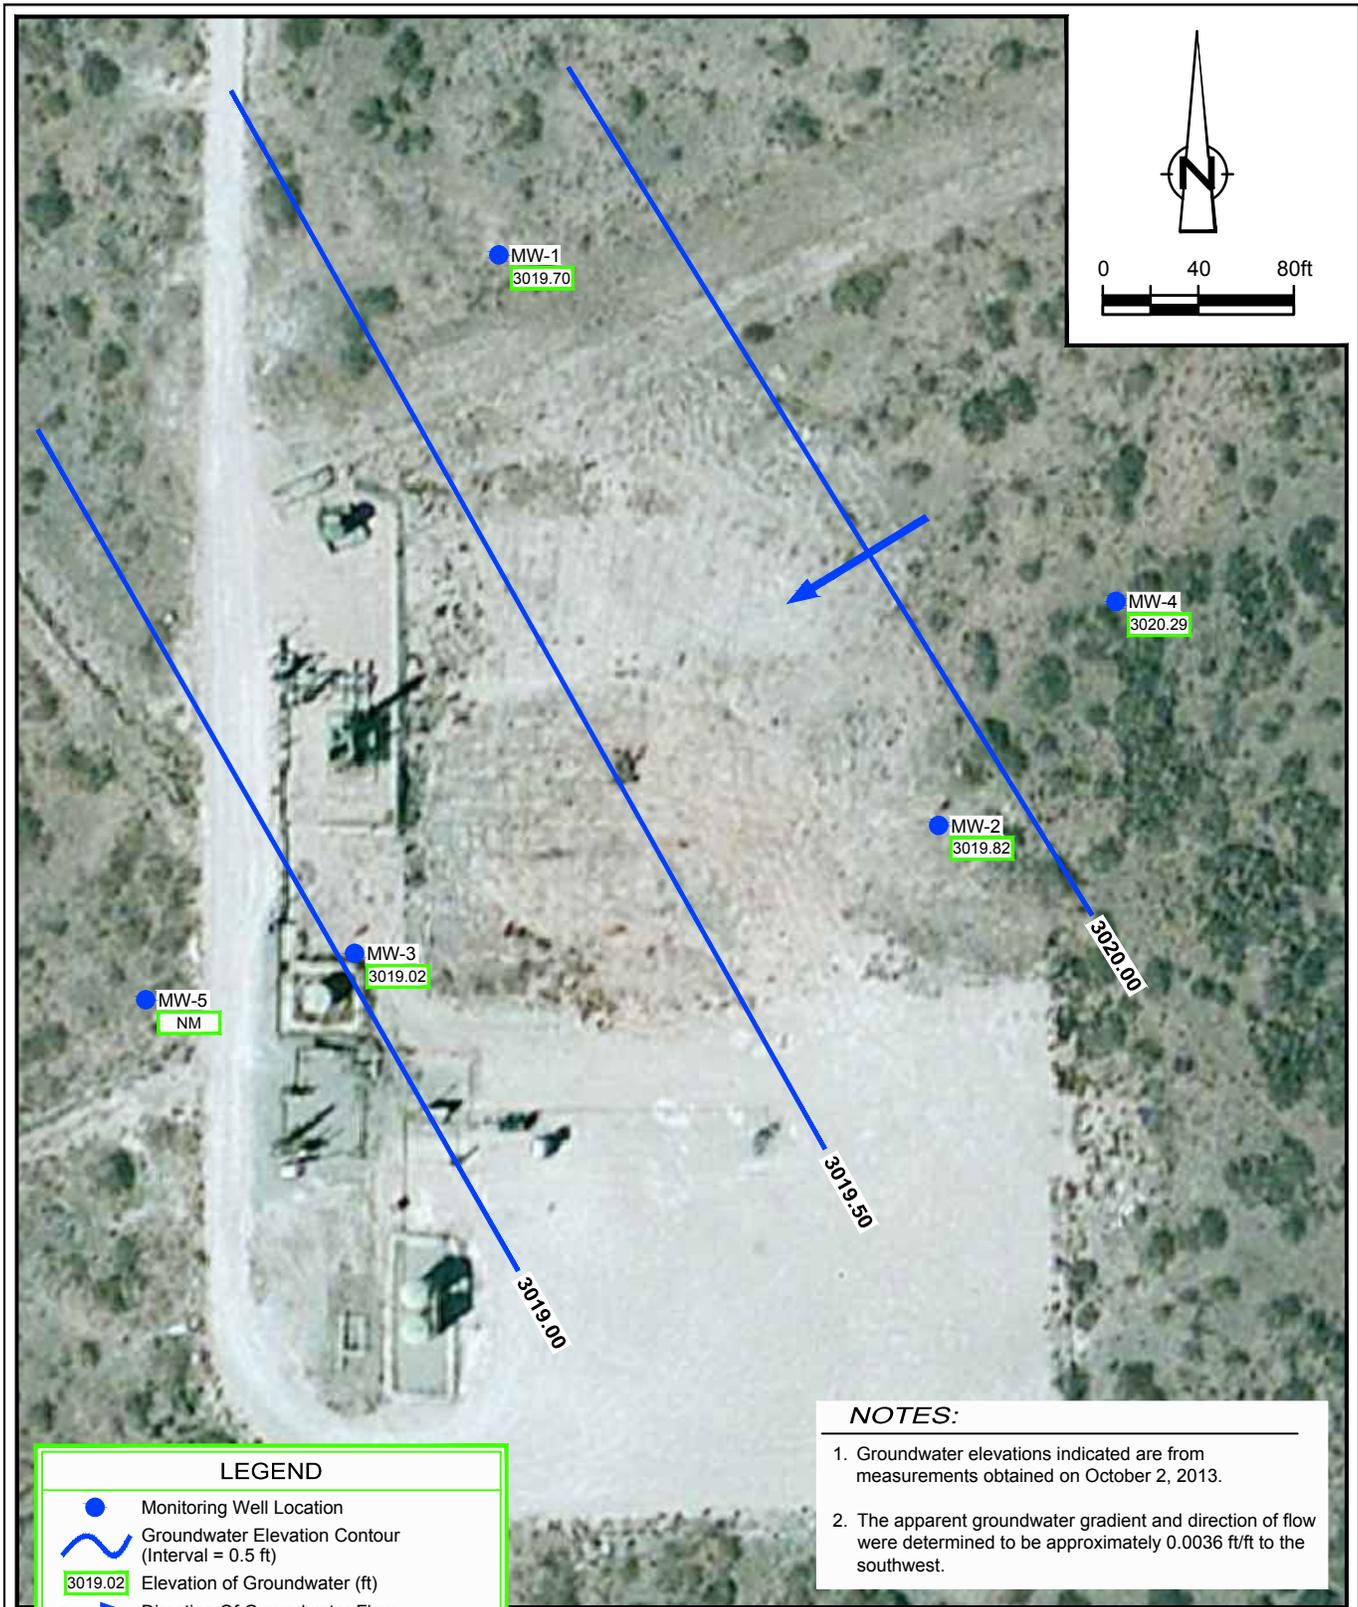
Figure 4
OCTOBER 2013 GROUNDWATER POTENTIOMETRIC MAP
GOURLEY FEDERAL #3
EDDY COUNTY, NEW MEXICO
Unit Petroleum Company

1. Groundwater elevations indicated are from measurements obtained on October 2, 2013.
2. The apparent groundwater gradient and direction of flow were determined to be approximately 0.0036 ft/ft to the southwest.

However, the reported regional hydraulic gradient is to the southwest towards the Pecos River. Data from the October 2013 and January 2014 events indicate that the gradient is to the southwest. Groundwater potentiometric surface maps reflecting October 2013 and January 2014 groundwater elevations are presented as **Figures 4** and **5**, respectively. The groundwater gradient was approximately 0.0036 and 0.0042 feet per foot to the southwest for the October 2013 and January 2014 monitoring events, respectively.

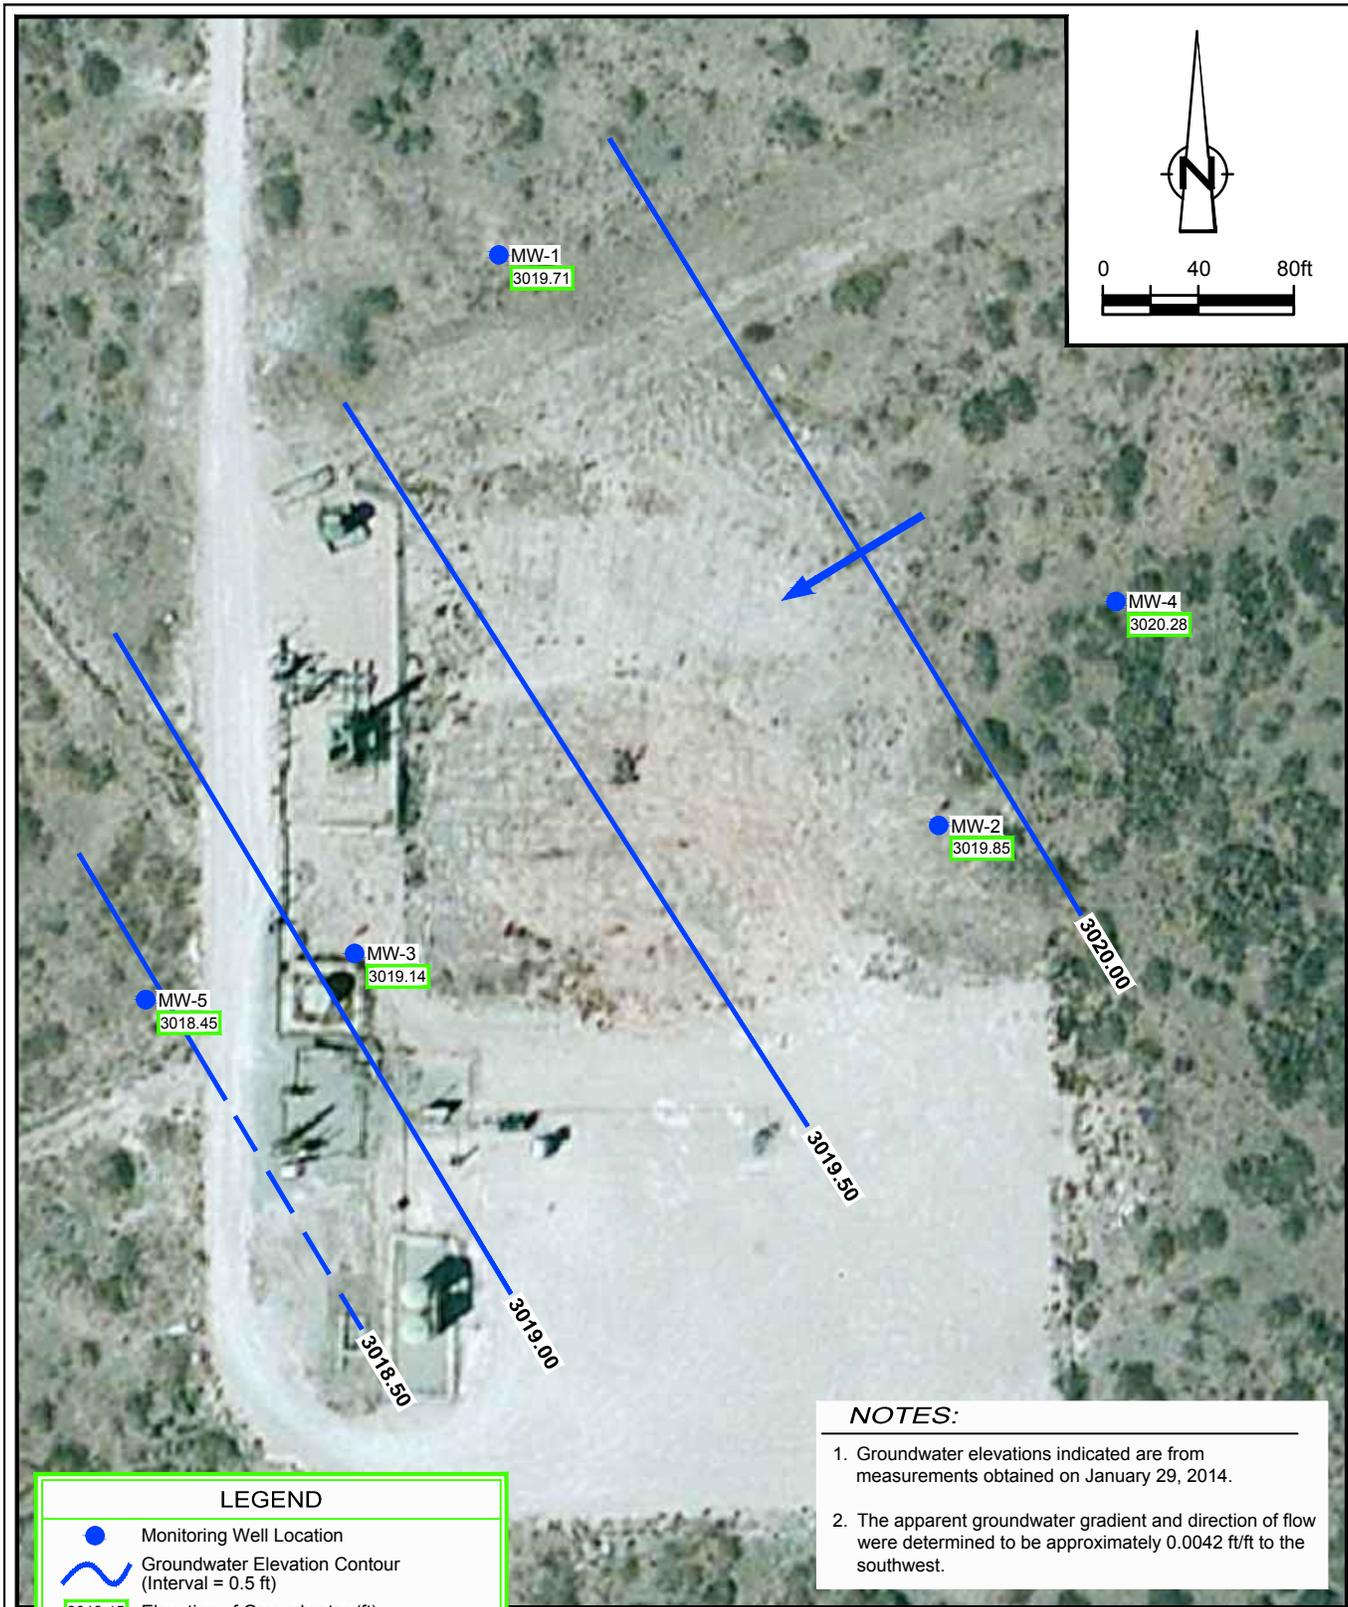
Figure 5

1. Groundwater elevations indicated are from measurements obtained on January 29, 2014.
2. The apparent groundwater gradient and direction of flow were determined to be approximately 0.0042 ft/ft to the southwest.

**JANUARY 2014 GROUNDWATER POTENTIOMETRIC MAP
GOURLEY FEDERAL #3
EDDY COUNTY, NEW MEXICO
*Unit Petroleum Company***

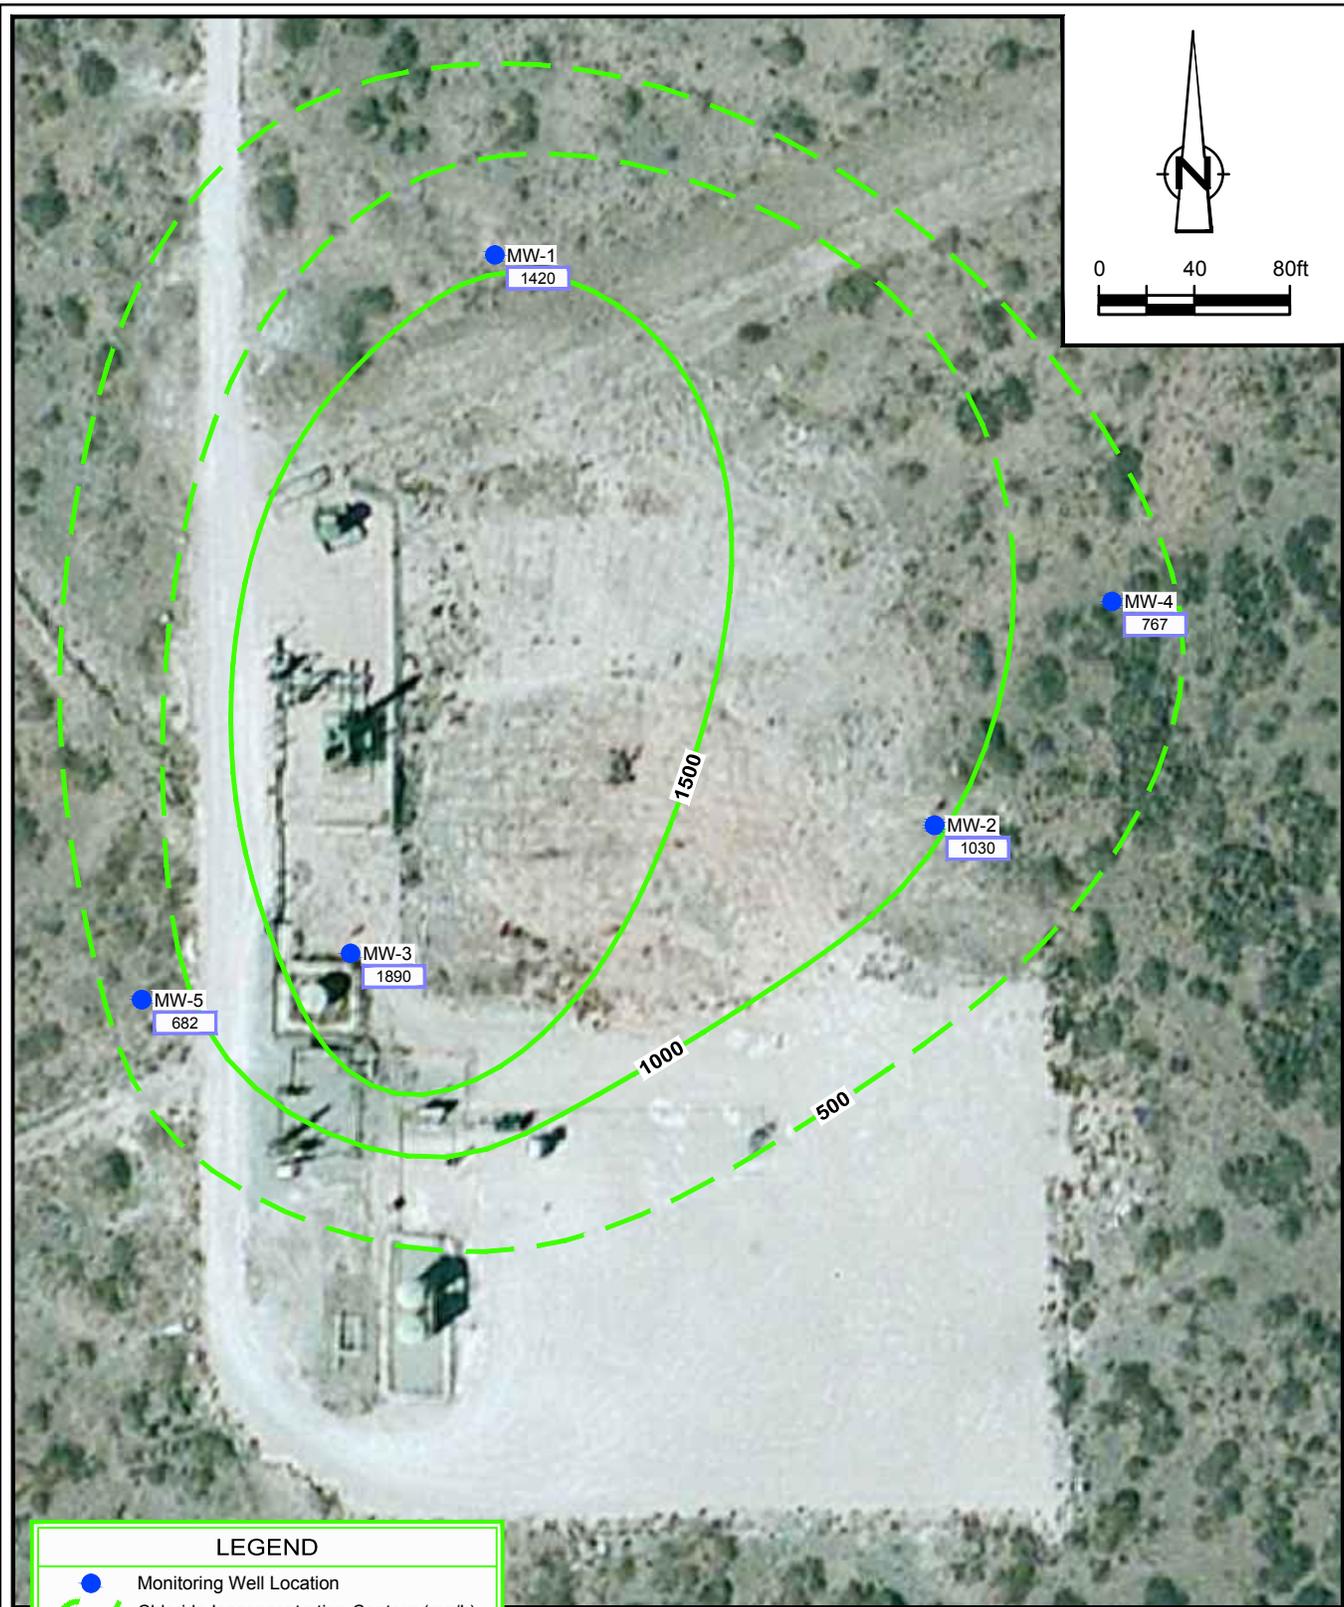
Figure 6

OCTOBER 2013 CHLORIDE CONCENTRATION MAP
 GOURLEY FEDERAL #3
 EDDY COUNTY, NEW MEXICO
Unit Petroleum Company

- Chlorides: The NMWQCC domestic water supply groundwater quality standard for chloride is 250 mg/L. In October 2013, MW-1, MW-2, MW-3, MW-4, and MW-5 returned results of 1,420 mg/L, 1,030 mg/L, 1,890 mg/L, 767 mg/L, and 682 mg/L, respectively. A chloride concentration map for this event is presented as **Figure 6**.
- TDS: The NMWQCC domestic water supply groundwater quality standard for TDS is 1,000 mg/L. In October 2013, MW-1, MW-2, MW-3, MW-4, and MW-5 returned results of 4,910 mg/L, 4,060 mg/L, 5,620 mg/L, 3,500 mg/L, and 3,280 mg/L, respectively.

The chloride concentrations observed in MW-5 are consistent with those found in MW-4 (683 mg/l and 913 mg/l in October and January, respectively). Since these concentrations are consistent with the background well (MW-4), CRA believes that MW-5 may delineate the down-gradient extent of chloride contributions from the pit. The observed concentrations from the remainder of the wells appear to be consistent with historical levels.

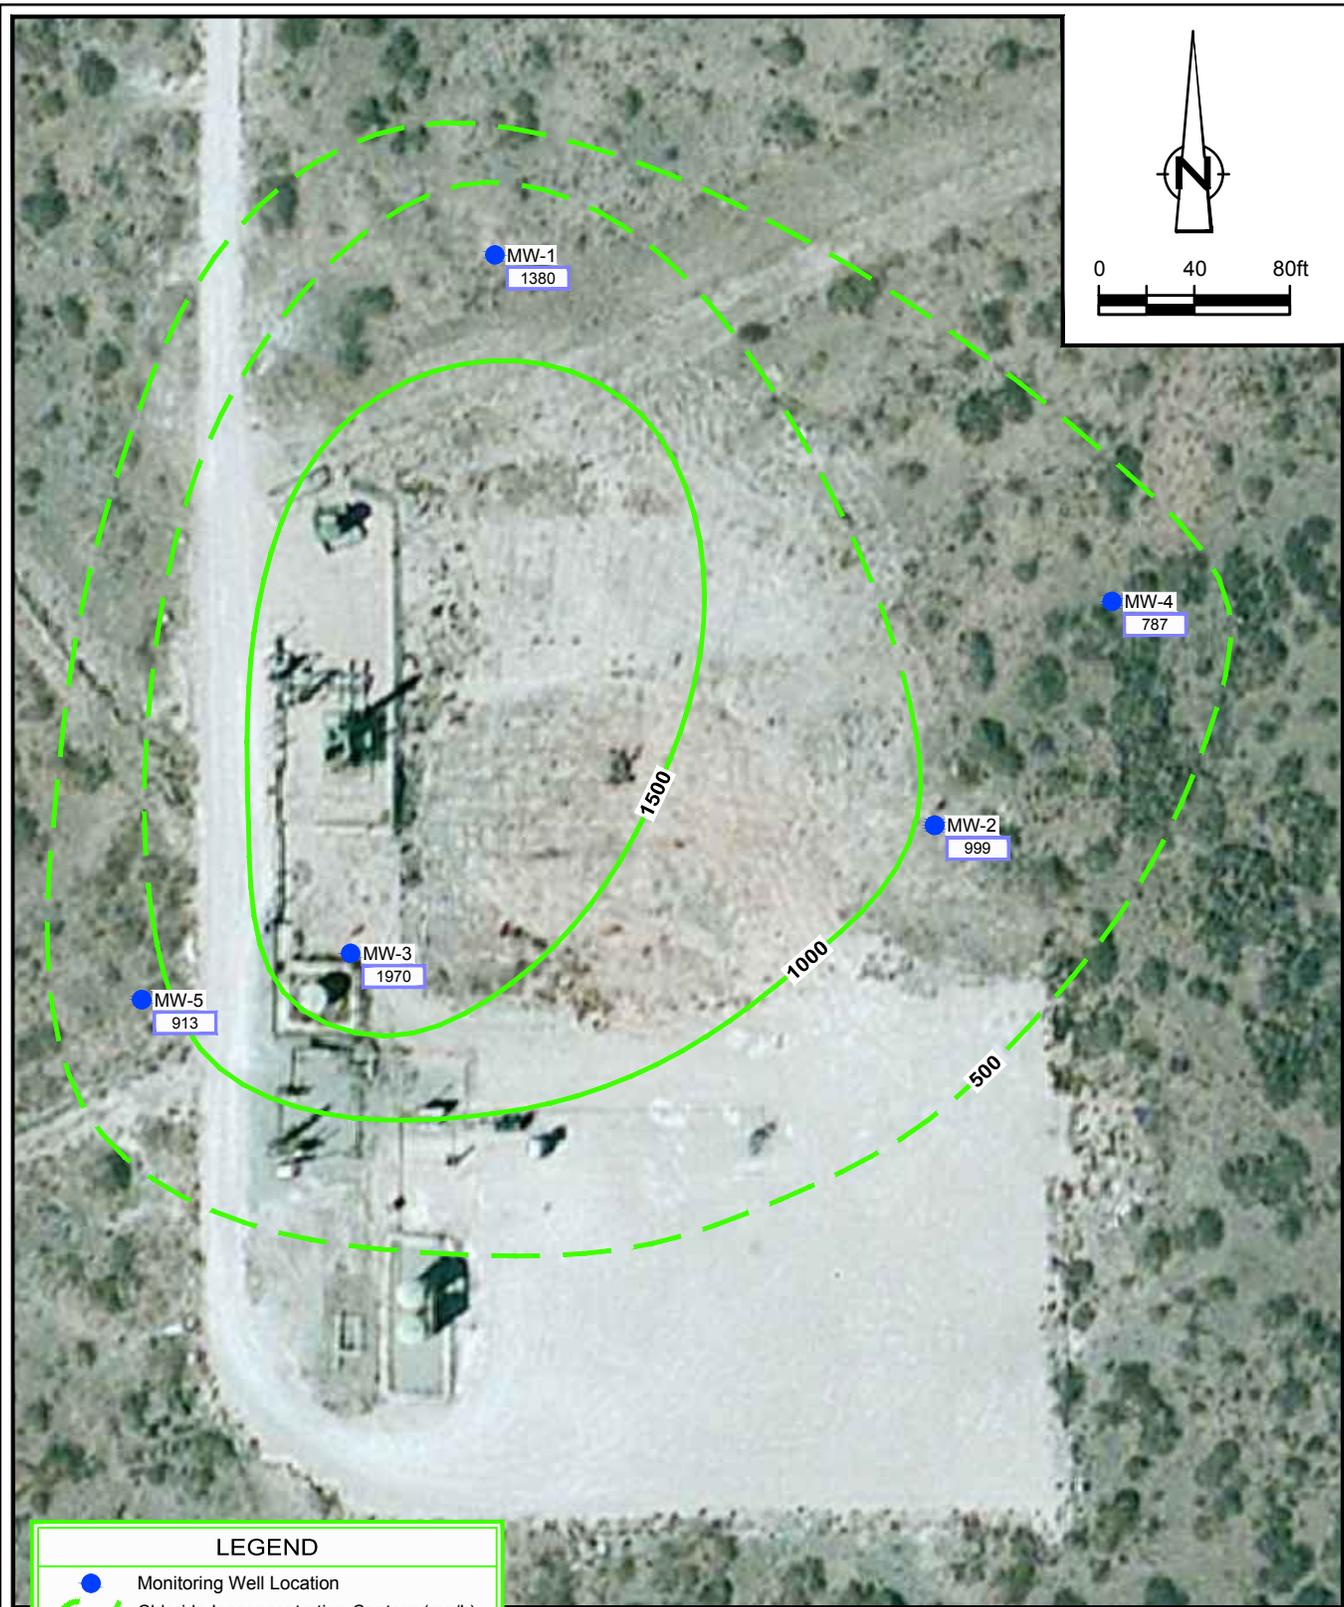
Figure 7

JANUARY 2014 CHLORIDE CONCENTRATION MAP
 GOURLEY FEDERAL #3
 EDDY COUNTY, NEW MEXICO
Unit Petroleum Company

- Chlorides: In January 2014, MW-1, MW-2, MW-3, MW-4, and MW-5 returned results of 1,380 mg/L, 999 mg/L, 1,970 mg/L, 787 mg/L, and 913 mg/L, respectively. A chloride concentration map for this event is presented as **Figure 7**.
- TDS: The In January 2014, MW-1, MW-2, MW-3, MW-4, and MW-5 returned results of 4,600 mg/L, 2,950 mg/L, 6,240 mg/L, 3,340 mg/L, and 3,500 mg/L, respectively.

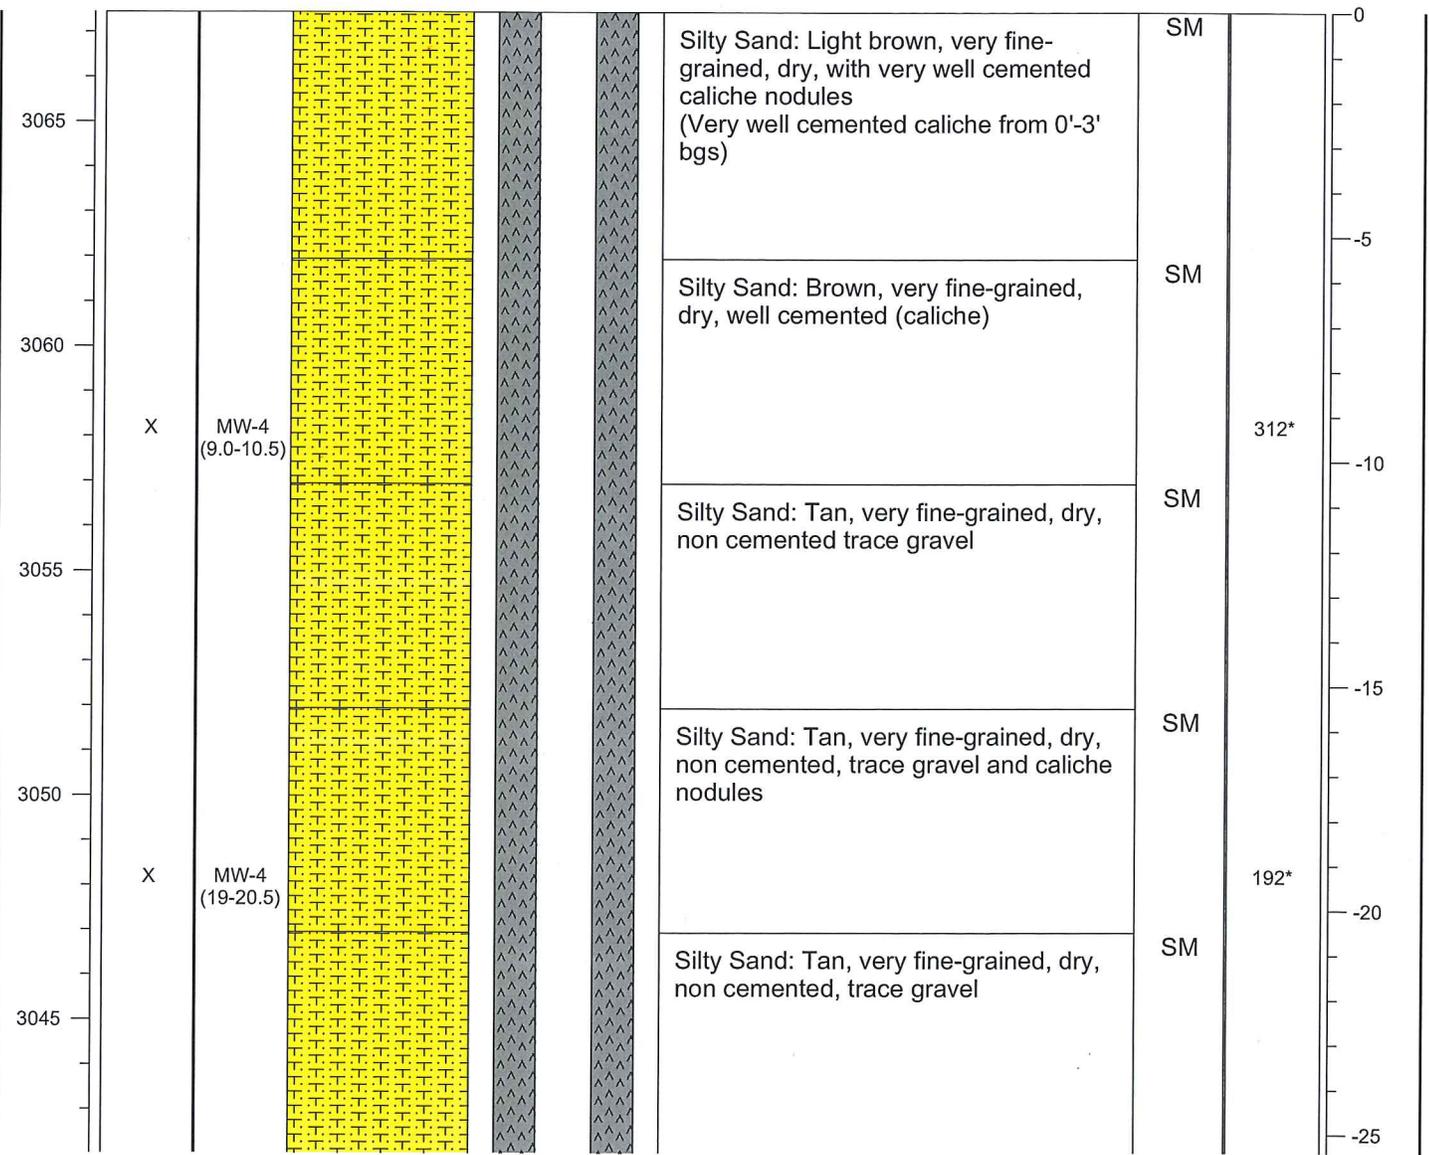
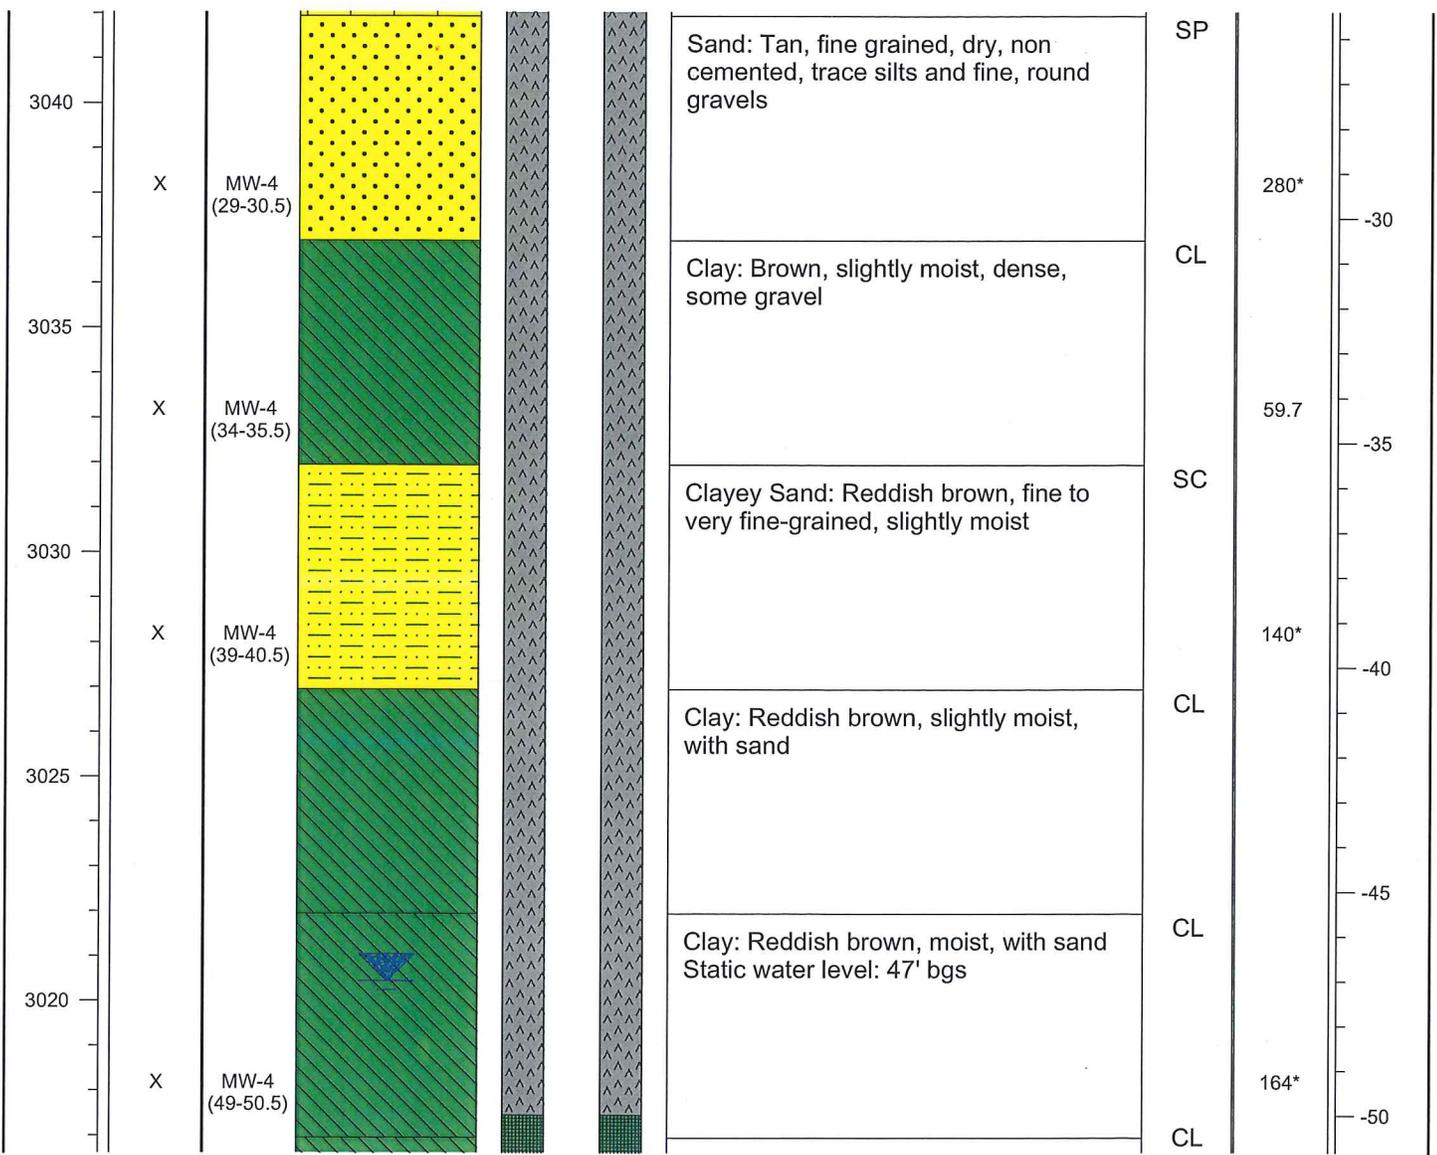
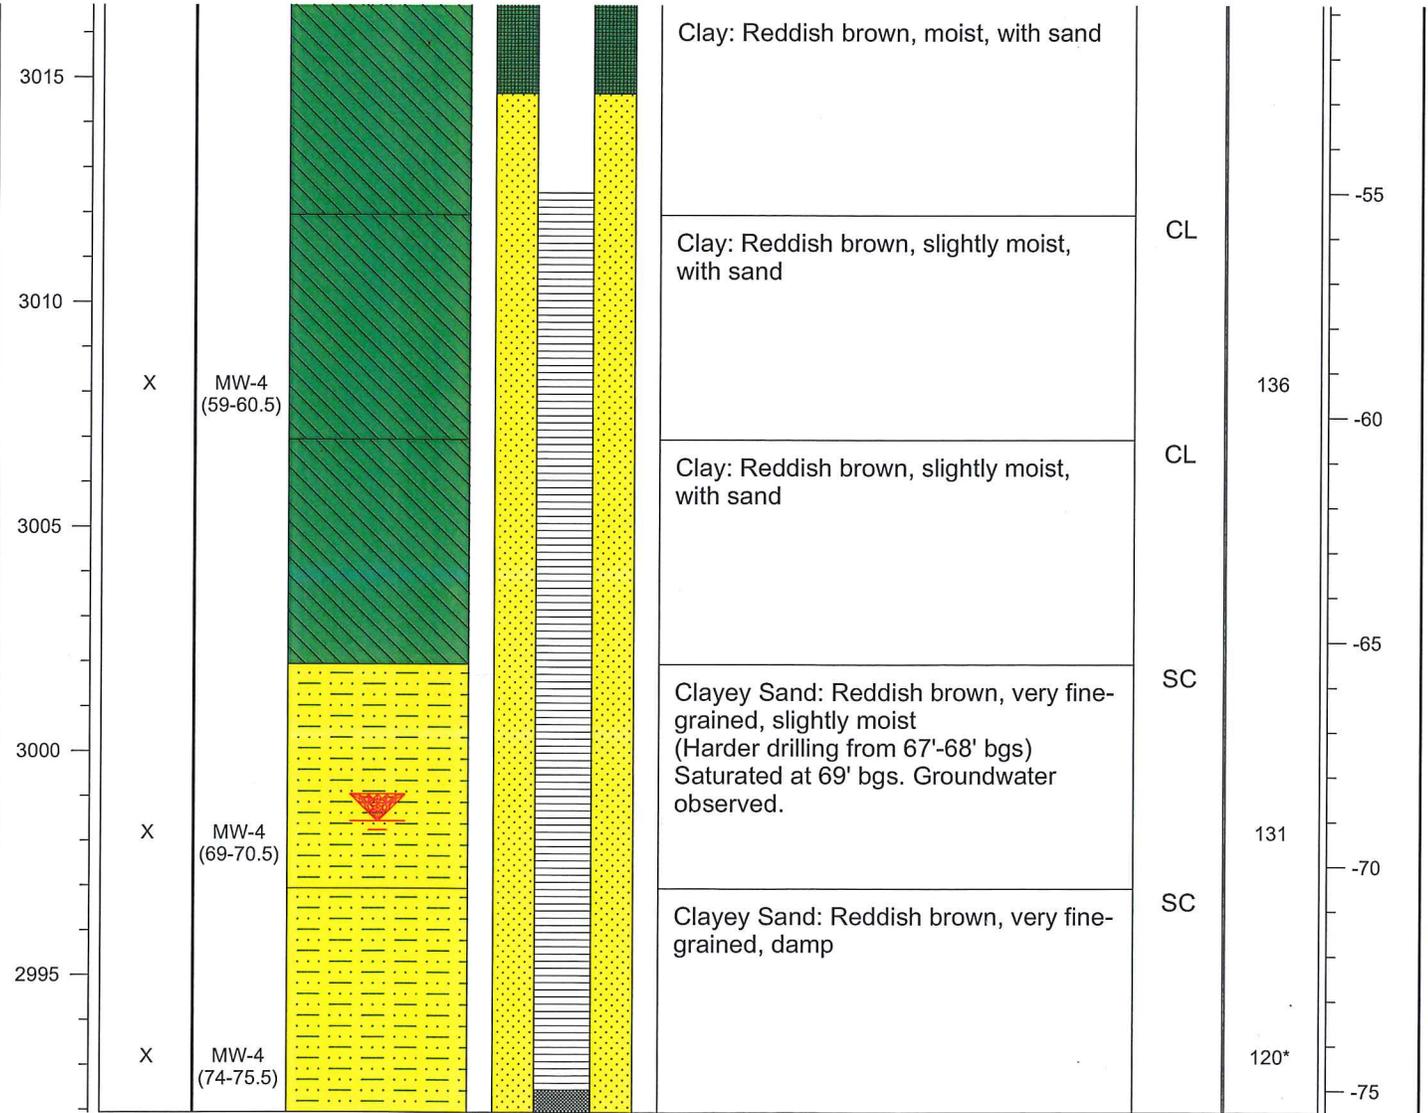
PROJECT NAME: Gourley Fed #3
 LOCATION: Eddy County, New Mexico
 FIELD LOGGED BY: Cale Kanack
 SURFACE ELEVATION (msl): 3067.44 feet
 GROUNDWATER ELEVATION (msl): 47 feet
 REMARKS: Blue arrow = static groundwater level
Red arrow = first groundwater encounter
 COORDINATES: 32.36709, -104.08618

SOIL BORING NO: MW-4
 DRILL TYPE: Hollow Stem Auger
 BORE HOLE DIAMETER: 7 7/8 inches
 DRILLED BY: Enviro-Drill, Inc.
 DATE/TIME HOLE STARTED: October 1, 2013 at 0845
 DATE/TIME HOLE COMPLETED: October 1, 2013 at 1425

MW-4 was installed to a total depth of 75 feet bgs. The well was constructed of 2-inch diameter, schedule 40, flush-joint, PVC casing and screen. The monitoring well consists of a 0.5-foot long, threaded PVC bottom plug and 20 feet of flush-joint, threaded, factory-slotted (0.020-inch) well screen. The annular space around the well screen was filled with 10/20 gradation silica sand to approximately 2.2 feet above the well screen, followed by approximately 2.8 feet of 3/8-inch bentonite chips. A cement/bentonite grout was placed from the top of the bentonite chips to ground surface. The wellhead is protected with an above-grade completion set within a 24-inch by 24-inch by 4-inch thick concrete pad.

The first 25 to 30 feet of soils consisted mainly of tan-brown, fine-grained, silty sands, with the first three feet being very well cemented (caliche). Below the silty sands, the soils were mostly reddish-brown clays or clayey sands.

The water table was expected to be encountered at approximately 50 feet bgs. However, saturated soil conditions were not encountered until 70 and 60 feet bgs for MW-4 and MW-5, respectively. When hydrostatic equilibrium was reached inside each well casing, groundwater was gauged to be approximately 47 and 49 feet bgs for MW-4 and MW-5, respectively. This is most likely indicative of confined conditions. MW-4 and MW-5 boring logs are presented as **Appendix A**. Boring logs for MW-1, MW-2, and MW-3 could not be located.
