**Unit Petroleum
Gourley Fed 3Q Drillpit**

**Annual Report
2013**

Annual Groundwater Monitoring Report

Gourley Federal #3 Well
Unit H, Section 28, T-22-S, R-28_E
Eddy County, New Mexico

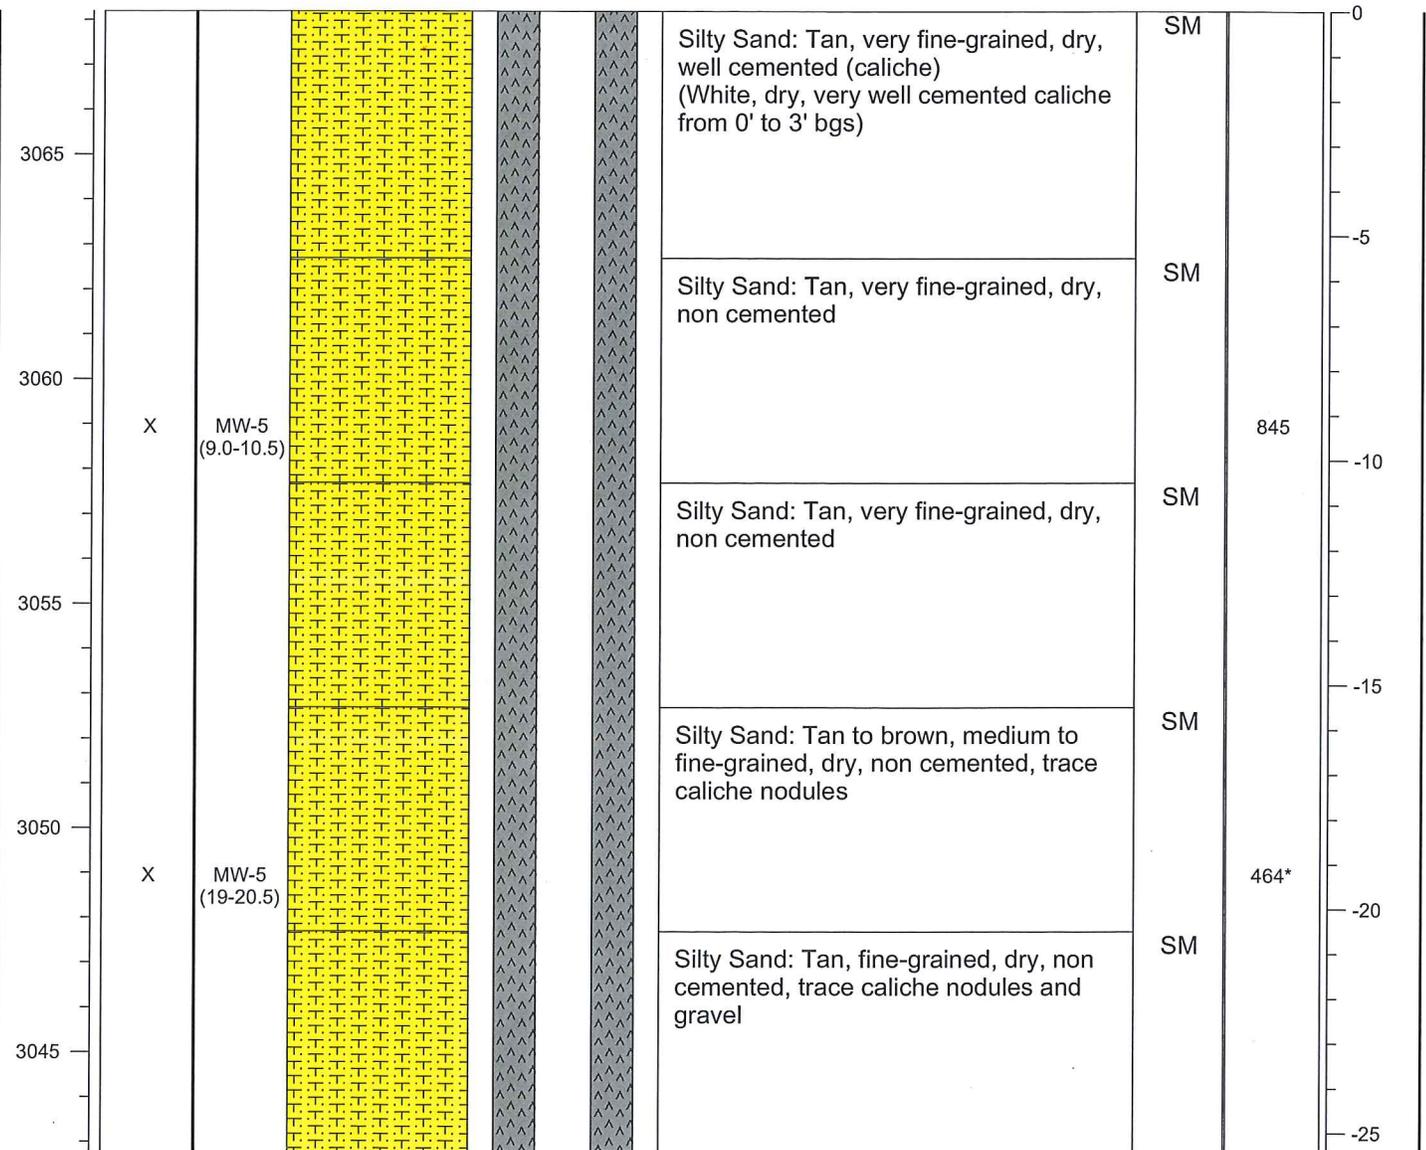
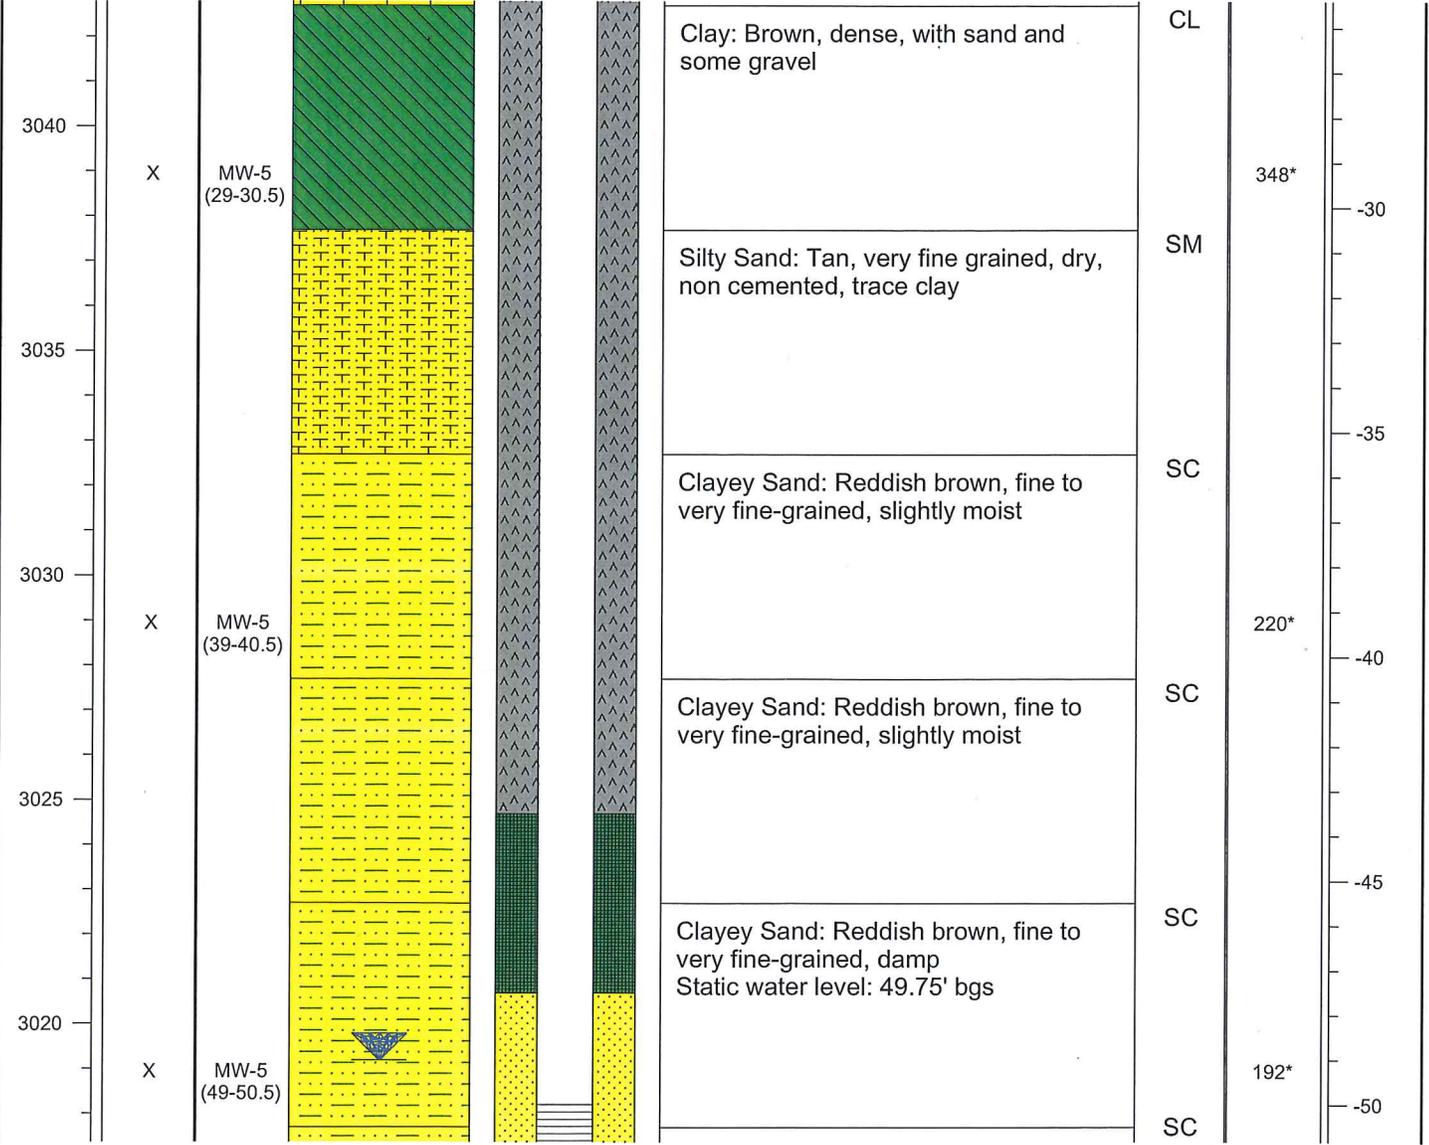
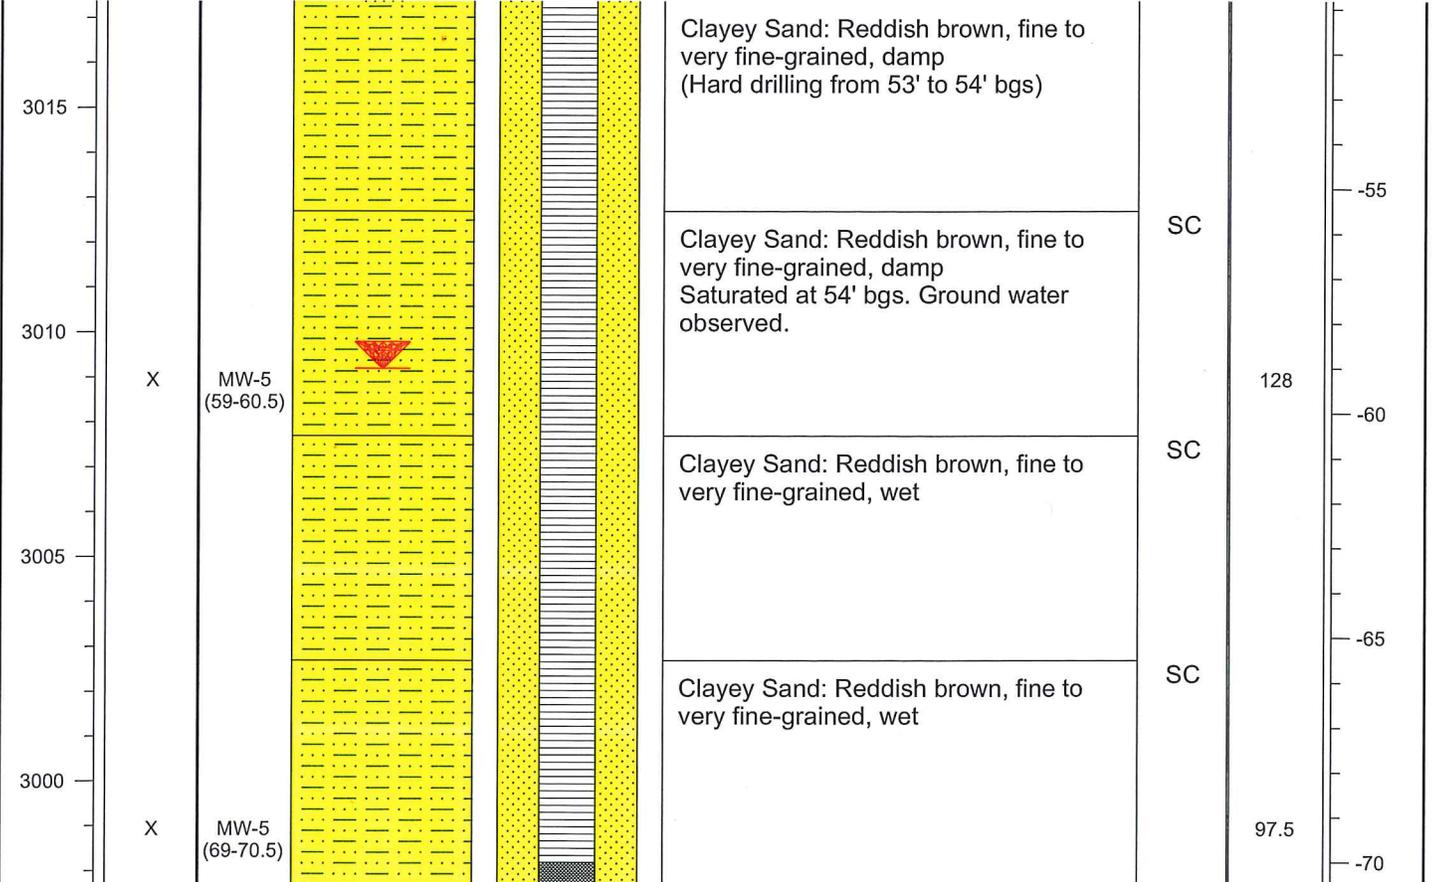
PROJECT NAME: <u>Gourley Fed #3</u>	SOIL BORING NO: <u>MW-5</u>
LOCATION: <u>Eddy County, New Mexico</u>	DRILL TYPE: <u>Hollow Stem Auger</u>
FIELD LOGGED BY: <u>Cale Kanack</u>	
SURFACE ELEVATION (msl): <u>3068.20 feet</u>	BORE HOLE DIAMETER: <u>7 7/8 inches</u>
GROUNDWATER ELEVATION (msl): <u>49 feet</u>	DRILLED BY: <u>Enviro-Drill, Inc.</u>
REMARKS: <u>Blue arrow = static groundwater level</u>	DATE/TIME HOLE STARTED: <u>October 2, 2013 at 0810</u>
<u>Red arrow = first groundwater encounter</u>	DATE/TIME HOLE COMPLETED: <u>October 2, 2013 at 1145</u>
COORDINATES: <u>32.36663, -104.08750</u>

MW-5 was installed to a total depth of 70 feet bgs. The well was constructed of 2-inch diameter, schedule 40, flush-joint, threaded polyvinyl chloride (PVC) casing and screen. The monitoring well consists of a 0.5-foot long, threaded PVC bottom plug and 20 feet of flush-joint, threaded, factory-slotted (0.020-inch) well screen. The annular space around the well screen was filled with 10/20 gradation silica sand to approximately 2.5 feet above the well screen, followed by approximately four feet of 3/8-inch bentonite chips.

A cement/bentonite grout was placed from the top of the bentonite chips to ground surface. The wellhead is protected with an above-grade completion set within a 24-inch by 24-inch by 4-inch thick concrete pad.

All soil samples returned analytical results below detection limits for TPH. The only soil sample that exceeded the NMOCD Recommended Remediation Action Level (RRAL) for chlorides was SS-082612-100213-CK-MW-5-10, which returned an analytical result of 845 mg/kg. This sample was collected from the MW-5 boring at a depth of 10 feet bgs. The RRAL for chlorides is 250 mg/kg. A summary of soil analytical results is presented as **Table 1** and the Laboratory Analytical Report is included in **Appendix B**.
