TANK WORKPLAN

RE: PROPOSED SOIL REMEDIATION AT THE "WEST SUMP" SUBGRADE TANK SITE AT
SOUTHERN UNION GAS SERVICES JAL #3 GAS PLANT (SECTION 33, TOWNSHIP 24 SOUTH,
RANGE 37 EAST – NMOCD PERMIT GW010)

Conceptual Remedial Design
West Sump Below Ground Tank, Jal #3 Gas Plant
Section 33, T24S, R37E, Lea County, New Mexico

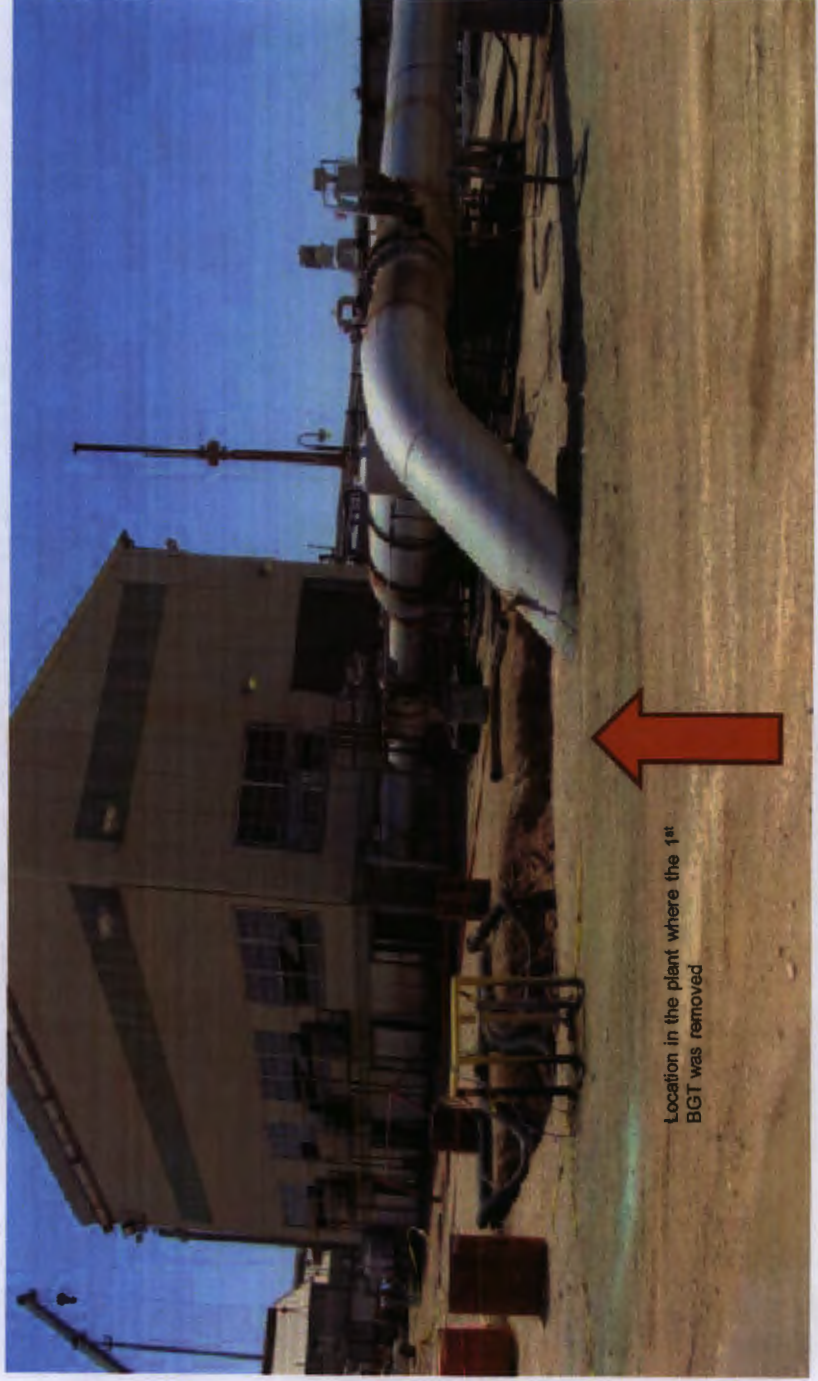
Figure 1:
Jal #3 BGWS Removal of #1 Tank

As seen in Figure 1, the location of the former BGWS is tightly constrained by the Turbine Building (background), a scrubber (right of the excavation), and a 30-inch natural gas pipeline (foreground of the excavation). Figure 2 shows the extent of the excavation on June 7, prior to the remedial excavation.

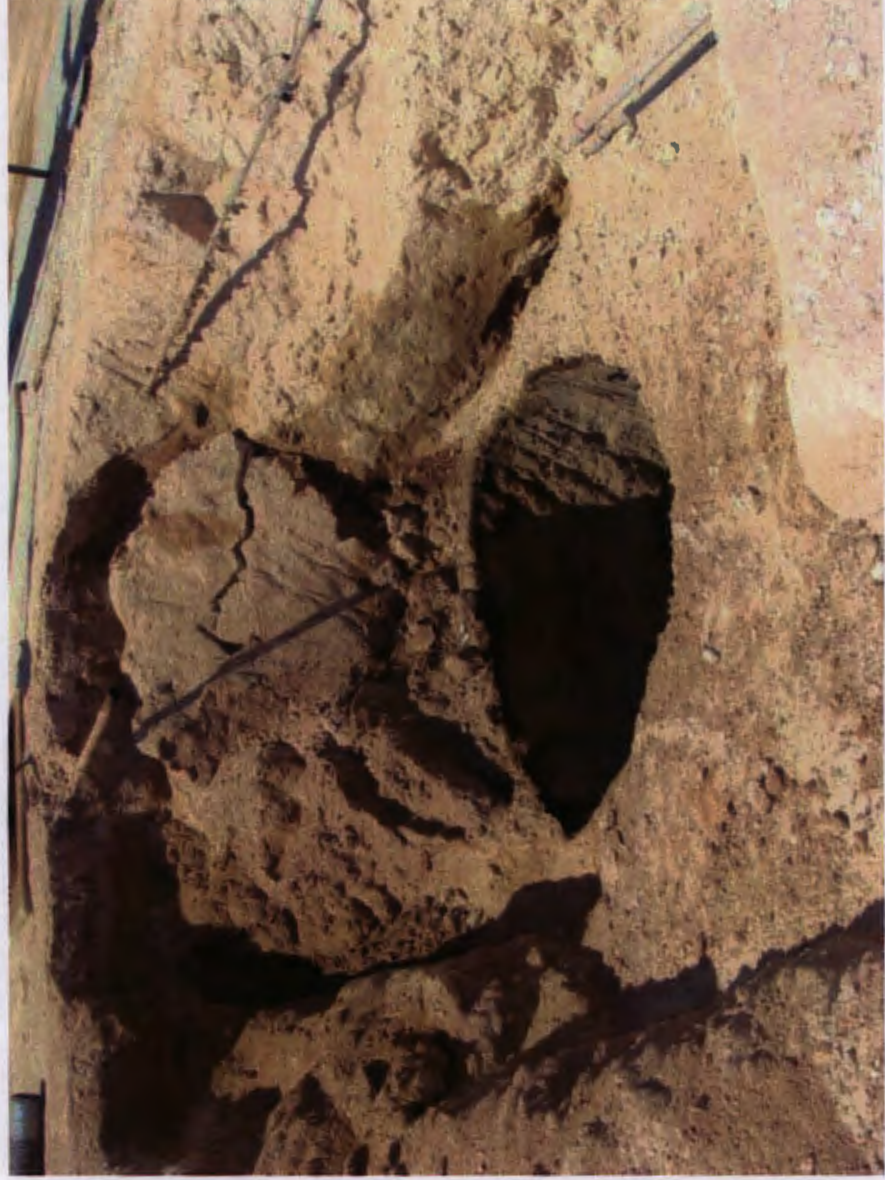
Figure 2: Original Excavation on 7/7/2011

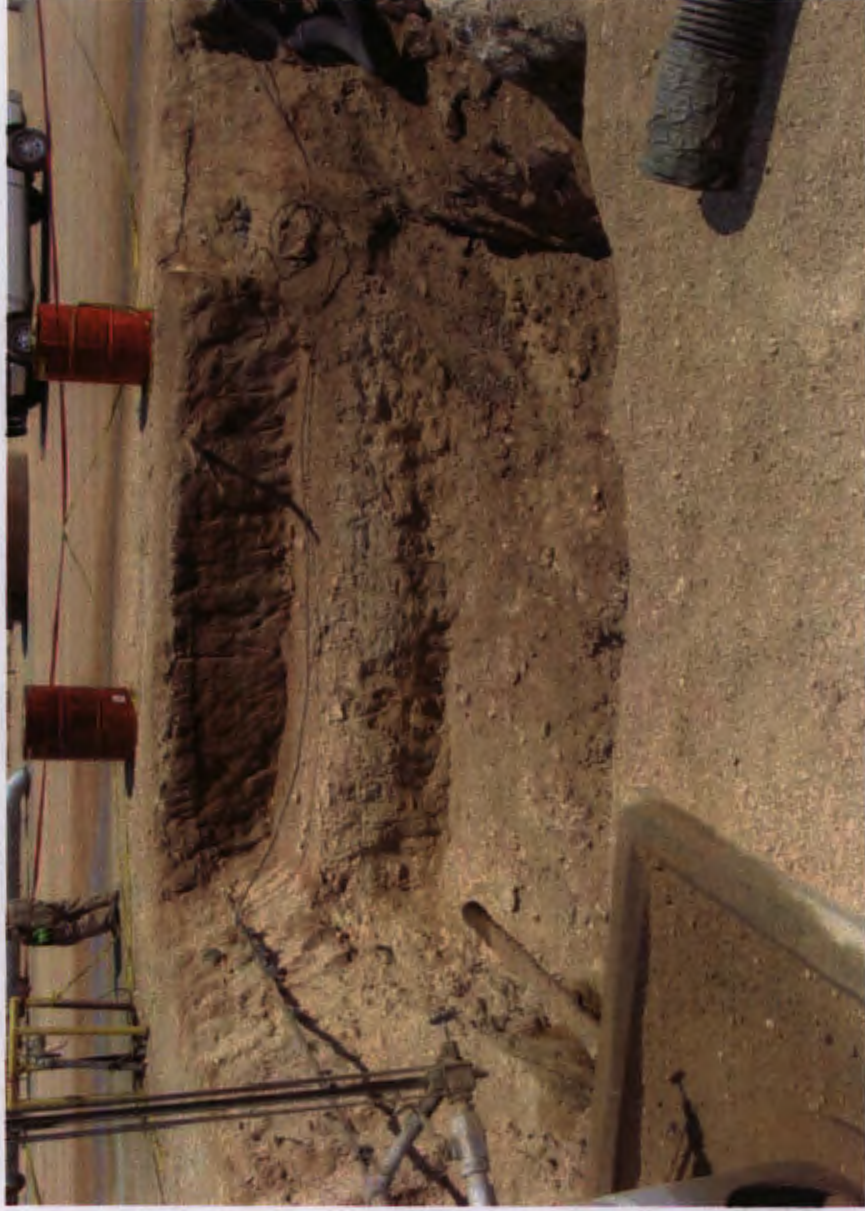
Figure 3: Final Excavation Extents, July 11, 2011
(Dimensions of the excavation
are: 20' wide x 21' length and 13 ' in depth)

Figure 3 shows the excavation after the removal of approximately 50 cubic yards of soils. The final excavation had an extent of approximately 20 by 11 feet, and a depth of 13 feet at its deepest point. Due to the close proximity of the adjacent, active equipment and the instability of the soils, no further excavation is feasible or safe in this area.

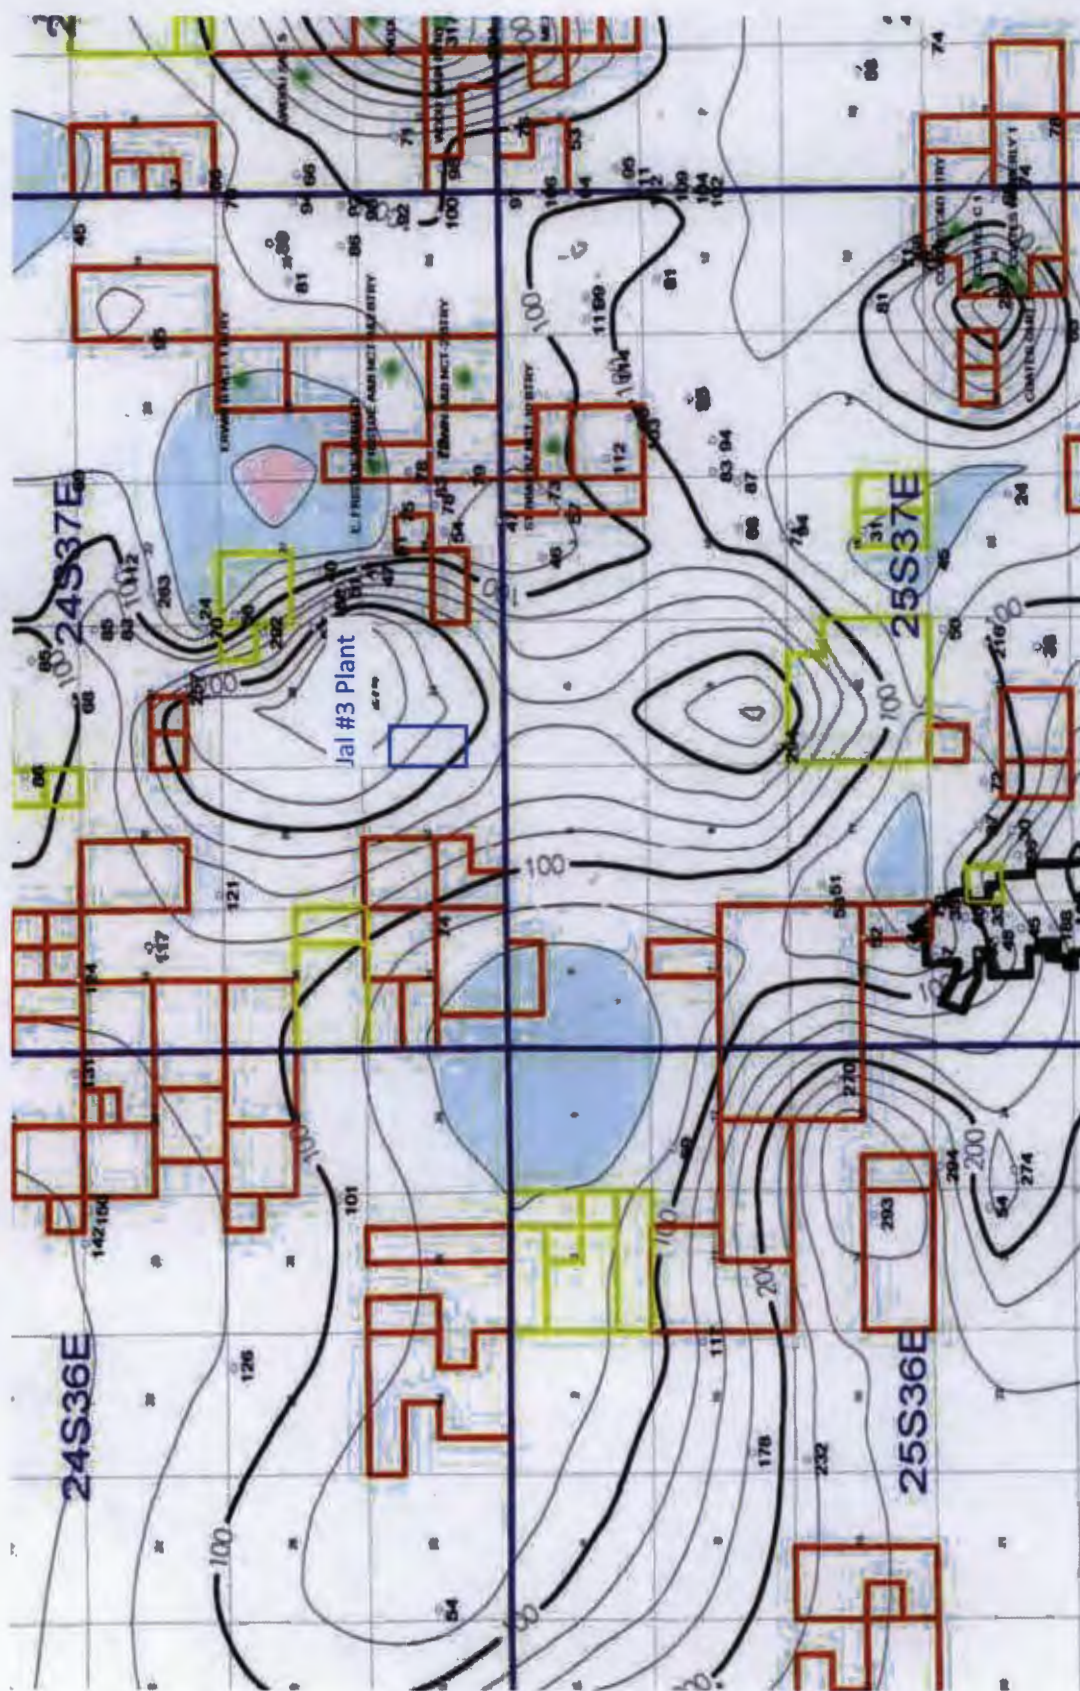
Figure 4: Groundwater Depths in Area of SUGS Jal #3 Gas Plant (After Chevron-Texaco 2005)

The Ogallala aquifer is the principal source of potable water in the area. The depth to groundwater is approximately 200 feet below ground surface (Figure 4). The background total dissolved solids (TDS) concentration for groundwater in the area is approximately 2,200 mg/l.

- The bulk of the hydrocarbon-contaminated soils were removed by the excavation,
- The depth to groundwater is approximately 200 feet (see Figure 4),
- Very low soil moisture (5.1 to 19 percent; average 8.28 in deeper samples; Table 2),
- The relatively high molecular weight of the hydrocarbons (92.7% Diesel range; Table 2), which indicates low mobility, and
- The lack of groundwater receptors within one mile of the release.
