Remedial Activities Report
Sammons #2 Pipeline 2009 Spill

Williams Four Corners, LLC
SE $\frac{1}{4}$ NE $\frac{1}{4}$ of Sect. 32, T30N, R12W
Flora Vista, San Juan County, New
Mexico

January 11, 2010

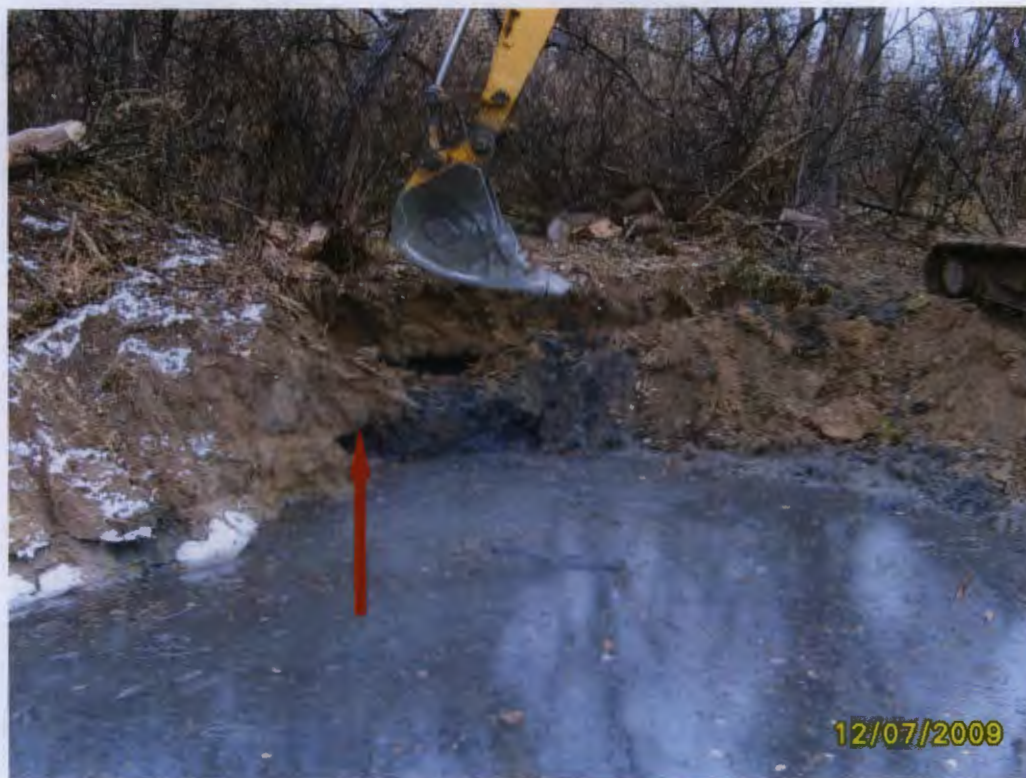
Photo 1: Location of Background soil sample.

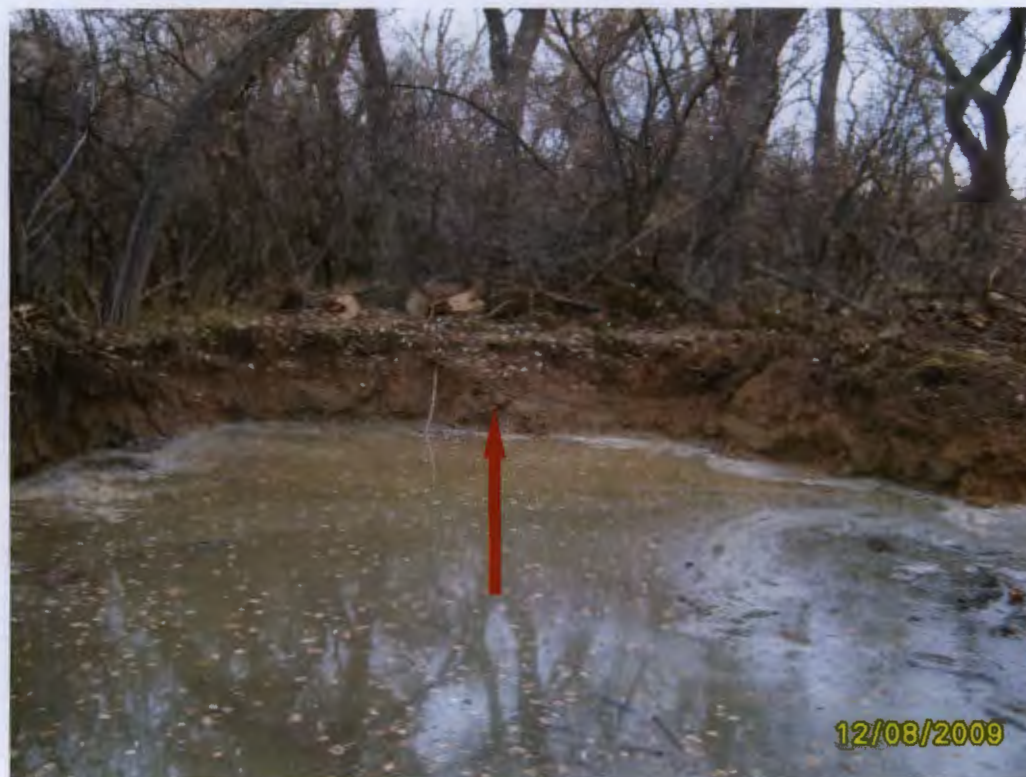
Photo 2: Location of South Bank at 2' soil sample.

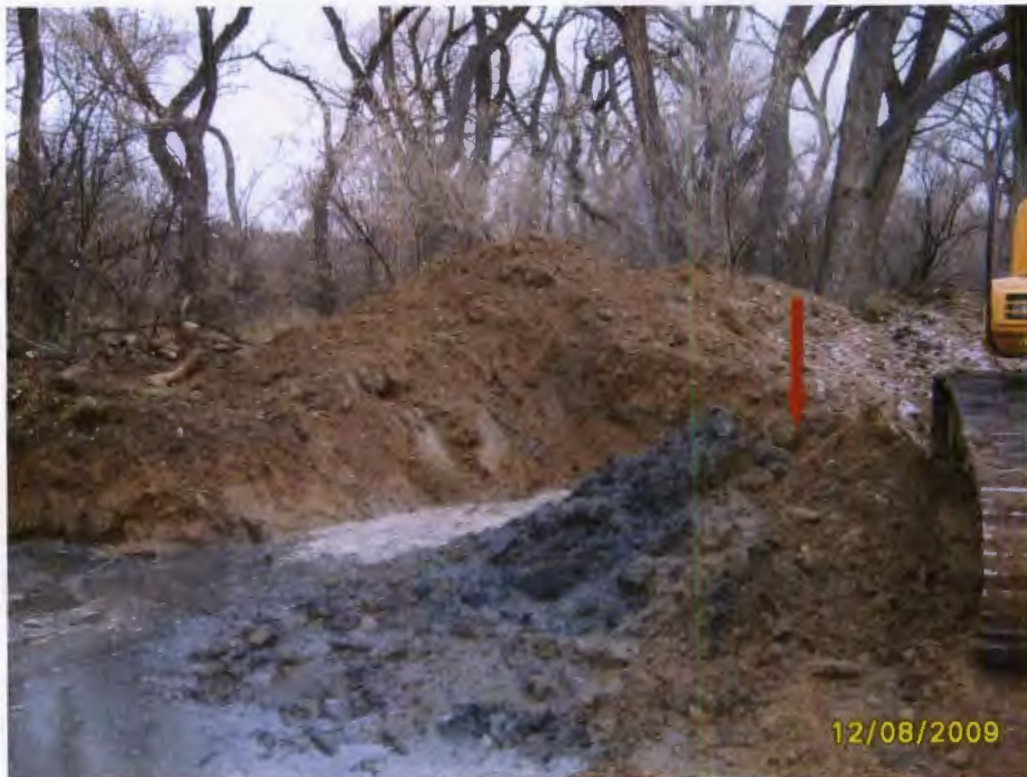
Photo 3: Location of West Bank at 2.5' soil sample (collected after stockpile removed).

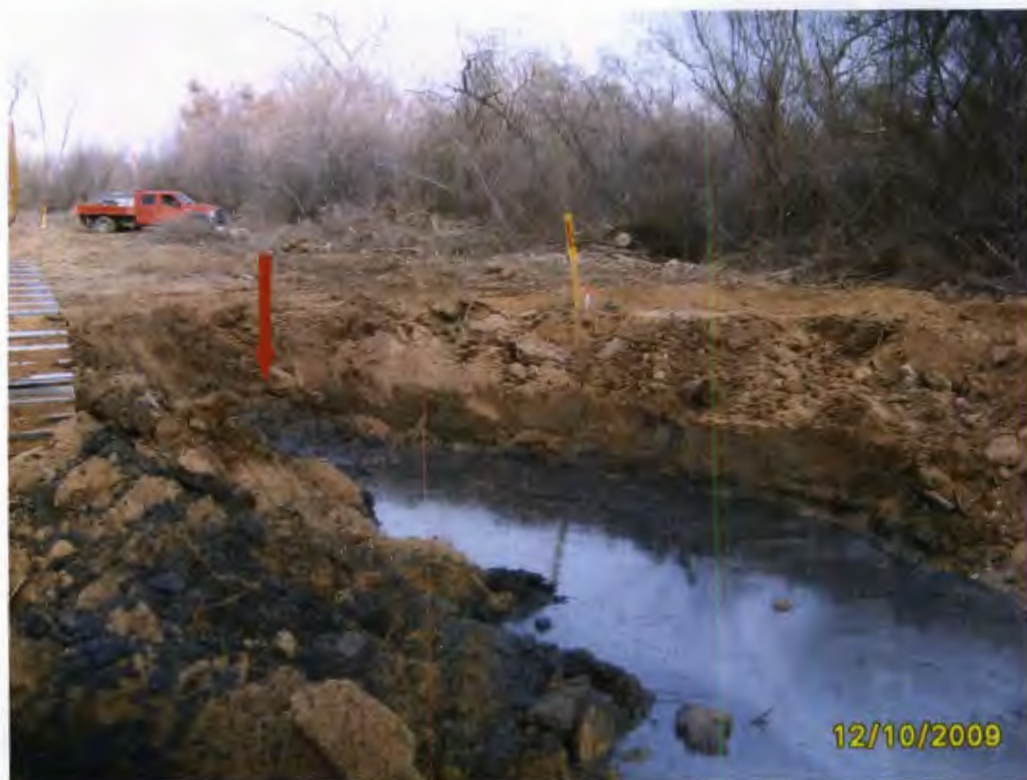
Photo 4: Location of East Wall Trench #2 soil sample.

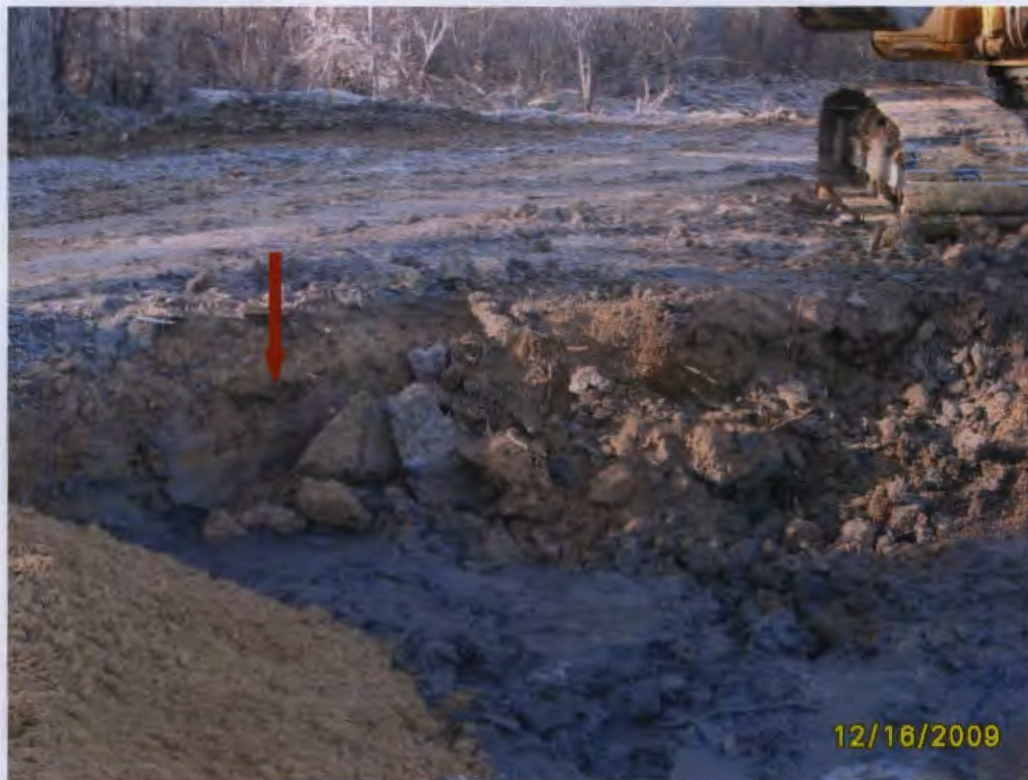
Photo 5: Location of SW Corner Trench #3 soil sample.

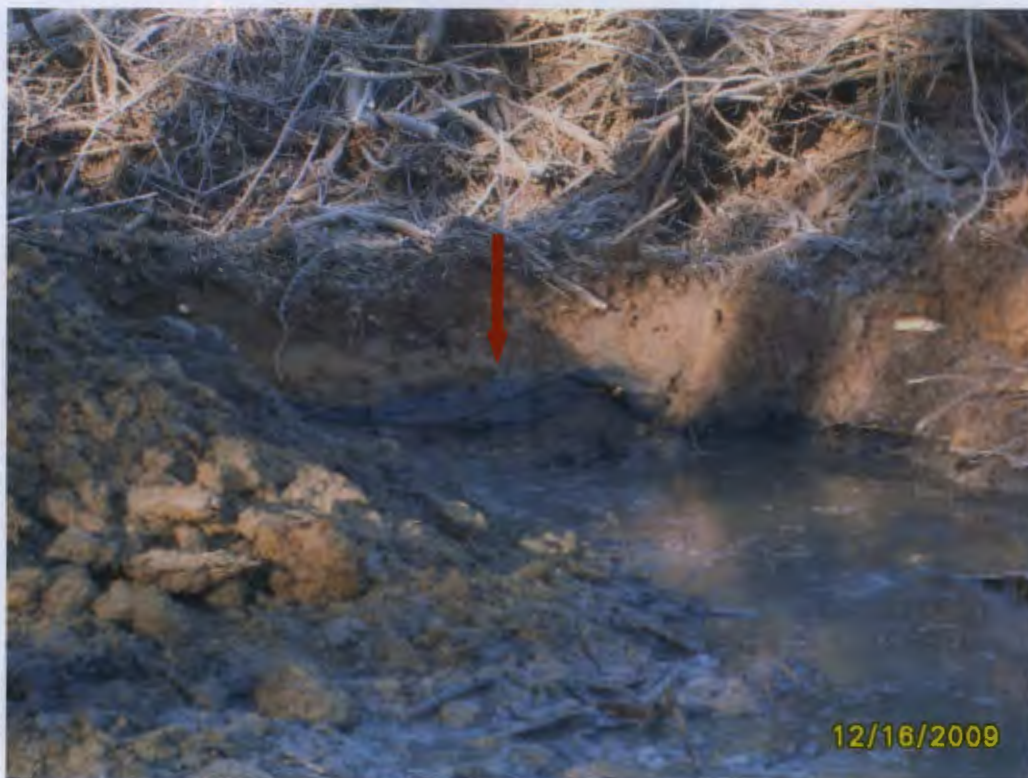
Photo 6: Location of NW Corner Trench #3 soil sample.

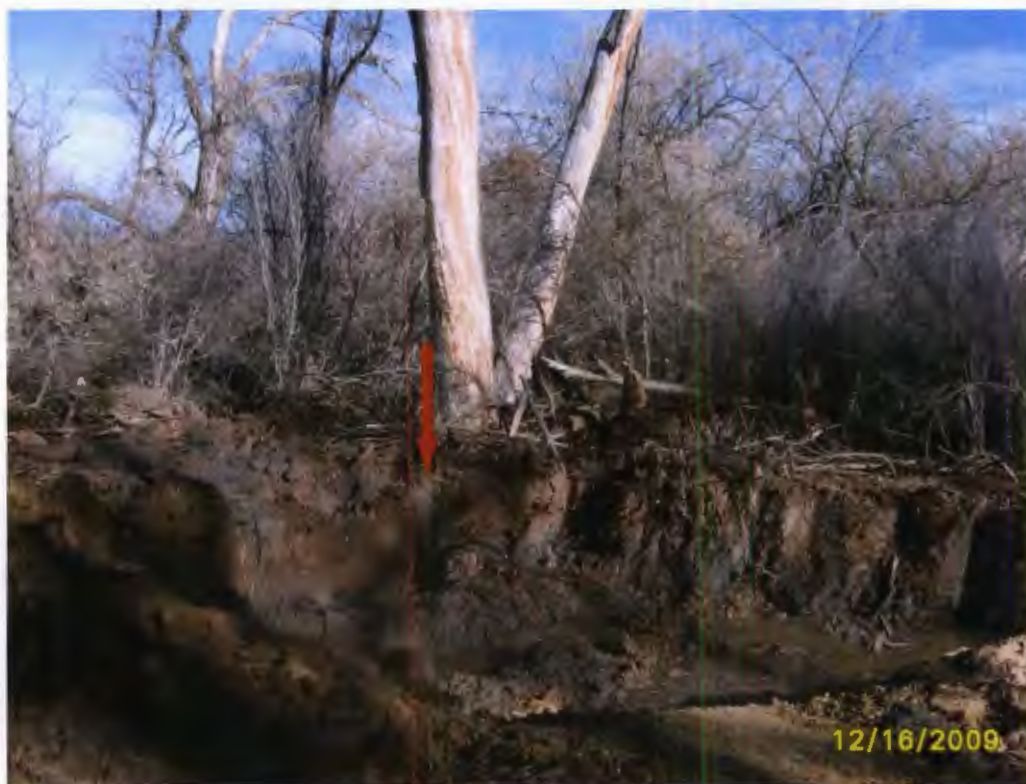
Photo 7: Soil sample location for NE Wall Trench #3.

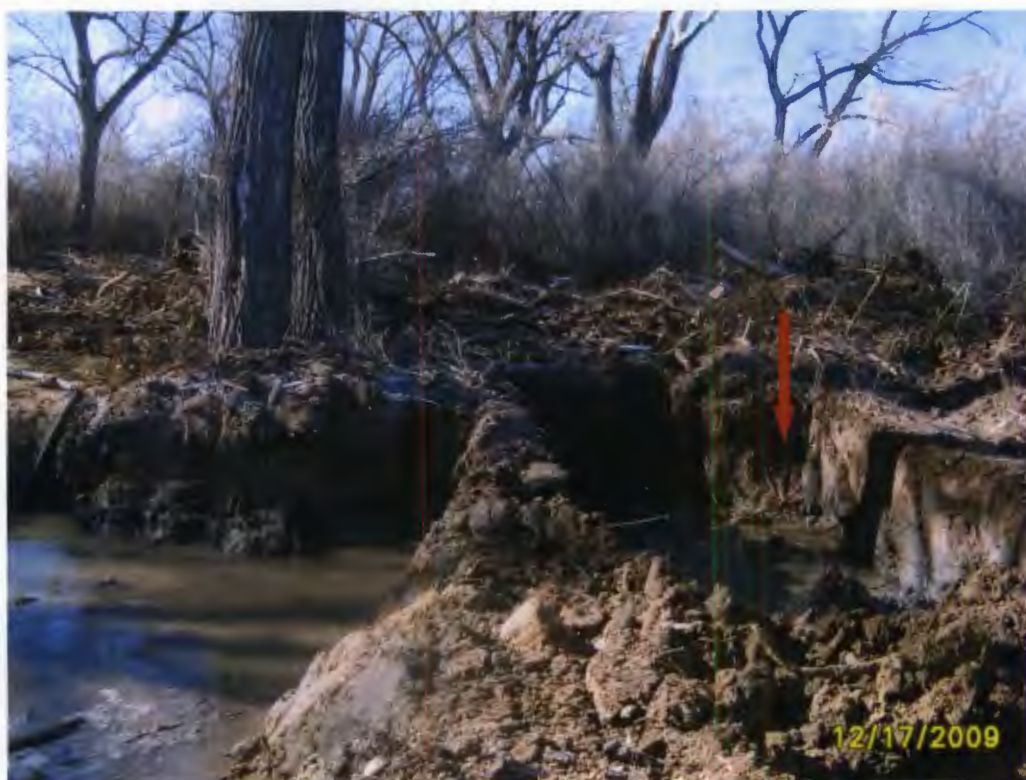
Photo 8: Soil sample location for NW Wall Trench #4.

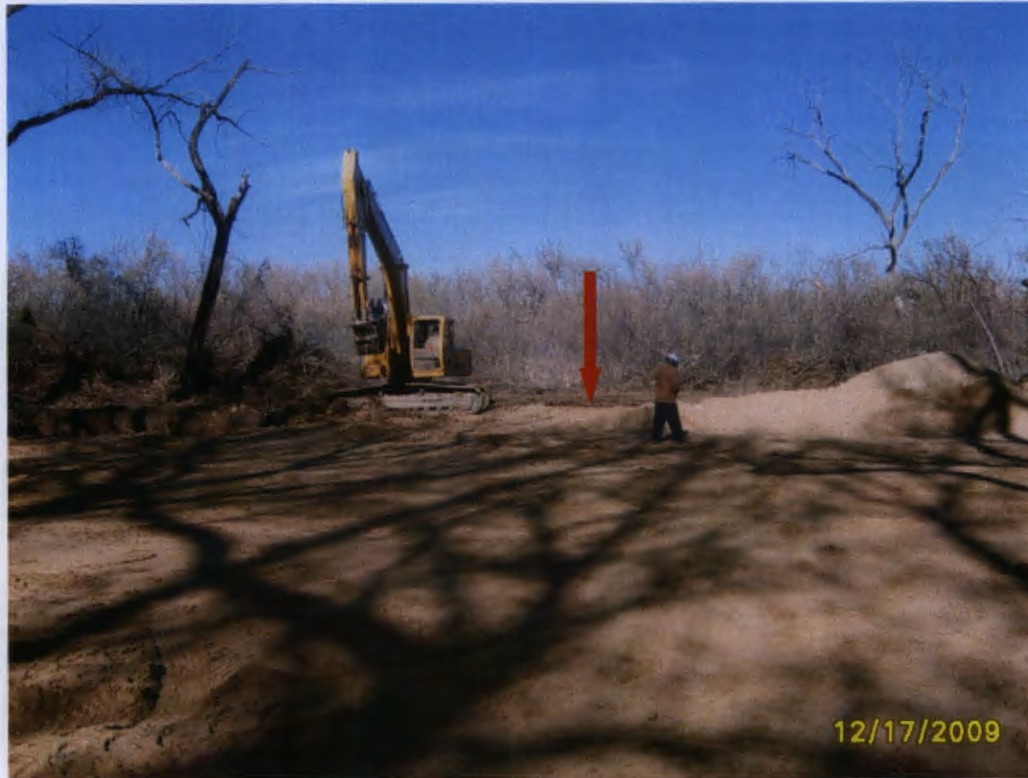
Photo 9: Location of soil sample N-Mid Trench #3.
