Re: **Julander Federal #1E**
Groundwater Investigation Report

Site Investigation Report
Julander Federal #1E
NE¼ SW¼, Section 31, T29N,
R11W
San Juan County, New Mexico

March 26, 2014

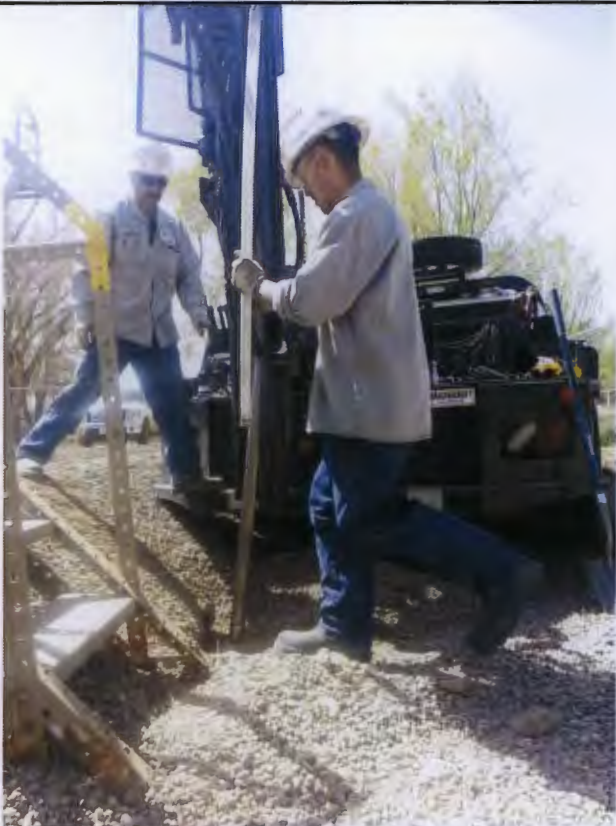
Photo #1

Client: Energen Resources Corporation	
Project: Julander Federal #1E	
Taken by: Heather Woods	
Date: May 1, 2013	
AES Project No. 130411	Description: Example of Simco direct push drilling rig and equipment used to install MW-2

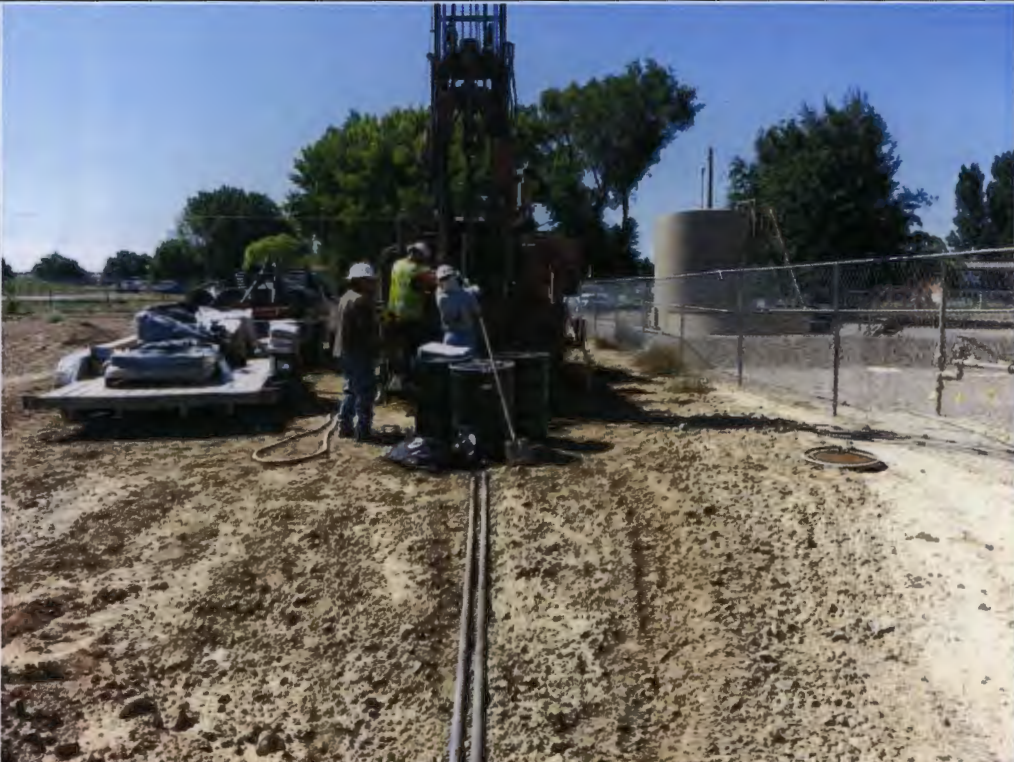
Photo #2

Client: Energen Resources Corporation	
Project: Julander Federal #1E	
Taken by: Heather Woods	
Date: August 16, 2013	
AES Project No. 130411	Description: View of CME-75 drill rig installing SB-7/MW-8.
