**3R – 451**

**03 / 19 / 2014**

LAT K-7 / 2012  
3R-451

**RE: Groundwater Investigation Report  
Enterprise Field Services, LLC  
Lateral K-7 September 2012 Pipeline Release  
NE¼ NW¼, Section 27, T26N, R7W  
Rio Arriba County, New Mexico**

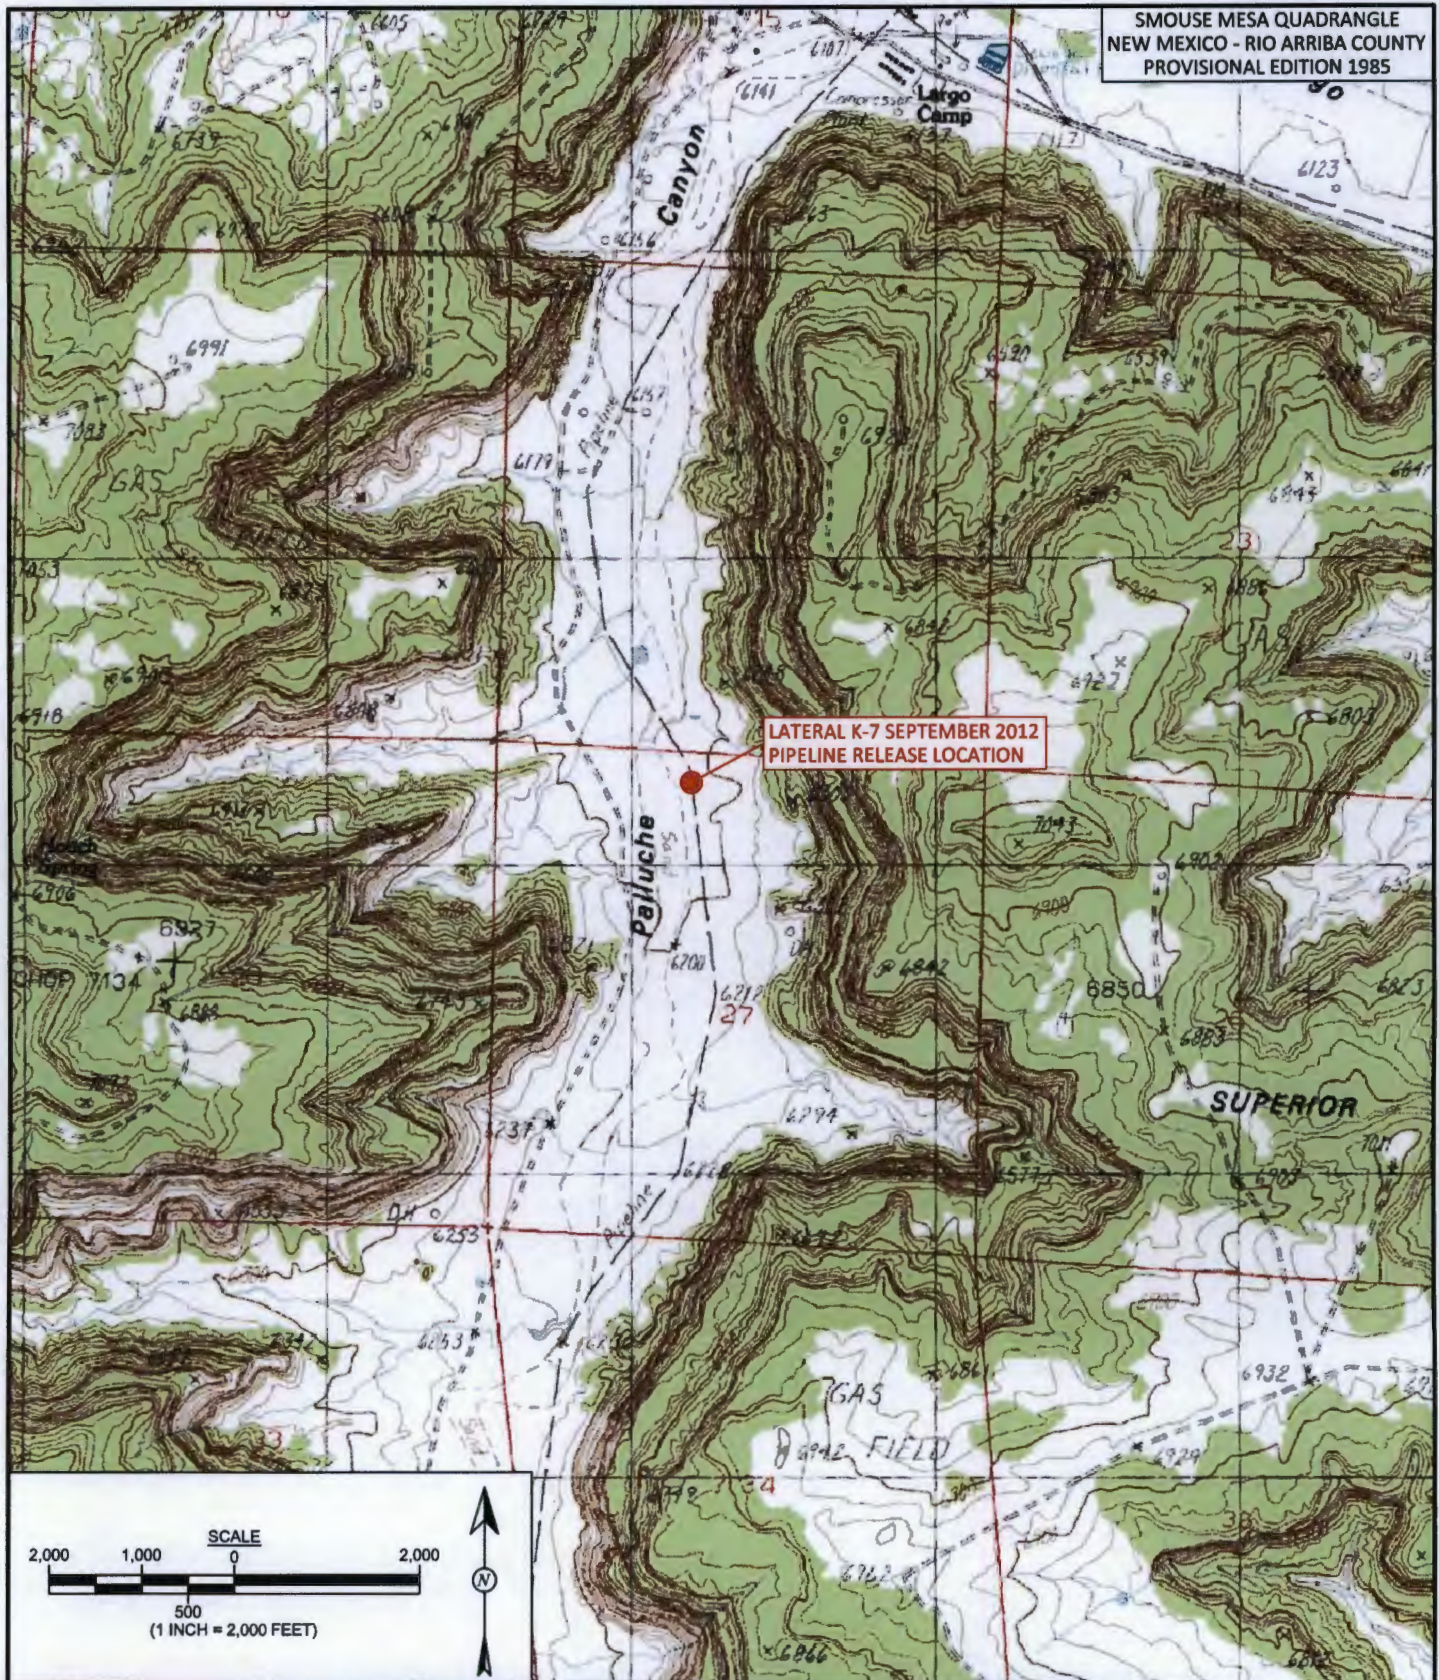
**FIGURE 1**

**TOPOGRAPHIC SITE LOCATION MAP**  
ENTERPRISE FIELD SERVICES, LLC  
LATERAL K-7 SEPTEMBER 2012 PIPELINE RELEASE  
NE¼ NW¼, SECTION 27, T26N, R7W  
RIO ARriba COUNTY, NEW MEXICO  
N36.46422, W107.56505

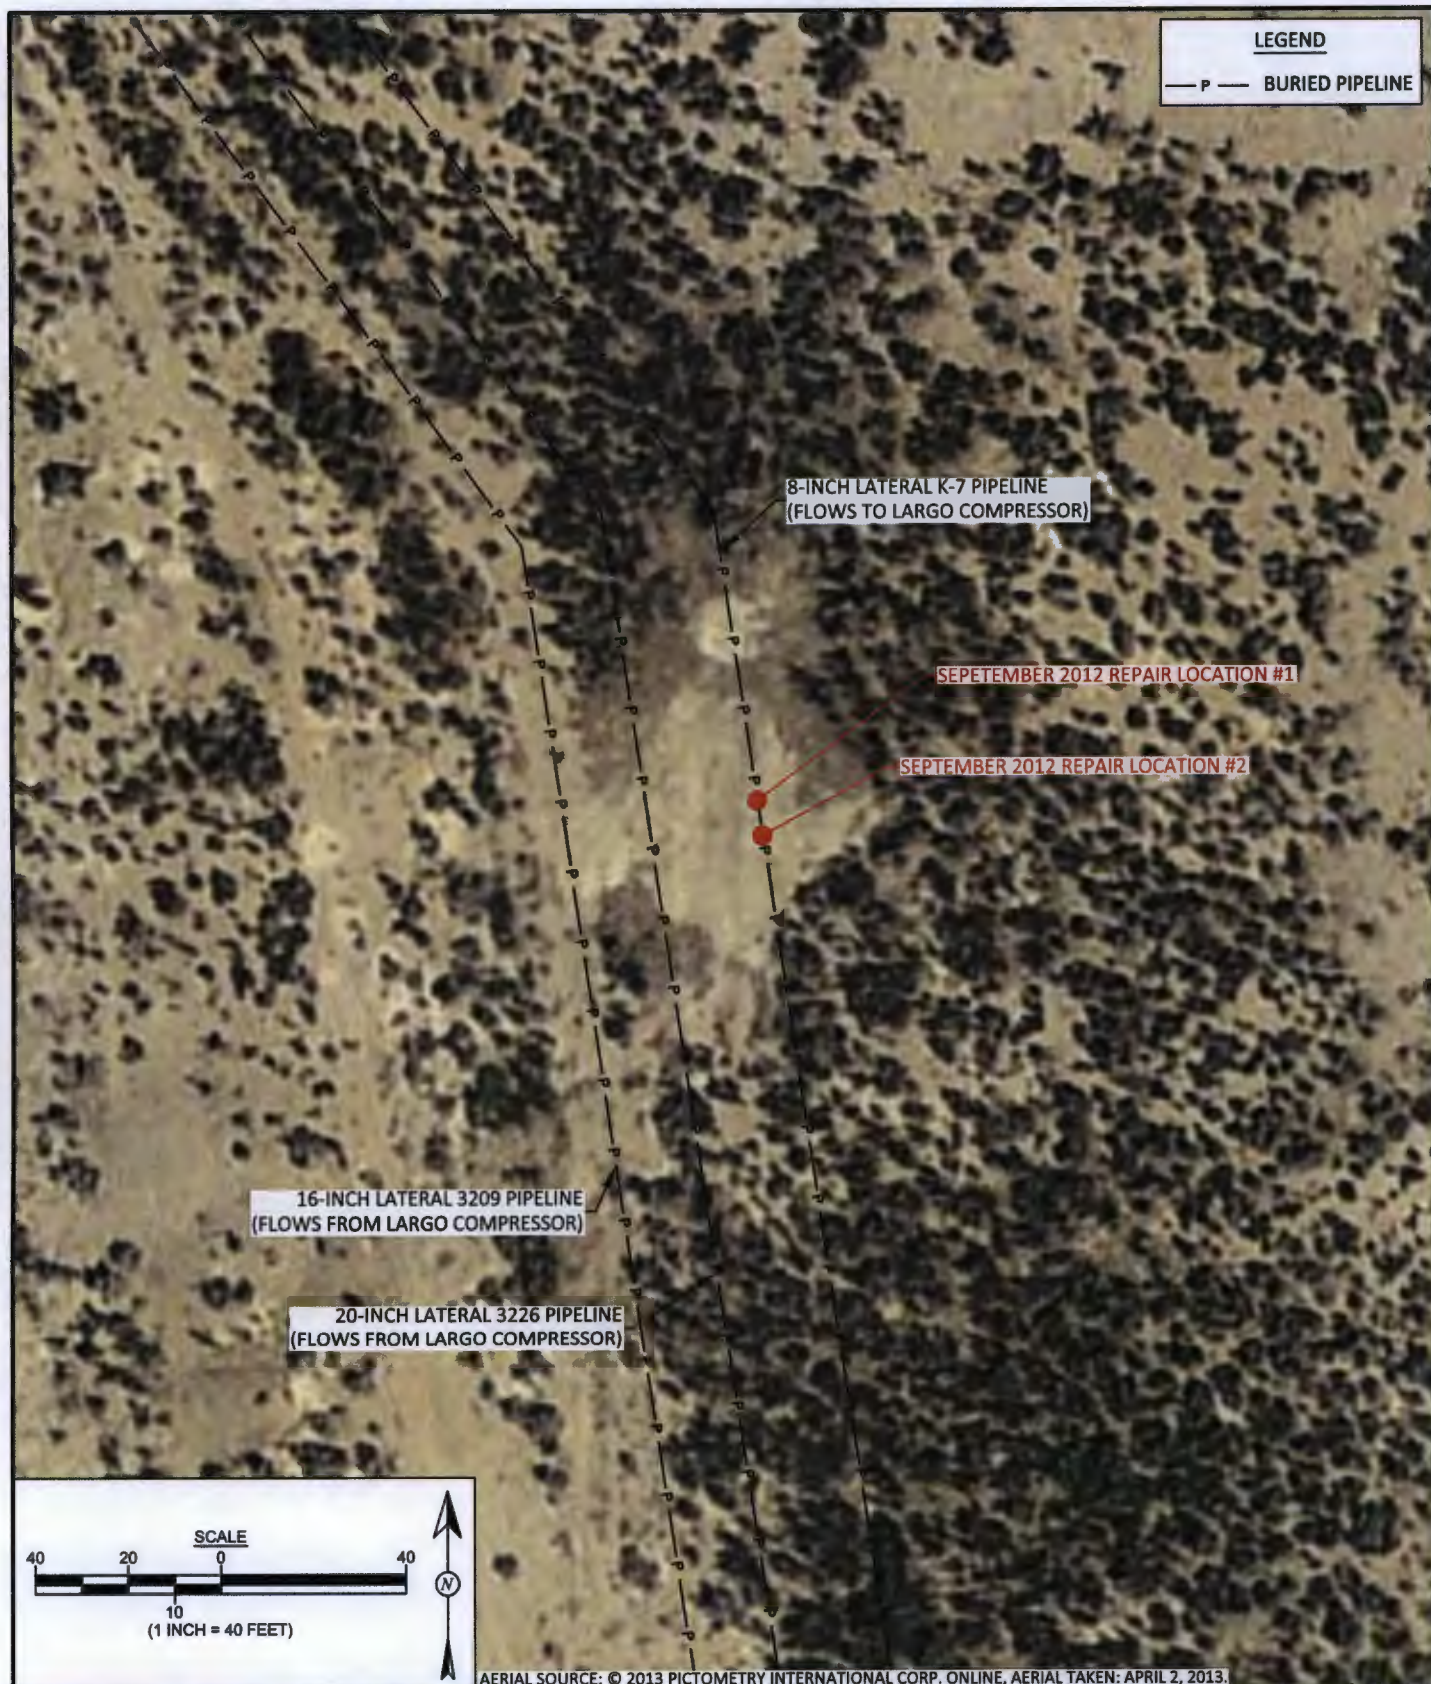
**FIGURE 2**

**AERIAL SITE MAP**  
ENTERPRISE FIELD SERVICES, LLC  
LATERAL K-7 SEPTEMBER 2012 PIPELINE RELEASE  
NE¼ NW¼, SECTION 27, T26N, R7W  
RIO ARriba COUNTY, NEW MEXICO  
N36.46422, W107.56505

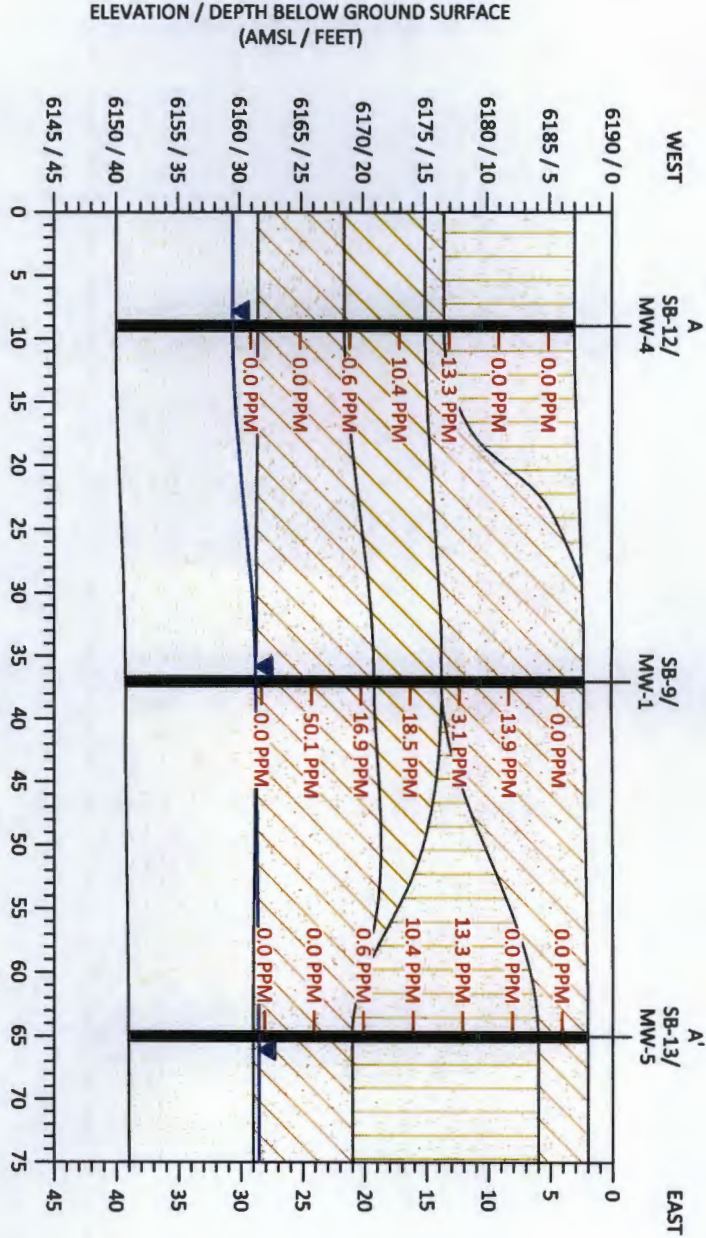
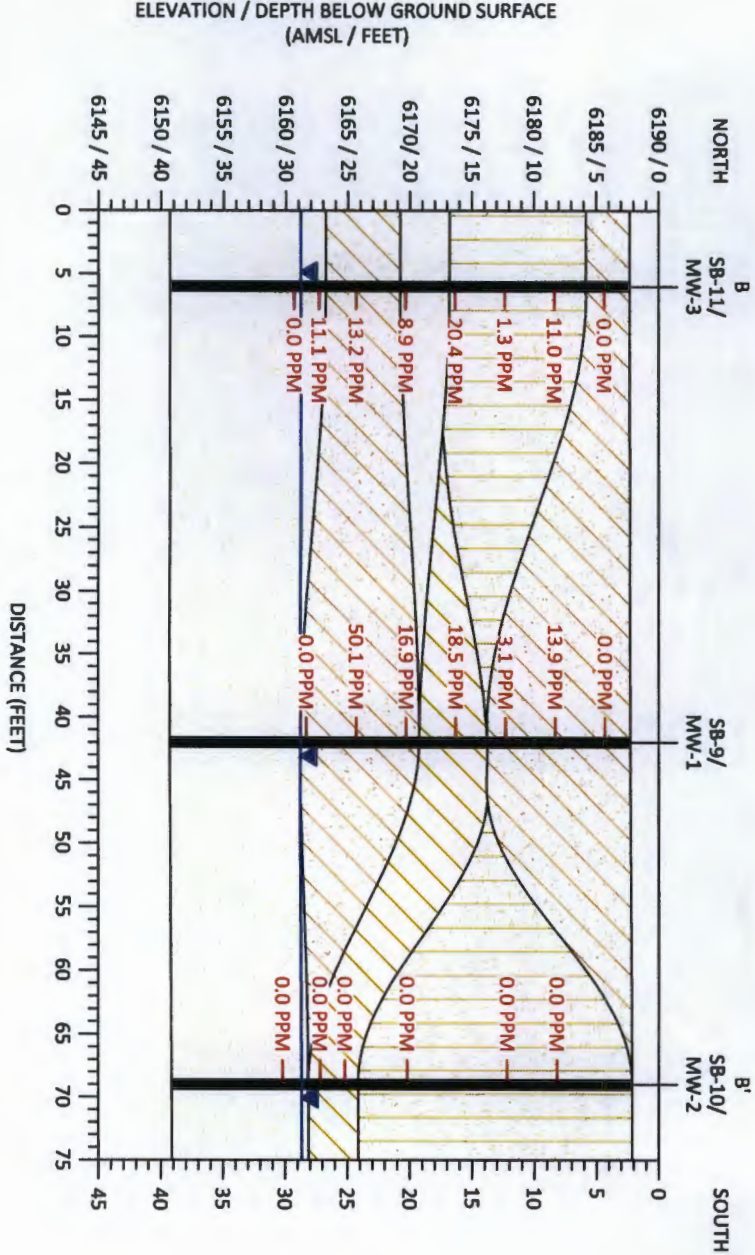
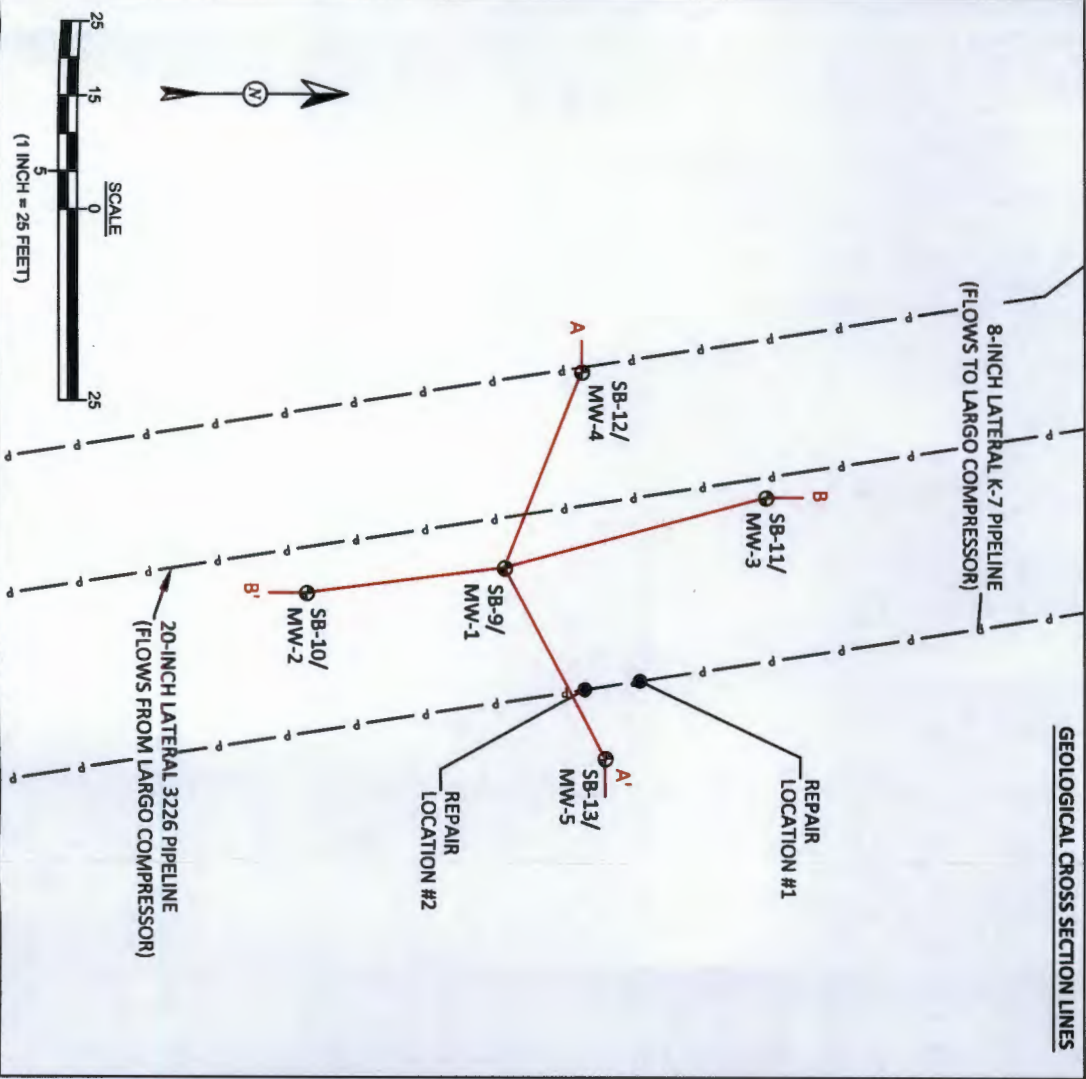
FIGURE 3

The local site lithology consisted of stream alluvium and floodplain material which constitutes the wash of Palluche Canyon. Bedrock was not encountered in the soil borings. Soils were observed to consist primarily of interbedded clayey sand and silty sand in the vadose zone, underlain by poorly graded sand below the water table at depths ranging from 25.5 feet to 27 feet bgs to total boring depth. Soil cross sections are included on Figure 3.

SOIL CROSS SECTIONS A - A' & B - B',  
FIELD SCREENING AND LABORATORY  
ANALYTICAL RESULTS, OCTOBER 2013  
ENTERPRISE FIELD SERVICES, LLC  
LATERAL K-7 SEPTEMBER 2012  
PIPELINE RELEASE  
NE 1/4 NW 1/4, SECTION 27, T26N, R7W  
RIO ARRIBA COUNTY, NEW MEXICO  
N36.46422, W107.56505

During the October 2013 site investigation, soil field screening showed VOC concentrations ranging from 0.0 ppm in 14 samples up to 50.1 ppm in SB-9 through SB-15, but ranged from 0.3 ppm at 0 to 4 feet up to 361 ppm at 12 to 16 feet in SB-13. Soil laboratory analytical results for benzene, total BTEX, and TPH (GRO/DRO) were below laboratory detection limits in all samples. Tabulated laboratory analytical results are presented in Table 1, and soil concentrations are included on Figure 3. Laboratory analytical reports are provided in Appendix D.

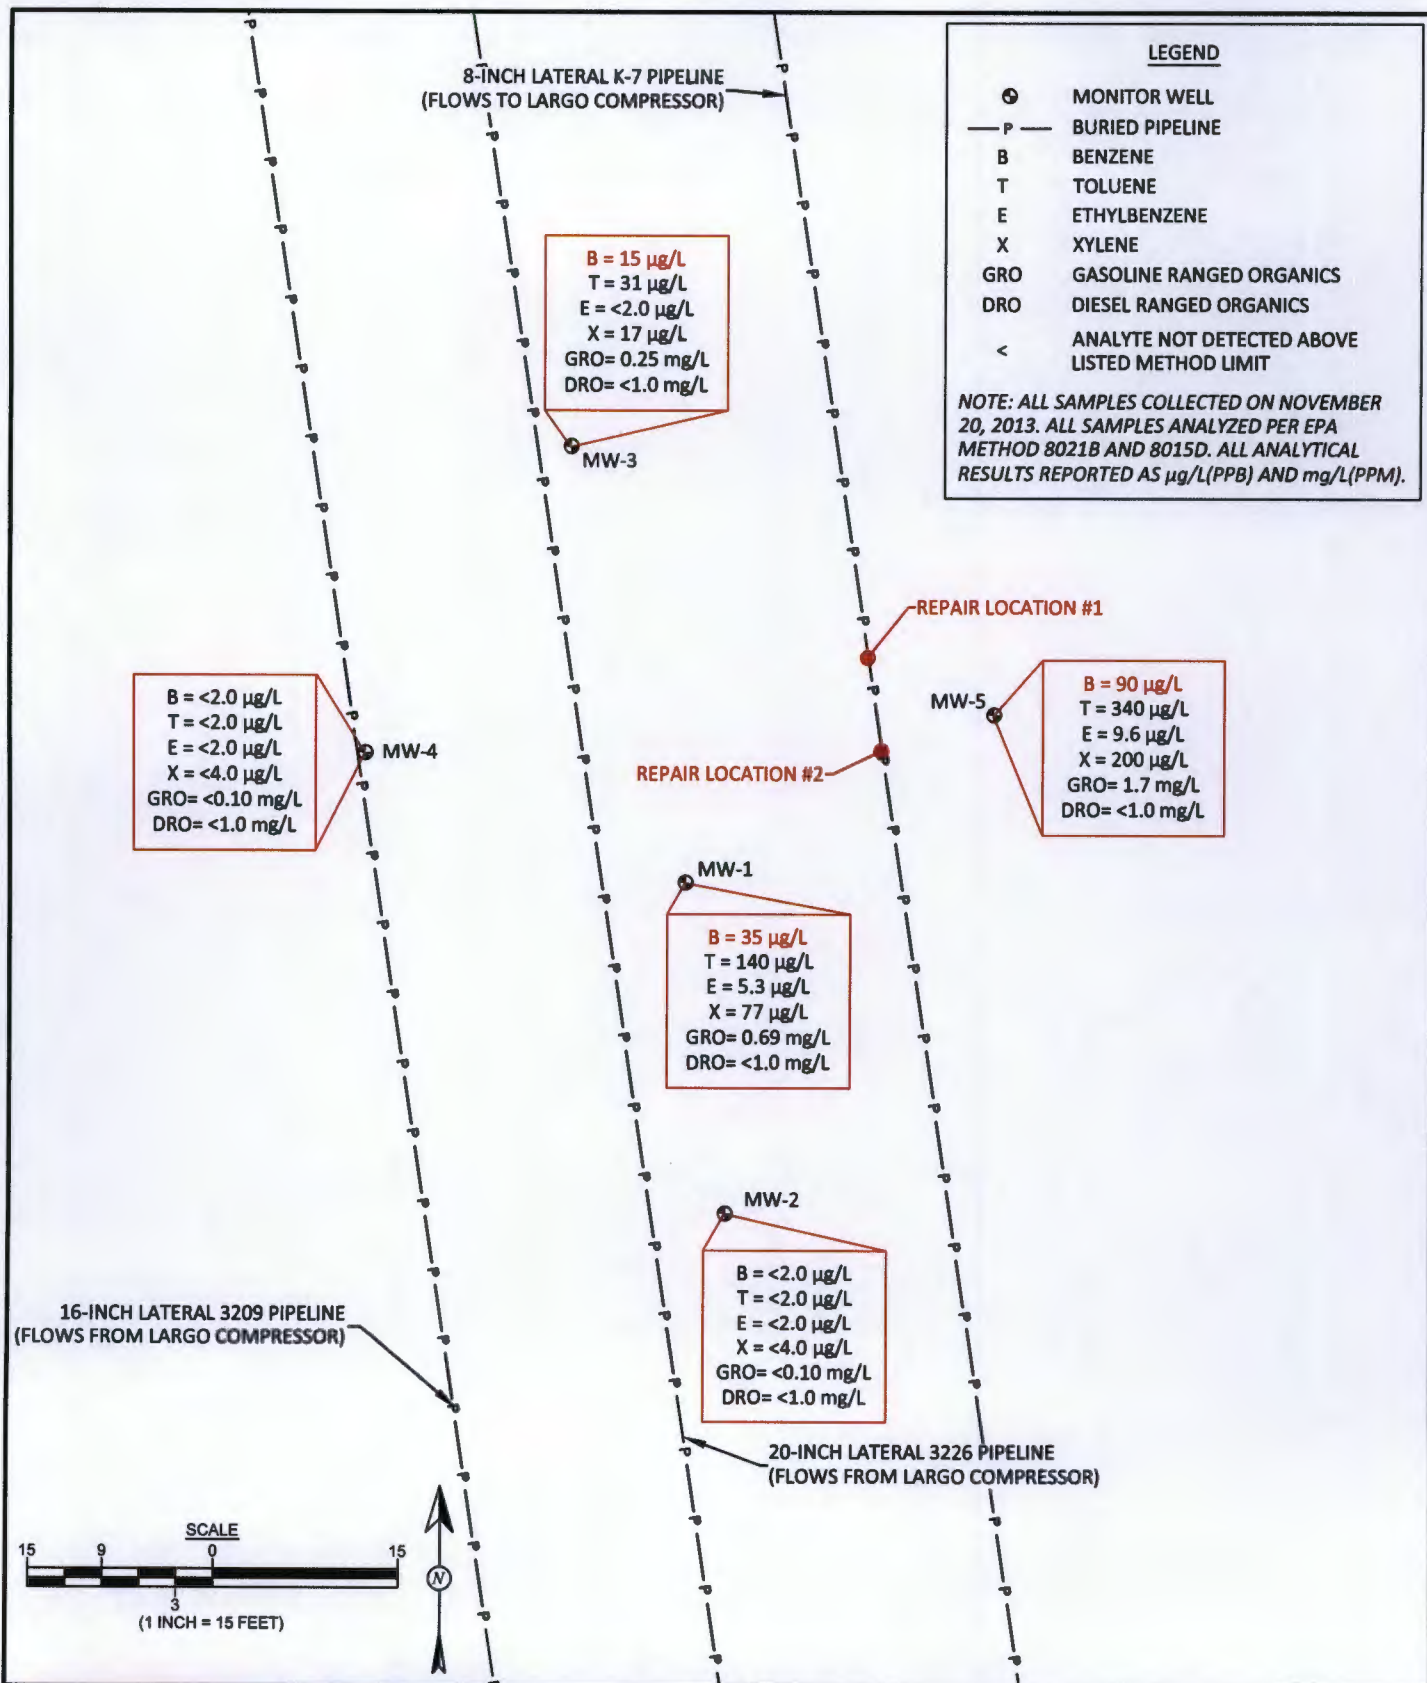
**FIGURE 5**

Groundwater laboratory analytical results showed that dissolved phase benzene, toluene, ethylbenzene, and xylenes concentrations were below laboratory detection limits in MW-2 and MW-3. For remaining wells MW-1, MW-3 and MW-5, dissolved phase benzene concentrations ranged from 15 µg/L in MW-3 to 90 µg/L in MW-5, and toluene concentrations ranged from 31 µg/L in MW-3 to 340 µg/L in MW-5. Also, dissolved phase ethylbenzene concentrations ranged from the laboratory detection limit of 2.0 µg/L in MW-3 up to 9.6 µg/L in MW-5, and xylenes concentrations were reported from 17 µg/L in MW-3 up

to 200 µg/L in MW-5. TPH as GRO ranged from below the laboratory detection limit of 0.10 mg/L in MW-2 and MW-4 to 1.7 mg/L in MW-5. TPH as DRO was below the laboratory detection limit of 1.0 mg/L in all samples. Tabulated groundwater analytical results are presented in Table 3 and on Figure 5 and dissolved phase benzene contours are presented on Figure 6. Groundwater laboratory analytical reports are presented in Appendix F.

**GROUNDWATER CONTAMINANT  
CONCENTRATIONS, NOVEMBER 2013**  
 ENTERPRISE FIELD SERVICES, LLC  
 LATERAL K-7 SEPTEMBER 2012 PIPELINE RELEASE  
 NE $\frac{1}{4}$  NW $\frac{1}{4}$ , SECTION 27, T26N, R7W  
 RIO ARriba COUNTY, NEW MEXICO  
 N36.46422, W107.56505

Based on field screening and laboratory analytical results from the October and November 2013 investigation, *in-situ* soils are below applicable NMOCD action levels. However, groundwater has been impacted above WQCC standards for benzene in the vicinity of the September 2012 release. The site appears to be appropriate for monitored natural attenuation. AES recommends quarterly monitoring for a period of two years. If groundwater concentrations of contaminants increase over time, AES recommends evaluation of an oxygen release compound (ORC) to promote biodegradation of residual contaminants.
