**RE: Corrective Action Plan (CAP)  
Rice Operating Company – Vacuum SWD System  
Vacuum Jct. D-31 (1R425-81): UL/D sec. 31 T17S R35E**

### **Corrective Action Plan**

## Vacuum Jct. D-31

NMOCD Case #: 1R425-81

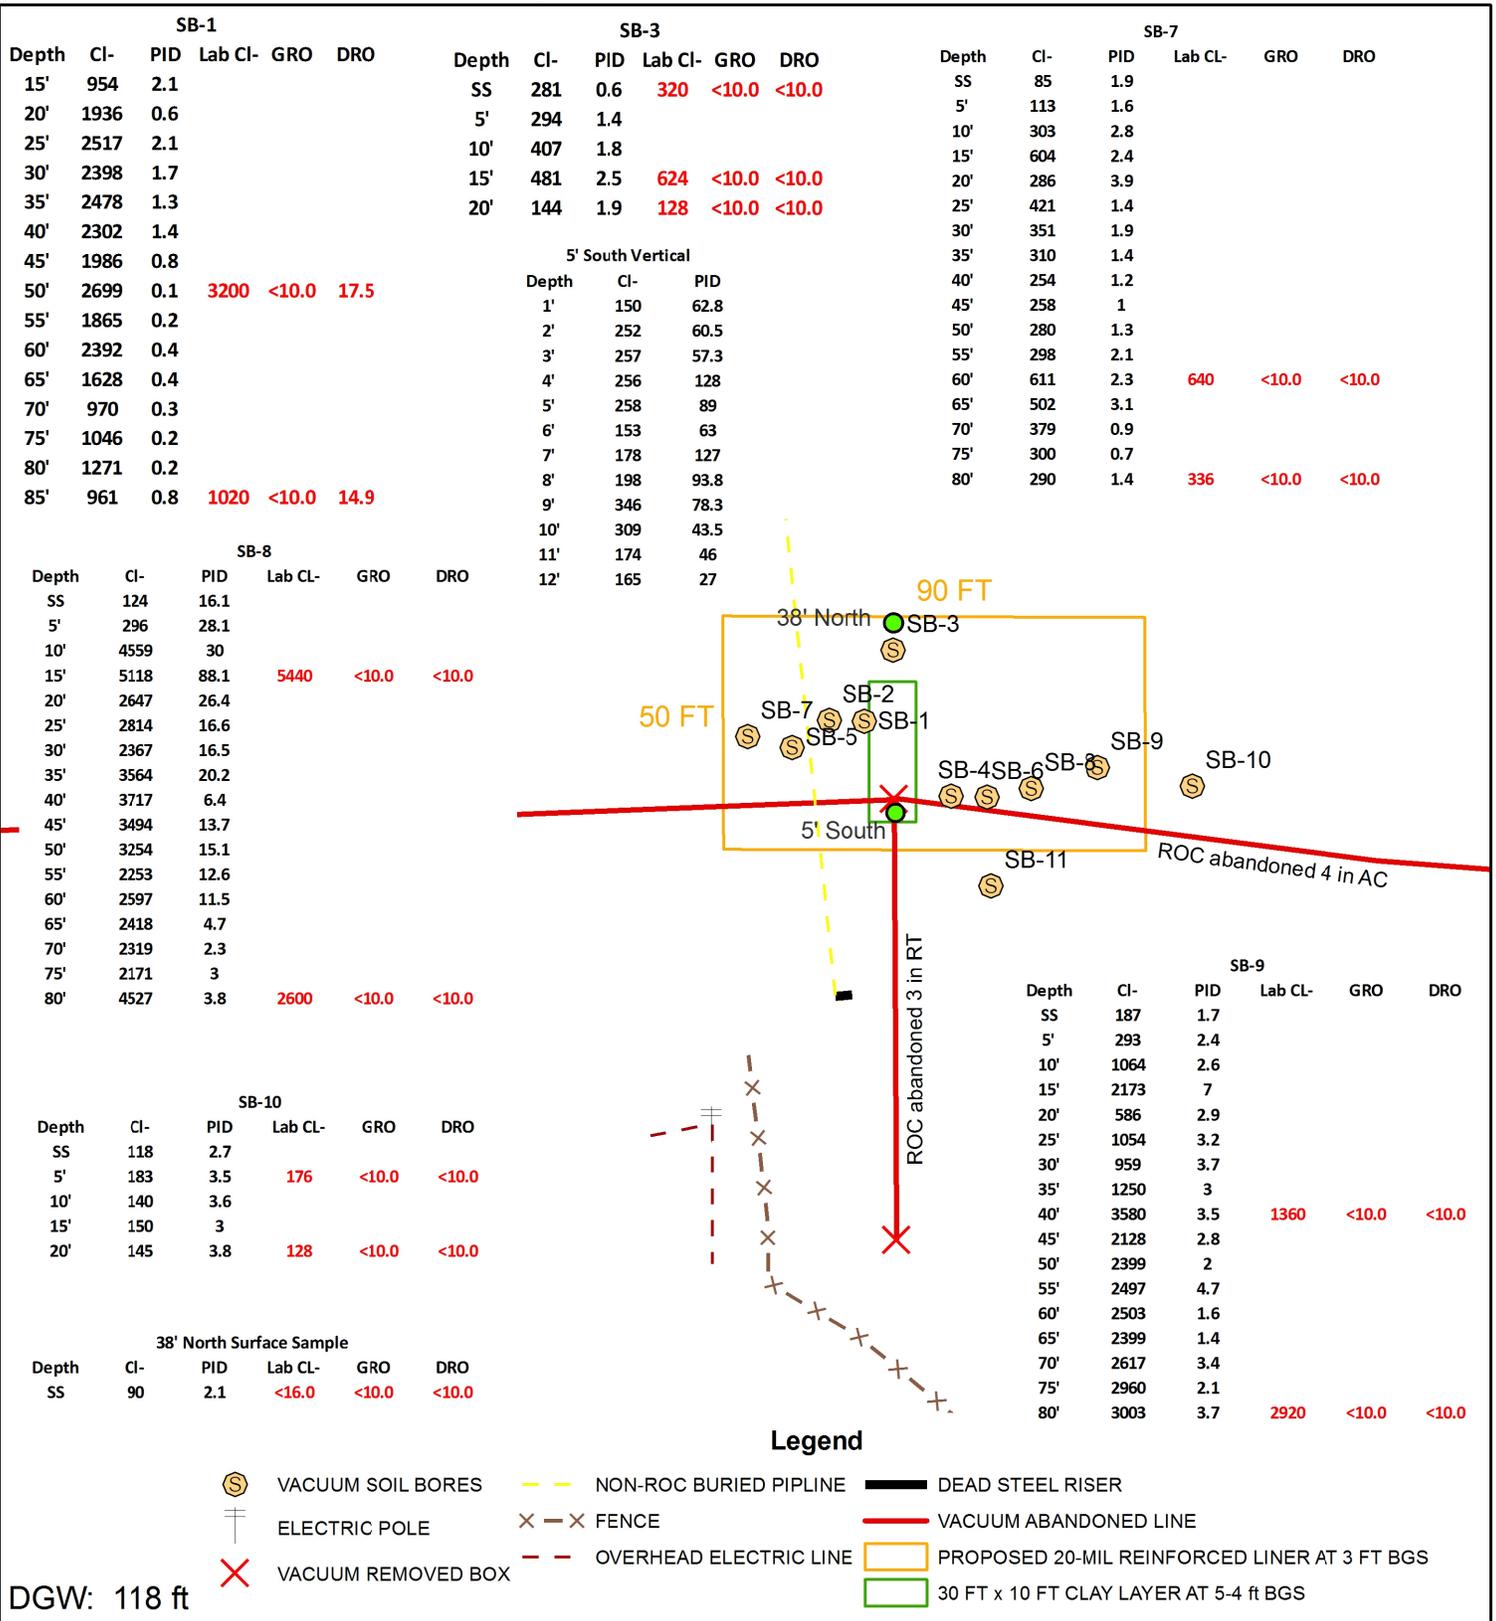
# SB Installation, Proposed Liner and MW Installations

In order to protect groundwater quality from potential chloride migration, RECS recommends the installation of a 20-mil, reinforced liner. The site will be excavated 50 ft x 90 ft to a depth of 3 ft bgs, due to the presence of hard rock in the area (Figure 2). The excavation will cover the 38 ft North Surface Sample and will extend 5 ft beyond the 5 ft south vertical taken during the junction box delineation phase. To the west, the edge of the excavation is located 5 ft beyond SB-7. To the east, the edge of the excavation is located half way between SB-9 and SB-10. The soils placed above the liner will have a laboratory chloride reading no greater than 500 mg/kg and a field PID reading below 100 ppm. Excavated soil will be evaluated for use as backfill and any soils requiring disposal will be properly disposed of at a NMOCD approved facility. At the base of the excavation, a 20-mil reinforced poly liner will be installed and properly seated. The liner will overlay the previously installed 30 ft x 10 ft clay liner at 5 – 4 ft bgs. The poly liner will provide a barrier that will inhibit the downward migration of chlorides to groundwater.

DGW: 118 ft
