REMEDIATION SUMMARY & SOIL CLOSURE REQUEST

**REGENCY FIELD SERVICES LLC.
2B2 Loop Drip Tank
Historical Release Site
Lea County, New Mexico
Unit Letter "C", Section 34, Township 24 South, Range 37 East
Latitude 32.178446, Longitude -103.152843
BGT-004**

April 2015
Apex Project No. 7030714G041

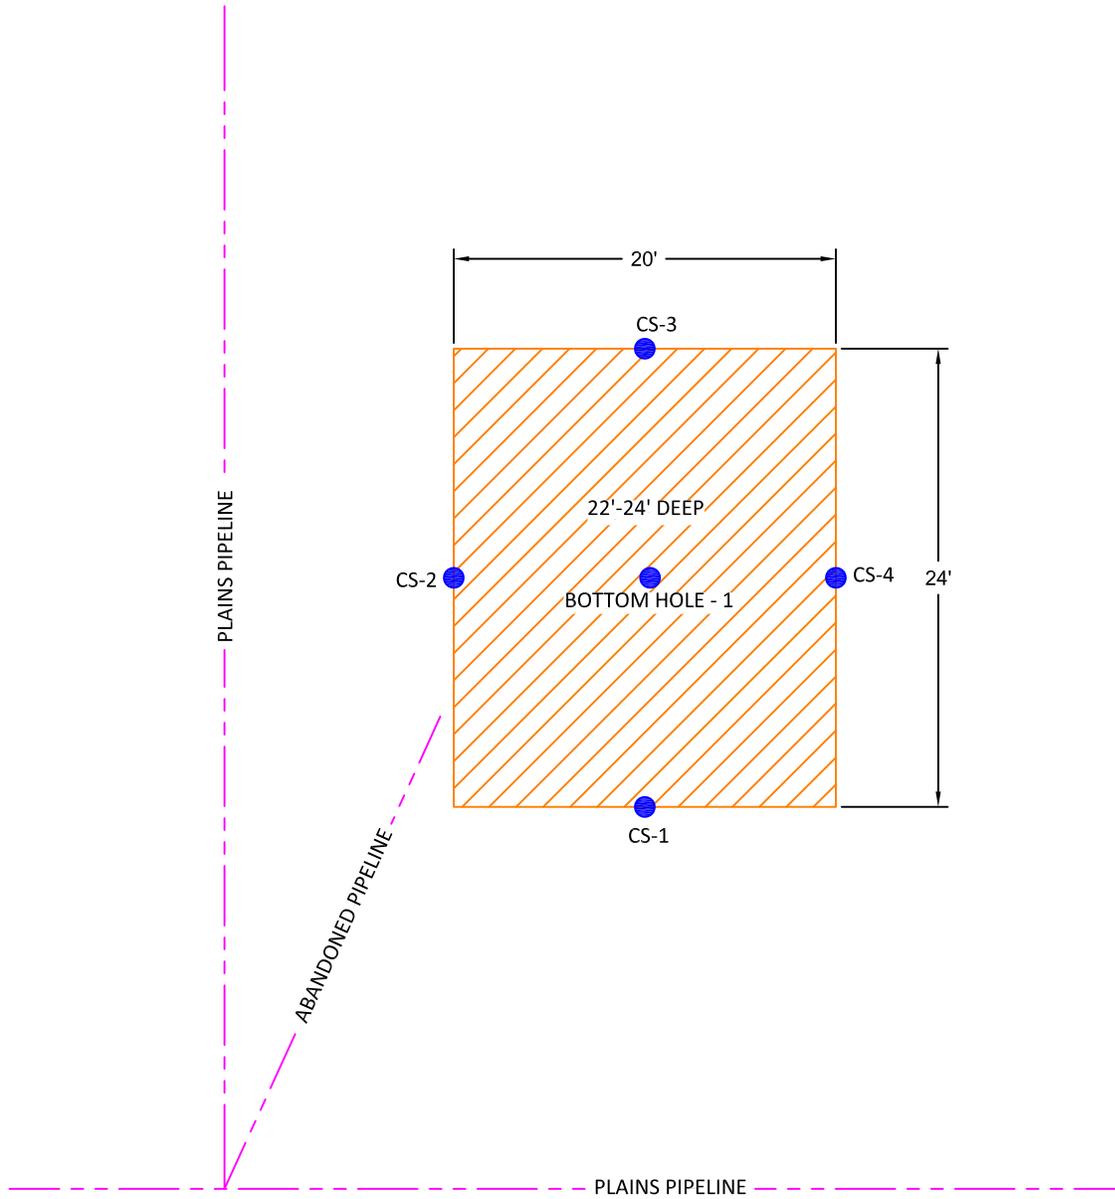
FIGURE 3
Site Map

- CONFIRMATION SAMPLE LOCATION
- ▨ EXTENT OF EXCAVATION

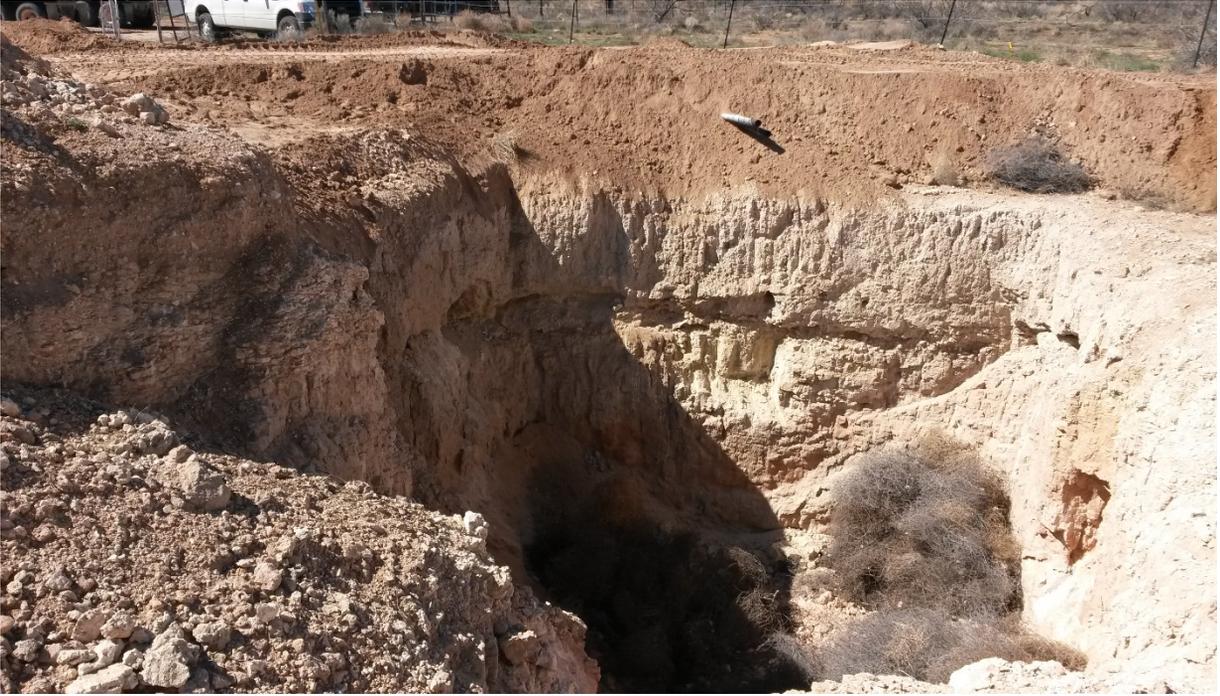
View West – Area of the side wall samples collected by Apex

On February 25, 2015, Mr. Thomas Franklin was present to observe on-Site activities and to collect soil samples with a track hoe as shown in the photos in Appendix C. Five soil samples (CS-1 through CS-4 and Bottom Hole-1) as shown on Figure 3, Appendix A were installed. Samples were collected and field screened for chlorides.

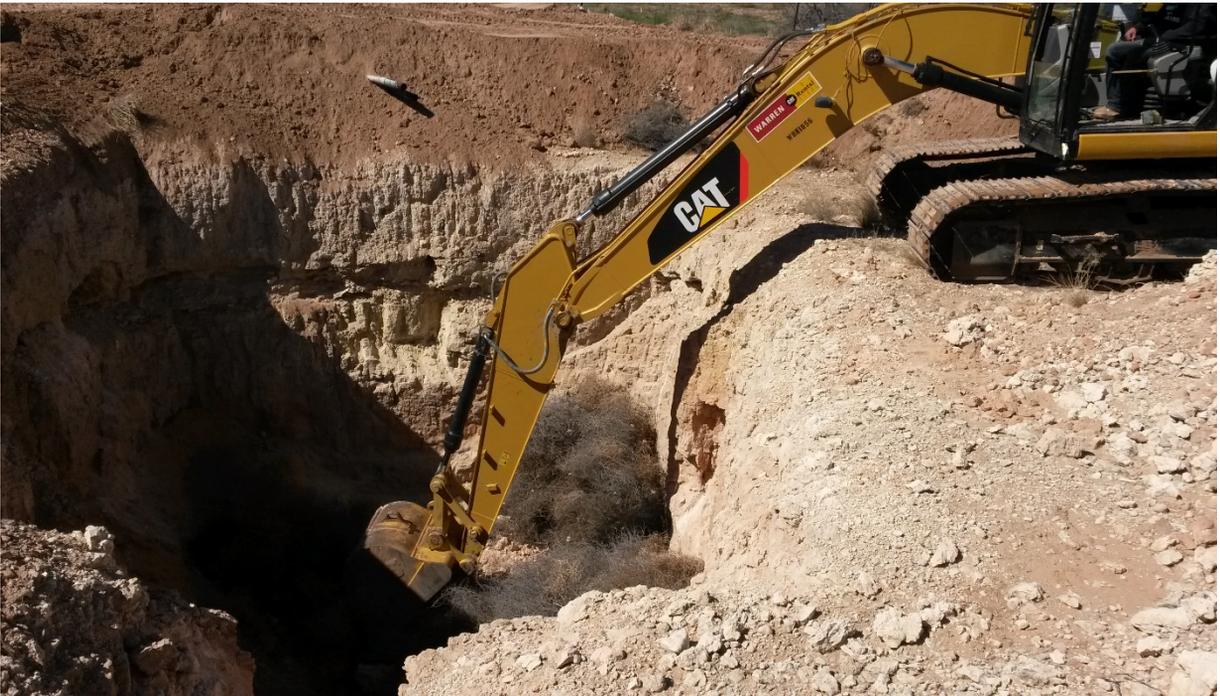
View West – Depth of the previously excavated area

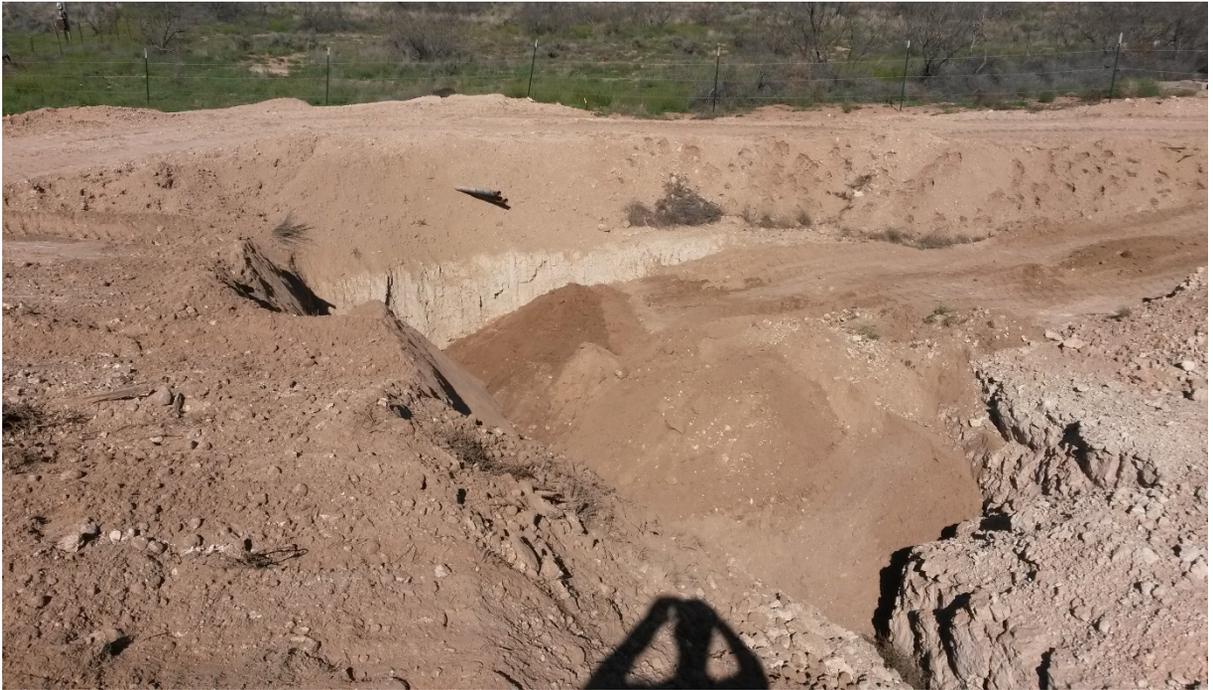
View Northwest – Backfill

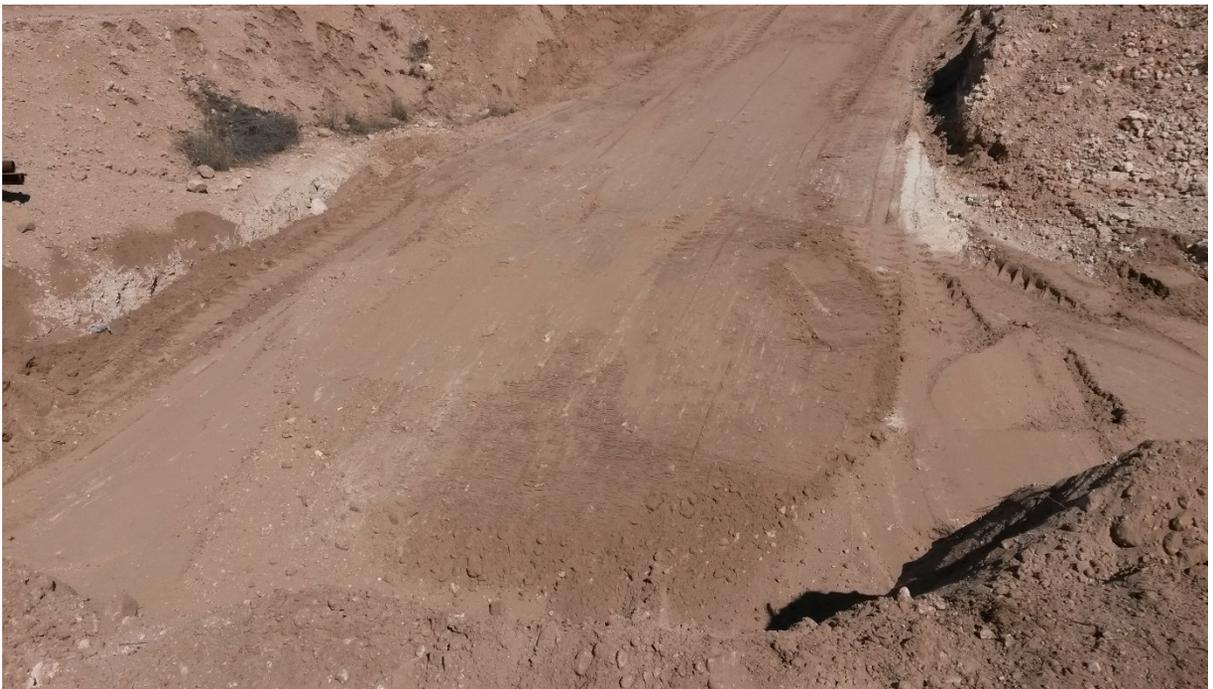
View North - Backfill

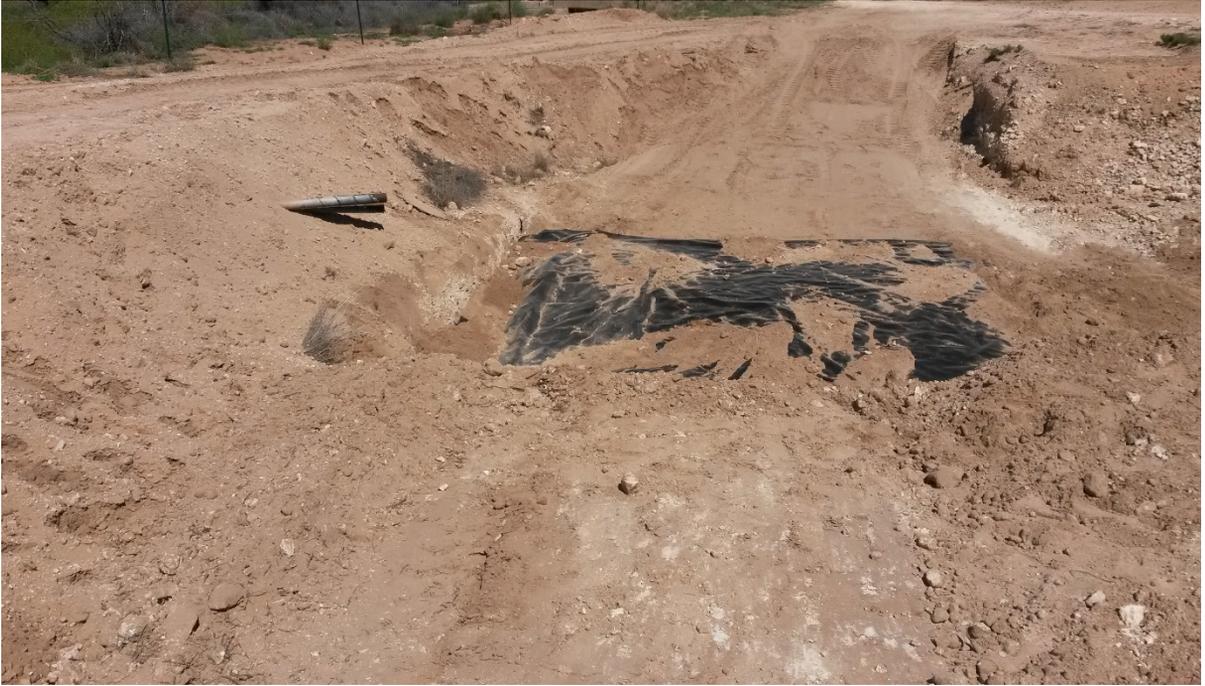
View North – Liner Installed

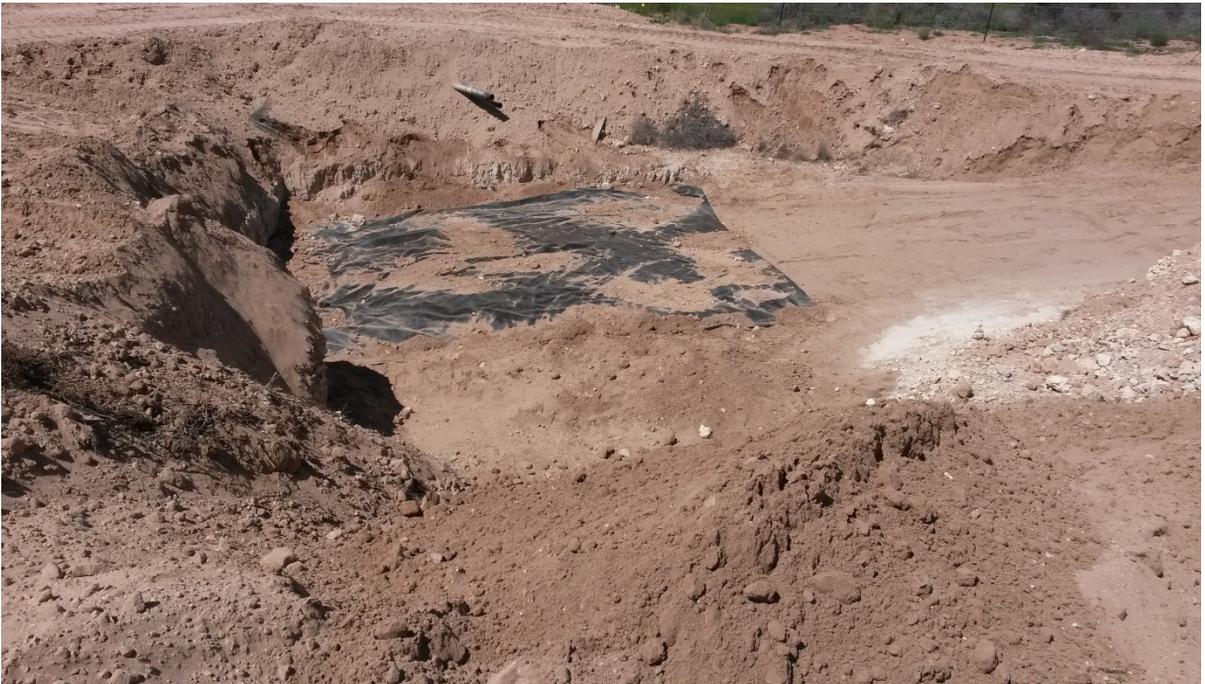
View West – Liner Installed

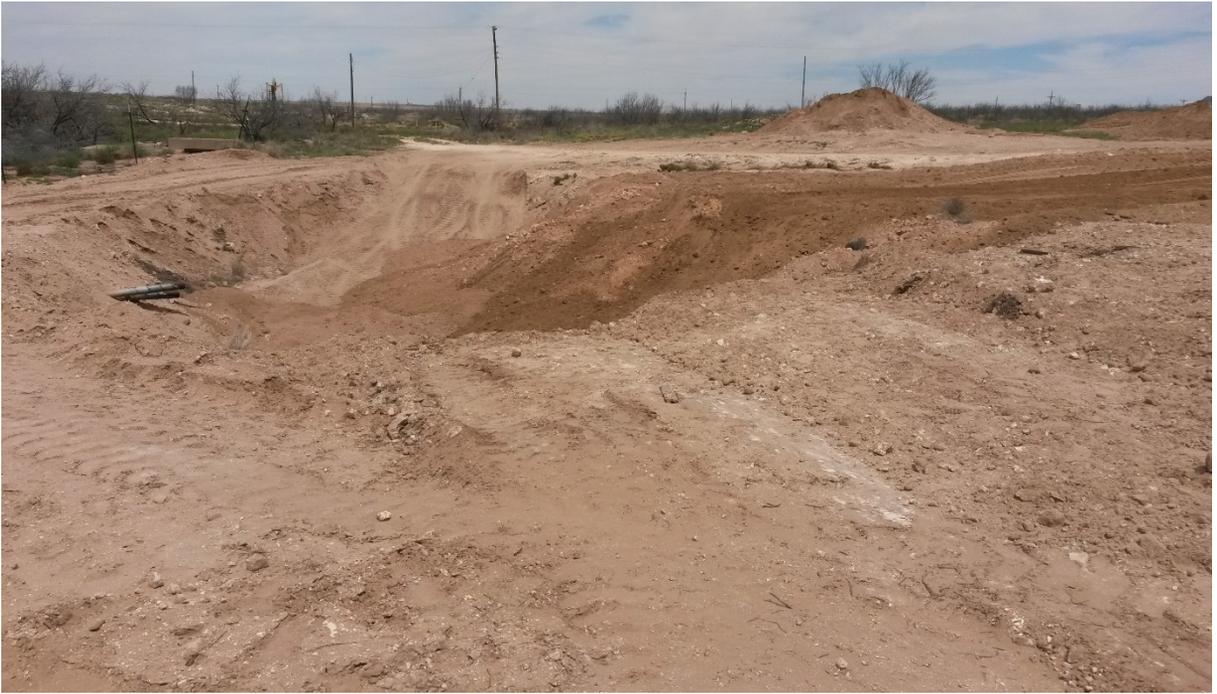
View North – Backfill

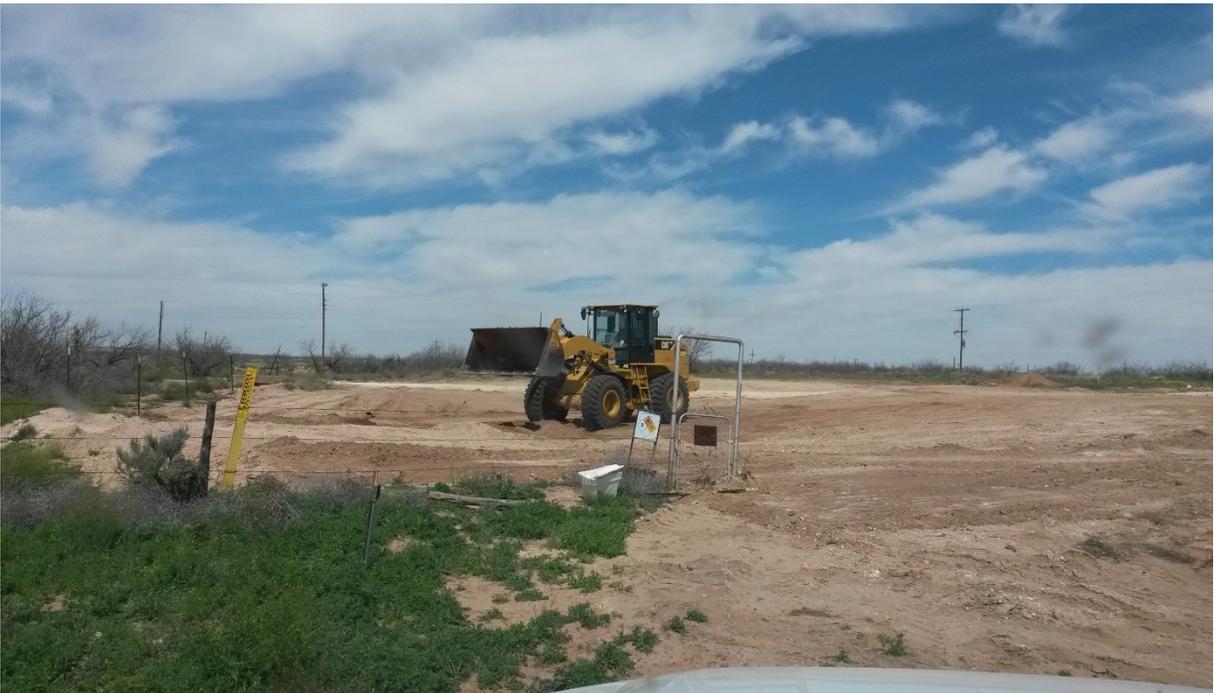
View North – Backfill

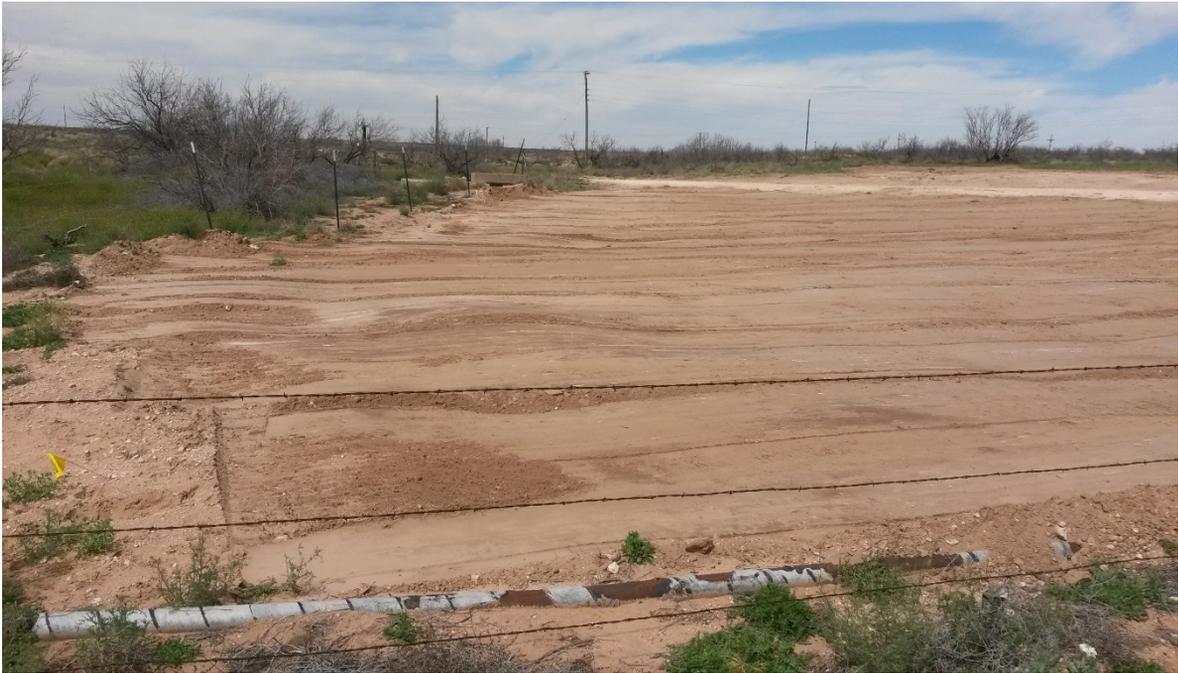
View North – Backfill to grade

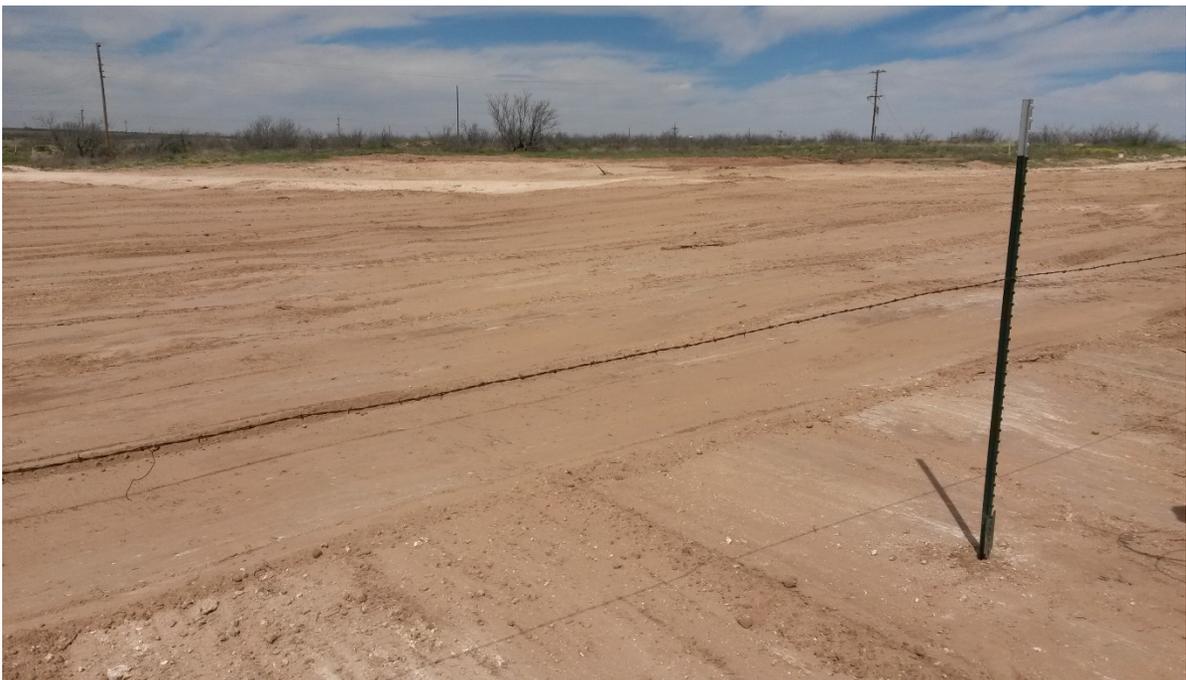
View Northeast – Backfill to grade
