RE: *Corrective Action Report – Soil Removal*
Enterprise Field Services, LLC – Federal 2E #1 Pipeline Release
San Juan County, New Mexico
OCD RP: 3R-453

CORRECTIVE ACTION REPORT – SOIL REMOVAL

**Federal 2E #1 Pipeline Release
SW ¼ NE ¼, S2 T27N R12W
San Juan County, New Mexico
3RP-453**

April 21, 2015
Apex Project No. 7030413G002

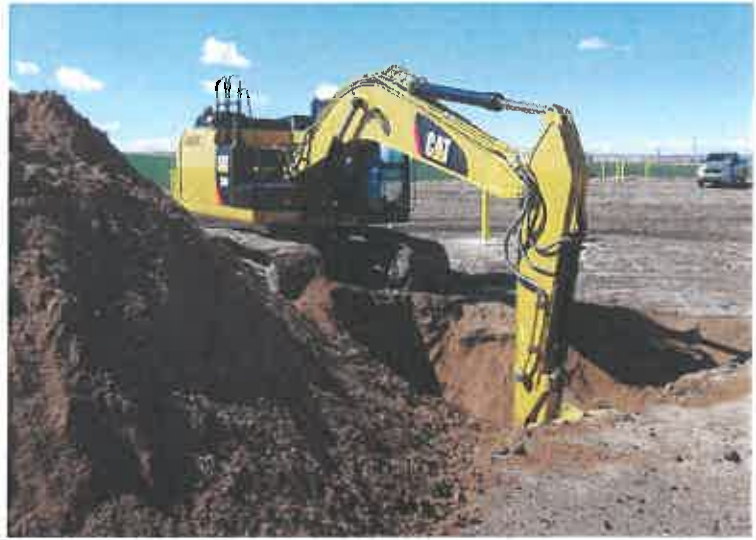
Photograph 1

View of early stages of excavation facing west.

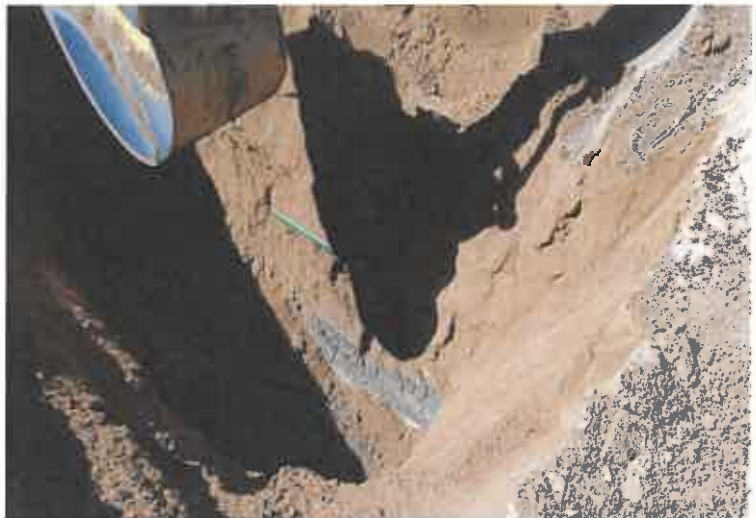
Photograph 2

View of stained soil beneath pipeline.

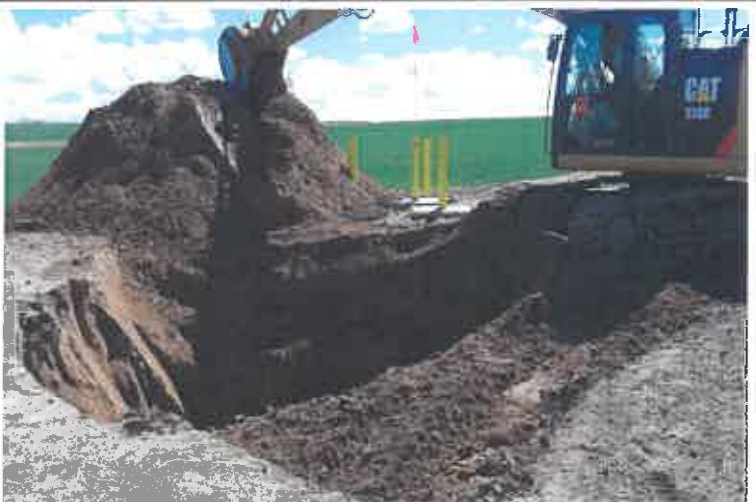
Photograph 3

View of removal of clean imported backfill from original 2012 excavation.

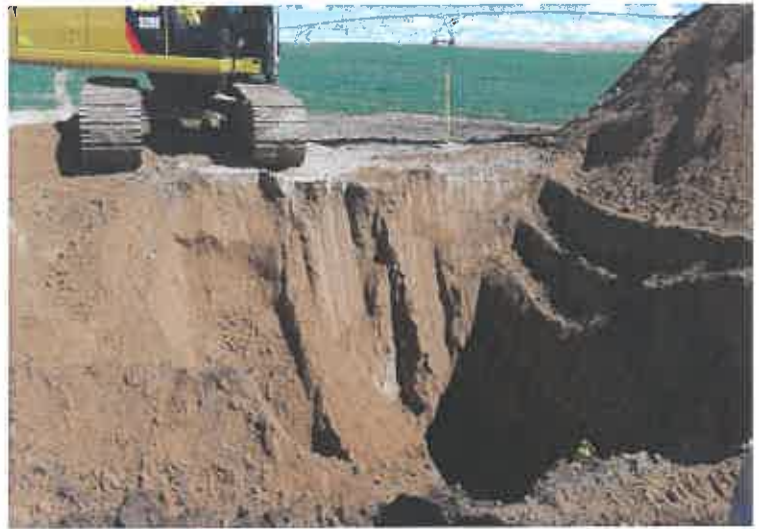
Photograph 4

View of early stage of excavation facing north.

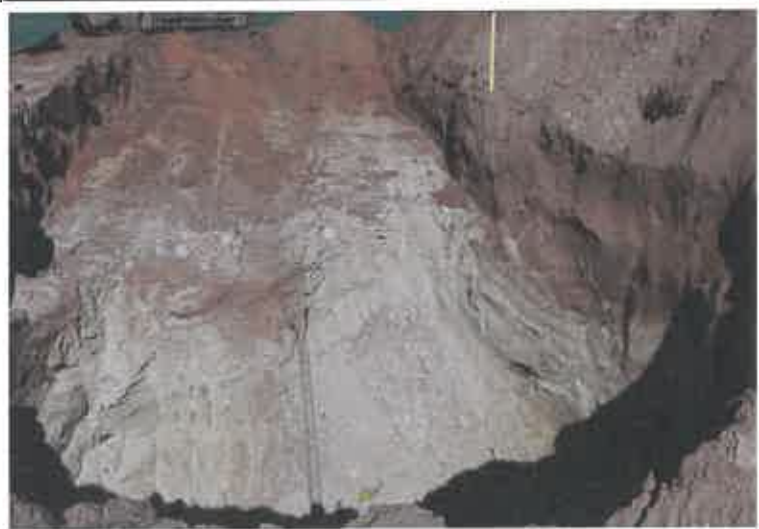
Photograph 6

View of partially completed excavation, facing north. The dark brown spot on the northeast wall is a weathered concretion.

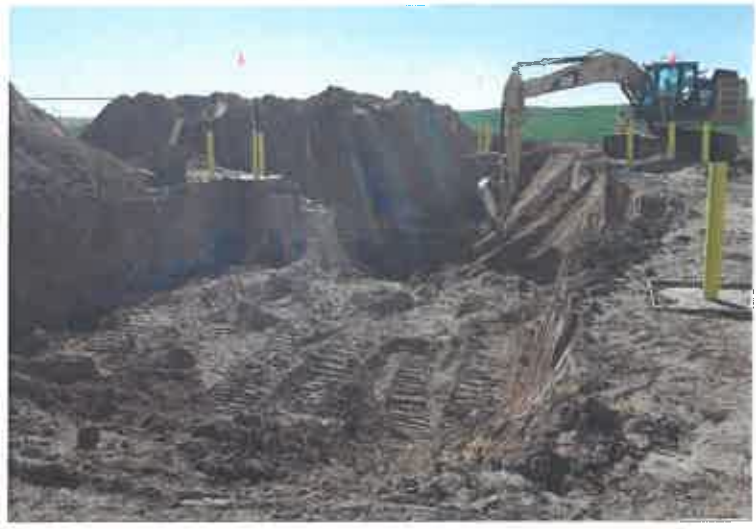
Photograph 7

View of ramp facing east. Ramps were utilized to give the excavator better access.

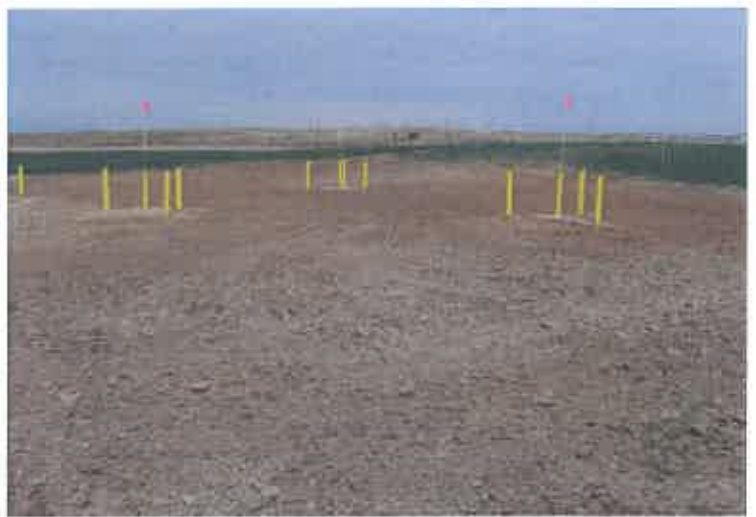
Photograph 8

View of Site at the completion of corrective action activities facing north-west.

- A total of approximately 888 cubic yards of hydrocarbon affected soils were transported to the Envirotech landfarm near Hilltop, New Mexico for disposal/treatment. The excavation was backfilled with clean/unaffected fill and contoured to surrounding grade.

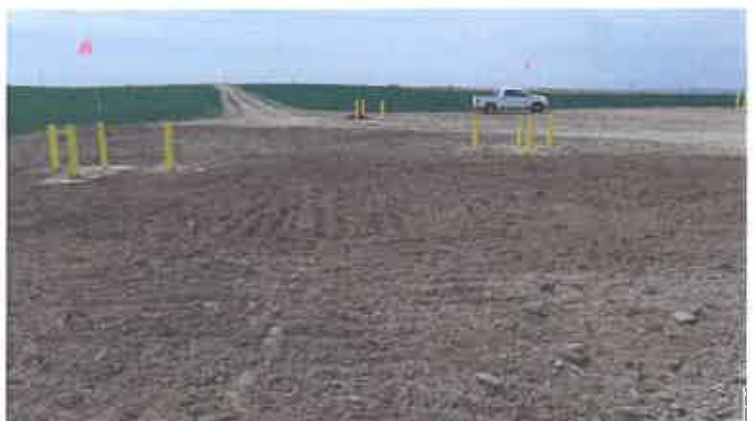
Photograph 9

View of Site after completion of corrective action activities facing south.
