Re: Site Closure Documentation
Central Vacuum Unit #47H (RP #1483)

- *Remediation and Pit Closure Activities Report,
Central Vacuum Unit #47H, RP #1483
Unit A, Section 31, Township 17S, Range 35E,
Lea County, New Mexico
(Final Form C-144 also included with report)*

**REMEDICATION AND PIT CLOSURE
ACTIVITIES REPORT
CENTRAL VACUUM UNIT NO. 47H
RP #1483**

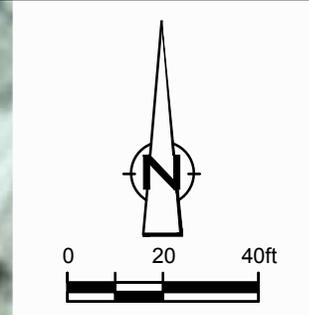
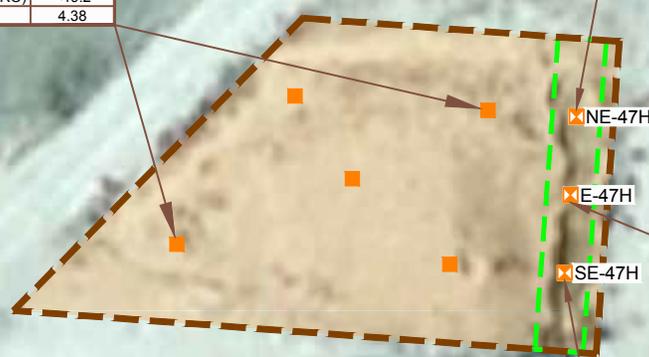
SITE DETAILS AND ANALYTICAL RESULTS MAP
CENTRAL VACUUM UNIT No. 47H
LEA COUNTY, NEW MEXICO
Chevron Environmental Management Company

Floor Sample-031015*	
Date	03/15/15
Depth	Surface
BTEX	<0.00128
TPH (GRO & DRO)	<19.2
Chloride	4.38

NE-47H-031915	
Date	03/19/15
Depth	5'
Chloride	15.4

E-47H-031915	
Date	03/19/15
Depth	5'
Chloride	15.7

SE-47H-031915	
Date	03/19/15
Depth	5'
Chloride	13.6

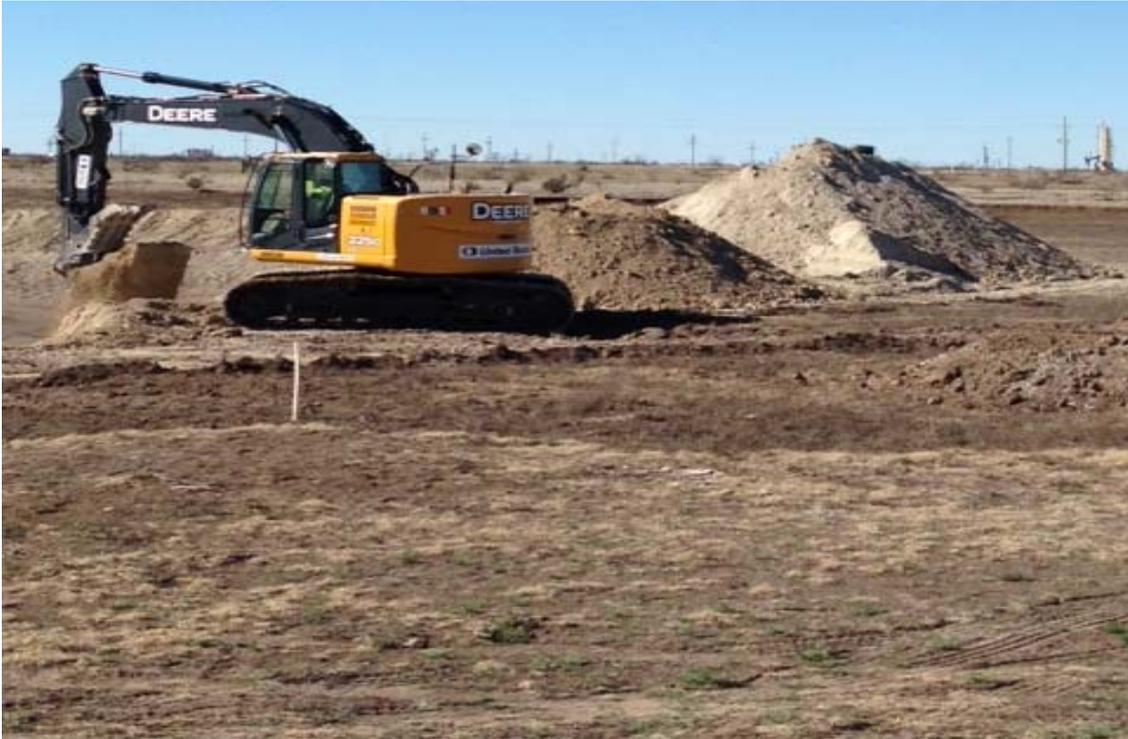
PHOTO 1: View of Pearce Ranch Trust borrow pit stockpiling activities facing west

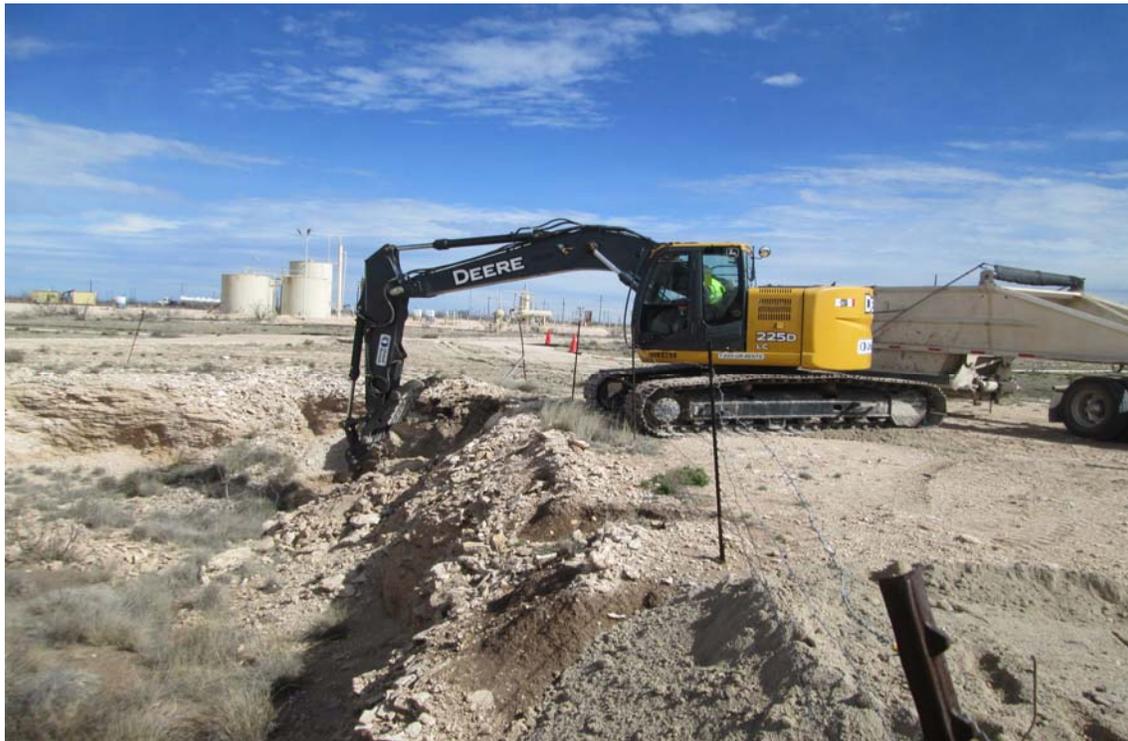
PHOTO 2: View of east sidewall excavation activities facing north

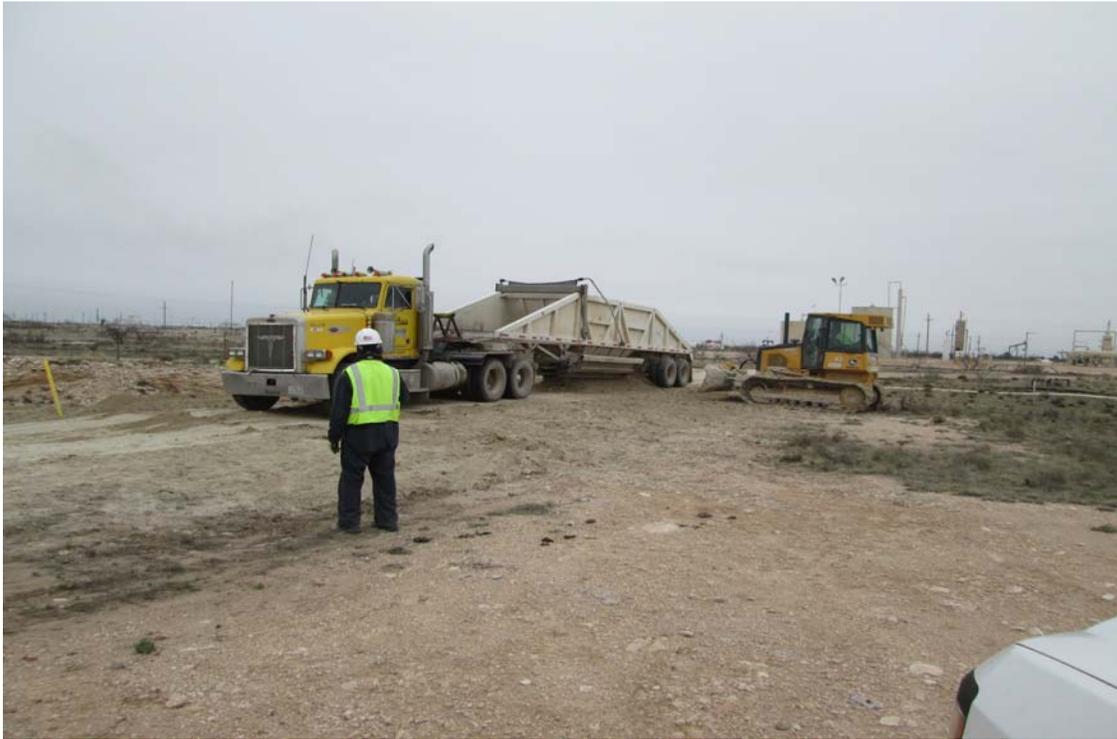
PHOTO 3: View of haul truck dispensing clean soil and heavy equipment facing west

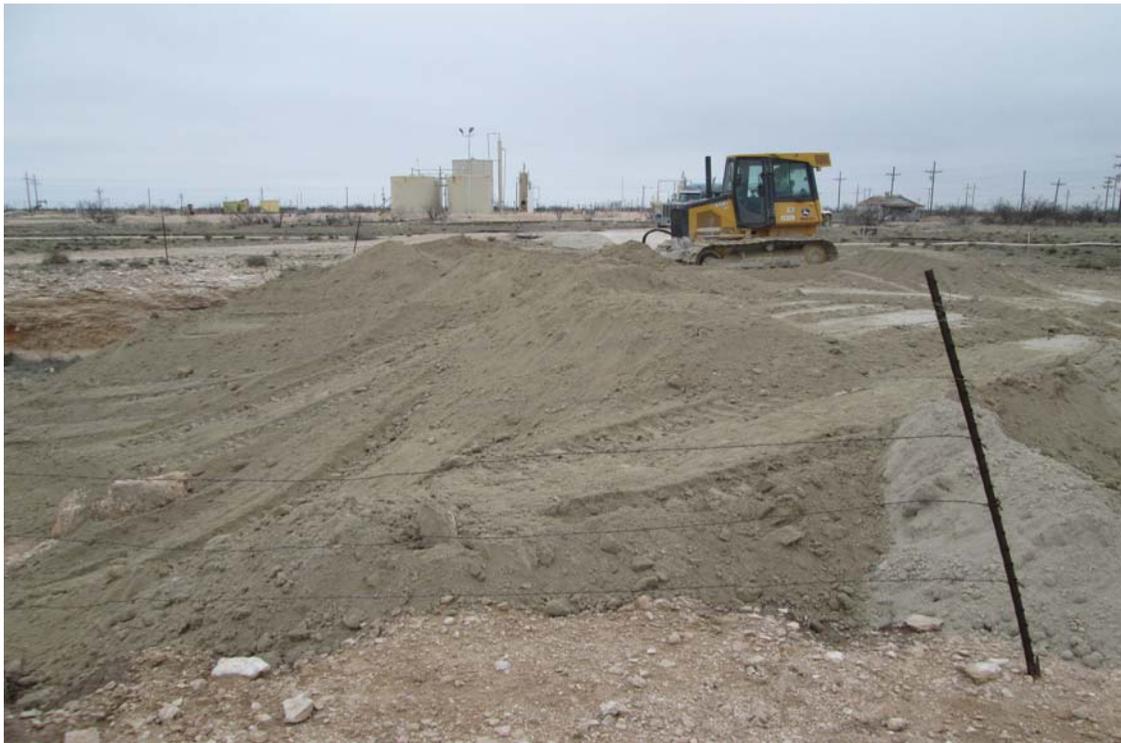
PHOTO 4: View of backfilling activities facing north

Backfilling activities at the Site began on March 19, 2015 with the staging of heavy equipment near the borrow pit and remedial excavation areas. Transportation of clean soil materials and backfill of the remedial excavation area began on March 19, 2015. Installation of the 20-mil poly liner was completed on March 21, 2015 by Entact. The liner seams were sealed at the time of installation to prevent water infiltration. Lobo's transported approximately 2,340 cy of clean soil materials (sand/caliche) and approximately 144 cy of clean top soil from the off-site borrow pit (Pearce Ranch Trust). Approximately 2,484 cy of clean soil materials was emplaced into the remedial excavation. Entact utilized heavy equipment to contour and grade construction affected areas to minimize erosion. The area was ripped and seeded with a native grass mixture to return construction affected areas to their pre-excavation state that existed before oil and gas operations. Remedial activities were concluded on March 25, 2015. A Remediation and Closure Activities map is presented as figure 4. A Site chronology of the backfilling activities is provided in Appendix E. Site photographs documenting work activities are presented in Appendix F.

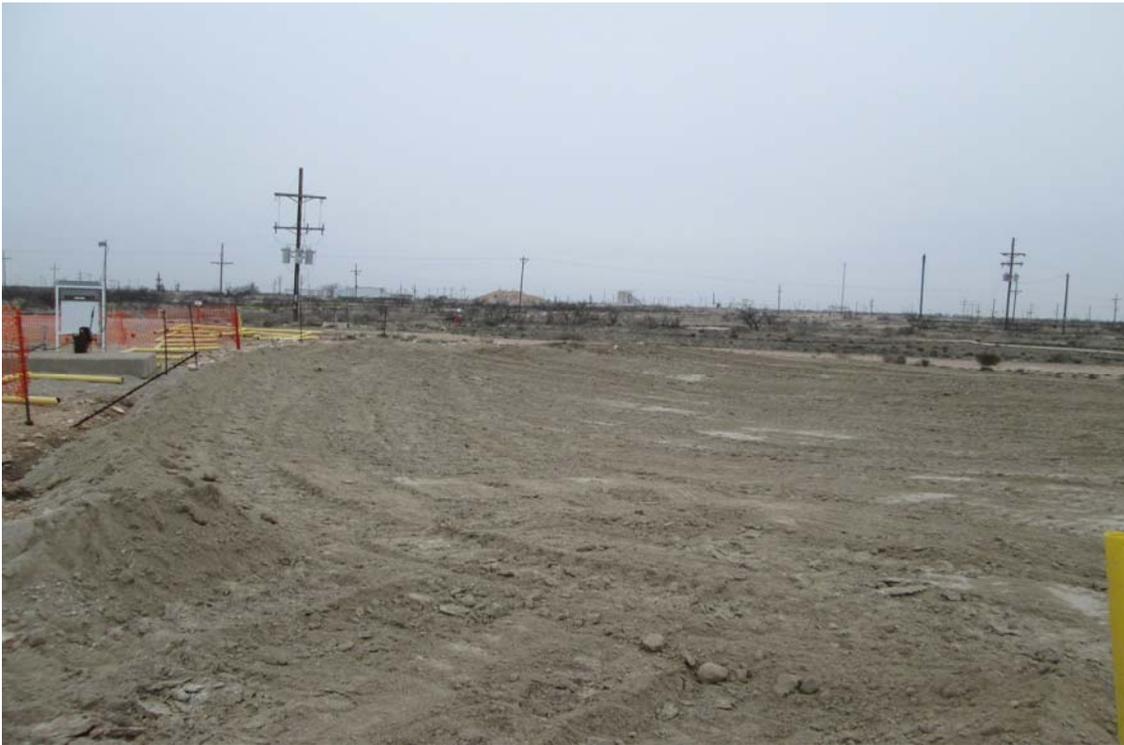
PHOTO 5: View backfill activities facing west

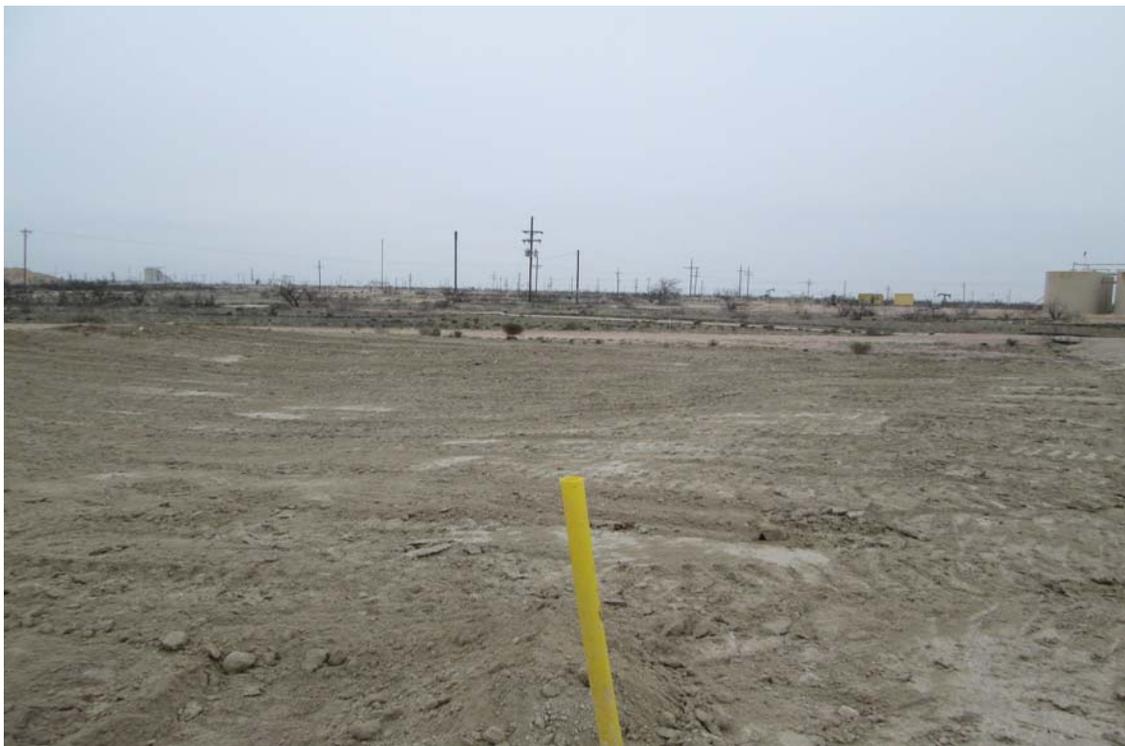
PHOTO 6: View of backfilling activities facing north

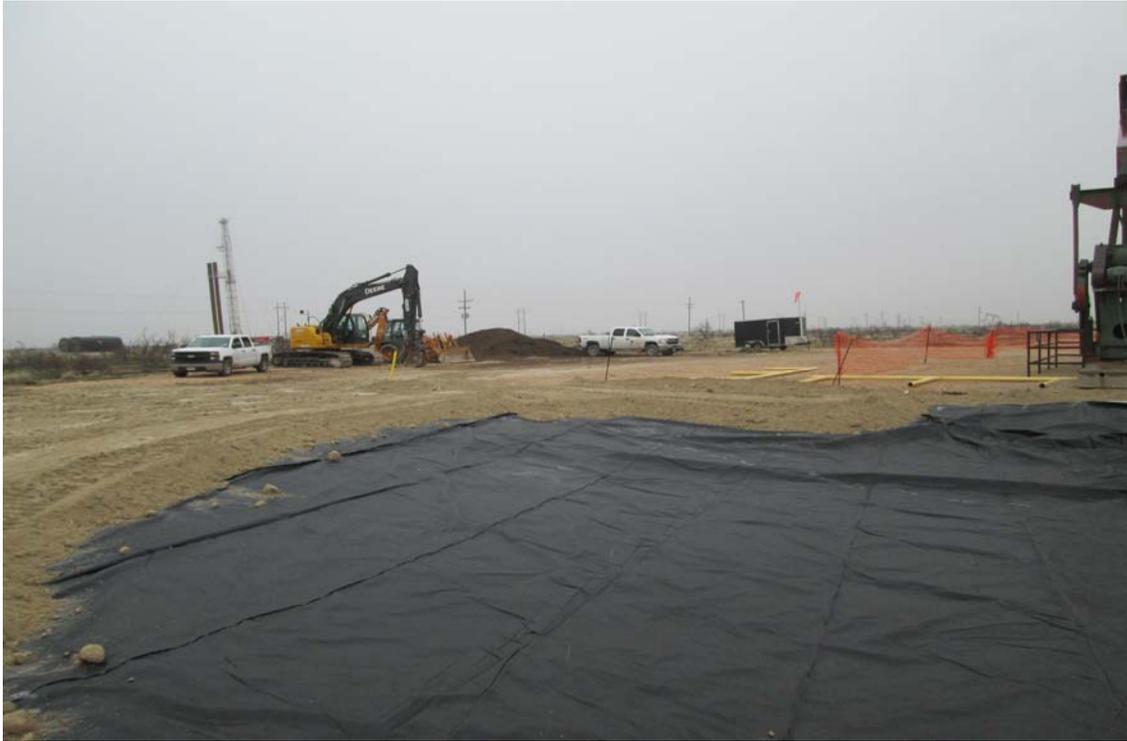
PHOTO 7: View 20-mil poly liner installation facing south

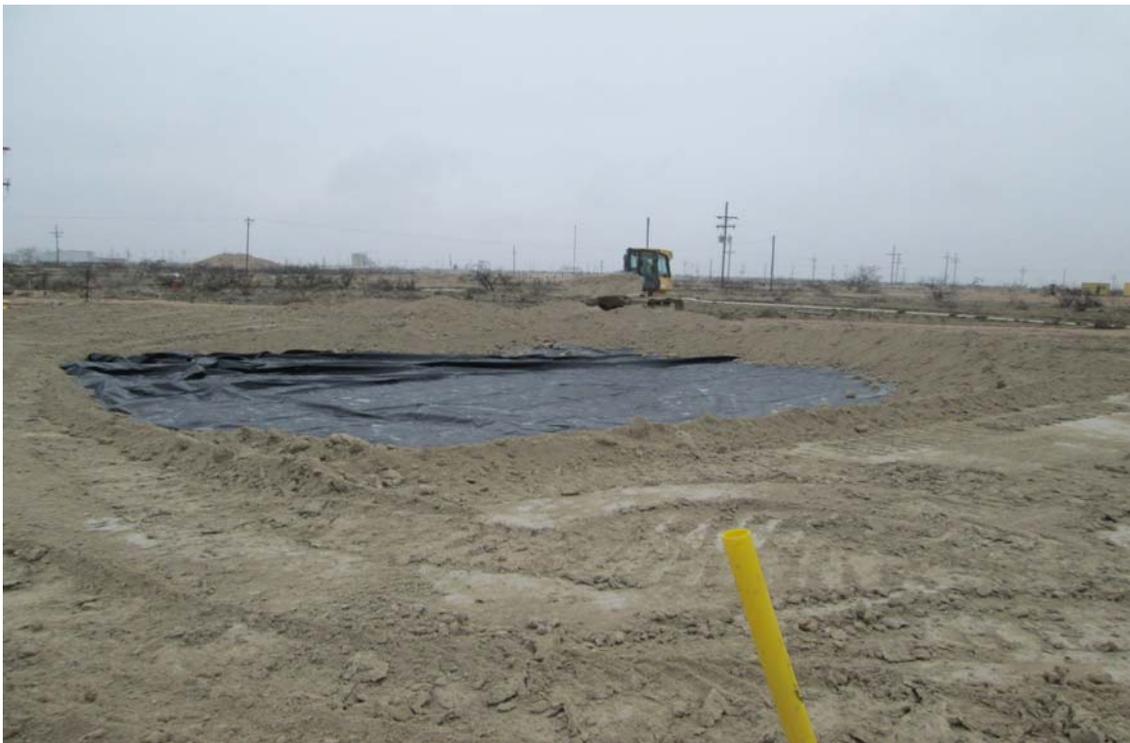
PHOTO 8: View of 20-mil poly liner installation and backfill activities facing north

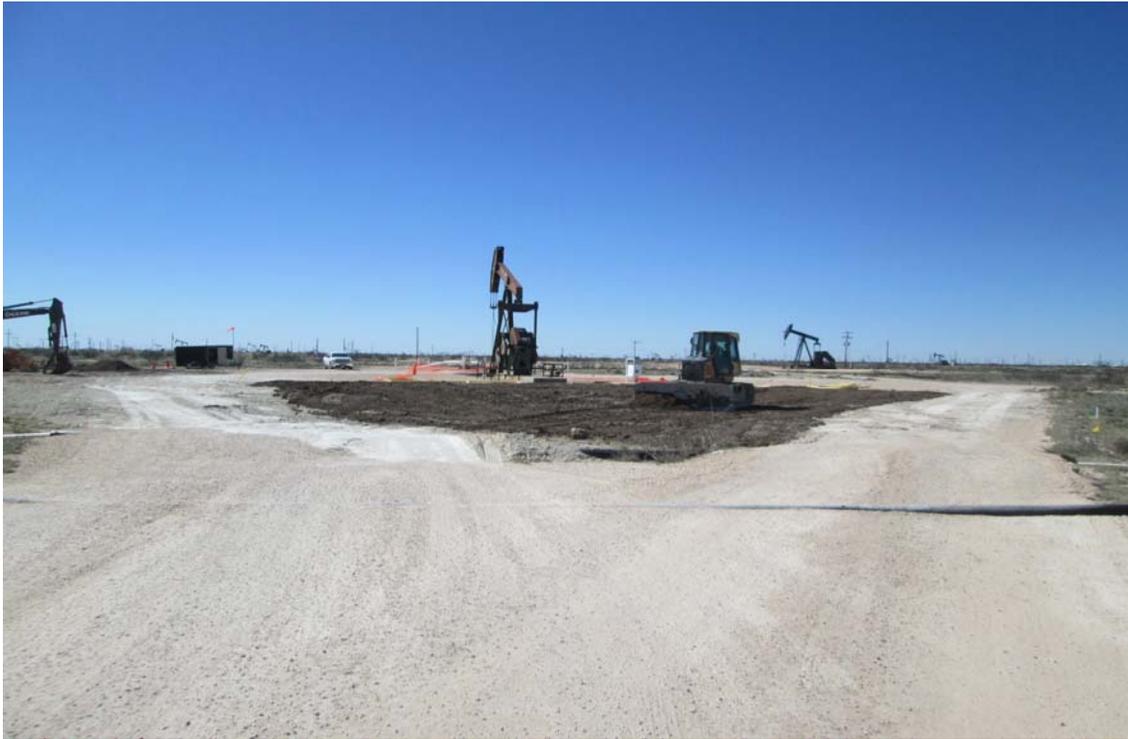
PHOTO 9: View of top soil backfill activities facing south

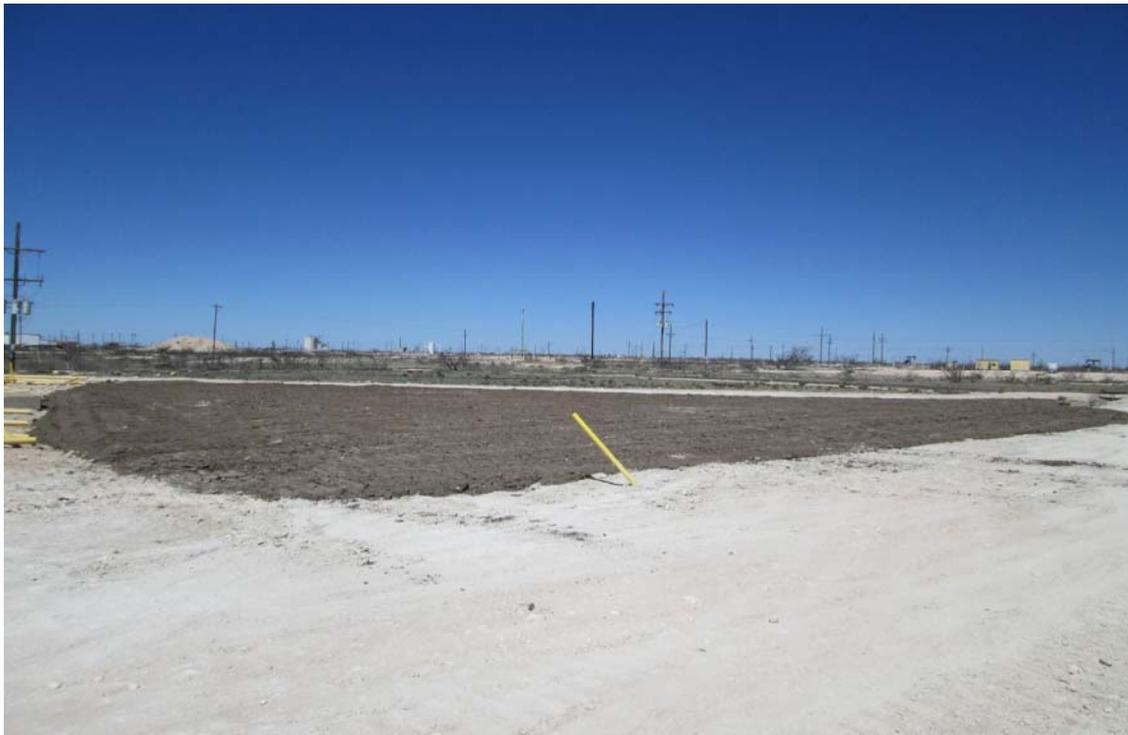
PHOTO 10: View of final grading, contouring, and seeding activities facing north west
