Disclosure Report

**RICE OPERATING COMPANY
JUNCTION BOX DISCLOSURE* REPORT**

EME Amerada St. 'D' boot EOL

Unit 'C', Sec. 1, T20S, R36E

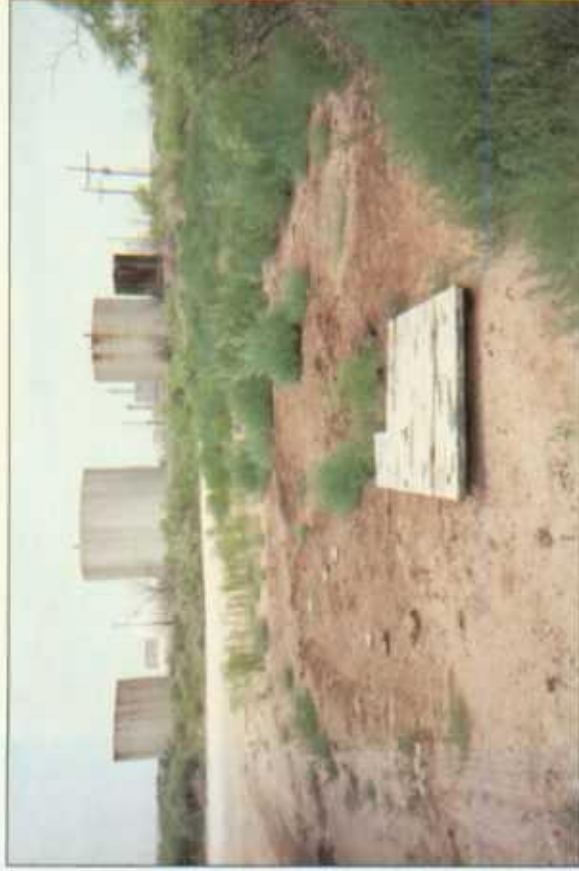
undisturbed junction box

10/28/2004

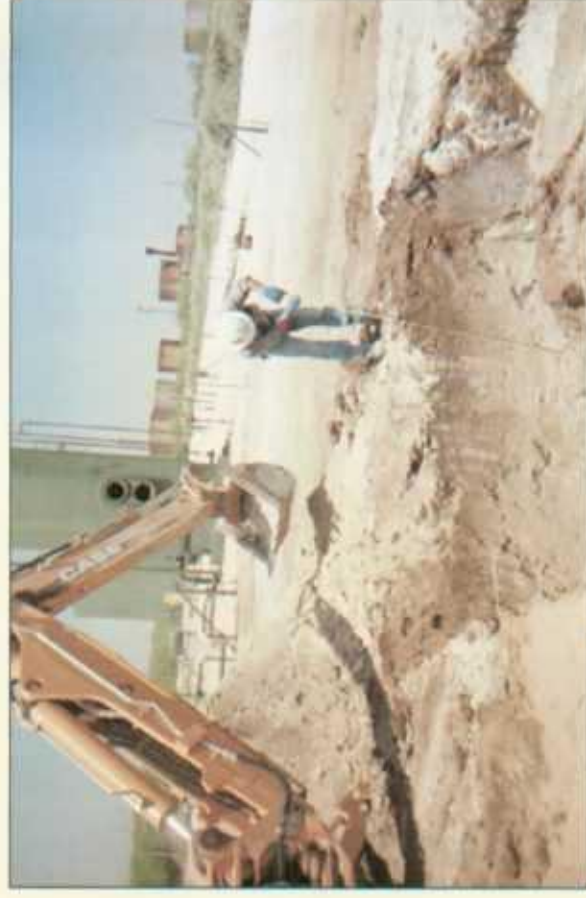
delineation & excavation

6/23/2005

General Description of Remedial Action: This End-Of-Line (EOL) junction box contained a boot. The junction was eliminated as part of the pipeline replacement program. The junction and box was removed and the location was re-plumbed with a new pipeline. A backhoe was used to conduct delineation trenches at the former junction site. Soil samples were collected at regular intervals and were field tested for chloride and screened using a PID. Chloride concentrations did not relent with depth throughout the 10 x 10 x 12-ft excavation. Soil samples exhibited signs of hydrocarbon impact and lab analysis on the final excavation samples confirmed that NMOCD TPH guidelines were not met. The excavated soil was blended on site and then backfilled into the excavation. The disturbed surface was seeded with a blend of native vegetation. An identification plate has been placed on the surface of the former junction site to mark the site for future environmental considerations. NMOCD has been notified of potential groundwater impact at this site.

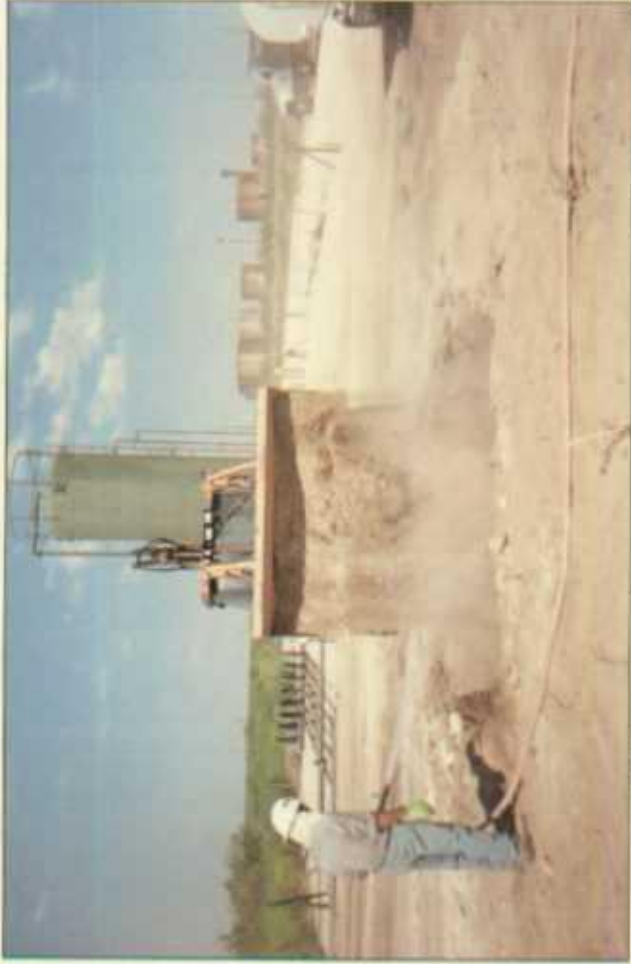
backfilling excavation

7/14/2005

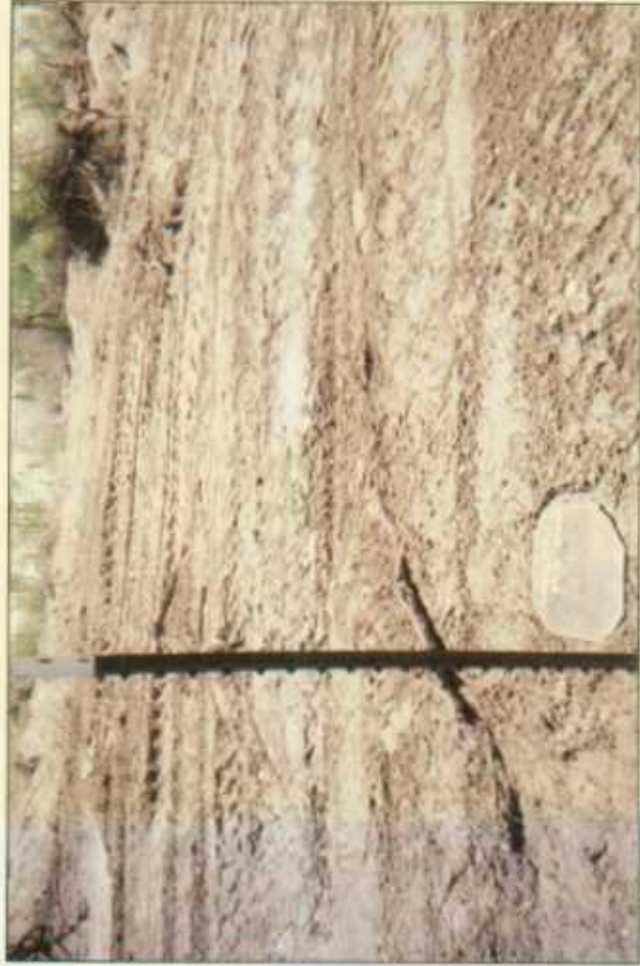
identification plate on surface of backfilled site

7/14/2005

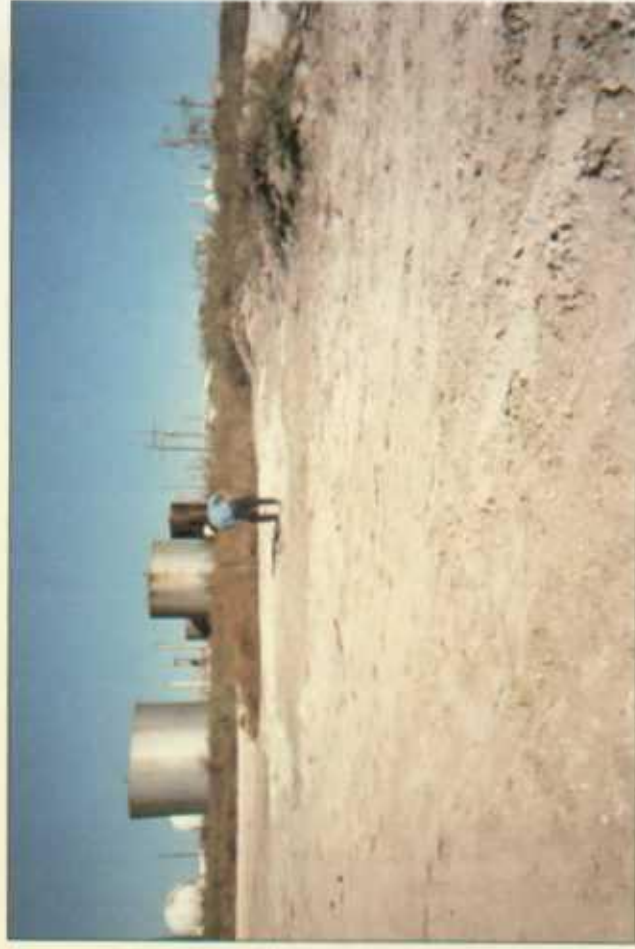
seeding disturbed surface

11/21/2005

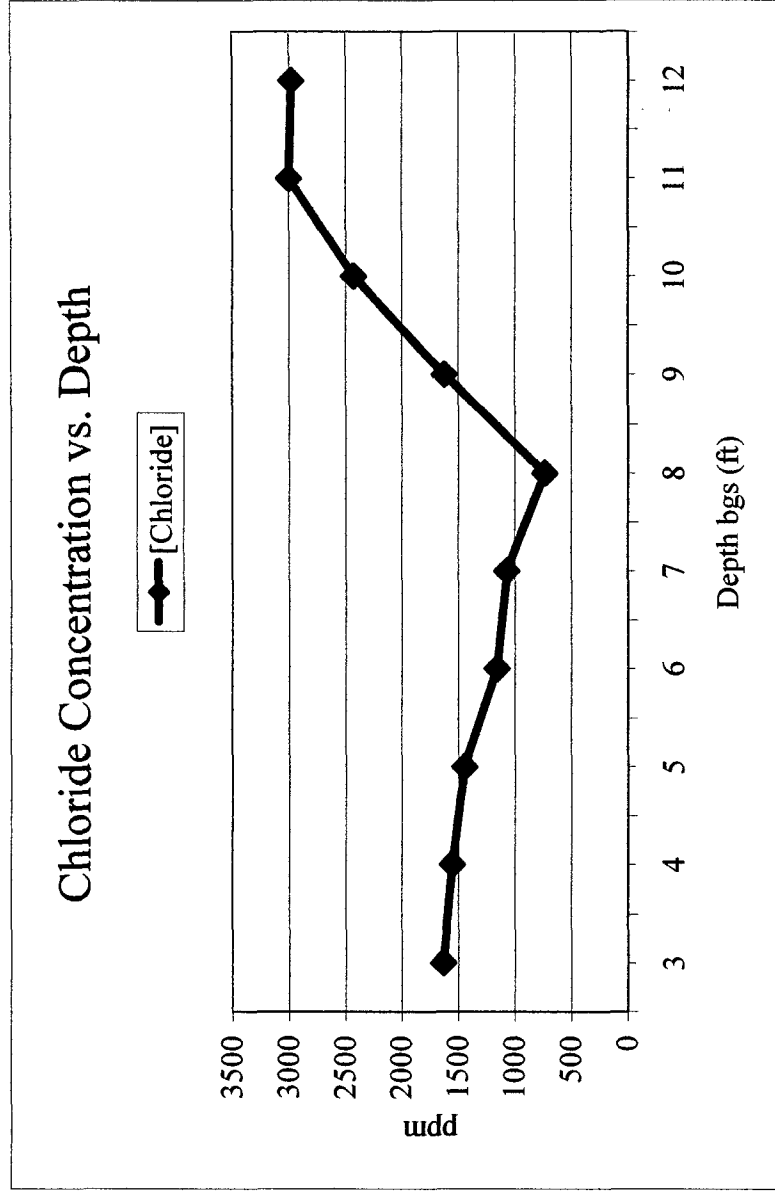
Vertical Delineation at Junction

Depth bgs (ft)	[Cl ⁻] ppm
3	1634
4	1554
5	1447
6	1159
7	1072
8	734
9	1621
10	2430
11	2999
12	2979

Groundwater = 40 ft

LOCATION	DEPTH (ft)	ppm
delineation trench at junction	3	1634
	4	1554
	5	1447
	6	1159
	7	1072
	8	734
	9	1621
	10	2430
	11	2999
	12	2979
5 ft SOUTH of junction	1	786
	2	962
	3	1425
	4	1238
	5	1825
	6	2532
	7	2313
	8	2001
	9	1882
	10	2005
	11	2909
	12	2138
4-wall comp.	n/a	1619
bottom comp.	12	1785
backfill comp.	n/a	1082

ADDITIONAL EVALUATION IS HIGH PRIORITY

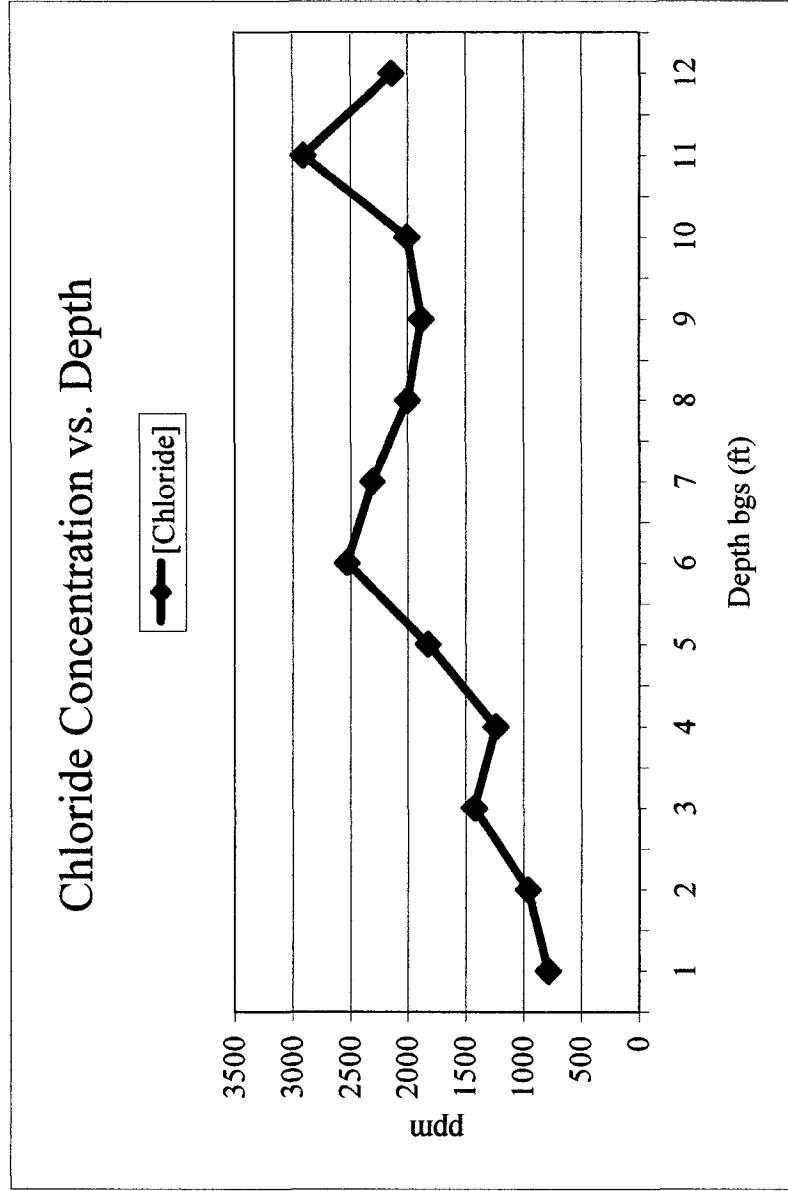
5 ft SOUTH of junction

Depth bgs (ft)	[Cl ⁻] ppm
1	786
2	962
3	1425
4	1238
5	1825
6	2532
7	2313
8	2001
9	1882
10	2005
11	2909
12	2138

Groundwater = 40 ft
