RE: El Paso Natural Gas Company Line No. 3031 Inadvertent Release – Rupture No. 2
Request for Closure of RP No. 4427

SITE CLOSURE REPORT

Line 3031 Hydrotest Water Release

NMOCD # 1RP-4427

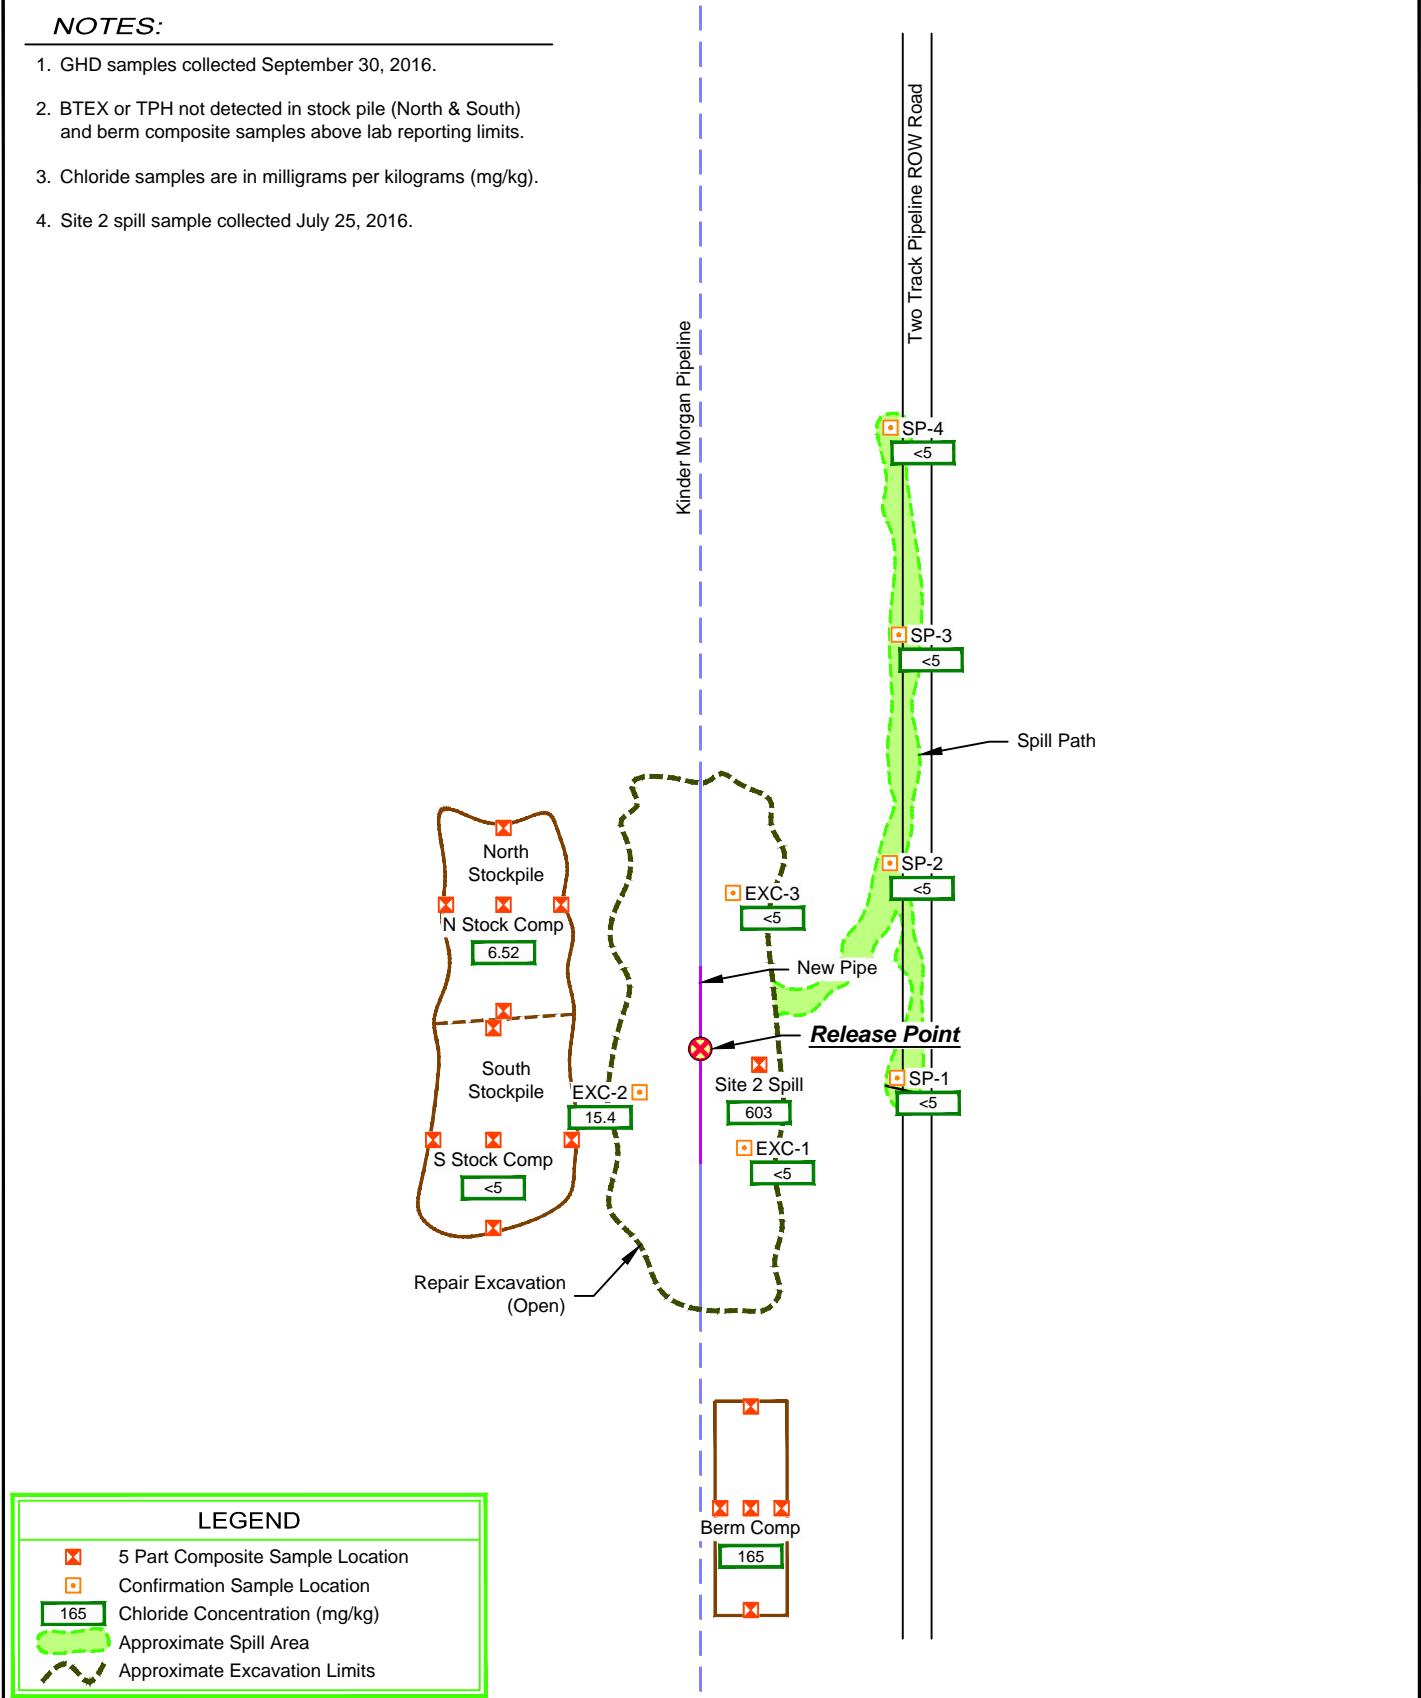
FIGURE 2

1. GHD samples collected September 30, 2016.
2. BTEX or TPH not detected in stock pile (North & South) and berm composite samples above lab reporting limits.
3. Chloride samples are in milligrams per kilograms (mg/kg).
4. Site 2 spill sample collected July 25, 2016.

SOIL ANALYTICAL RESULTS

The repair excavation is currently open and has not been backfilled. Analytical sample results from the excavation floor and stockpiled soils indicate that existing soil concentrations (chlorides, BTEX, and TPH) are protective of groundwater, human health and the environment. Consequently, GHD, on behalf of KM, recommends no further excavation is necessary and request onsite soils be used as backfill material for the repair excavation.

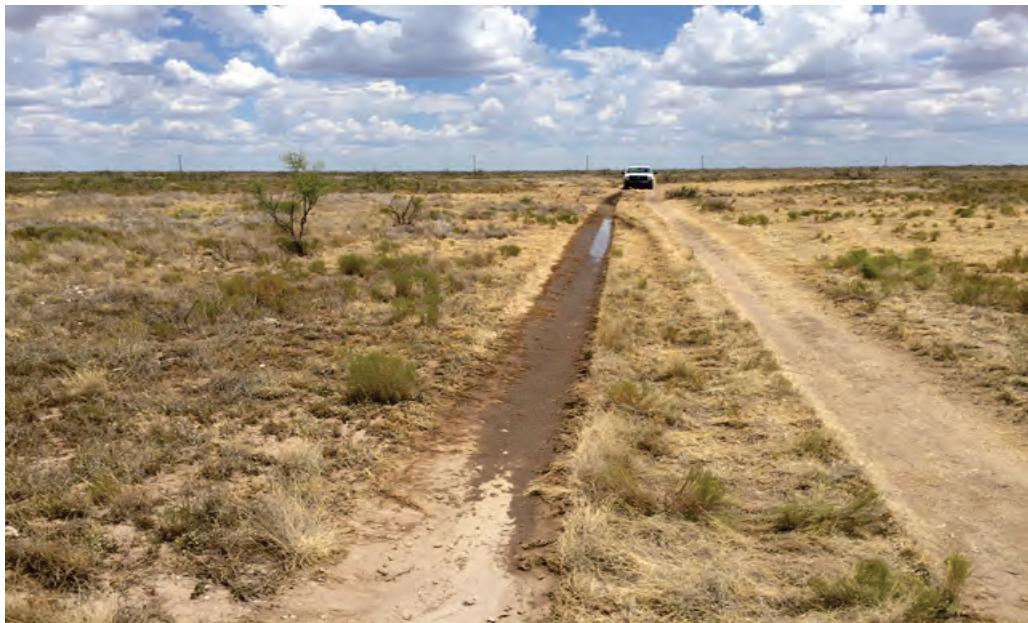
The released fluids followed a narrow 1 to 2 ft. and shallow spill path toward the north (see Appendix B – Site Photographs). As shown on the attached photo log, the water flowed along the western side of the two track pipeline patrol road. KM originally reported the release to have travelled approximately 20 to 30 feet along the western side of the pipeline patrol road. After reviewing site photographs (see Photo 1 in Appendix B), and in a conservative effort to delineate any impact to the soil, GHD collected soil samples over a length of approximately 120 feet along the western side of the pipeline patrol road. The New Mexico Office of the State Engineer (NMOSE) website was utilized to research the depth to groundwater in the general area. Available depth to groundwater well (DTW) data within a 4-5 mile radius of the release indicated a DTW in the range of 100 – 120 feet in the vicinity.

Photo 1 – View to north at hydrotest water spill path along west side of patrol road on July 25, 2016

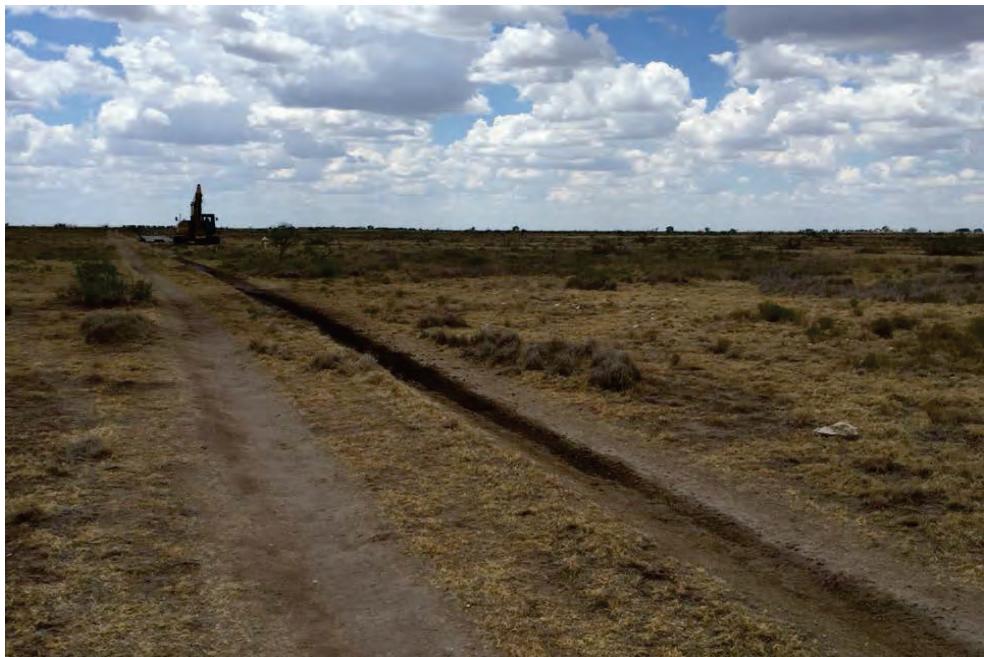
Photo 2 – View to south at hydrotest water spill path along west side of patrol road on July 25, 2016.

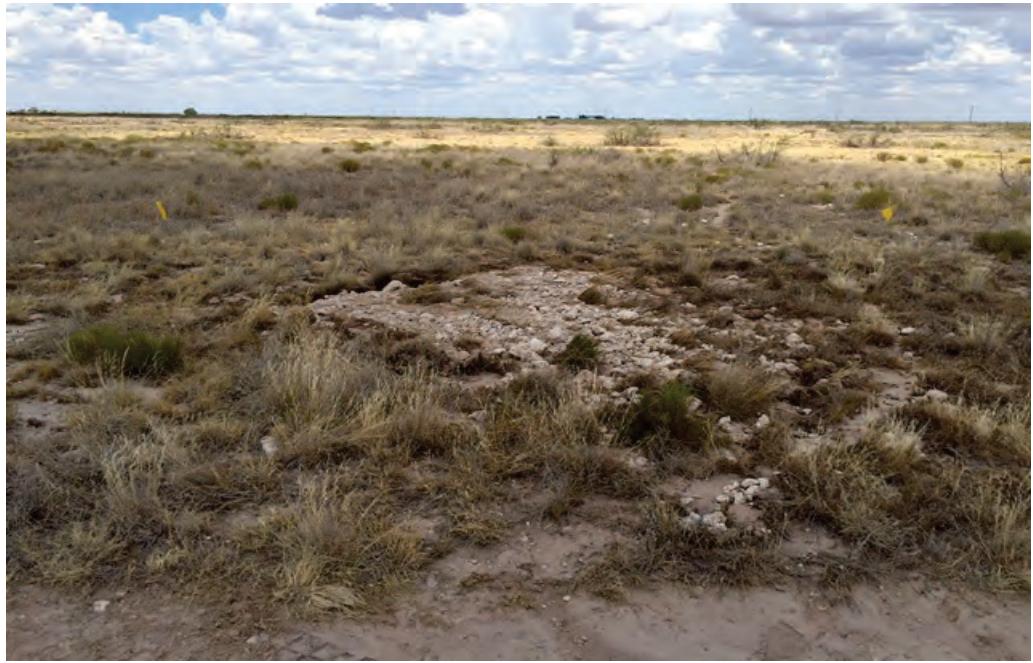
A release of hydrostatic test water was discovered at the Site at 8:30 a.m. (MST) on July 25, 2016, during pipeline hydrotesting operations. The release was caused by a small breach in the 8" natural gas steel pipeline, Line 3031. An estimated release of 1,500 gallons of freshwater was immediately verbally reported to the NMOCD by KM at 2:15 p.m. (MST) on July 25, 2016. Mr. Jim Griswold and Dr. Tomas Oberding with the NMOCD Environmental Bureau in Santa Fe were notified of the release, as was Mr. Maxey Brown with the NMOCD District 1 office in Hobbs. NMOCD Form C-141, Release Notification and Corrective Action, dated August 9, 2016 was submitted to the agency containing "Initial Report" information regarding the location, nature of release, remedial actions taken, along with the updated release amount of approximately 4,350 gallons, the recovered amount of approximately 3,850 gallons, and other additional information. A copy of this NMOCD Form C-141 is attached in Appendix A. A remediation permit number 1RP-4427 was assigned to this release.

Photo 3 – Close in view of hydrotest water ‘release bulge’ – looking west, July 25, 2016.

A section of the pipeline that containing the breach associated with the hydrotest water release was replaced and repaired by KM. An approximate 110' x 30' x 4' deep area was excavated as part of the repair activities. A composite soil sample was collected in the repair excavation, adjacent to the release point, on July 28, 2016. The chloride concentration from the July sample (Site 2 Spill; by TraceAnalysis) was 603 milligrams per kilogram (mg/kg). Removed soils were placed to the south and west of the excavation. It is noted that the area received substantial precipitation (~4+ inches) in August and September 2016. On September 30, 2016, GHD mobilized to the site to perform additional soil sampling at the release site. Soil samples were collected from within the repair excavation and spill path and then analyzed for chlorides (EPA Method 300). The sample locations and chloride concentrations are posted on Figure 2. All four soil samples collected from 0-6" along the spill path exhibited chloride concentrations below the laboratory reporting limit of 5 mg/kg. Two of the three soil samples collected from 0-6" in the repair excavation floor also had chloride concentrations below 5 mg/kg. The remaining excavation sample, EXC-2, had a chloride concentration of 15.4 mg/kg.

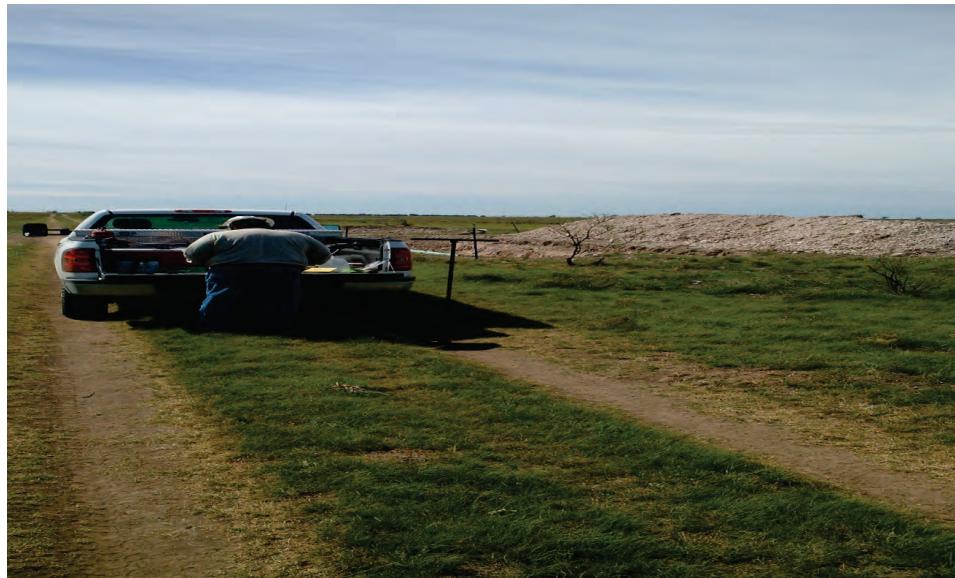
- The extent of the chloride-impacted soils was defined by collecting delineation and confirmation samples from the area proximate to the release site and along the spill path.

Photo 4 – 9/30/16: GHD geologist collecting hand auger samples along the spill path.

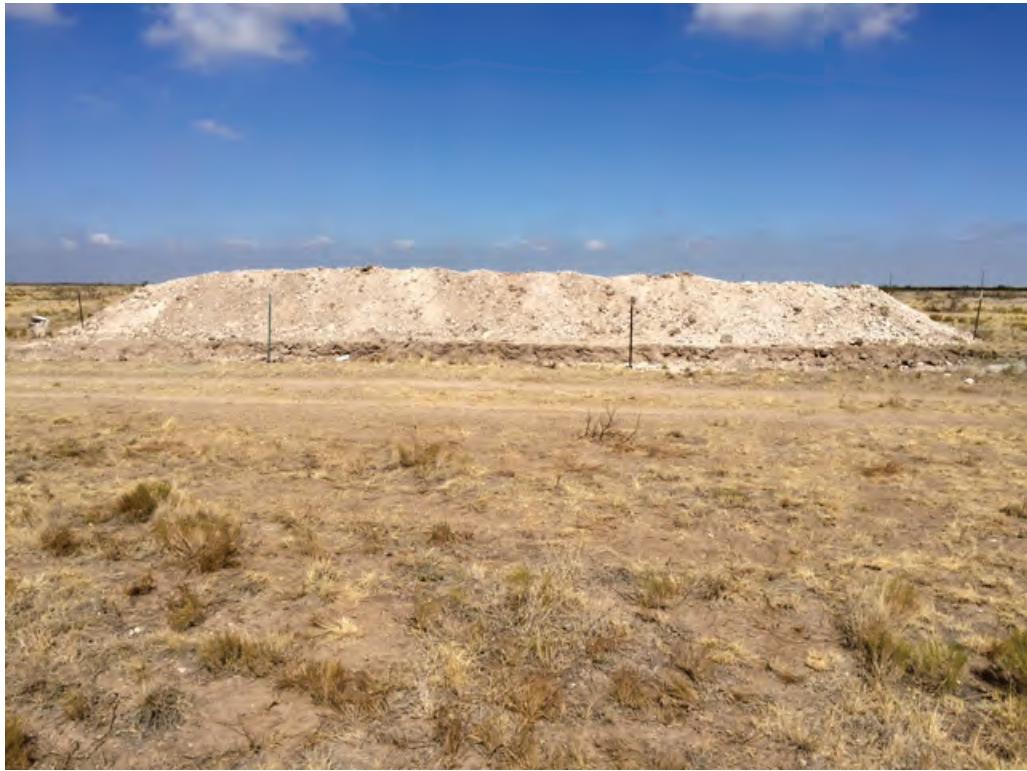
In an effort to demonstrate that stockpiled soils could be used to backfill the repair excavation, additional analytical testing was performed at the North Stockpile, South Stockpile, and Berm locations. Chlorides, benzene, toluene, ethylbenzene, xylenes (BTEX; EPA 8260C), and total petroleum hydrocarbons (S 8015D) analysis were performed on composite samples obtained from stockpiled soils staged outside of the repair excavation. Chloride concentrations are posted on Figure 2. All BTEX and TPH concentrations from the three composite stockpile locations exhibited levels below laboratory detection limits. Laboratory reports and chain of custody forms are provided in Appendix C.

Photo 5 – View to west at soil stockpile on west side of repair excavation.
