**Re: Site Assessment Report May and June 2014
Benson-Montin-Greer
Highway 537 Truck Receiving Station
Rio Arriba County, New Mexico**

TOPOGRAPHIC SITE LOCATION MAP
 BENSON-MONTIN-GREER
 LLAVES PIPELINE HWY. 537
 TRUCK RECEIVING STATION
 2014 EXCAVATION ASSESSMENT
 SW ¼ NW ¼ SECTION 18, T25N, R3W
 RIO ARRIBA COUNTY, NEW MEXICO
 N36.39866, W107.19328

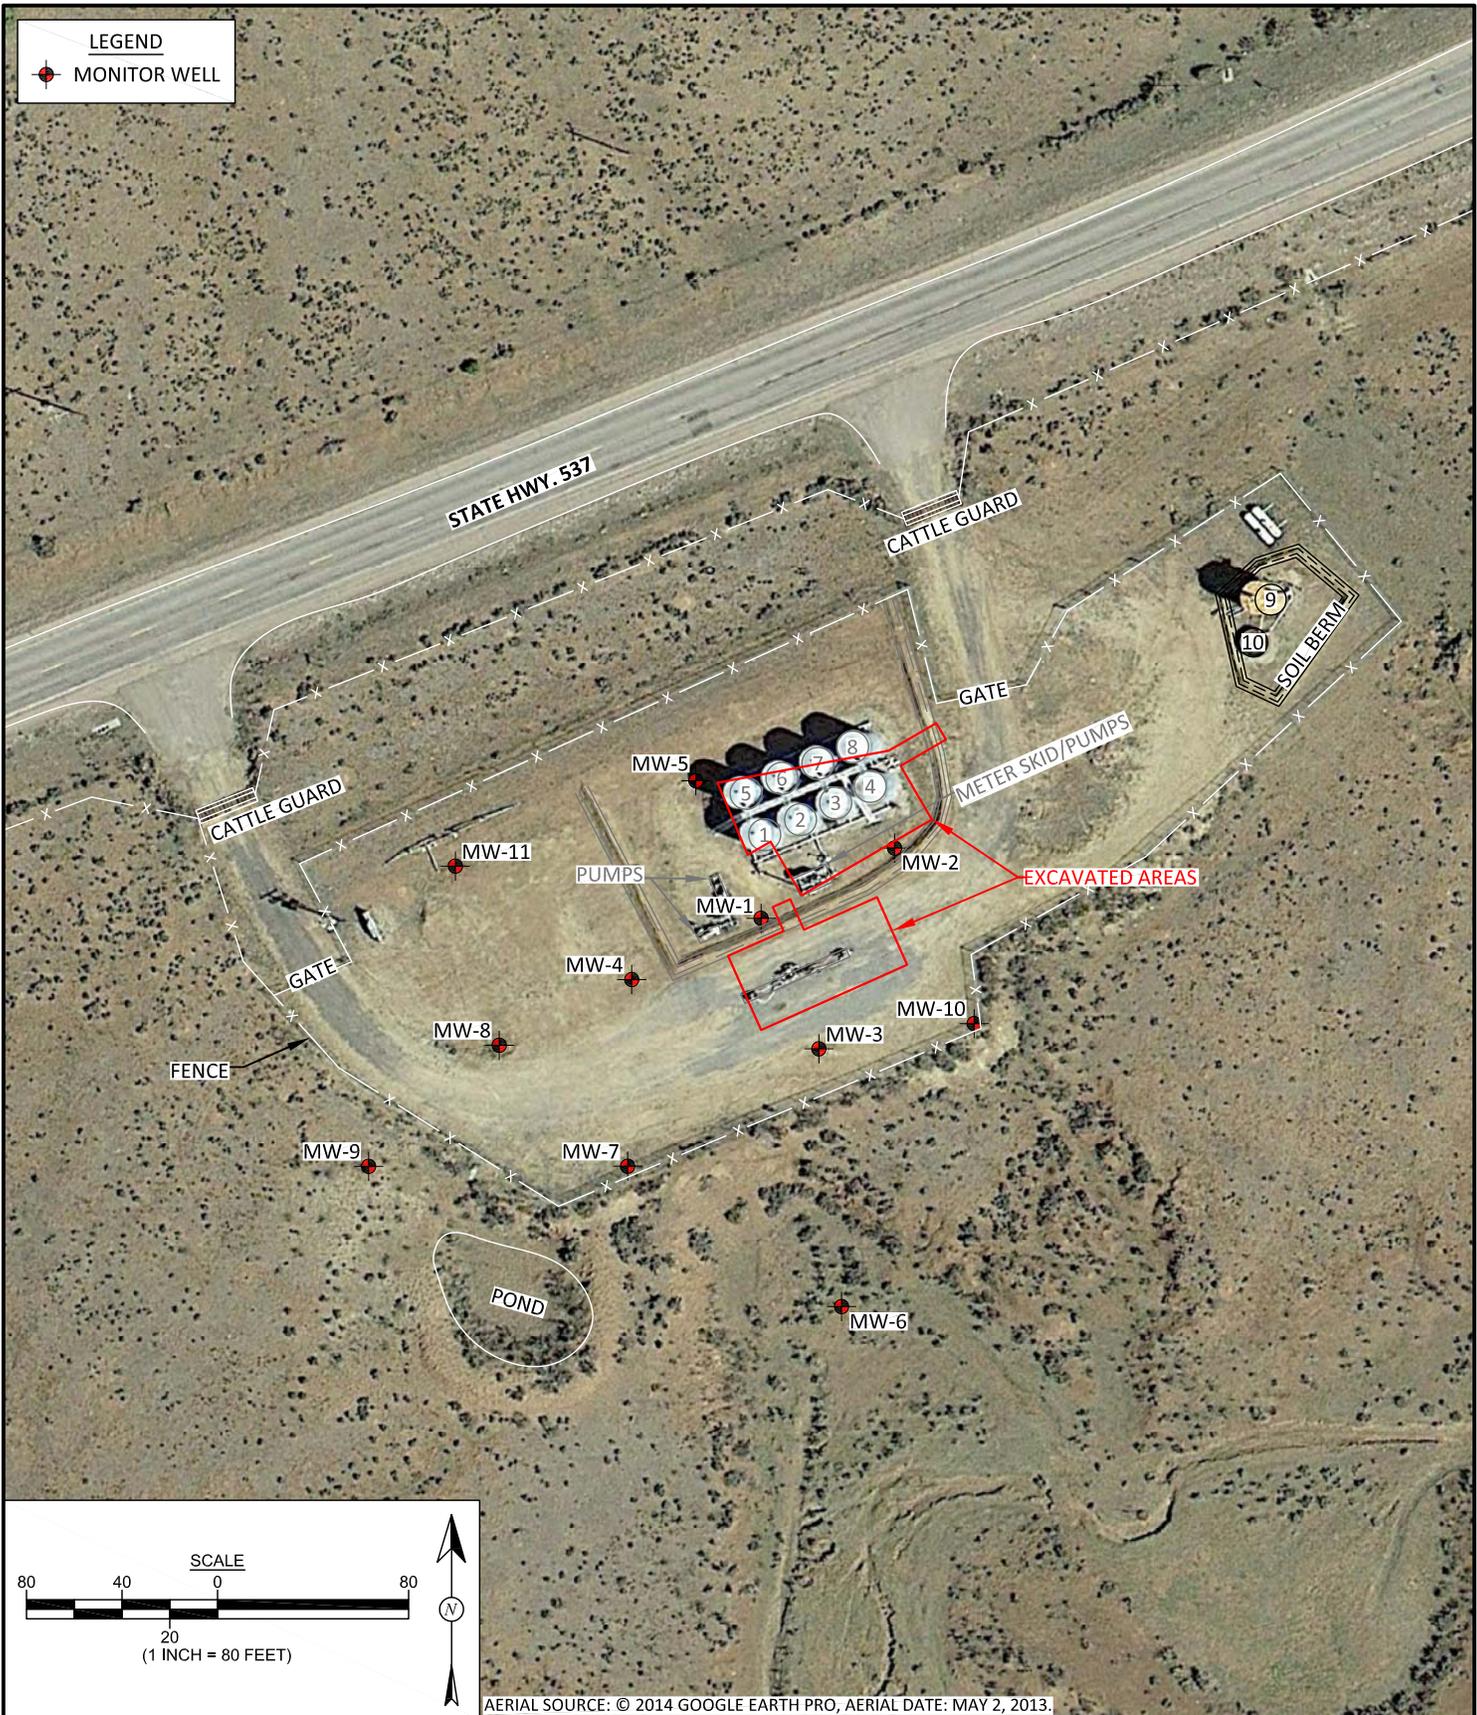
FIGURE 2

Map with a site plan, including existing monitor wells, is included as Figure 2.

AERIAL SITE MAP
 BENSON-MONTIN-GREER
 LLAVES PIPELINE HWY. 537
 TRUCK RECEIVING STATION
 2014 EXCAVATION ASSESSMENT
 SW ¼ NW ¼ SECTION 18, T25N, R3W
 RIO ARRIBA COUNTY, NEW MEXICO
 N36.39866, W107.19328

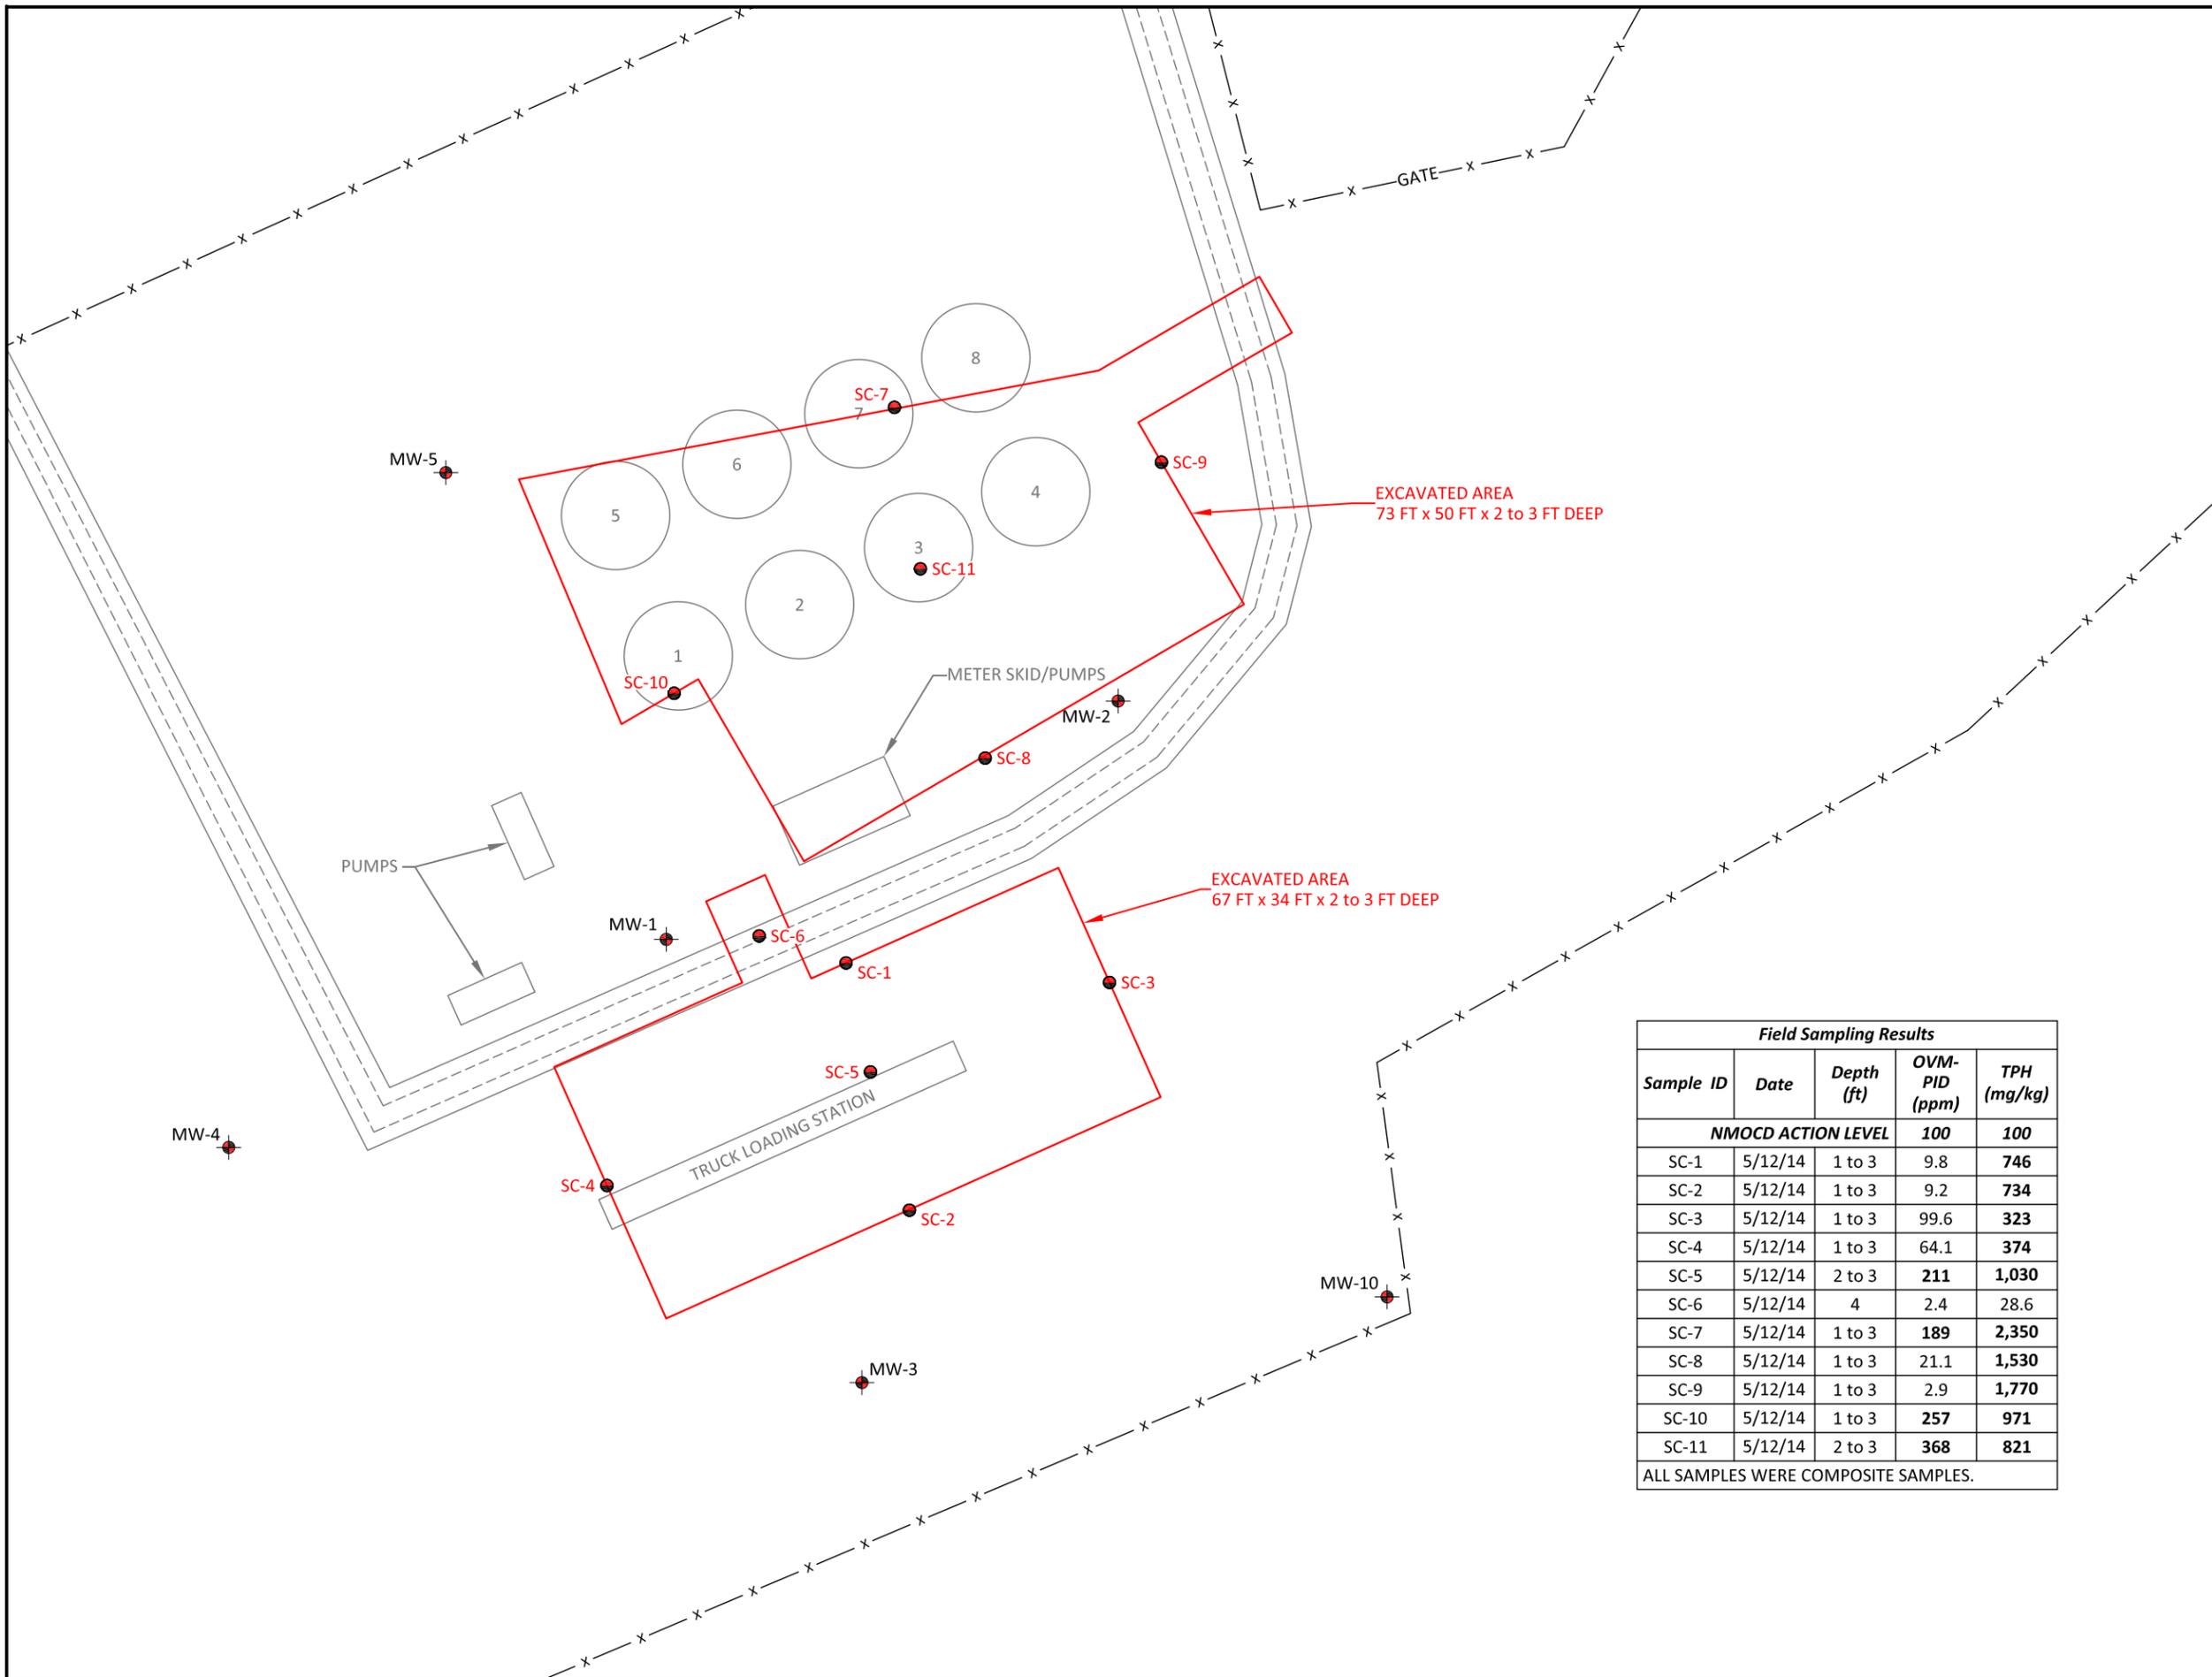
FIGURE 3

On May 12, 2014, a total of 11 composite (SC-1 through SC-11) soil samples were collected from the two discrete areas of excavation. Samples were collected from each wall (i.e. north, south, east, and west) and base of both excavations and from the center trench. All soil samples were field-screened for volatile organic carbons (VOCs) and total petroleum hydrocarbons (TPH). Excavation area extents and the sample locations from May 2014 are shown on Figure 3.

On May 12, 2014, excavation assessment field screening results for VOCs via OVM showed concentrations ranging from 2.9 ppm in SC-9 up to 368 ppm in SC-11. Field TPH concentrations ranged from 28.6 mg/kg in SC-6 up to 2,350 mg/kg in SC-7. Field sampling results are presented in Table 1 and on Figure 3.

EXCAVATION AREA SAMPLE LOCATIONS AND RESULTS, MAY 2014

Field Sampling Results				
Sample ID	Date	Depth (ft)	OVM-PID (ppm)	TPH (mg/kg)
NMOCD ACTION LEVEL			100	100
SC-1	5/12/14	1 to 3	9.8	746
SC-2	5/12/14	1 to 3	9.2	734
SC-3	5/12/14	1 to 3	99.6	323
SC-4	5/12/14	1 to 3	64.1	374
SC-5	5/12/14	2 to 3	211	1,030
SC-6	5/12/14	4	2.4	28.6
SC-7	5/12/14	1 to 3	189	2,350
SC-8	5/12/14	1 to 3	21.1	1,530
SC-9	5/12/14	1 to 3	2.9	1,770
SC-10	5/12/14	1 to 3	257	971
SC-11	5/12/14	2 to 3	368	821

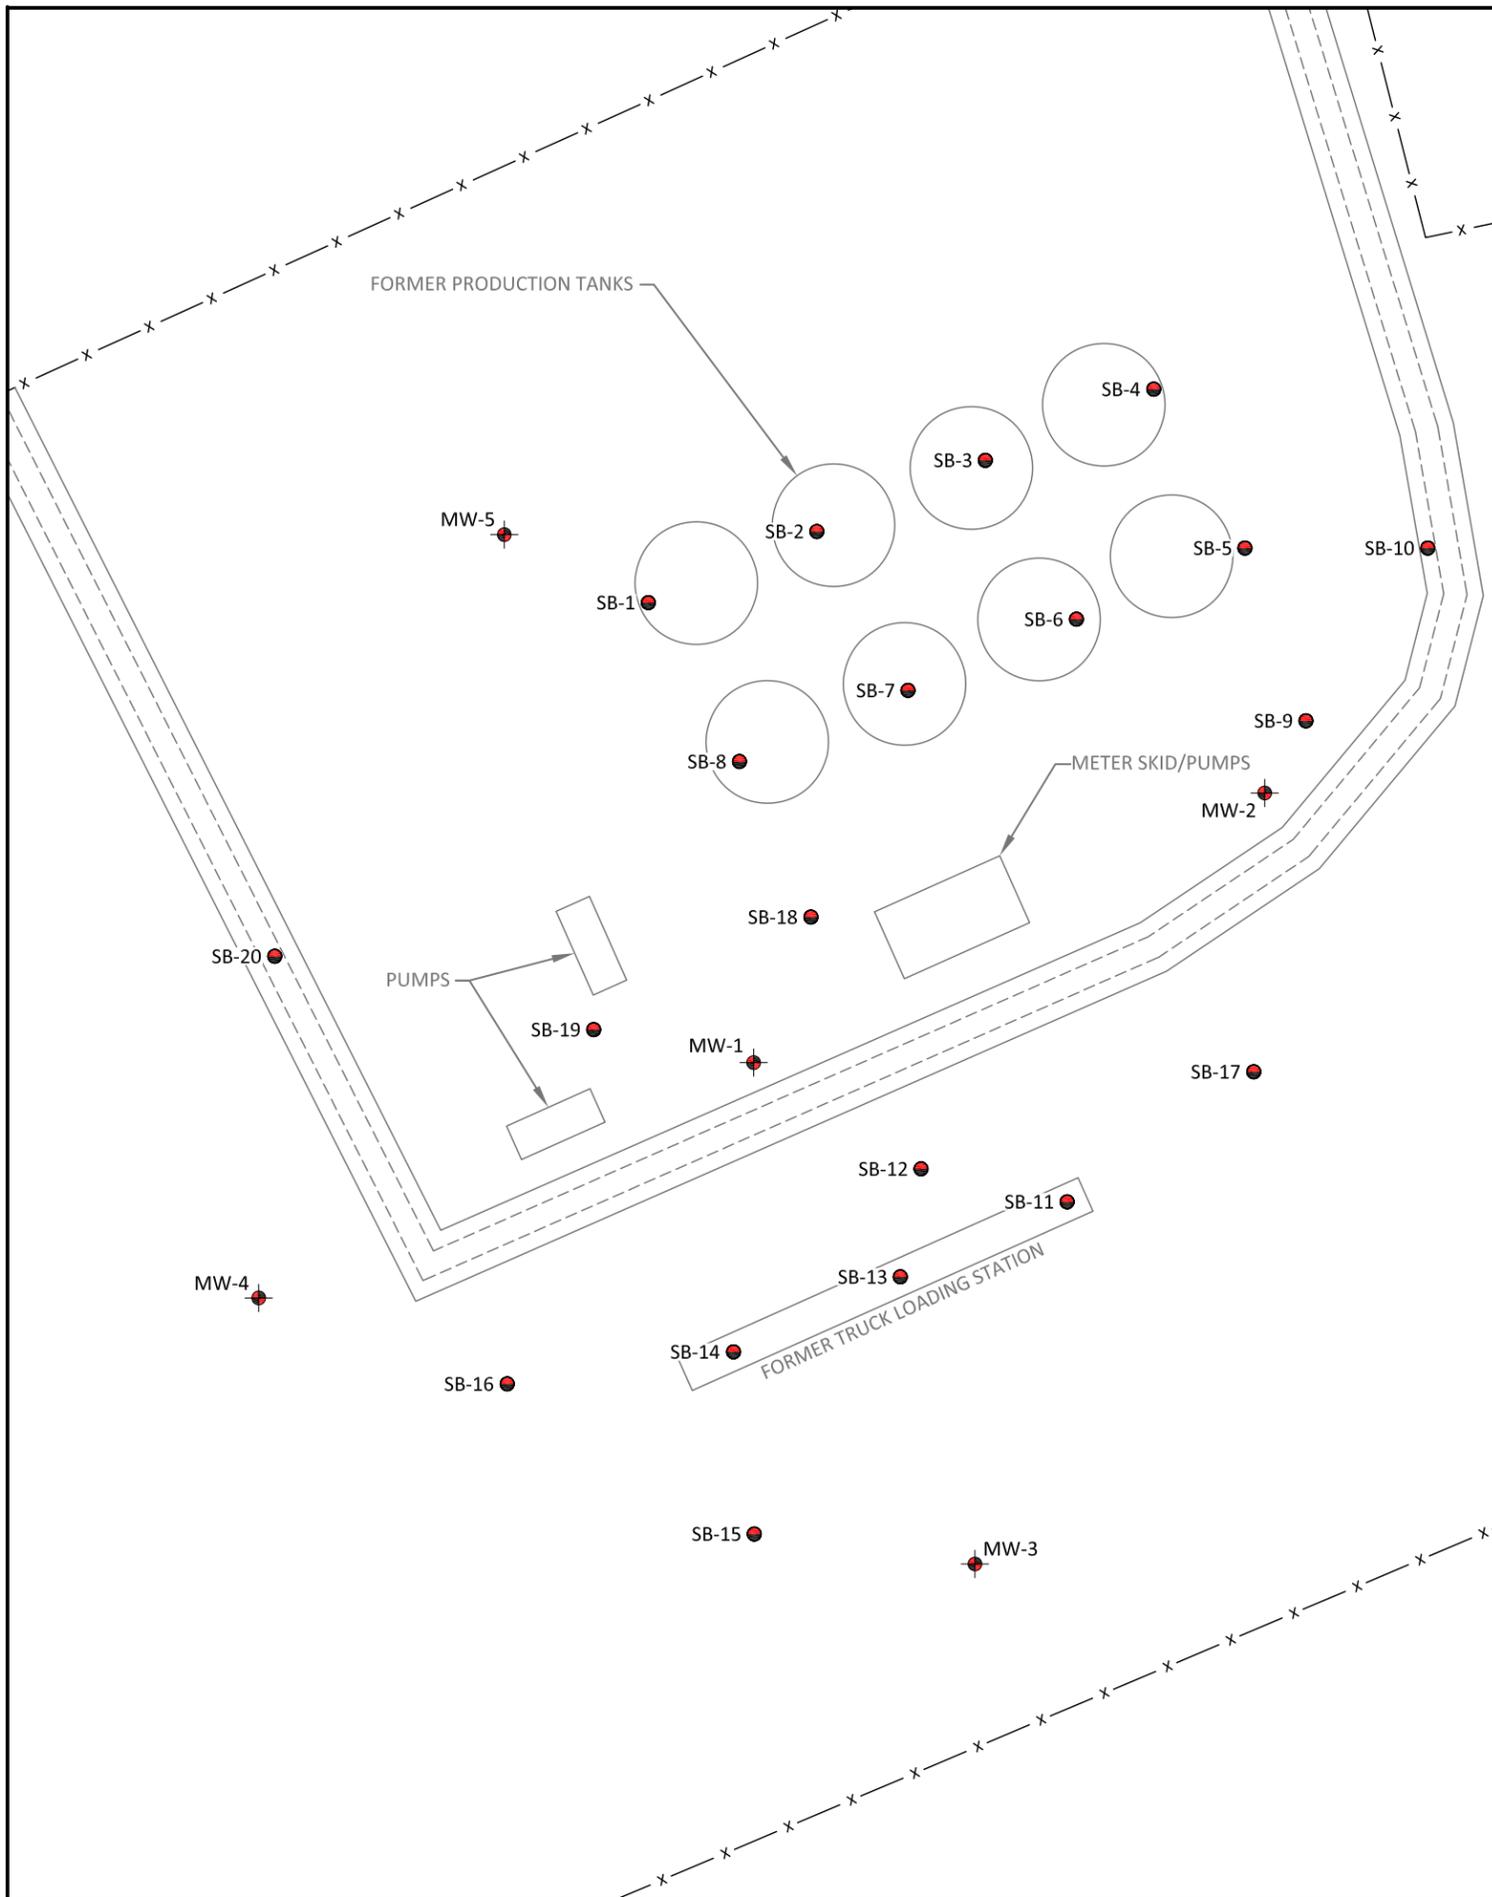
FIGURE 4

On June 4, 2014, a total of 59 discrete soil samples from 20 Geoprobe borings (SB-1 through SB-20) were collected as part of further investigating petroleum contaminated soils at the site. Soil borings were advanced to between 8 and 20 feet bgs to avoid intersecting the water table. Soil samples were field-screened for VOCs, and selected samples were also field-analyzed for TPH. One composite sample from the storage tank area collected during the June assessment was submitted for confirmation laboratory analysis. The soil boring locations are shown in Figure 4.

On June 4, 2014, assessment results for VOCs via OVM ranged from 0.0 ppm in SB-1, SB-2, SB-4, and SB-6 up to greater than 5,000 ppm in SB-11 through SB-14, SB-18, and SB-19. Field TPH concentrations ranged from 28.1 mg/kg in SB-1 up to greater than 2,500 mg/kg in SB-12 and SB-19. Results are included in Table 1 and on Figure 4. The AES Field Sampling Reports are included in the appendix.

Under the former tank area, the field screening results for VOCs via OVM ranged from 0.0 ppm in SB-1, SB-2, SB-4, and SB-6 up to 1,048 ppm in SB-5 (8 to 12 ft). With the exception of SB-5, VOC concentrations in the tank area borings were below the NMOCD action level of 100 ppm VOCs. Field TPH concentrations were also below the NMOCD action level of 100 mg/kg in all borings, with the exception of SB-5, in which the highest TPH concentration was noted at 225 mg/kg (12 to 16 ft bgs). The remaining intervals in SB-5 had TPH concentrations of 61.5 mg/kg (4 to 8 ft and 8 to 12 ft bgs) and 69.2 mg/kg (16 to 20 ft bgs). With the exception of SB-5, residual contaminant concentrations below the former tank area are below applicable NMOCD action levels for VOCs and TPH.

Under the former loading area, the field screening results for VOCs via OVM ranged from 0.3 in SB-15, SB-16, SB-17 and SB-20 up to greater than 5,000 ppm in SB-11 through SB-14, SB-18, and SB-19. Field TPH concentrations were also reported above the NMOCD action level of 100 mg/kg. Based on VOC and TPH concentrations, residual contaminants in subsurface soils are still present at the former truck loading station area and former pump area.

RELEASE ASSESSMENT SAMPLE LOCATIONS AND RESULTS, JUNE 2014

Laboratory Analytical Results					
Sample ID	Date	Benzene (mg/kg)	Total BTEX (mg/kg)	TPH - GRO (mg/kg)	TPH - DRO (mg/kg)
NMOCD ACTION LEVEL		10	50	100	
Tank Composite	6/4/14	<0.028	<0.14	<2.8	26
TANK COMPOSITE WAS A COMPOSITE SAMPLE OF SB-1 THROUGH SB-8 AT 4 TO 8 FEET.

Truck Loading Station Field Sampling Results				
Sample ID	Date	Depth (ft)	OVM-PID (ppm)	TPH (mg/kg)
NMOCD ACTION LEVEL			100	100
SB-11	6/4/14	4 to 8	>5,000	NA
		8 to 12	>5,000	NA
		12 to 16	>5,000	NA
		16 to 20	>5,000	692
SB-12	6/4/14	4 to 8	>5,000	NA
		8 to 12	>5,000	NA
		12 to 16	>5,000	NA
		16 to 20	>5,000	>2,500
SB-13	6/4/14	4 to 8	>5,000	NA
		8 to 12	>5,000	NA
		12 to 16	>5,000	NA
		16 to 20	>5,000	NA
SB-14	6/4/14	4 to 8	>5,000	NA
		8 to 12	2,800	NA
		12 to 16	23.6	41.0
		16 to 20	22.4	NA
SB-15	6/4/14	0 to 4	4.1	NA
		4 to 8	4.1	NA
		8 to 12	1.5	35.8
		16 to 20	0.3	NA
SB-16	6/4/14	0 to 4	0.3	NA
		4 to 8	1.2	NA
		8 to 12	3.2	NA
		16 to 20	0.3	NA
SB-17	6/4/14	0 to 4	55.9	NA
		4 to 8	3.5	NA
		8 to 12	4.5	NA
		16 to 20	13.2	NA
SB-18	6/4/14	0 to 4	1.3	NA
		4 to 8	96.1	NA
		8 to 12	>5,000	>2,500
		16 to 20	1.2	NA
SB-19	6/4/14	0 to 4	1.3	NA
		4 to 8	1.1	NA
		8 to 12	0.8	NA
		16 to 20	0.8	NA
SB-20	6/4/14	0 to 4	1.2	NA
		4 to 8	1.1	NA

Tank Field Sampling Results				
Sample ID	Date	Depth (ft)	OVM-PID (ppm)	TPH (mg/kg)
NMOCD ACTION LEVEL			100	100
SB-1	6/4/14	4 to 8	0.7	35.8
		8 to 12	0.0	35.8
		12 to 16	0.1	28.1
SB-2	6/4/14	4 to 8	0.0	35.4
		8 to 12	0.0	NA
SB-3	6/4/14	4 to 8	0.1	41.0
		8 to 12	0.3	NA
SB-4	6/4/14	4 to 8	0.1	76.9
		8 to 12	0.0	NA
SB-5	6/4/14	4 to 8	102	61.5
		8 to 12	1,048	61.5
		12 to 16	NA	225
SB-6	6/4/14	4 to 8	0.9	43.5
		8 to 12	0.2	NA
		12 to 16	0.0	44.8
SB-7	6/4/14	4 to 8	20.6	55.1
		8 to 12	10.9	35.8
SB-8	6/4/14	4 to 8	33.4	89.8
		8 to 12	10.4	34.6
SB-9	6/4/14	4 to 8	0.3	NA
		8 to 12	0.3	NA
		12 to 16	1.9	44.8
SB-10	6/4/14	4 to 8	1.4	NA
		8 to 12	2.3	NA
		12 to 16	2.2	41.0

In an effort to expedite remediation of residual vapors, soil concentrations and free product at the site, AES installed a Remediation Service International (RSI) mobile extraction and treatment system on August 4, 2014. The RSI unit is currently extracting from existing MW-1, which is located in the area between the former pumps and loading station.

AES recommends running the RSI unit on a bi-weekly basis until December 2014 and then taking the unit off-line during the winter months. Results of the MPE system operations will be summarized in the Periodic Progress Report 4th Quarter 2014. Additionally, AES is currently reviewing options to continue remediation during winter months.

Additional site characterization of the lateral and vertical extent of impacted soils in the former truck loading station area (beyond the site characterization work completed in 2009) is also recommended.
