# 2017 Annual Groundwater Monitoring Report

Flora Vista No. 1

Hilcorp Energy Company

11145982| MN00| Report No 1 | January 11, 2018

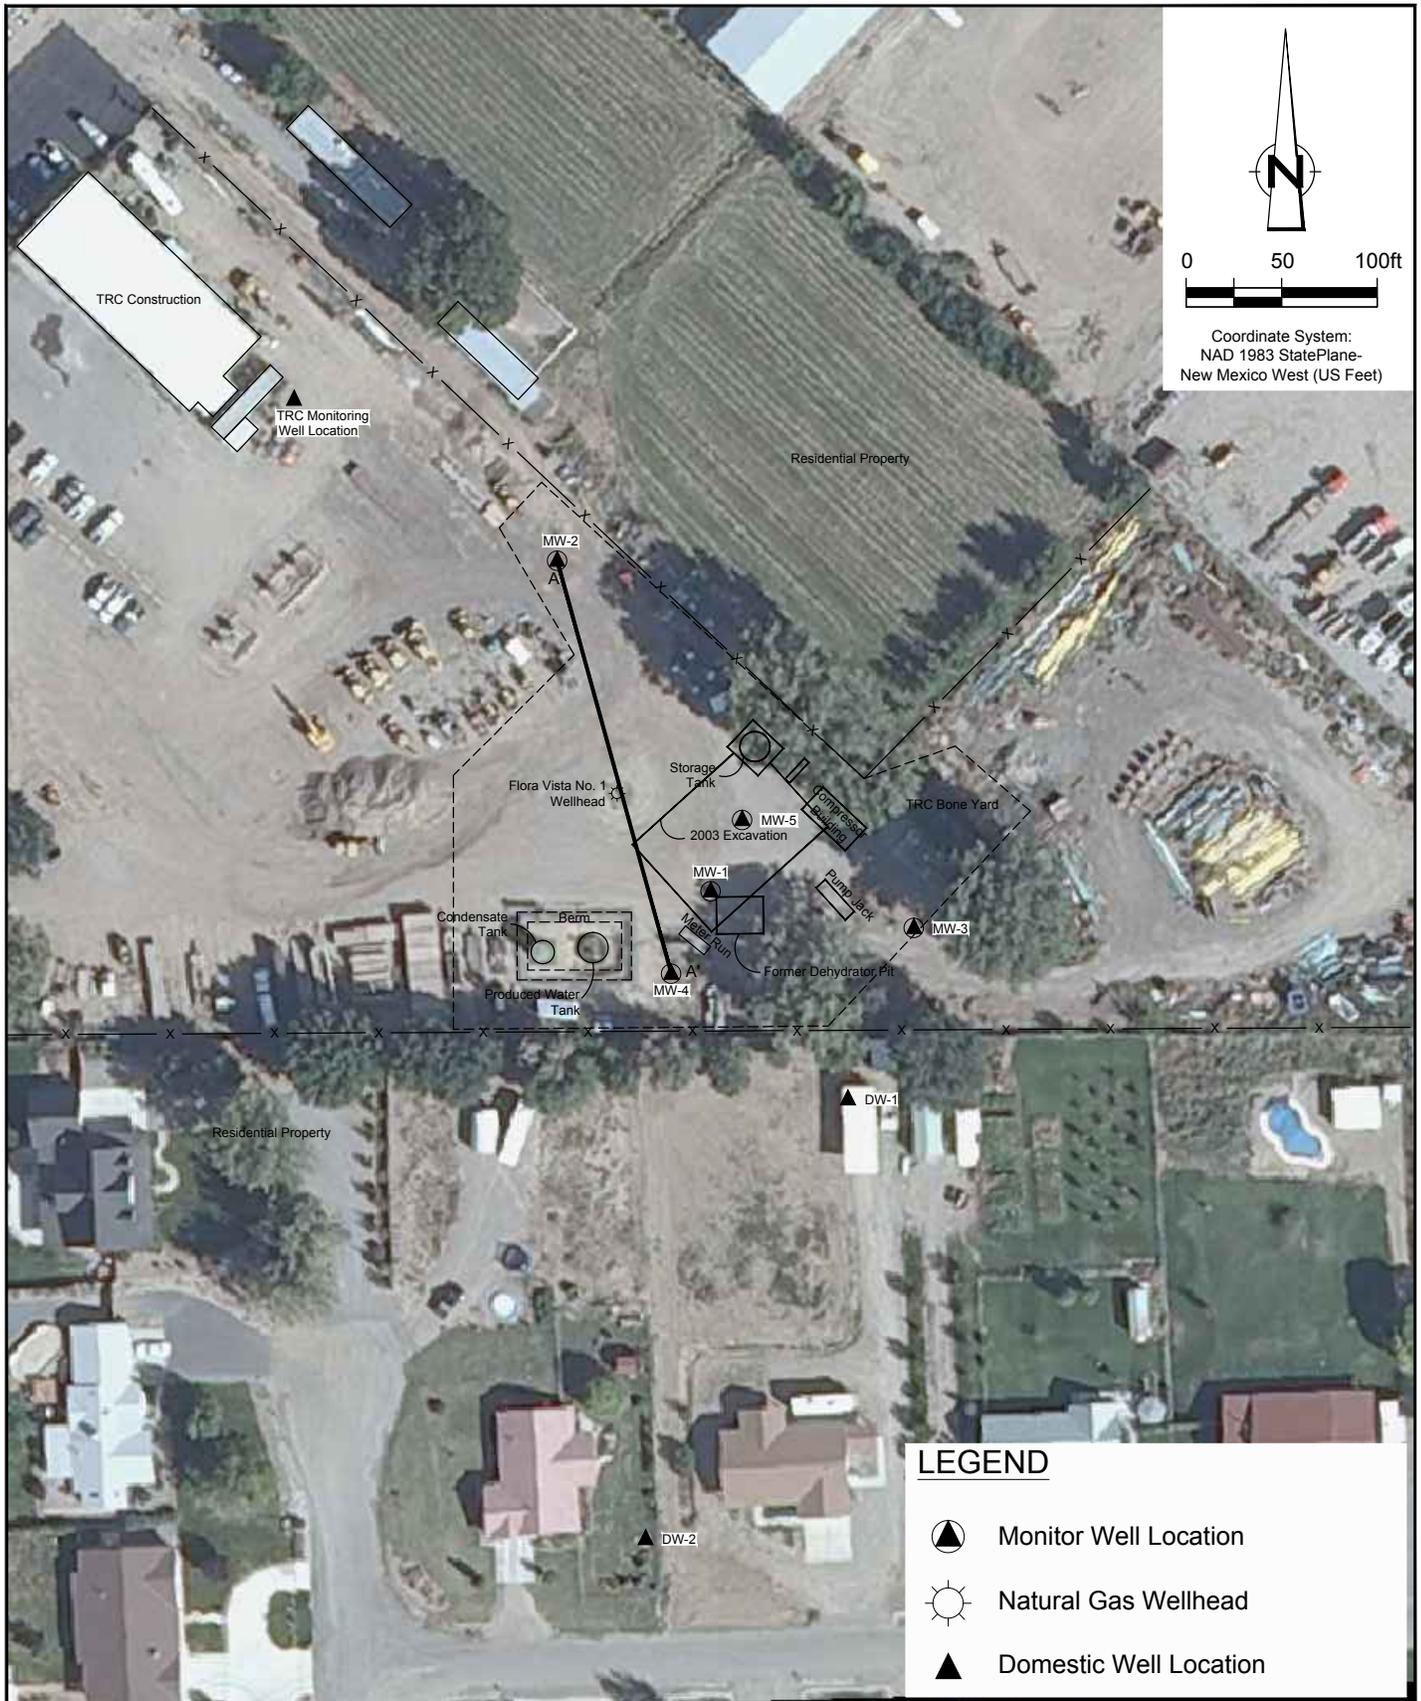
FIGURE 2

SITE PLAN

This annual report presents the results of the quarterly groundwater monitor events conducted by GHD Services, Inc. (GHD) during 2017 at the Flora Vista No. 1 natural gas well site (hereafter referred to as the "Site"). The Site is operated by Hilcorp Energy Company after their acquisition of ConocoPhillips Company (ConocoPhillips) San Juan Basin assets in spring of 2017. The Site is located on private property in Unit Letter F, Section 22, Township 30N, Range 12W, of San Juan County, New Mexico (Figure 1). The Site consists of a gas well and associated equipment and installations. A detailed Site Plan is provided as Figure 2.

In September 2003, Envirotech installed a groundwater monitor well (MW-1) slightly down gradient from the center of the excavation (Figure 2). Subsequent groundwater sampling included analyses for benzene, toluene, ethylbenzene, and total xylenes (BTEX), as well as total petroleum hydrocarbons (TPH). Analytical results indicated the presence of benzene and total xylenes above regulatory standards. Monitor wells MW-2, MW-3, and MW-4 were installed at the Site in August 2008 in response to an April 2008 request from NMOCD for Site characterization and additional laboratory analyses. Monitor well MW-5 was installed in September 2015 to assess soil and groundwater impacts upgradient from MW-1 and to ascertain whether or not storage tanks north of this location were a potential source of groundwater impacts. A generalized geologic cross section was prepared using boring logs from the August 2008 monitoring well installation and is presented as Figure 3.

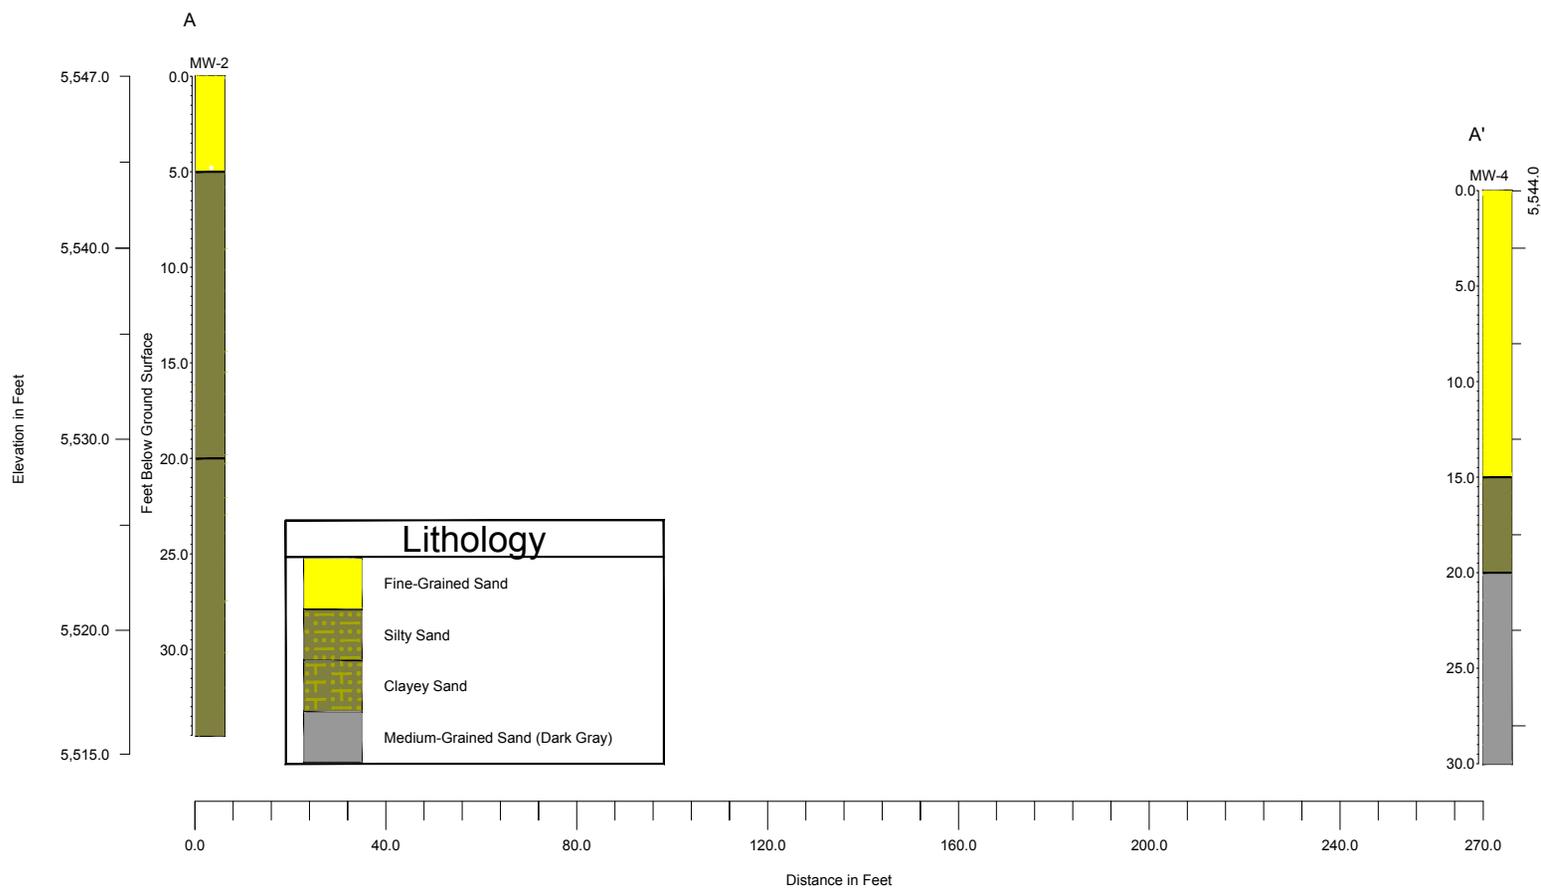
FIGURE 3

Flora Vista No. 1 - Cross-Section A-A'

GEOLOGICAL CROSS SECTION

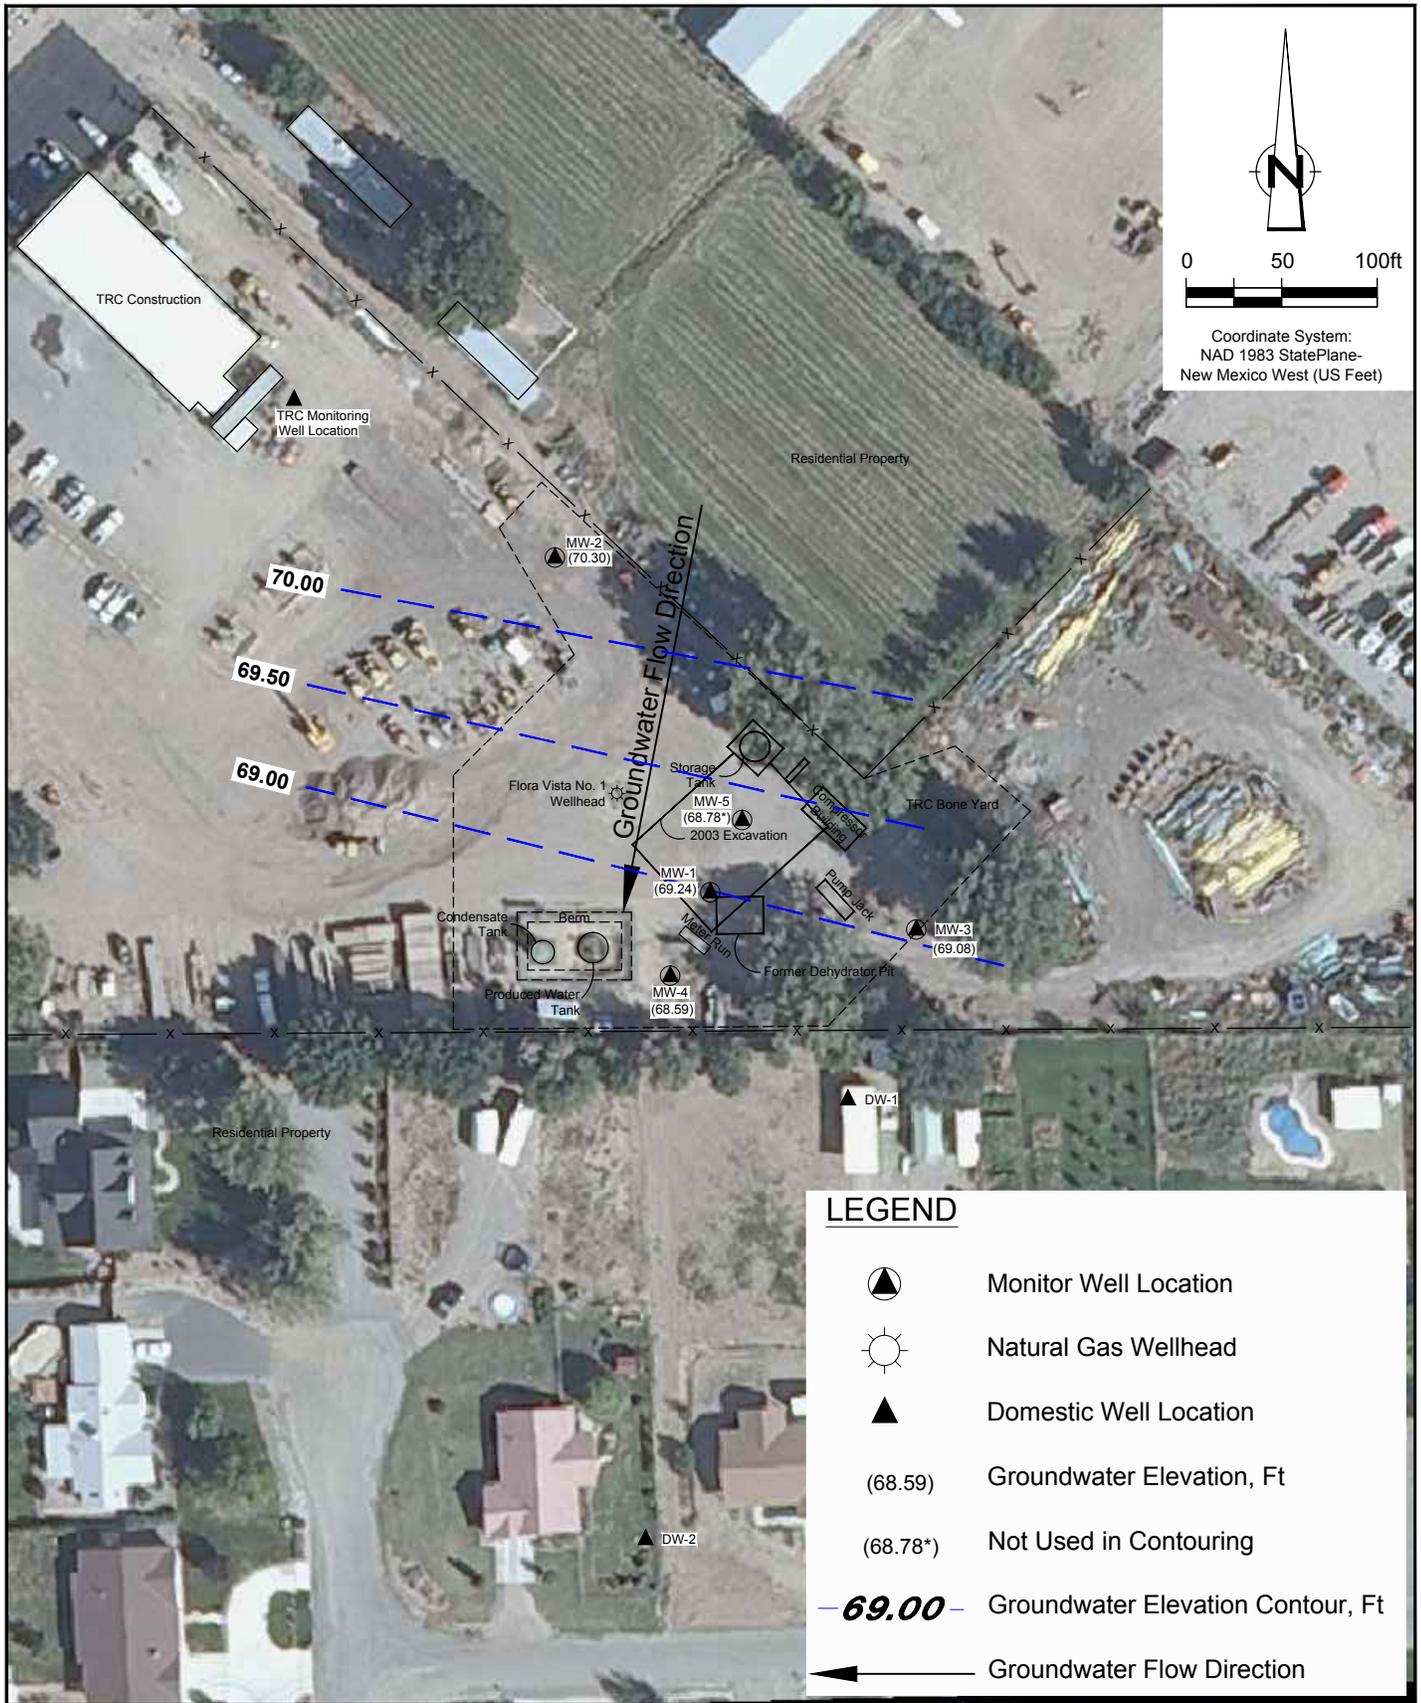
FIGURE 4

MARCH 2017

GROUNDWATER POTENTIOMETRIC SURFACE MAP

Quarterly groundwater monitoring was conducted at the Site on March 7, June 15, September 27, and December 5, 2017. Groundwater elevation measurements were recorded in all accessible Site monitor wells using an oil/water interface probe. Some monitor wells were inaccessible due to either being covered with construction materials or being under standing water from recent rains. Groundwater elevations are detailed in Table 2. Groundwater potentiometric surface maps created from 2017 data are presented as Figures 4, 5, and 6. A map for the September sampling event was not generated due to insufficient data. Groundwater flow fluctuates from southwest to southeast seasonally and is consistent with historical data.

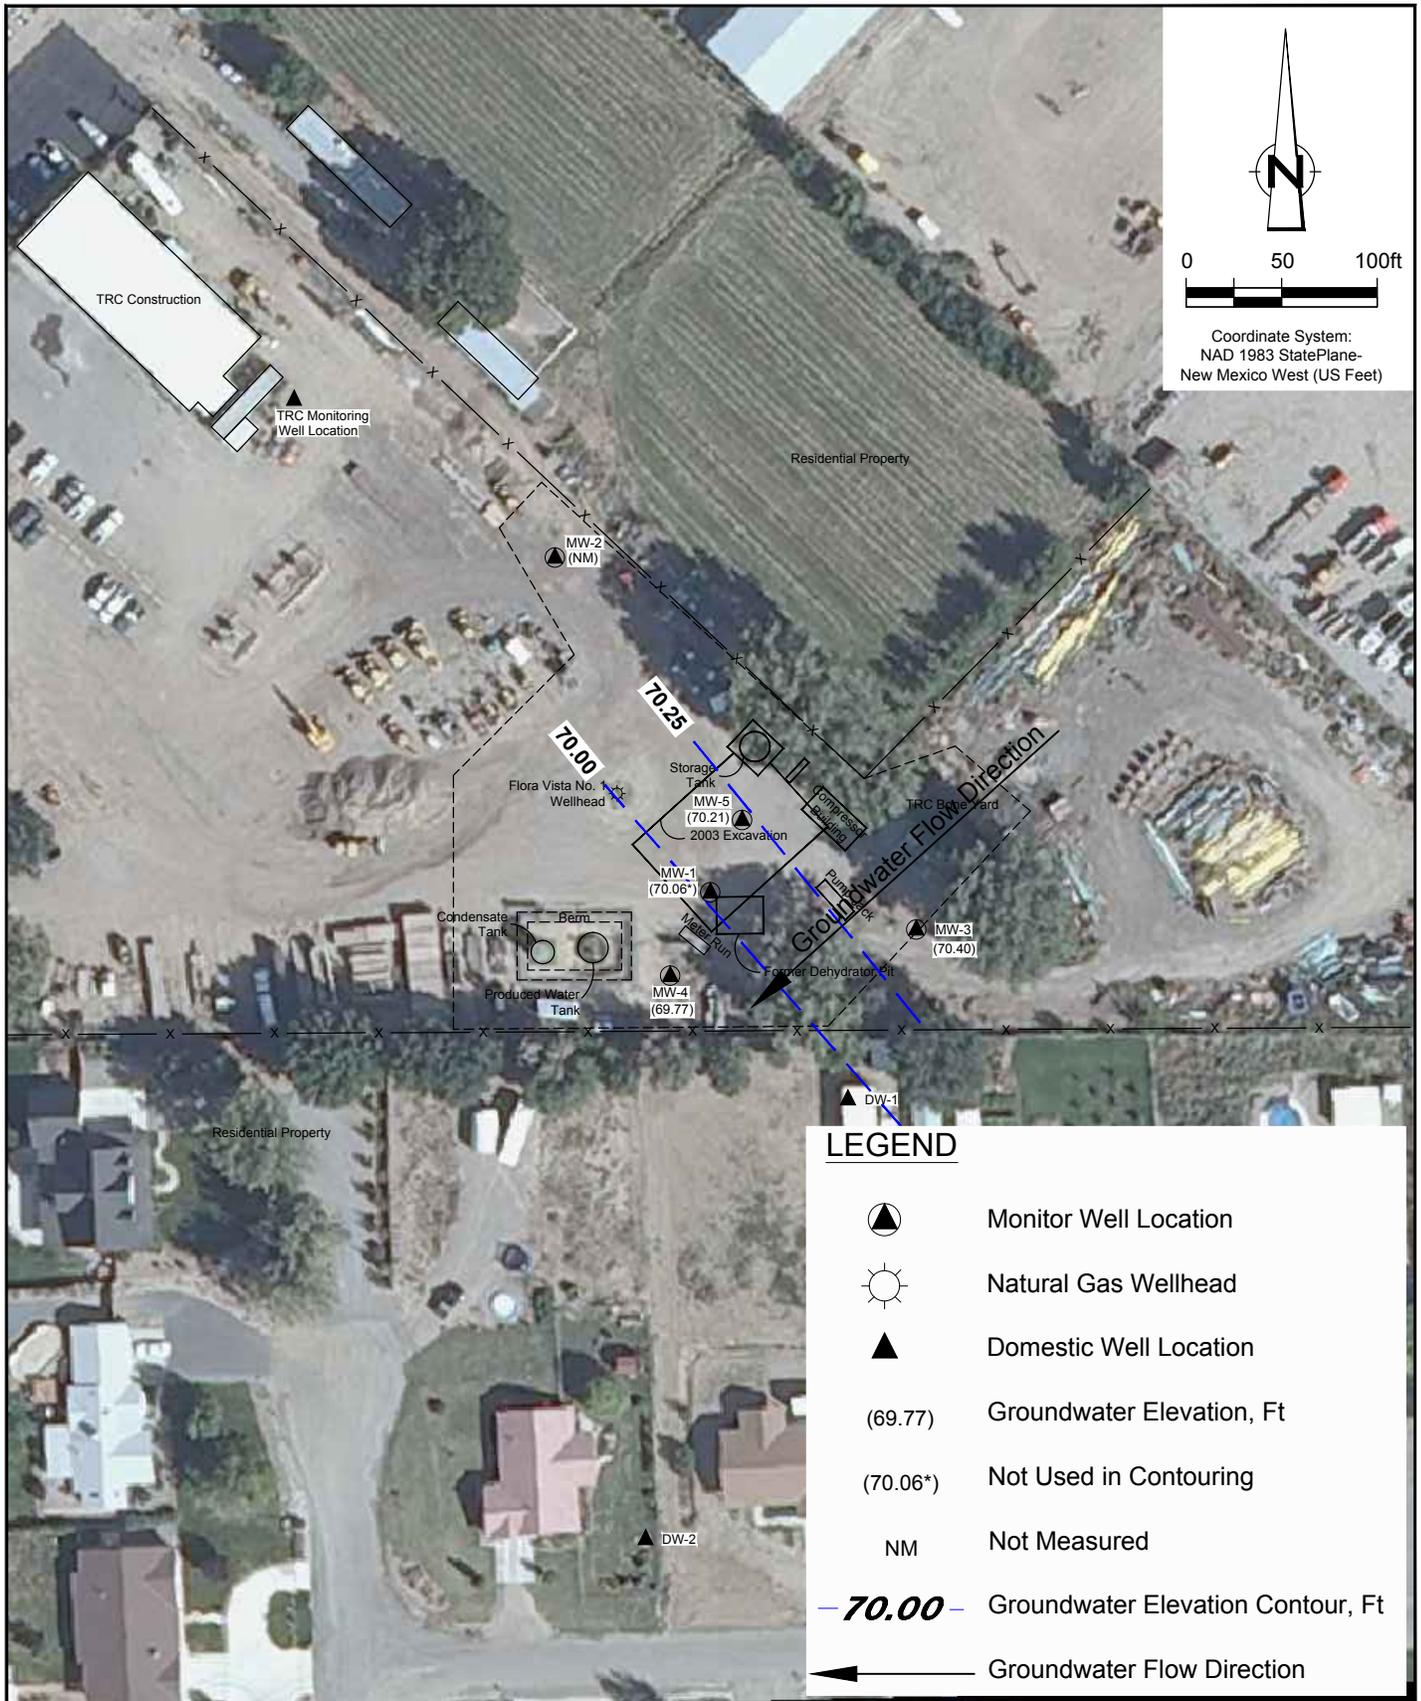
FIGURE 5

JUNE 2017

GROUNDWATER POTENTIOMETRIC SURFACE MAP

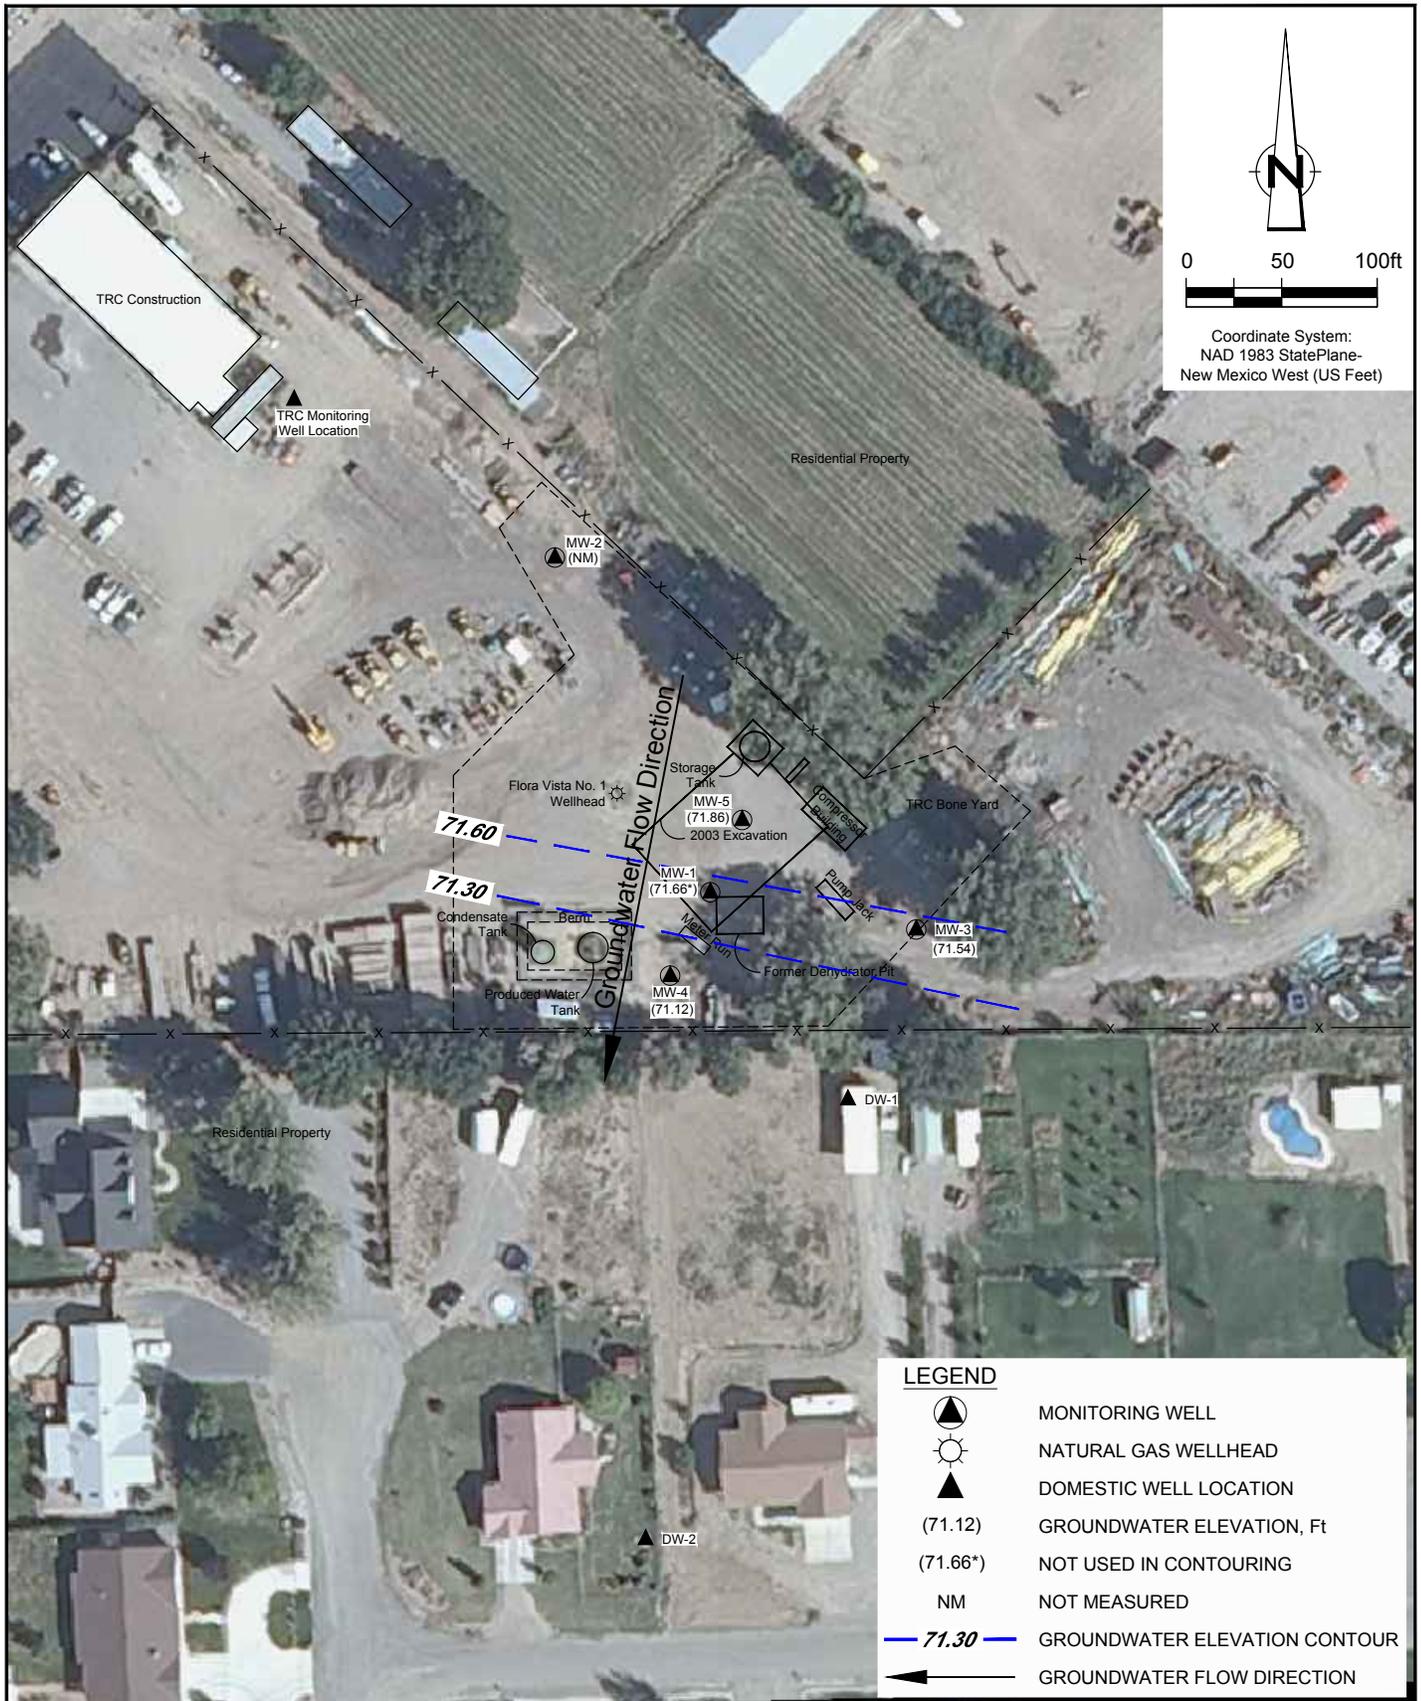
FIGURE 6

HILCORP ENERGY COMPANY  
 SECTION 22, T30N-R12W, SAN JUAN COUNTY, NEW MEXICO  
 FLORA VISTA NO. 1 NATURAL GAS WELL SITE  
 DECEMBER 2017  
 GROUNDWATER POTENTIOMETRIC SURFACE MAP

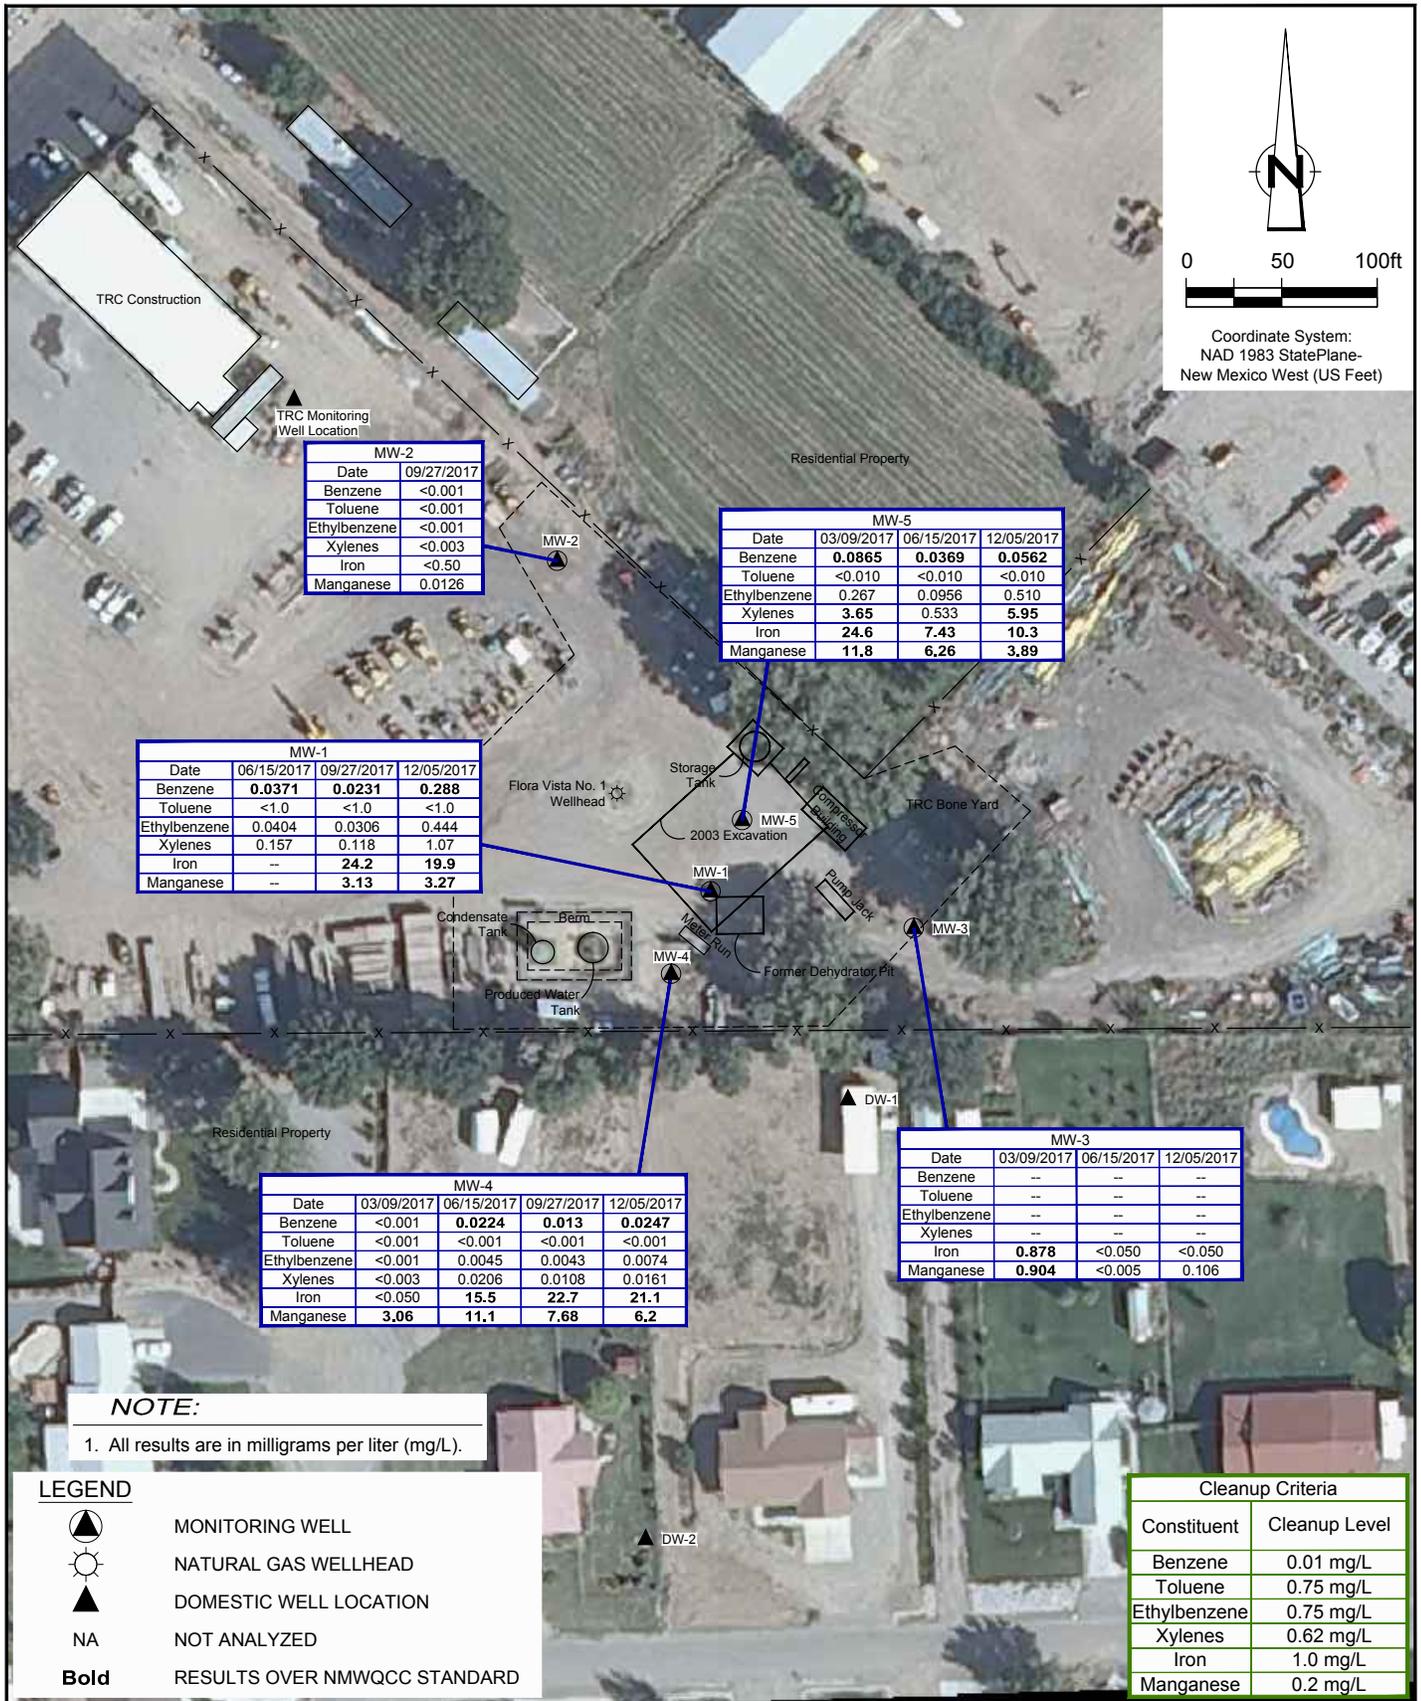
FIGURE 7

2017 CONTAMINANT CONCENTRATION MAP

A contaminant concentration map for 2017 quarterly groundwater monitor events is presented on Figure 7. A summary of the historical groundwater laboratory analytical results is presented in Table 4. The 2017 laboratory analytical reports are included in Appendix C.
