Subject: Marker Oil

Director Catanach and I visited the Rose #2 (30-025-28772) well operated by Marker Oil on the afternoon of February 25th while in the area on other business. When we approached the location there were numerous cattle (bulls, cows, and calves) in the immediate area. You already have the photographs I took at the time. There was no fencing around the bermed area east of the wellhead which contained two tanks and a heater treater. Crude oil filled a significant portion of the bermed area. I stepped off the approximate size of the berm (19 x 14 paces) which had approximately 2 inches of oil across more than one-half of the overall footprint. That would provide an estimated fluid volume as follows:

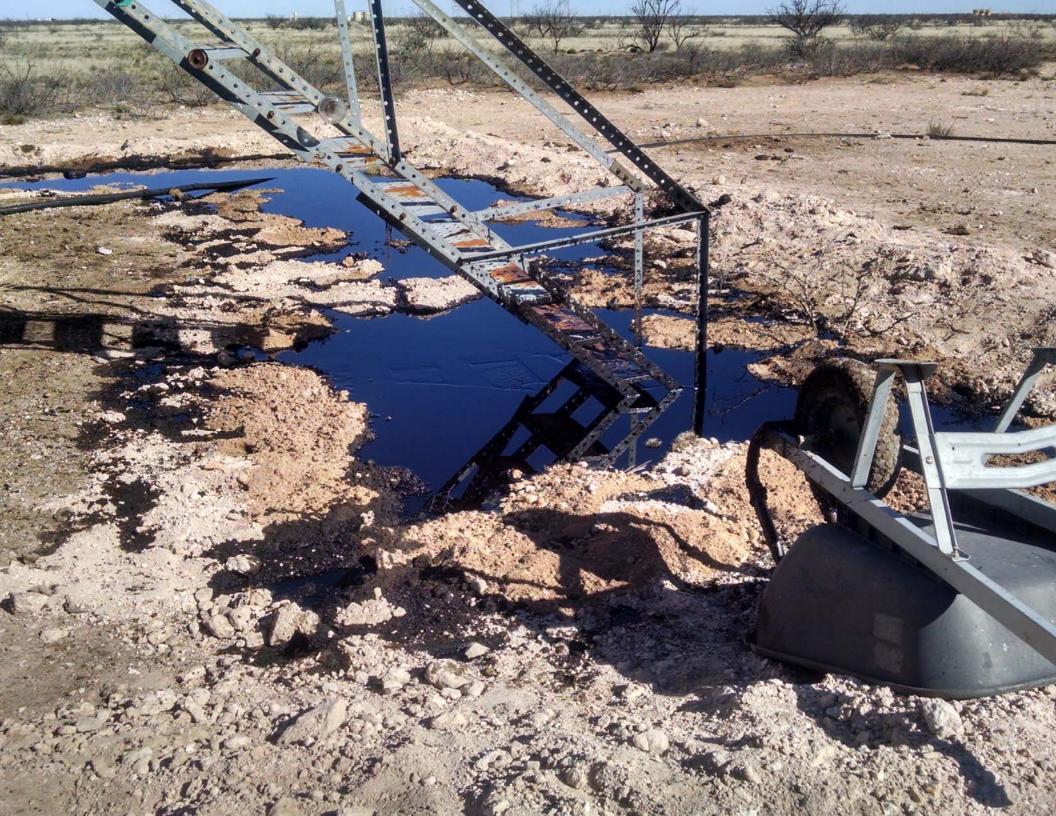
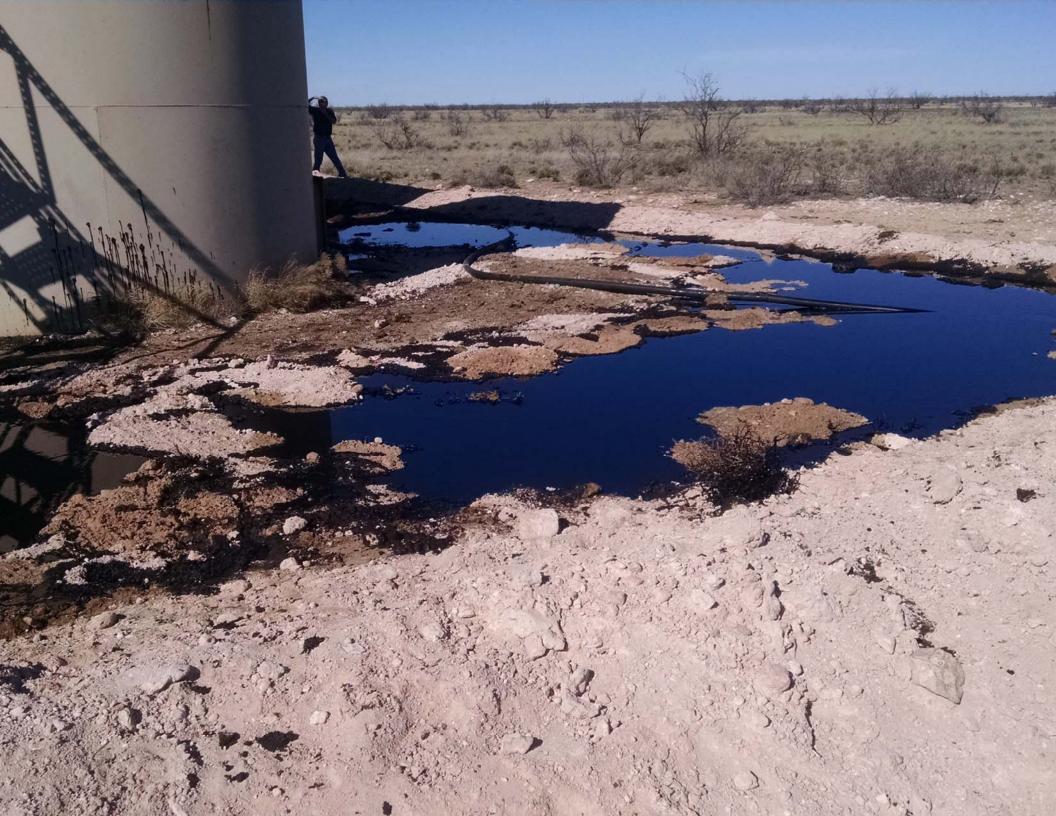
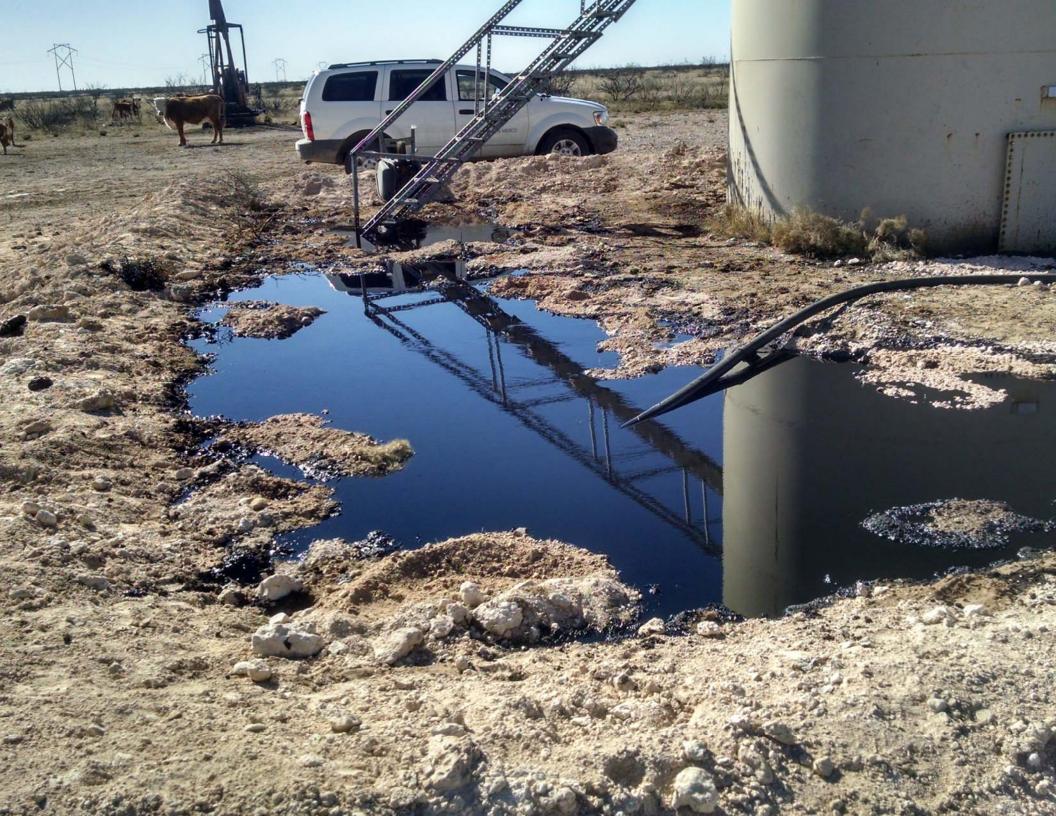
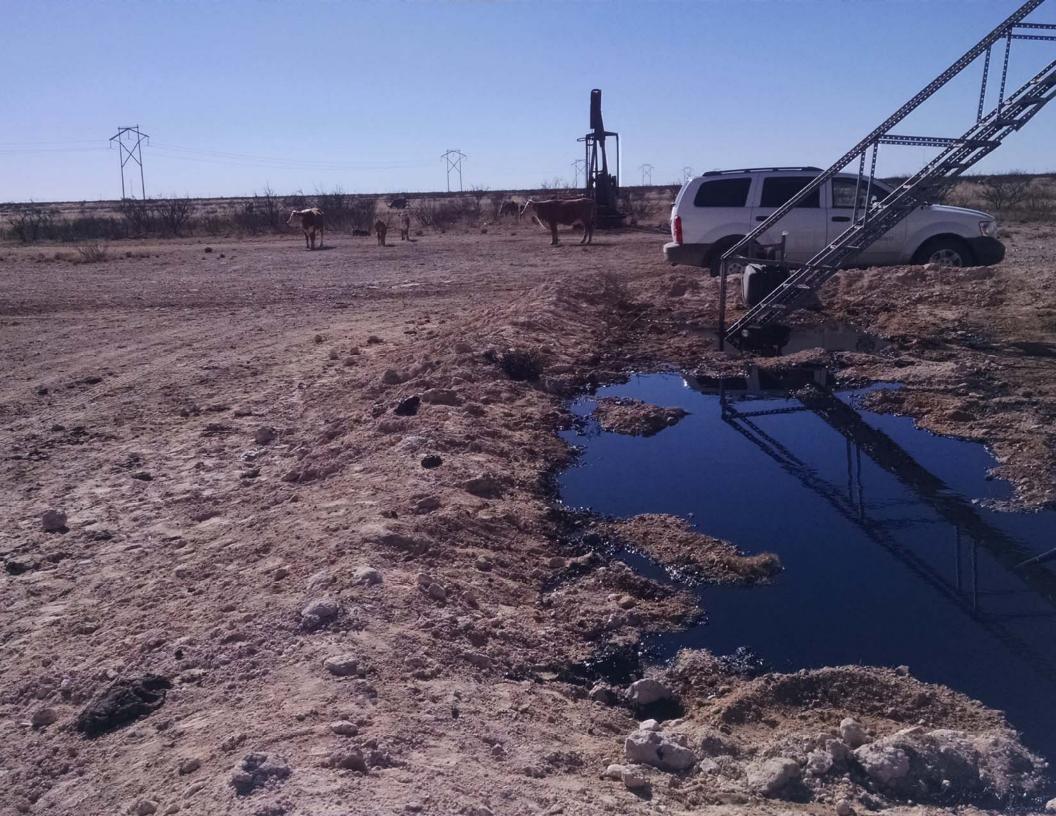
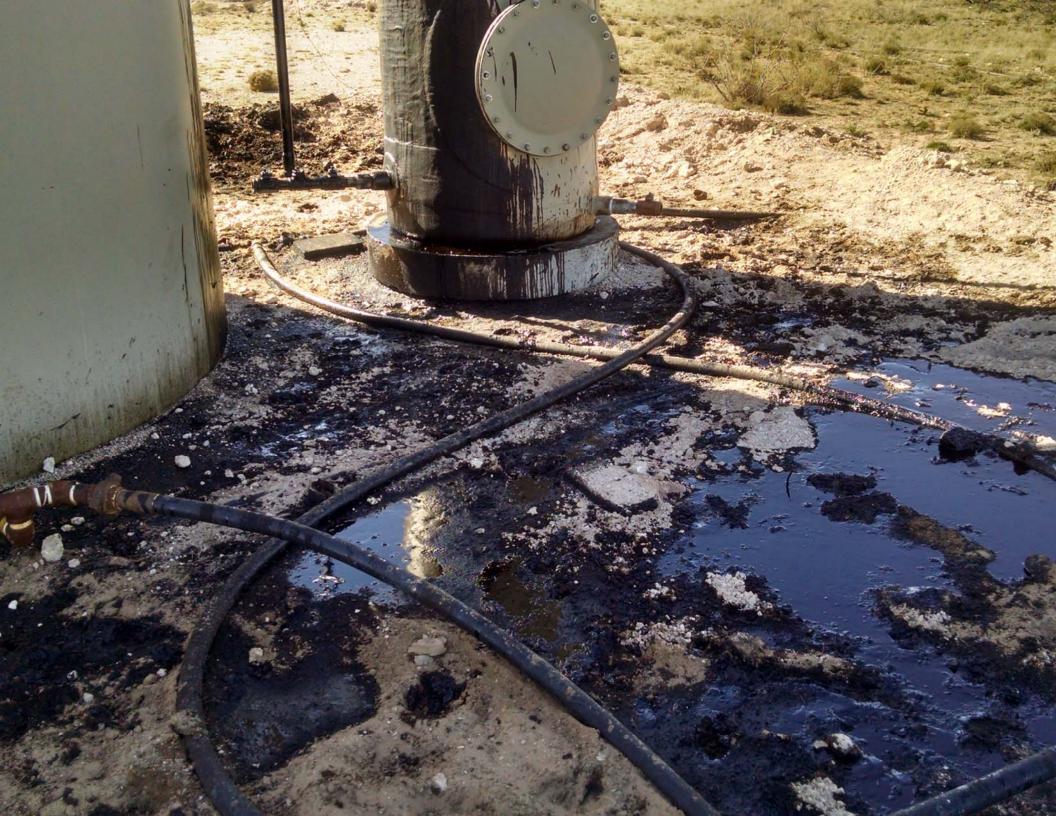
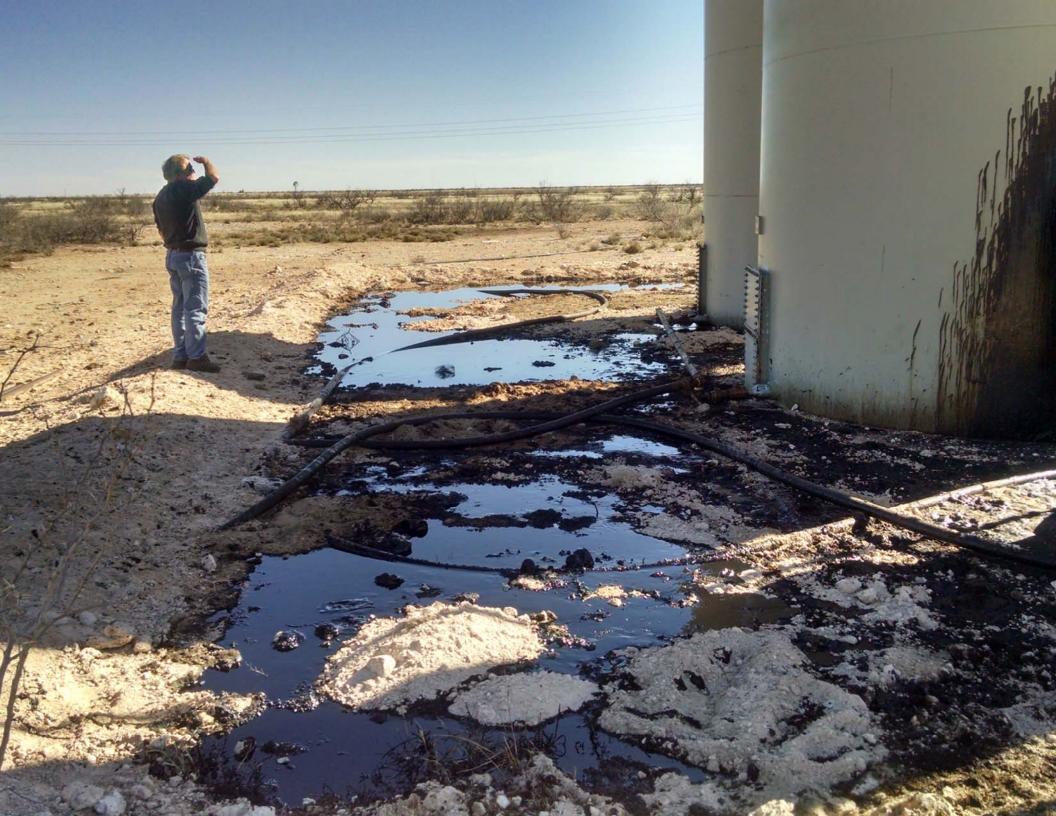
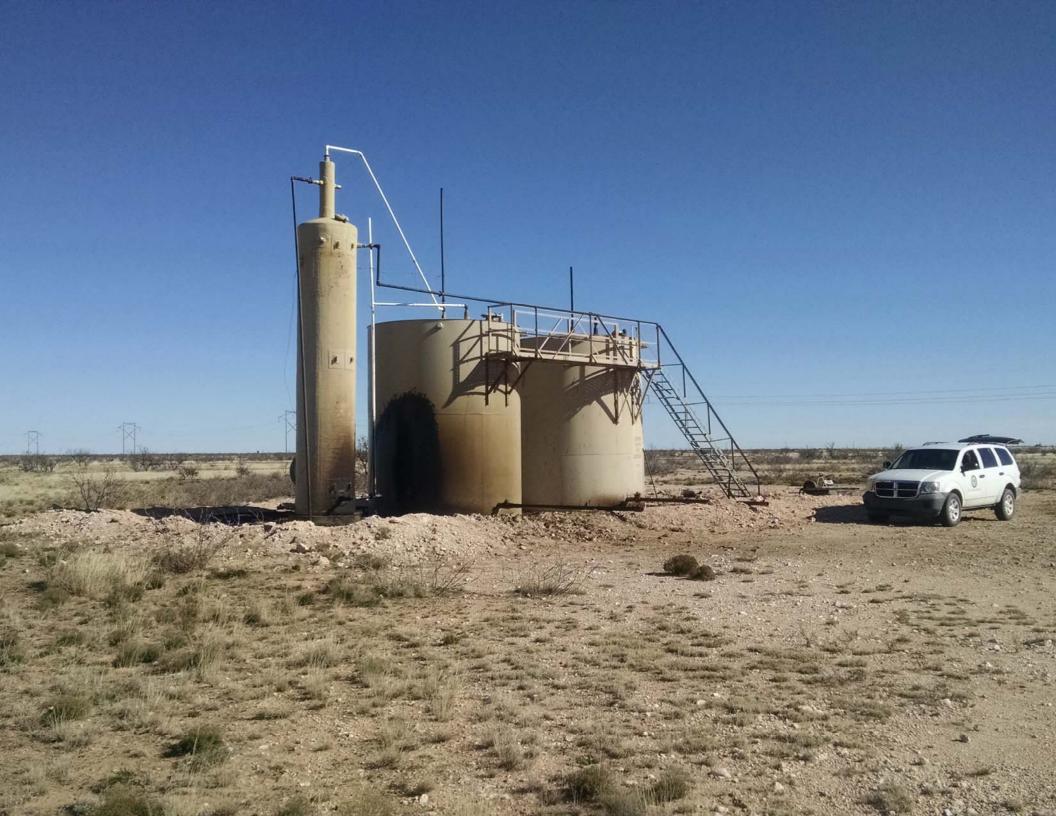
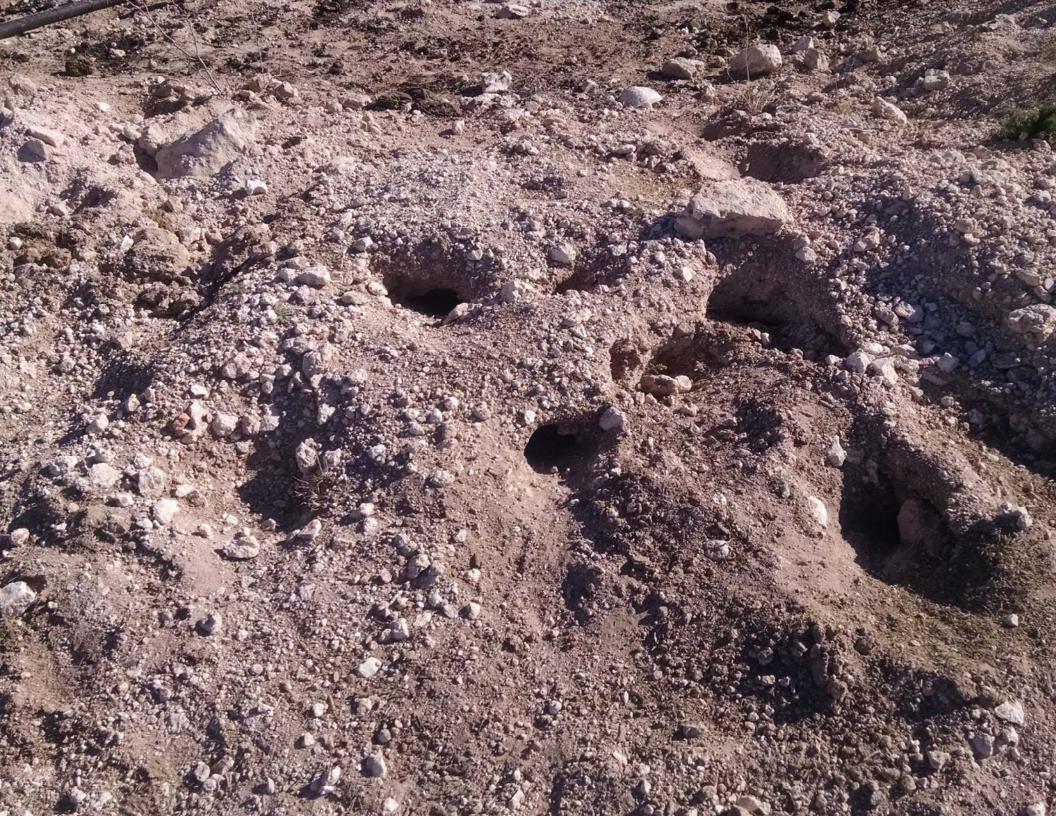
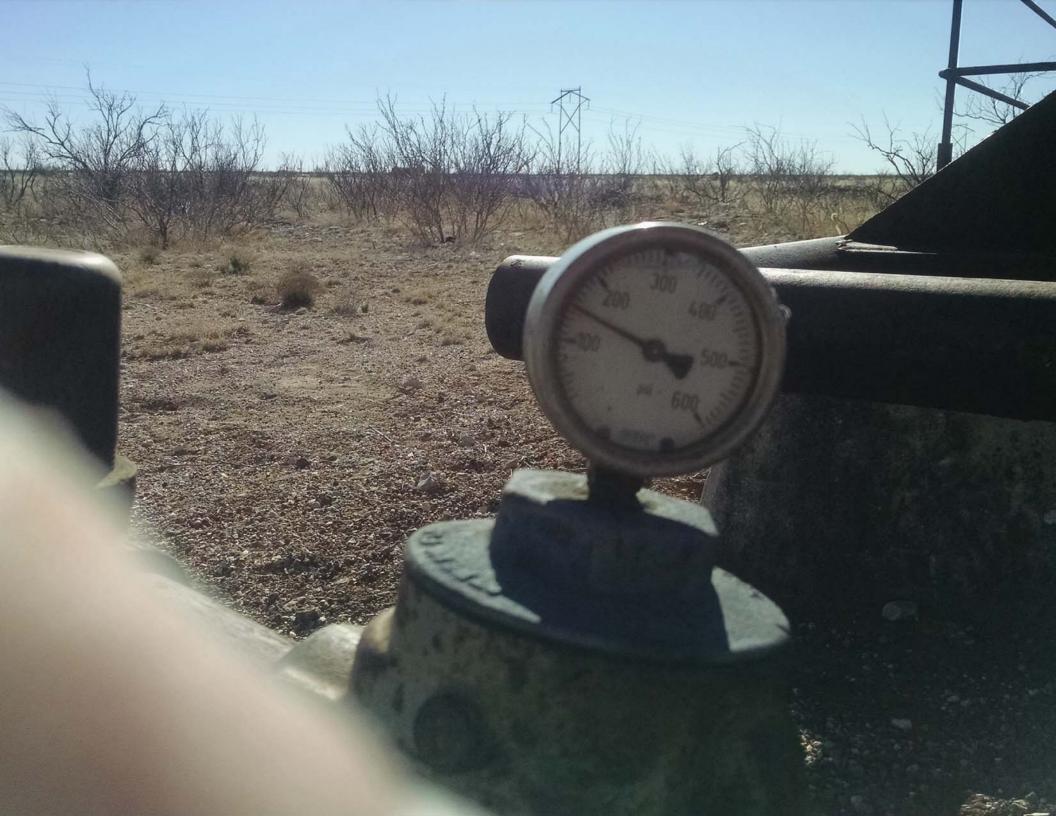
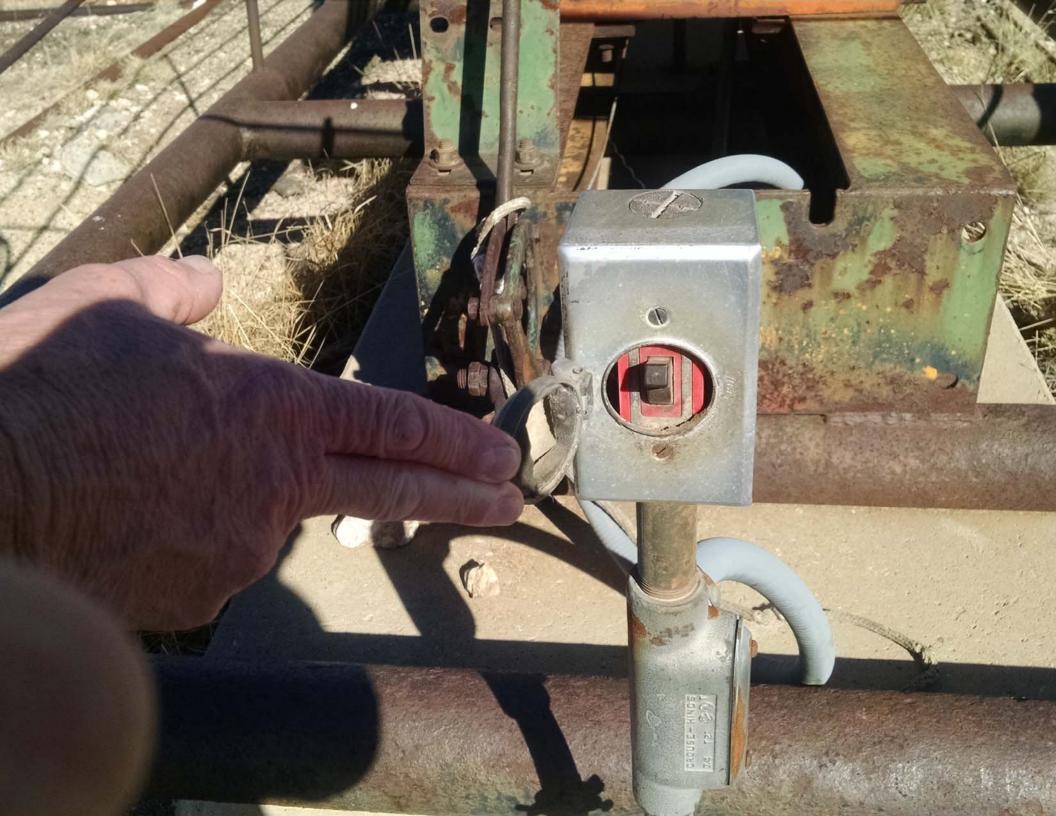
19 paces at 3 feet per pace = 57 feet 14 paces = 42 feet 2 inches = 0.1667 feet Total volume within berm = 57 x 42 x 0.1667 x 0.5 = 199.5 cubic feet = 1492.8 gallons = 35.5 barrels

This does not include any liquid which has soaked into the underlying soils. There was a wheelbarrow and rake onsite. It appeared that someone was placing caliche into the berm rather than attempting to pump out the free liquid. Electrical power to the pumpjack appeared to shut off.

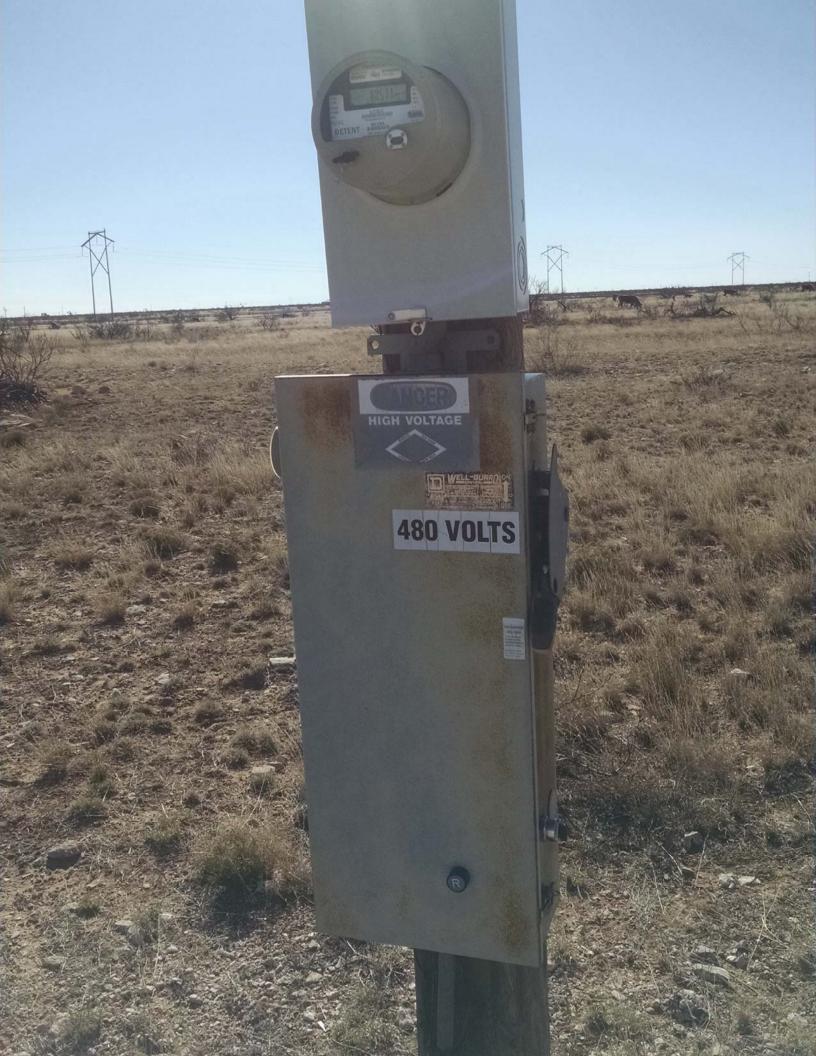
2/25/14 Mercher Oil Rose # 2 30-025-28772 N-5-185-34E 2:45 PM there trester 19 peces x 14 peces x 2" deep
