**Re: Site Assessment Report  
Vaca Line Strike  
1RP-5243  
EOG Resources, Inc.  
Site Location: Unit A, Sec. 36, T 24-S, R 33-E  
(Lat 32.180794°, Long -103.518761°)  
Lea County, New Mexico**

At the request of EOG Resources, Inc. (EOG), New Tech Global Environmental, LLC (NTGE) has prepared this letter to document assessment activities following a release at the Vaca Line Strike (Site). The Site is an active produced water line at the intersection of Vaca Lane and Resource Lane within Unit C, Section 36, Township 24 South, Range 33 East, approximately 19.6 miles northwest of Jal, New Mexico (Figures 1 and 2).

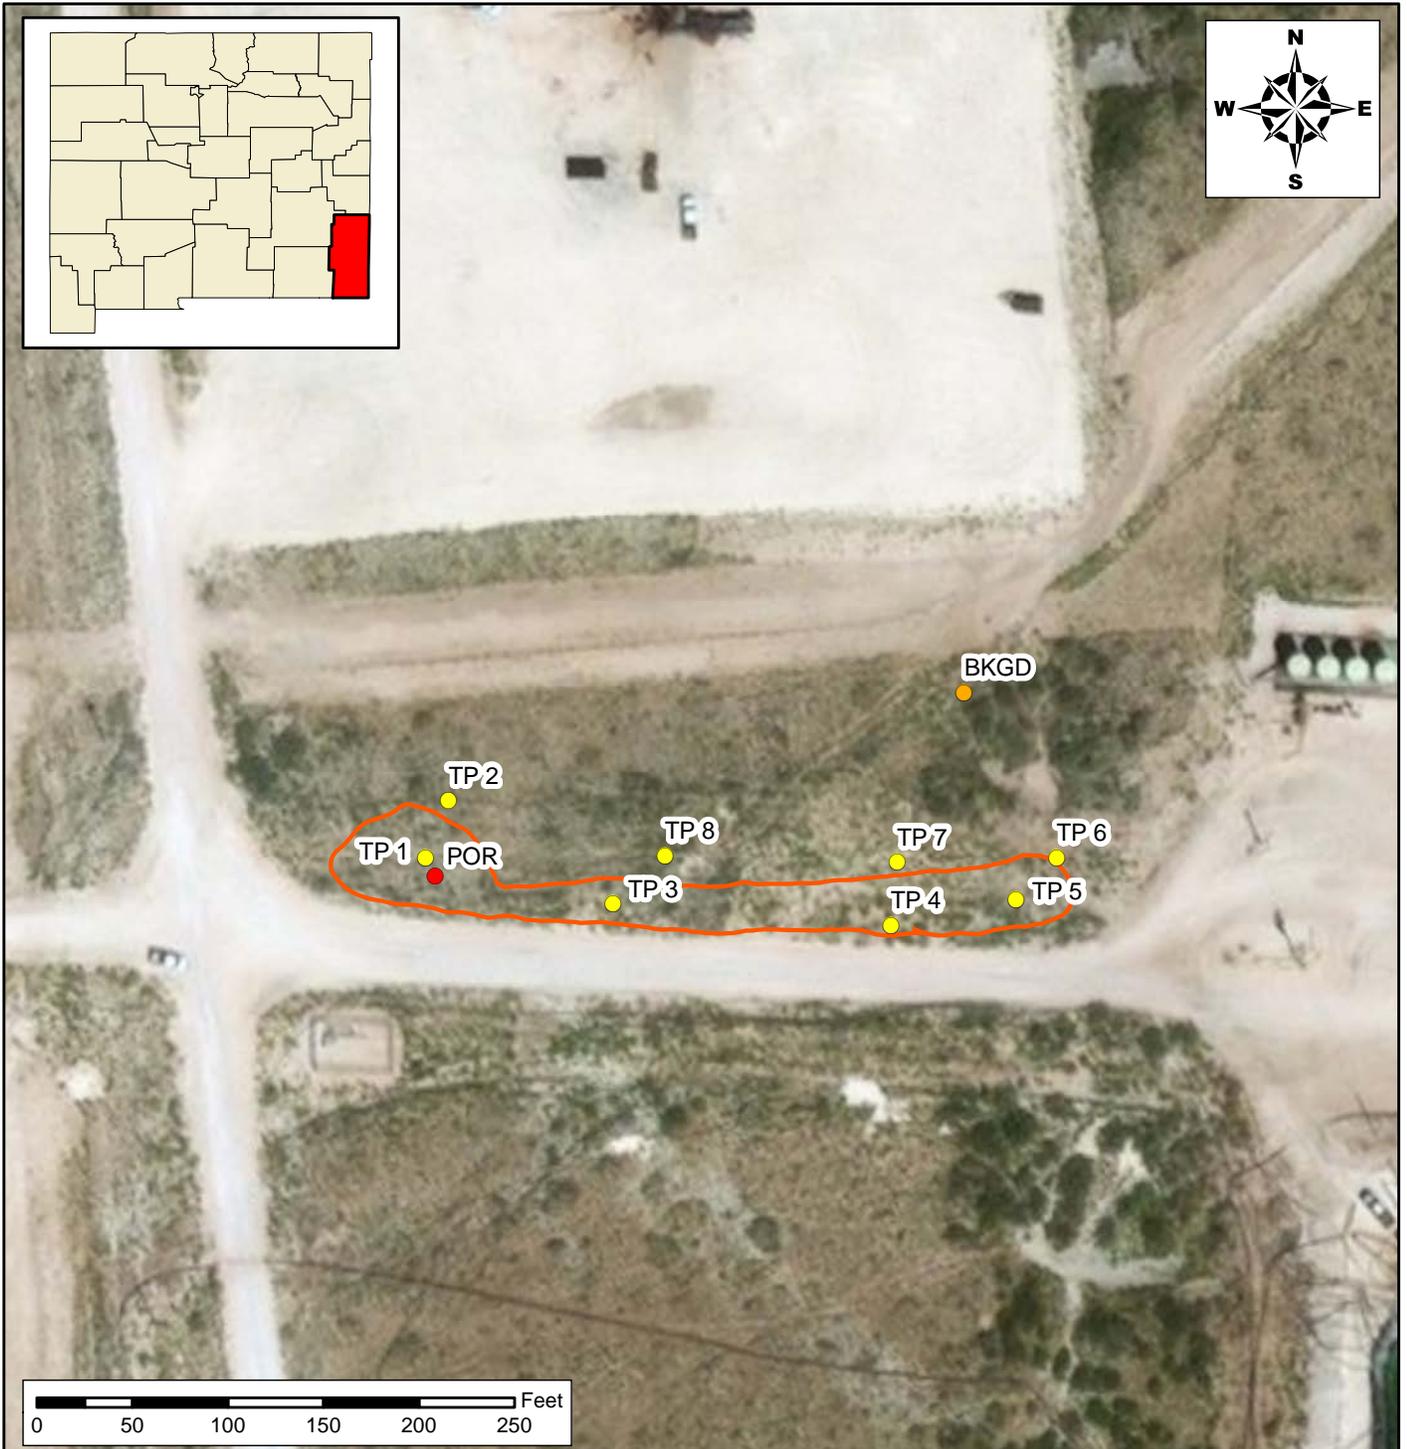
DRAWING NUMBER:  
**FIGURE 3**  
 SHEET NUMBER:  
**1 of 1**

Personnel on site initiated response actions by constructing earthen berms to contain the release. The pipeline flow was stopped and a vacuum truck was used to recover fluids. The amount of fluids recovered was estimated to be 55 bbls. The spill trajectory is illustrated on Figure 3, attached.

Chloride Concentrations (mg/kg) at Test Pit Locations										
Depth (ft)	TP1	TP2	TP3	TP4	TP5	TP6	TP7	TP8	BKGD	Regulatory Limit
0	---	<4.98	---	---	<4.99	<4.99	<4.99	<4.99	---	650 <sup>A</sup>
1	---	---	---	---	---	---	---	---	<4.99	
2	3100	---	287	---	---	---	---	---	---	
3	---	---	---	715	---	---	---	---	<4.97	
4	---	---	706	---	---	---	---	---	---	
5	48.4	13.3	---	140	<4.98	55.8	58.8	41.6	<5.00

- Background Sample
- Point of Release
- Test Pit
- Spill Trajectory

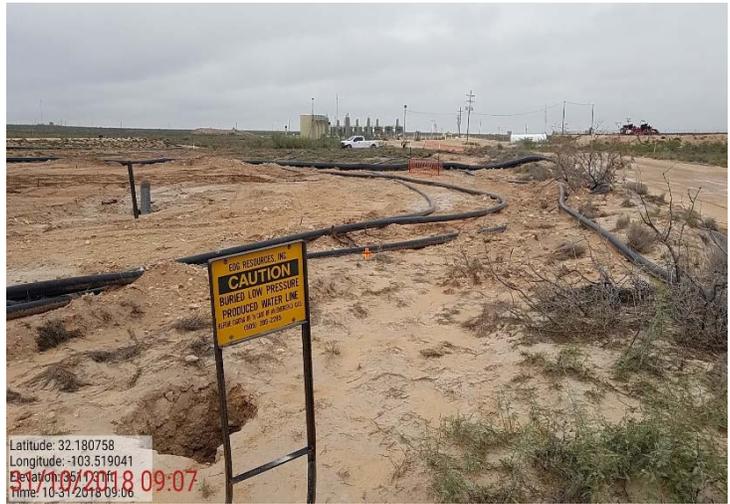
### Photograph No. 1

View of spill trajectory looking east. Note Resource Lane to the south.

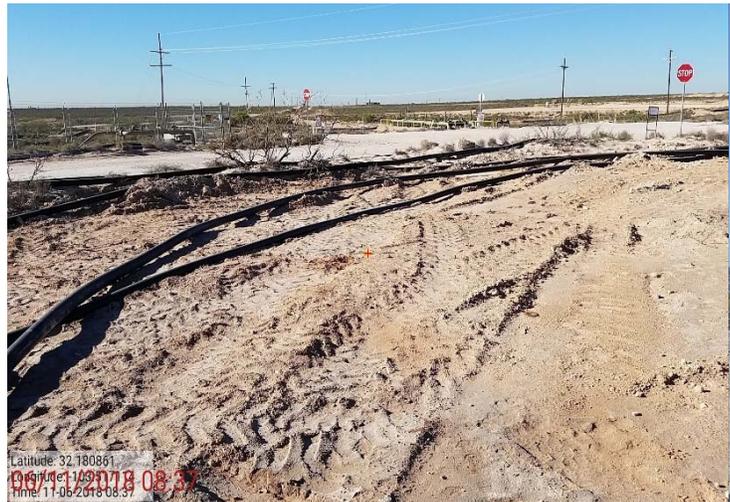
### Photograph No. 2

After reviewing the laboratory results, it is determined that chloride levels of all samples within the spill trajectory, with the exception of TP1-2' (3100 mg/kg), TP3-4' (706 mg/kg), and TP4-3' (715 mg/kg), were below regulatory limits.

View of point of release and area of TP 1 looking southwest. Note intersection of Vaca Lane (N to S) and Resource Land (E to W).

- 1) Excavate soils in the area of TP1 to a depth of 3 ft bgs, TP3 to a depth of 5 ft bgs, and TP4 to a depth of 4 ft bgs. Hach Quantab Chloride Strips will be used to field screen sidewalls until horizontal impacts have been removed.
- 2) Collect samples from the base and sidewalls of the excavation and analyze for chlorides to confirm removal of impacts has been achieved. TP1 confirmation samples will be analyzed for constituents listed in NMAC 19.15.29 Table 1.
- 3) Once the confirmation samples are determined to be below regulatory limits, backfill excavation with clean soil from a NMOCD approved quarry.

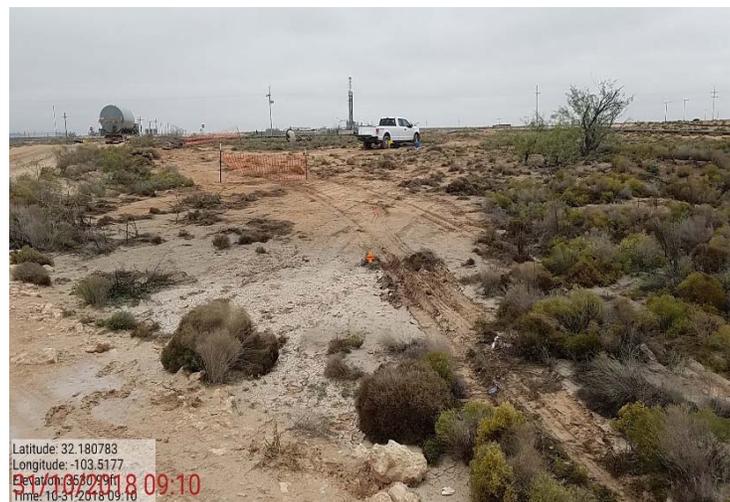
### Photograph No. 3

View of spill trajectory looking west from area of TP5.
