Texland Petroleum
State 'A' 29 Lease – Well #7
Unit K, Sec. 29-T18S-R38E, Lea Co., NM
Oil & Produced Water Spill
Affected Surface Area – 6,720 sq. ft. / .15 acre
GPS Coordinates: N32.71488 W103.17128

OCD Case Number 1RP-5025

**Texland Petroleum
State 'A' 29 Lease – Well #7
Unit K, Sec. 29-T18S-R38E, Lea Co., NM
Affected Surface Area – 6,720 sq. ft. / .15 acre
GPS Coordinates: N32.71488 W103.17128**

Summary of Remedial Activities

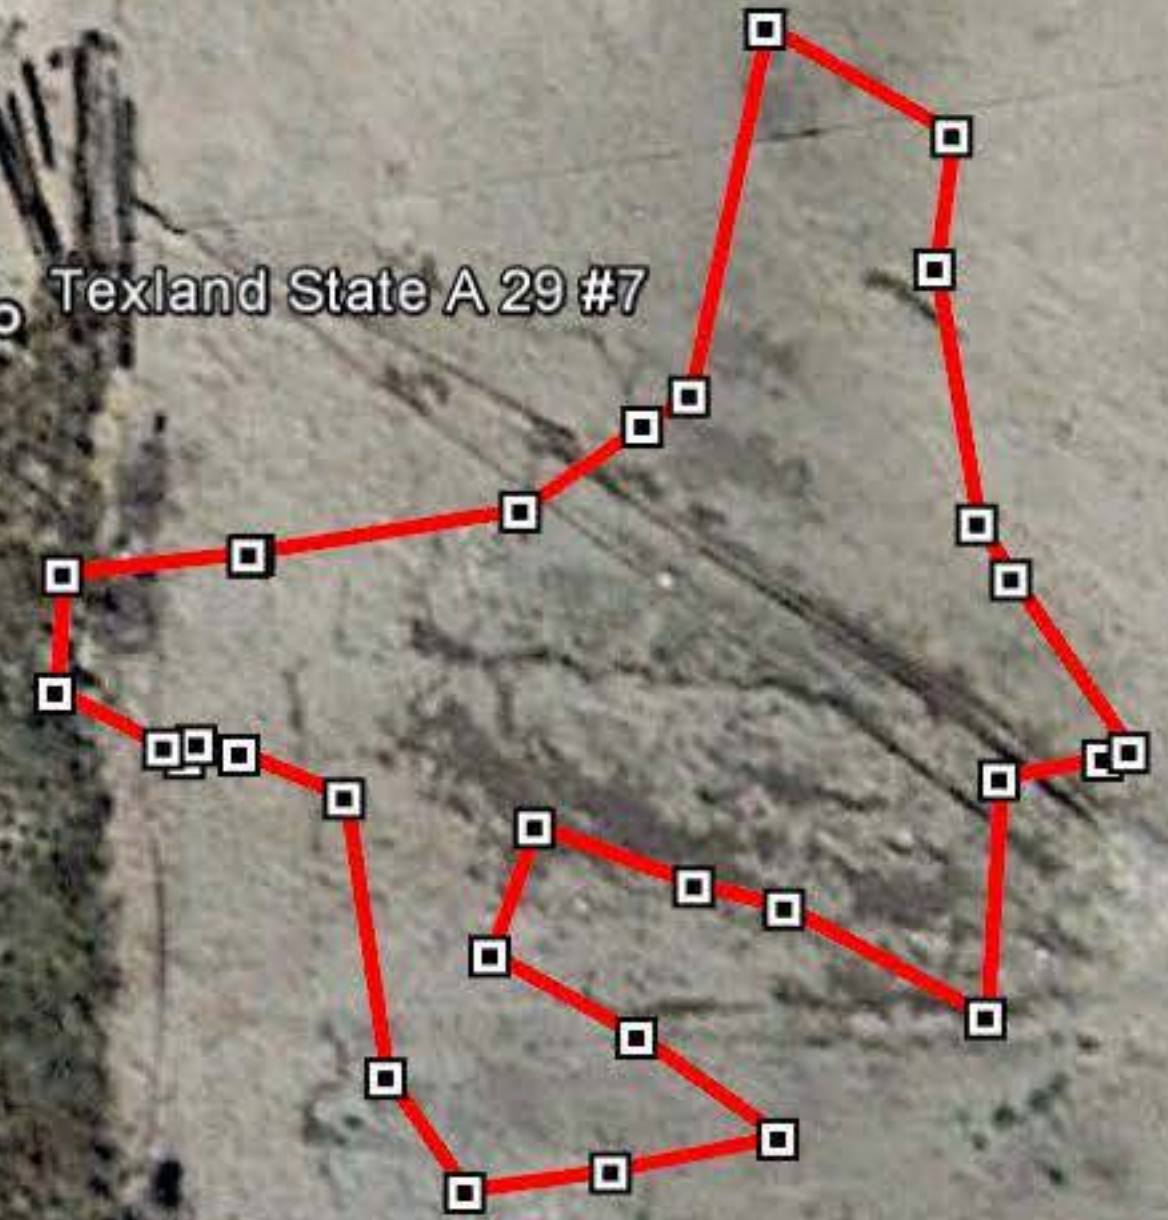
Texland Petroleum
State 'A' 29 Lease - Well #7
Oil & Produced Water Spill
Affected Surface Area - 6,720 sq. ft. / .15 acre
GPS Coordinates: N32.71488
W103.17128

Sample ID	Depth (in. or ft.)	Field or Lab Test	Benzene (mg/kg)	BTEX (mg/kg)	TPH (mg/kg)	Chloride (mg/kg)	GPS Coordinates
1A	24 in.	Field			<1,000	4,652	N32.714885 W103.171295
1A	36 in.	Field			<1,000	888	N32.714885 W103.171295
1A	48 in.	Field			<1,000	456	N32.714885 W103.171295
1A	108 in.	Lab	<0.00843	<0.00437	<15.3	109	N32.714885 W103.171280
1B	24 in.	Field			<1,000	759	N32.714728 W103.171131
1B	36 in.	Field			<1,000	168	N32.714728 W103.171131
1B	96 in.	Lab	<0.00876	<0.00453	<15.3	131	N32.714735 W103.171120
1C	24 in.	Field			<1,000	1,091	N32.714873 W103.170944
1C	36 in.	Field			<1,000	741	N32.714873 W103.170944
1C	48 in.	Field			<1,000	503	N32.714873 W103.170944
1C	108 in.	Lab	<0.00890	<0.00461	<15.3	182	N32.714873 W103.170959
1D	36 in.	Field			<1,000	389	N32.714949 W103.171063
1D	96 in.	Lab	<0.00868	<0.00449	<15.2	180	N32.714948 W103.171045
1E	24 in.	Field			<1,000	647	N32.715052 W103.171003
1E	36 in.	Field			<1,000	493	N32.715052 W103.171003

1E	96 in.	Lab	<0.00888	<0.00460	<15.1	238	N32.715039 W103.171002
1F	48 in.	Field			<1,000	407	N32.714872 W103.171126
1F	108 in.	Lab	<0.00878	<0.00454	31.1	104	N32.714886 W103.171105
