**FOURTH ANNUAL GROUNDWATER
MONITORING REPORT
CHESAPEAKE ENERGY CORPORATION
STATE M LEASE (AP-72)
LEA COUNTY, NEW MEXICO**

May 14, 2018

**FOURTH ANNUAL GROUNDWATER MONITORING REPORT
CHESAPEAKE ENERGY CORPORATION
STATE M LEASE (AP-72)
LEA COUNTY, NEW MEXICO
MAY 14, 2018**

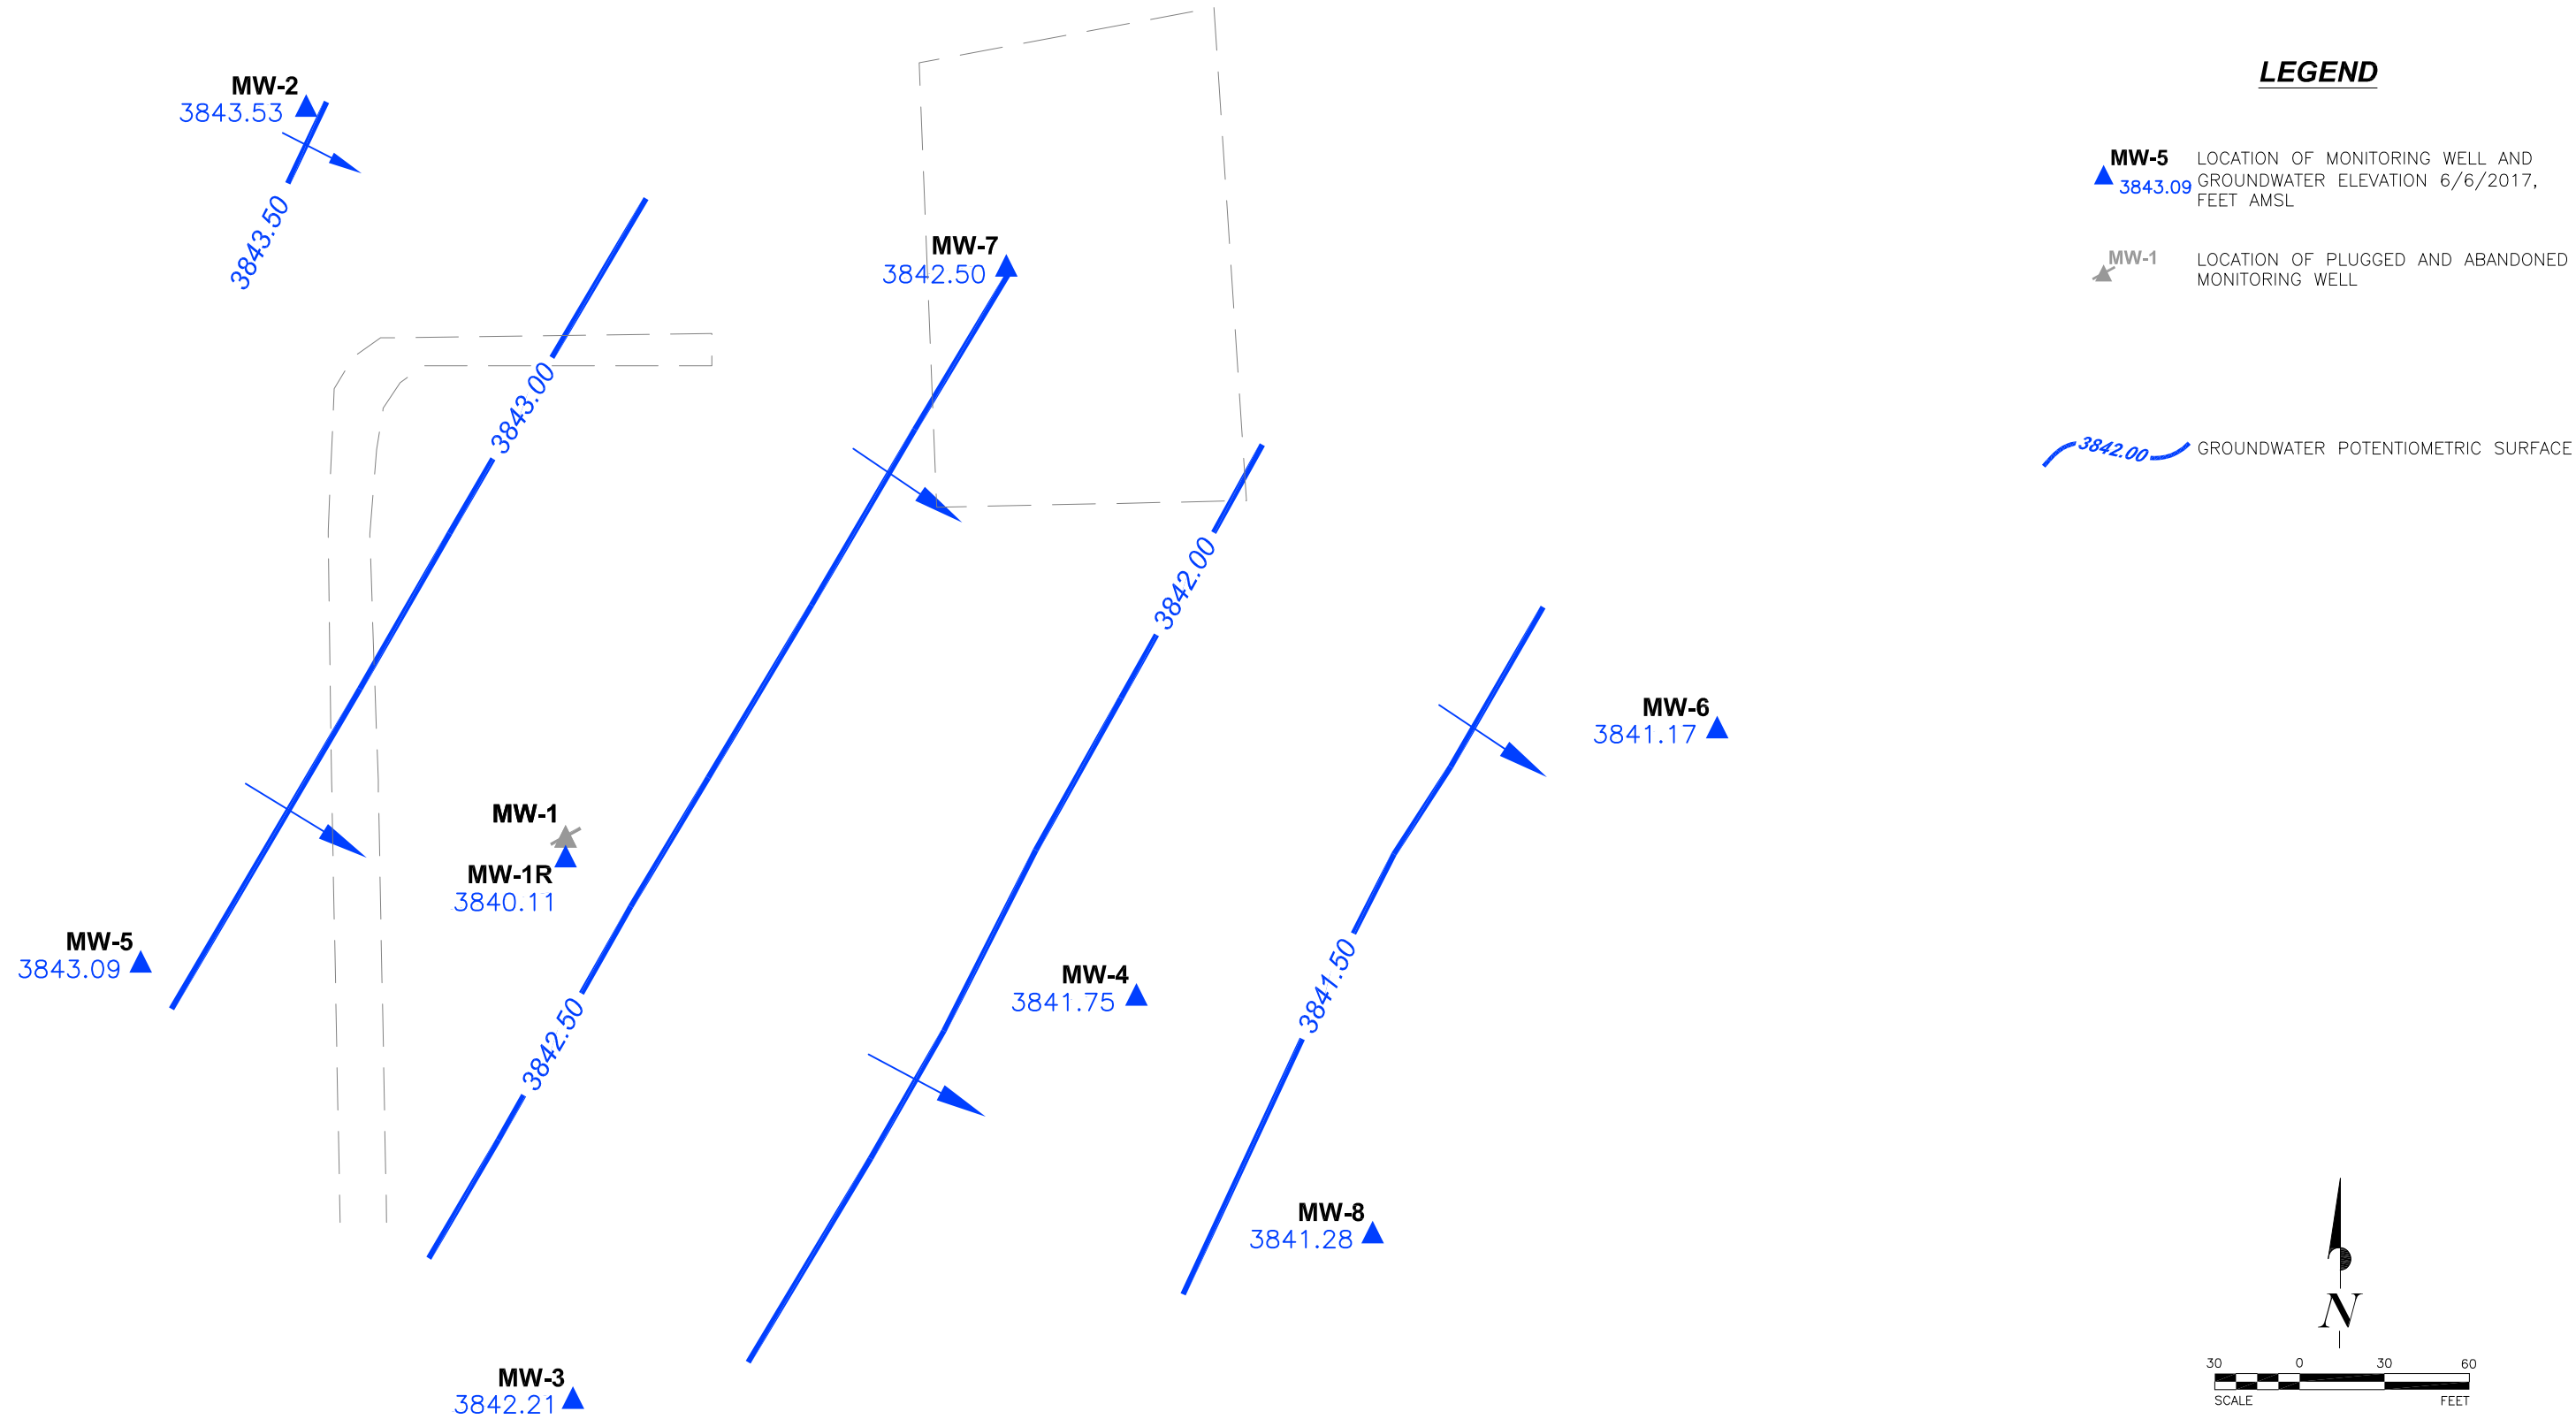
Prior to collecting groundwater samples during each quarterly event, ECC gauged all 8 monitoring wells (MW-1R through MW-8) at the Site using an electronic interface probe to determine the depth-to-water (DTW) and LNAPL thickness within each well. The locations of these monitoring wells are shown on **Figure 2**. DTWs were measured from the surveyed top-of-casing (TOC) of each well and converted to elevations relative to mean sea level. These data are presented in **Table 3**. Potentiometric surface maps were constructed utilizing these data to illustrate the groundwater flow direction within the shallow groundwater system beneath the Site. These potentiometric surface maps are presented on **Figures 4** through **7**. As can be seen on the figures, groundwater flow at the Site is, in general, from the northwest to the southeast.
