Remediation Plan

January 11, 2019

Re: Big Kick Battery
API# 30-025-36745
Case # 1RP-5237

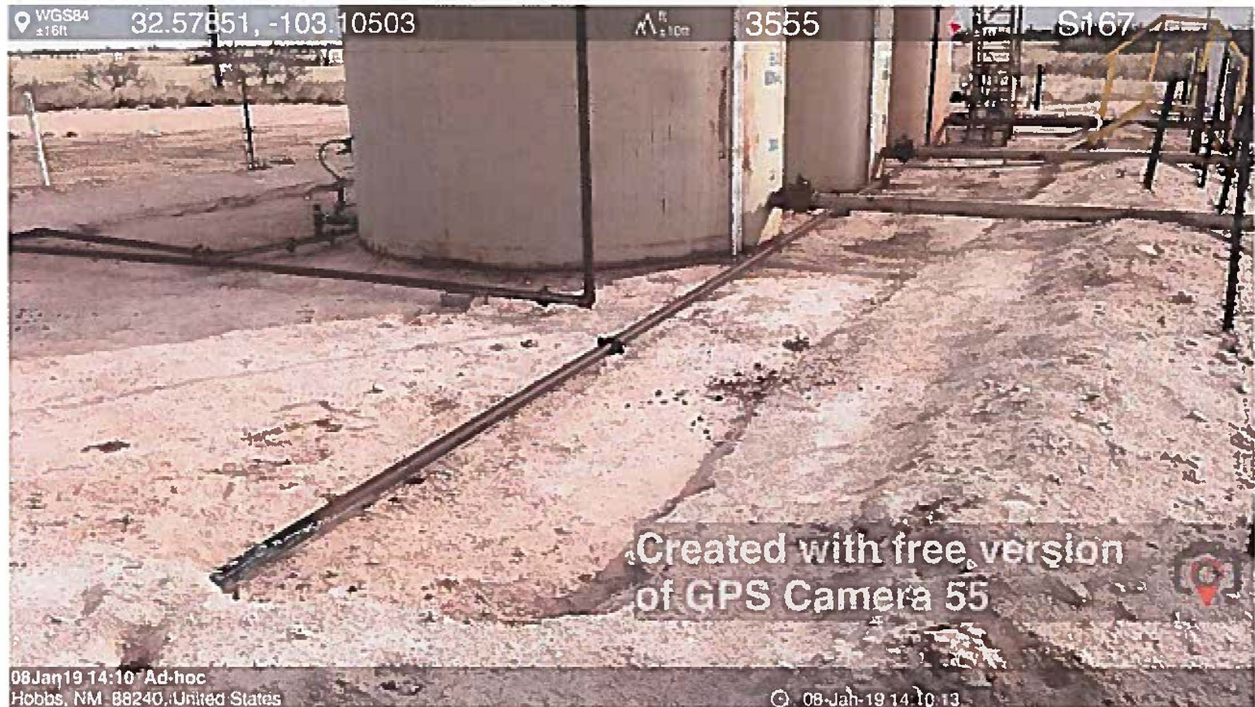
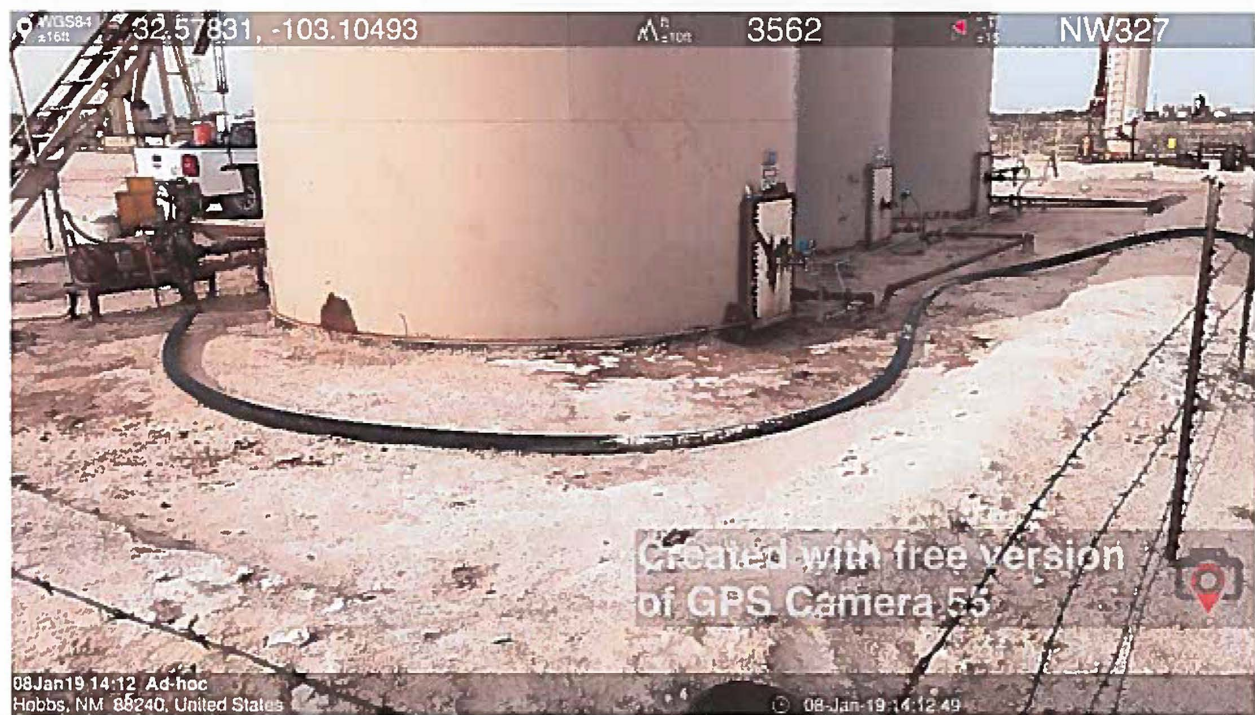
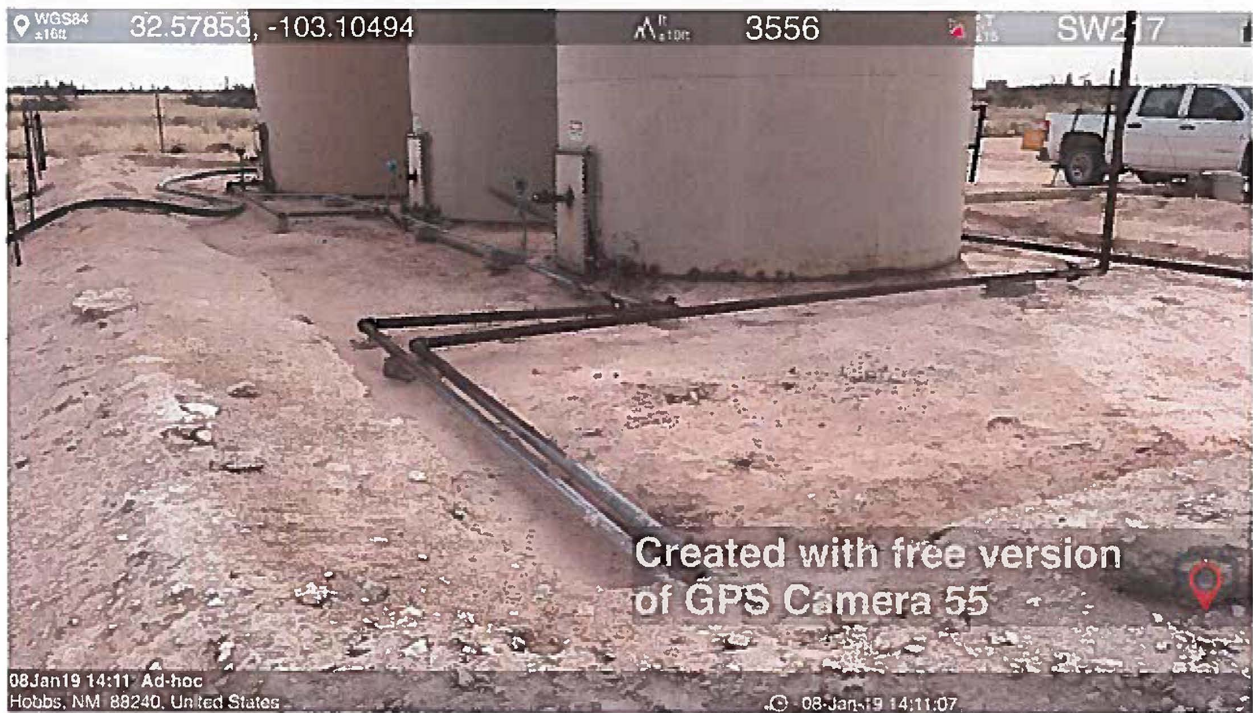
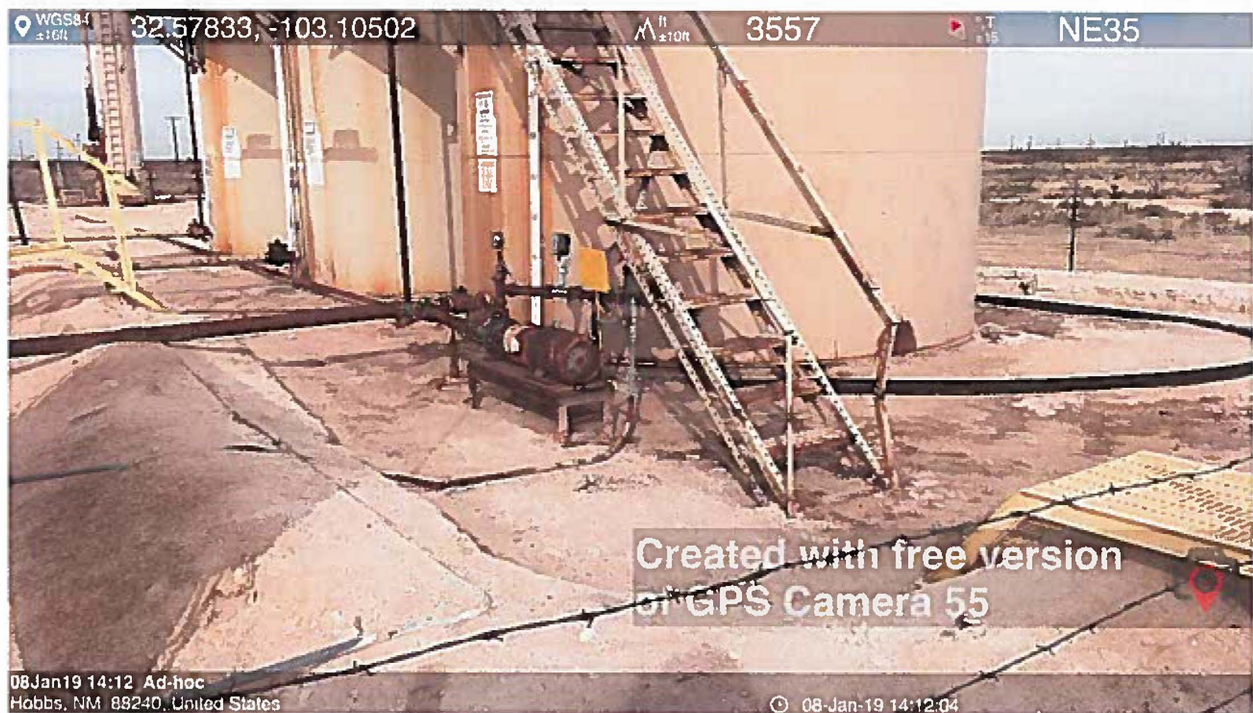
Big Kick Battery Photos

On 10/01/2018 a release was discovered due to a nipple corroded on the transfer pump. An initial C-141 was submitted and approved by NMOCD on 10/16/2018. The Big Kick Battery (GPS Coordinates 32.57835 -103.10499) is located south of Hobbs New Mexico in unit letter C section 13 township 20S range 38E. A 2000 meter radius groundwater survey was conducted utilizing the NMOSE web page. According to the NMOSE the average depth of groundwater in the area is 47 feet below ground surface. A fresh water well is within 1,000 feet radius of the release site.

To date the release area has been excavated to a depth of 6 inches and all excavated material (24 yards) has been exported to a NMOCD approved facility. After the excavation was complete samples were collected on the east and west side of the battery and sent to a commercial laboratory for analysis of chloride, TPH, and BTEX. The laboratory results yielded chloride values above table 1 standards (600 mg/kg) for releases less than 50 feet to groundwater. The sample point east of the battery (SP 1) and west of the battery (SP 2) were delineated utilizing a hand auger collecting samples in 1 foot intervals and were submitted to a laboratory for analysis of chloride, TPH, and BTEX. Also horizontal samples were collected and field tested for chlorides. Although the release was contained inside the battery containment the samples east and south of the battery demonstrated contamination outside on the lease pad and east of the battery. A possible cause was cross contamination during excavating inside the battery and removing the excavated material. Once field composites suggested chloride values less than 600 horizontally a hand auger was advanced between the battery and the clean composite on the south and east side of battery to determine depth of contamination and samples were sent to a commercial laboratory for analysis of chloride, TPH, and BTEX. All samples came back below table one standards except for the west wall.

Apache Corporation proposes that the area inside the battery be excavated to a depth of 1.5 feet. The berms will be removed on the south, east, and west side of the containment and hauled to a NMOCD approved facility. Once the berms are removed the excavation will be extended south to south composite and east to east composite to a depth of 1 foot. The west

will be extended until below table 1 standards are meet. Once the excavation is complete final wall and bottom composite samples representing every 200 square feet will be collected and submitted to a commercial laboratory for analysis of chloride, TPH, and BETX. NMOCD will be notified 48 hours prior to final samples collected. Approximately 36 yards will be excavated and disposed of at a NMOCD approved facility. Remediation activities will be completed in 90 days of NMOCD approval of plan.
