NM1 - 65

**PART 36
PERMIT
APPLICATION
Attachments 6**

Attachment #6

This plan complies with all applicable requirements contained in 19.15.36.13, 19.15.36.14, 19.15.36.15 and 19.15.36.17 NMAC.

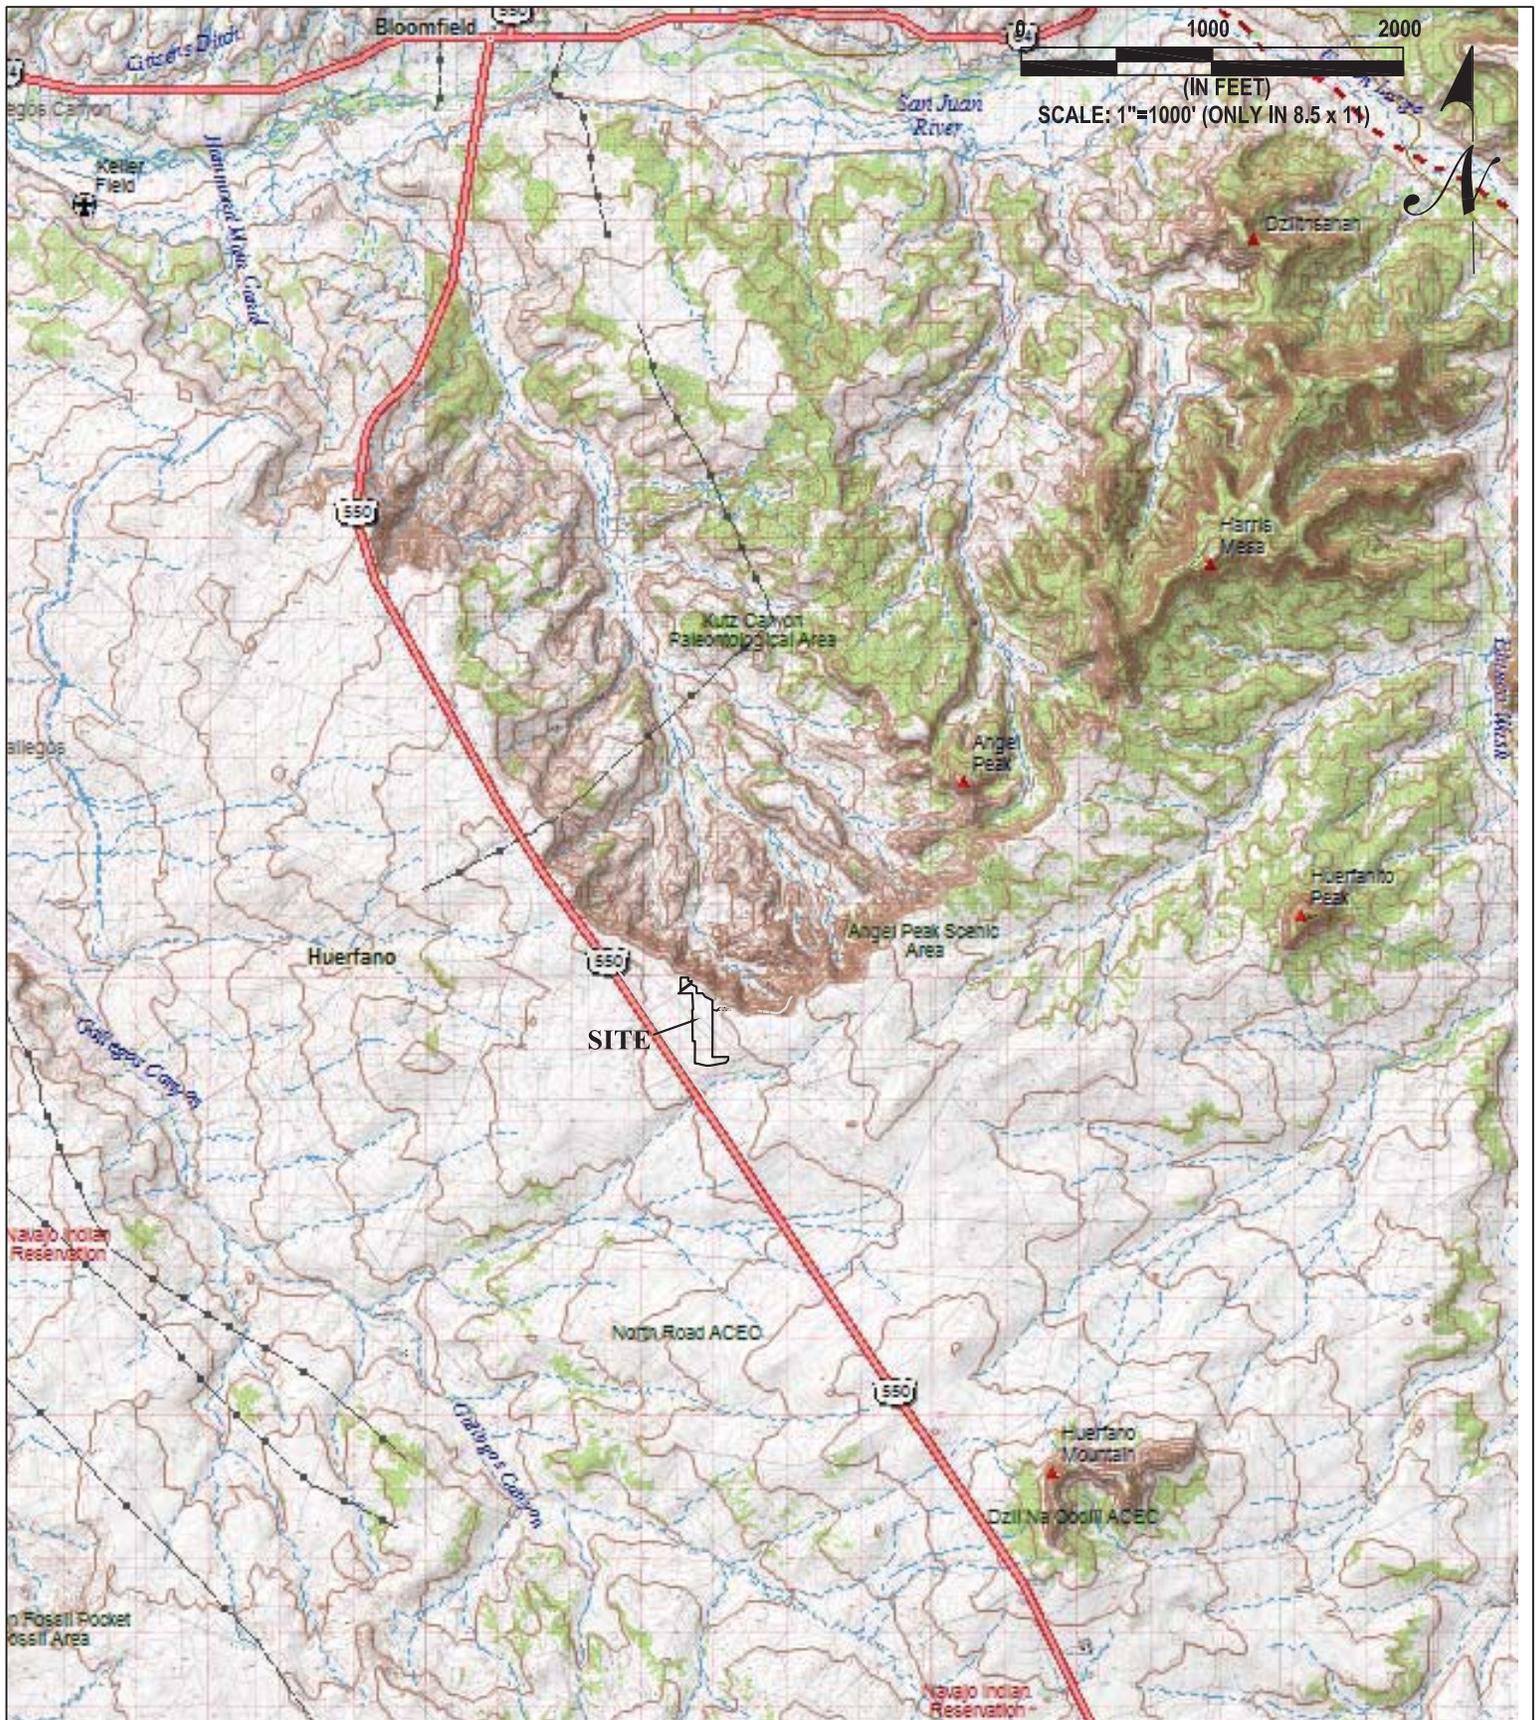
FIGURE 1
Vicinity Map

- KEY**
- 3 FOOT PERIMETER BERM & SWALE COMBINATION
 - 3 FOOT PERIMETER BERM ONLY
 - 2 FOOT PIPELINE BERM
 - 2 FOOT LANDFARM CELLS BERM
 - 3 FOOT GREAT NORTH ROAD ARCH BERM
 - SURVEYED LANDFARM #4 BOUNDARY/FENCELINE
 - EXISTING EDGE OF ROAD

Figure 1, Vicinity Map

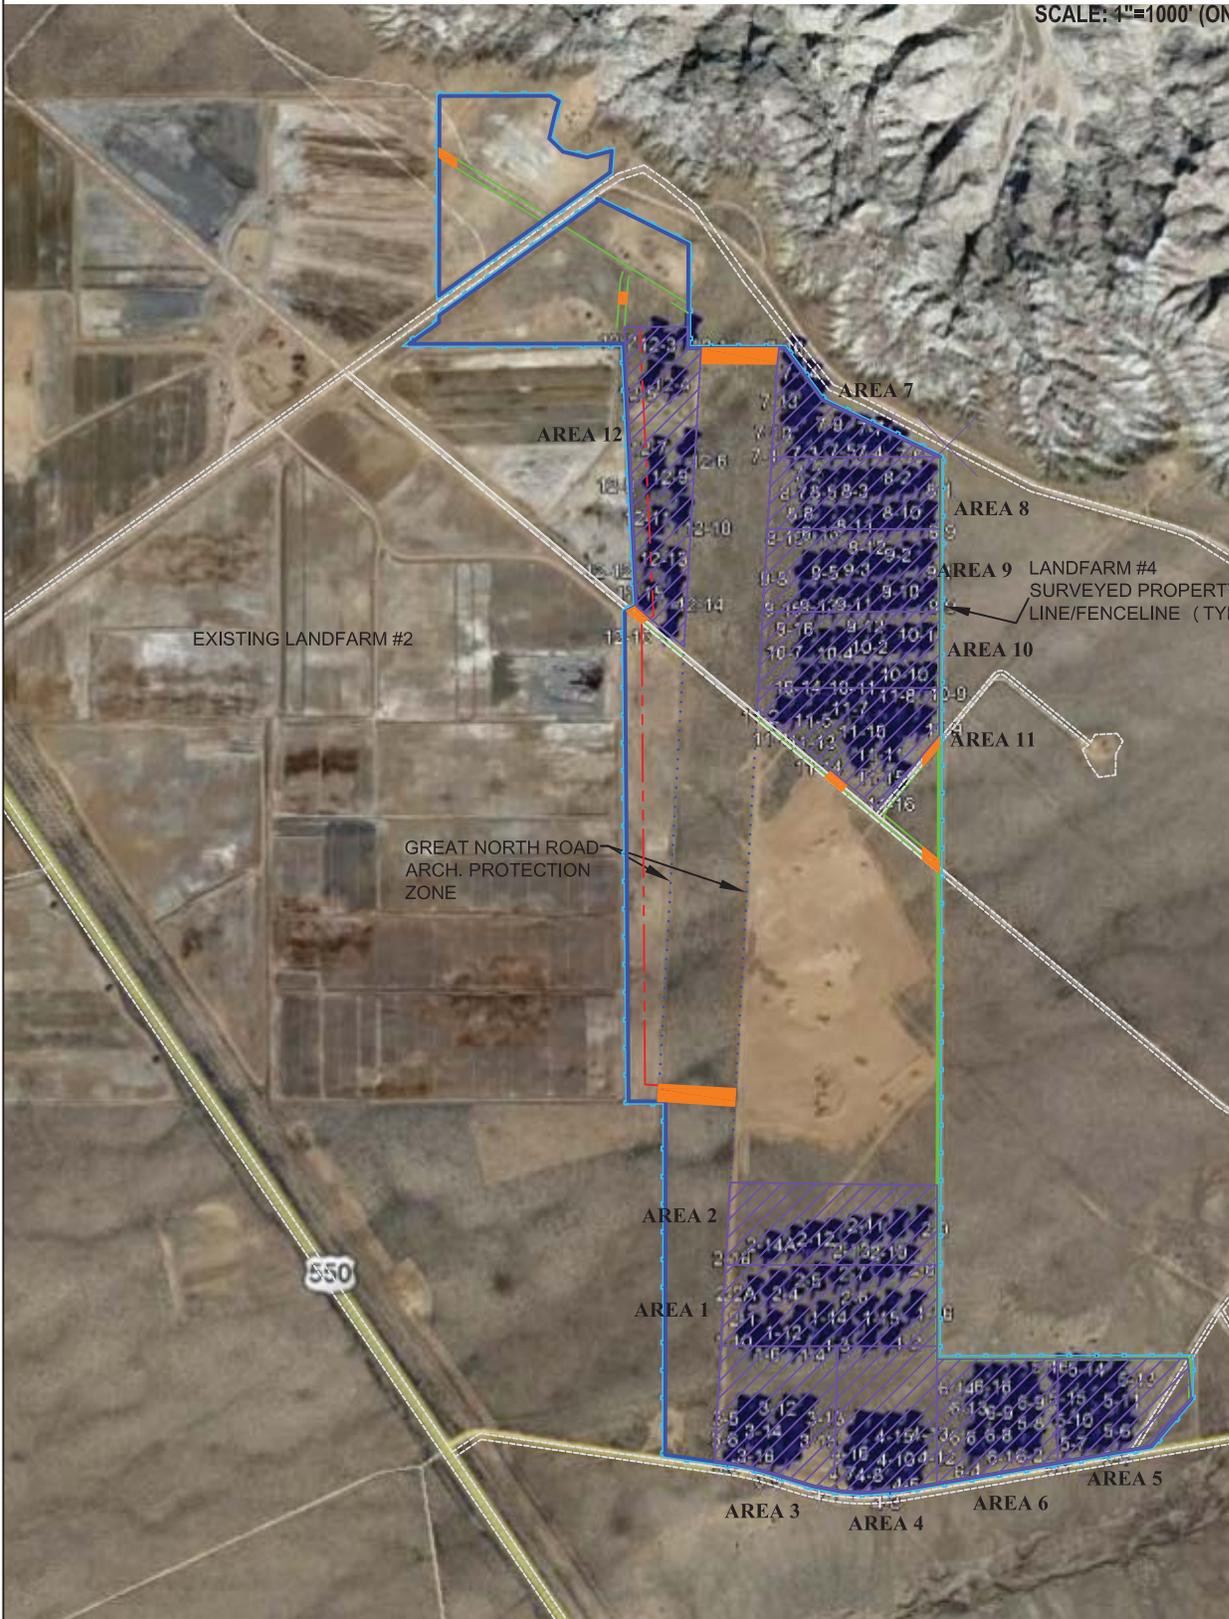
FIGURE 2
Sampling Location Map
Initial Background Sampling and Analysis

KEY	
	3 FOOT PERIMETER BERM & SWALE COMBINATION
	3 FOOT PERIMETER BERM ONLY
	2 FOOT PIPELINE BERM
	2 FOOT LANDFARM CELLS BERM
	3 FOOT GREAT NORTH ROAD ARCH BERM
	SURVEYED LANDFARM #4 BOUNDARY/FENCELINE
	EXISTING EDGE OF ROAD
	100 FOOT BUFFER
	BERM CROSSINGS
	APPROX BACKGROUND SAMPLE LOCATIONS
	BACKGROUND SAMPLE GRIDS

Figure 2, Landfarm Background Sampling
Location Map
