June 25, 2019

RE: Whiting Oil and Gas, Remediation Plan for the Carlson Fed A 2 TB, 1RP-5525, API# 30-025-11764, located in Lea County, New Mexico.

Lobo Services was contracted to assess and direct remedial activities for soils impacted from a production fluid release at the Carlson Fed A 2 TB. The release was caused by severe weather that created an electrical failure causing the transfer pump to fail. The down hole pump continued to produce causing the tanks to overflow. The GPS coordinates for the release site located in Lea County, New Mexico are N 32.09978 and W -103.11074.

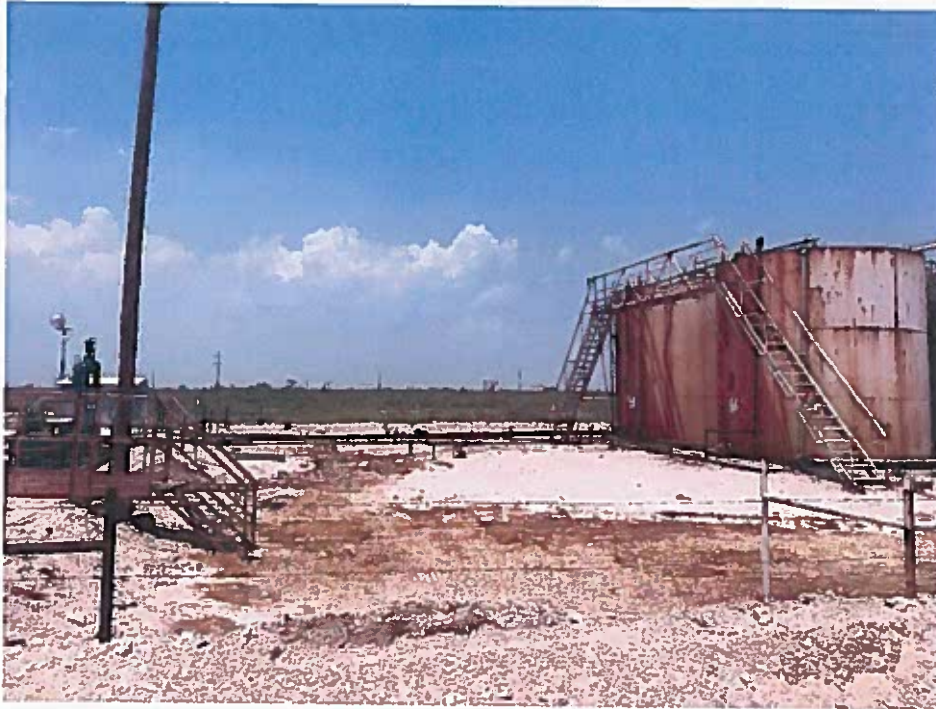
View of Impacted Area to the North

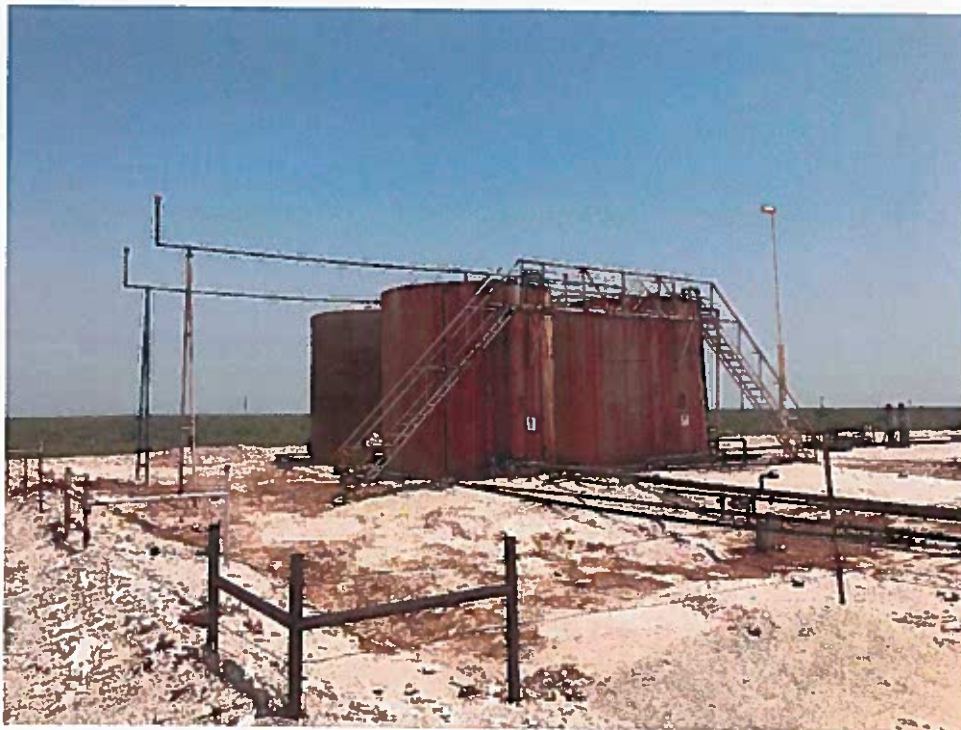
View of Impacted Area to the South East
