**Re: Site Assessment Summary and Proposed Remediation Plan
Stratojet 31 State Com #007H
API No. 30-025-43792
GPS: Latitude 32.52454 Longitude -103.49931
UL "N", Sec. 31, T20S, R35E
Lea County, NM
NMOCD Ref. No. 1RP-5146, 1RP-5278**

TRC Environmental Corporation (TRC), on behalf of COG Operating, LLC (COG), has prepared this *Site Assessment Summary and Deferral Request* for the Release Site known as the Stratojet 31 State Com #007H. Details of the Release are summarized below:

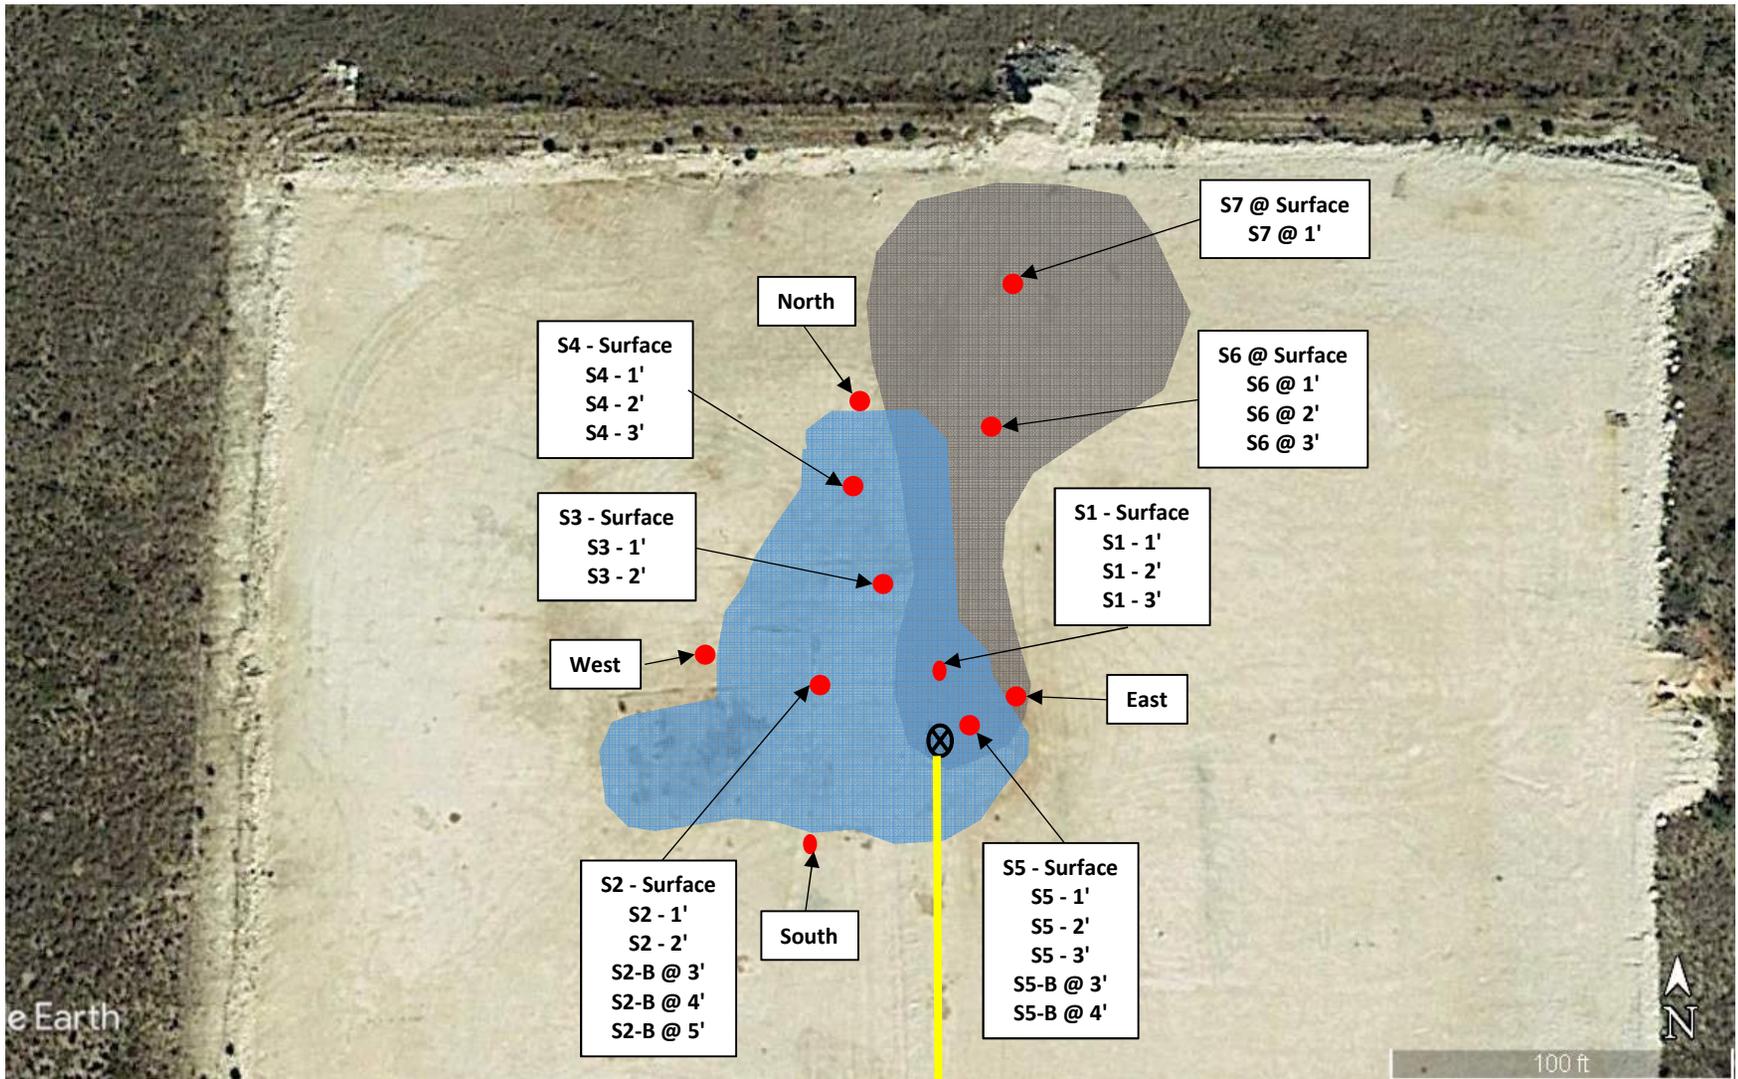
Inferred Release Margins (8/04/18)
	Inferred Release Margins (11/05/18)
	Sample Point Location
	Wellhead
	Underground Pipeline

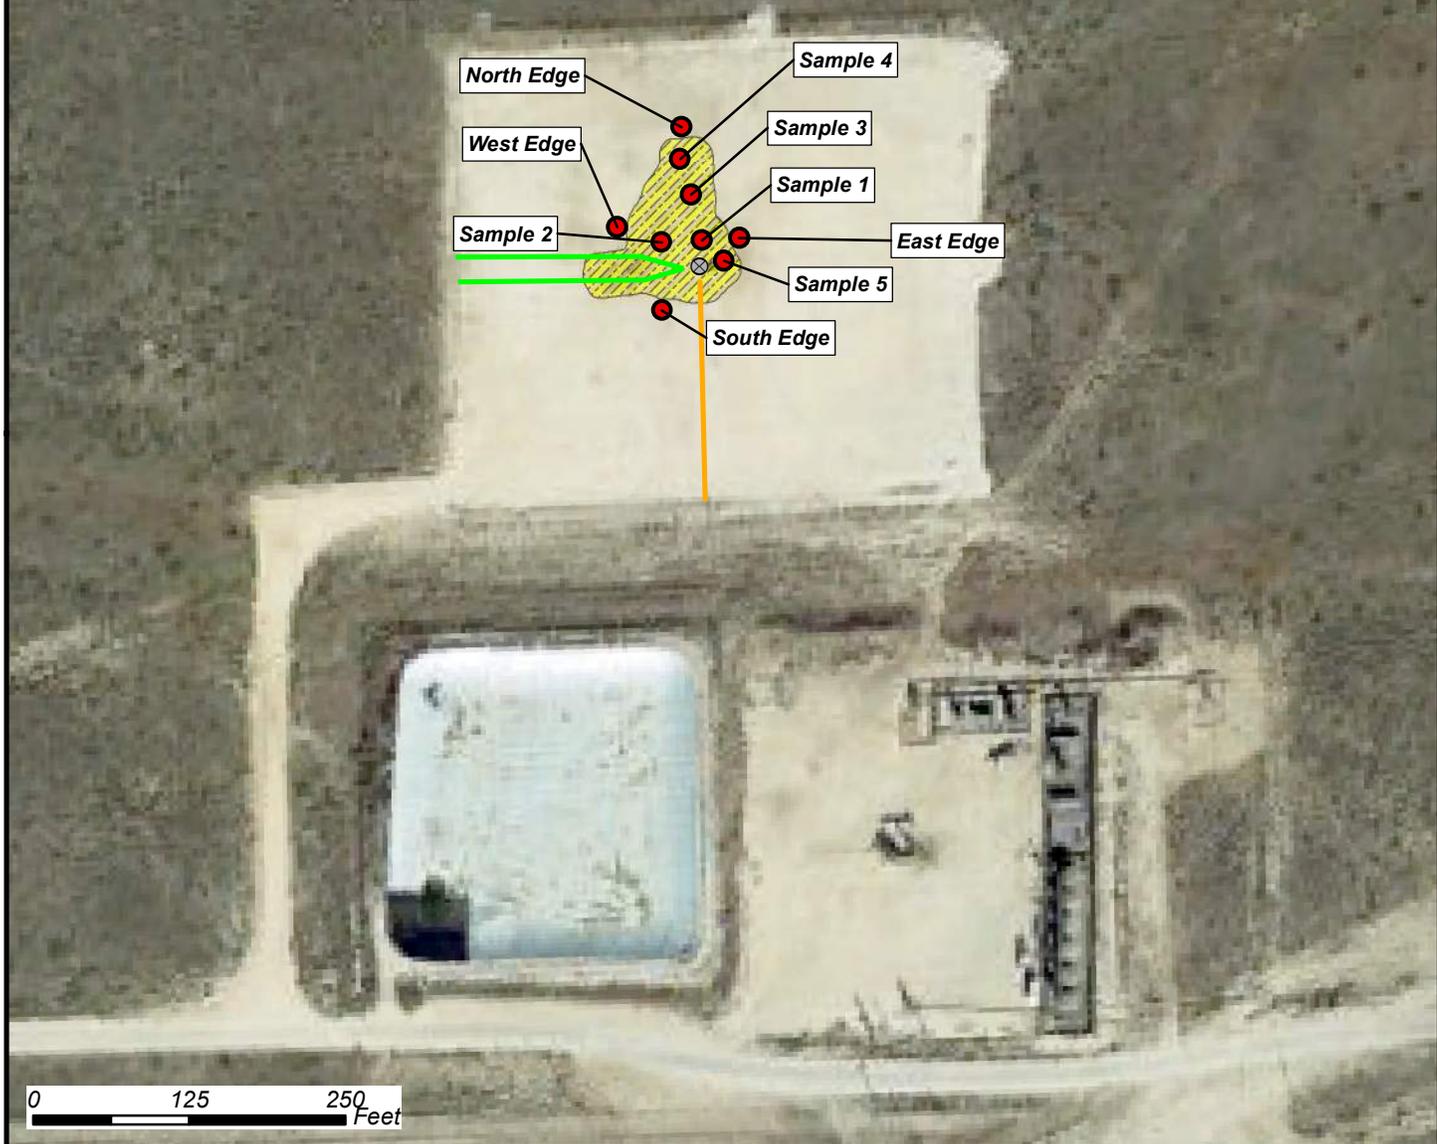
Attachment C:
Sample Location Map

Sample Location Map
