Re: Jackson B Federal #51
30-015-40139
M-1-17S-30E
Eddy County, NM
2RP-5547

Jackson B Federal #51

Closure Report

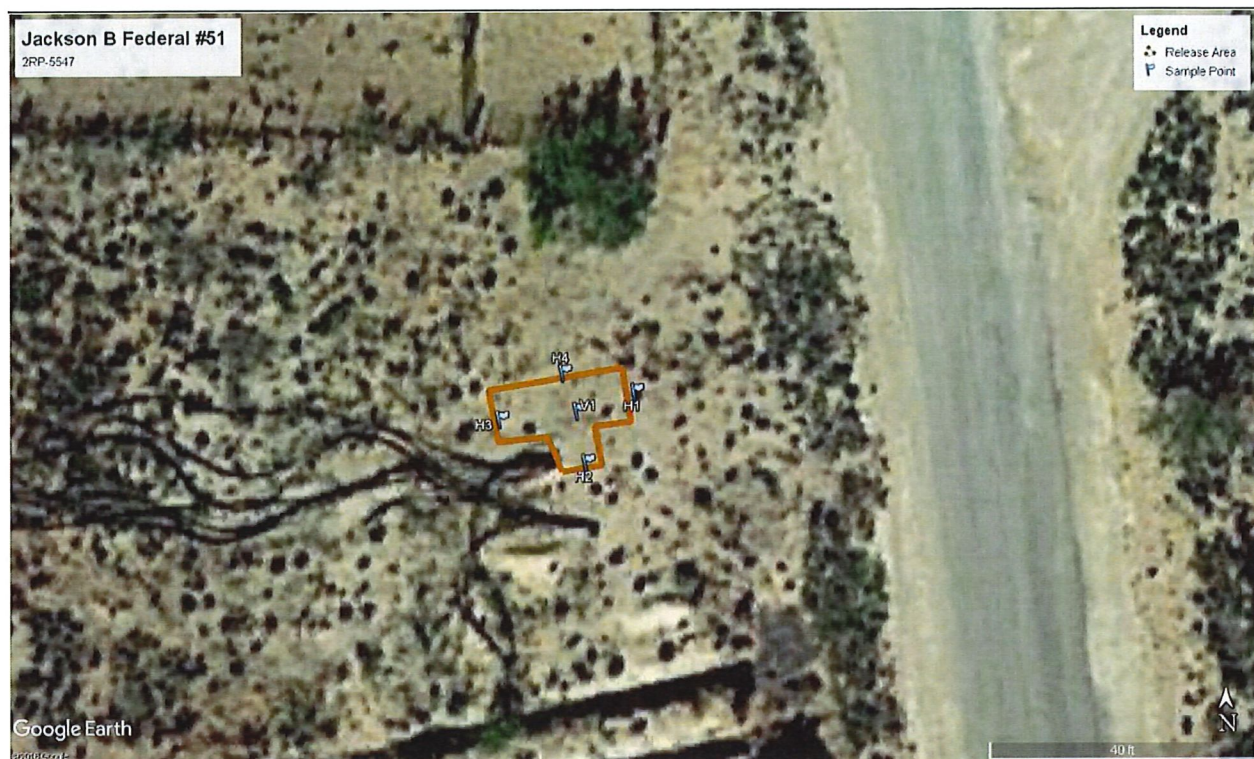
Figure 1

Site Map with Sample Points

EOG Resources, Inc. excavated to an initial depth of four (4) feet bgs prior to sampling activities conducted on August 27, 2019 (results enclosed). Analytical data from that sampling activity displayed results to be below Table 1 standards. All samples represented less than 200 square feet. Notification for sampling activities was sent to NMOCD and BLM, August 22, 2019. All

excavated soil was hauled to a NMOCD approved facility for disposal, then the excavated area was backfilled to grade with locally sourced soil of similar type. The site was then reseeded with BLM LPC mixture. A C-141 Final Report is hereby submitted to NMOCD requesting closure of the site.
