## Release Notification

| Site Name Mis Amigos #907H | Site Type Production Well Facility |

**RE: Closure Request  
Mis Amigos #907H  
Remediation Permit Number 1RP-5568  
Lea County, New Mexico**

LT Environmental, Inc. (LTE), on behalf of XTO Energy, Inc. (XTO), presents the following Closure Request detailing site assessment, excavation, and soil sampling activities at the Mis Amigos #907H (Site) in Unit P, Section 31, Township 23 South, Range 33 East, in Lea County, New Mexico (Figure 1). The purpose of the site assessment, excavation, and soil sampling activities was to confirm the presence or absence of soil impacts following a release of fresh water with biocide at the Site. Based on the excavation activities and results of the soil sampling events, XTO is submitting this Closure Request and requesting no further action for Remediation Permit (RP) Number 1RP-5568.

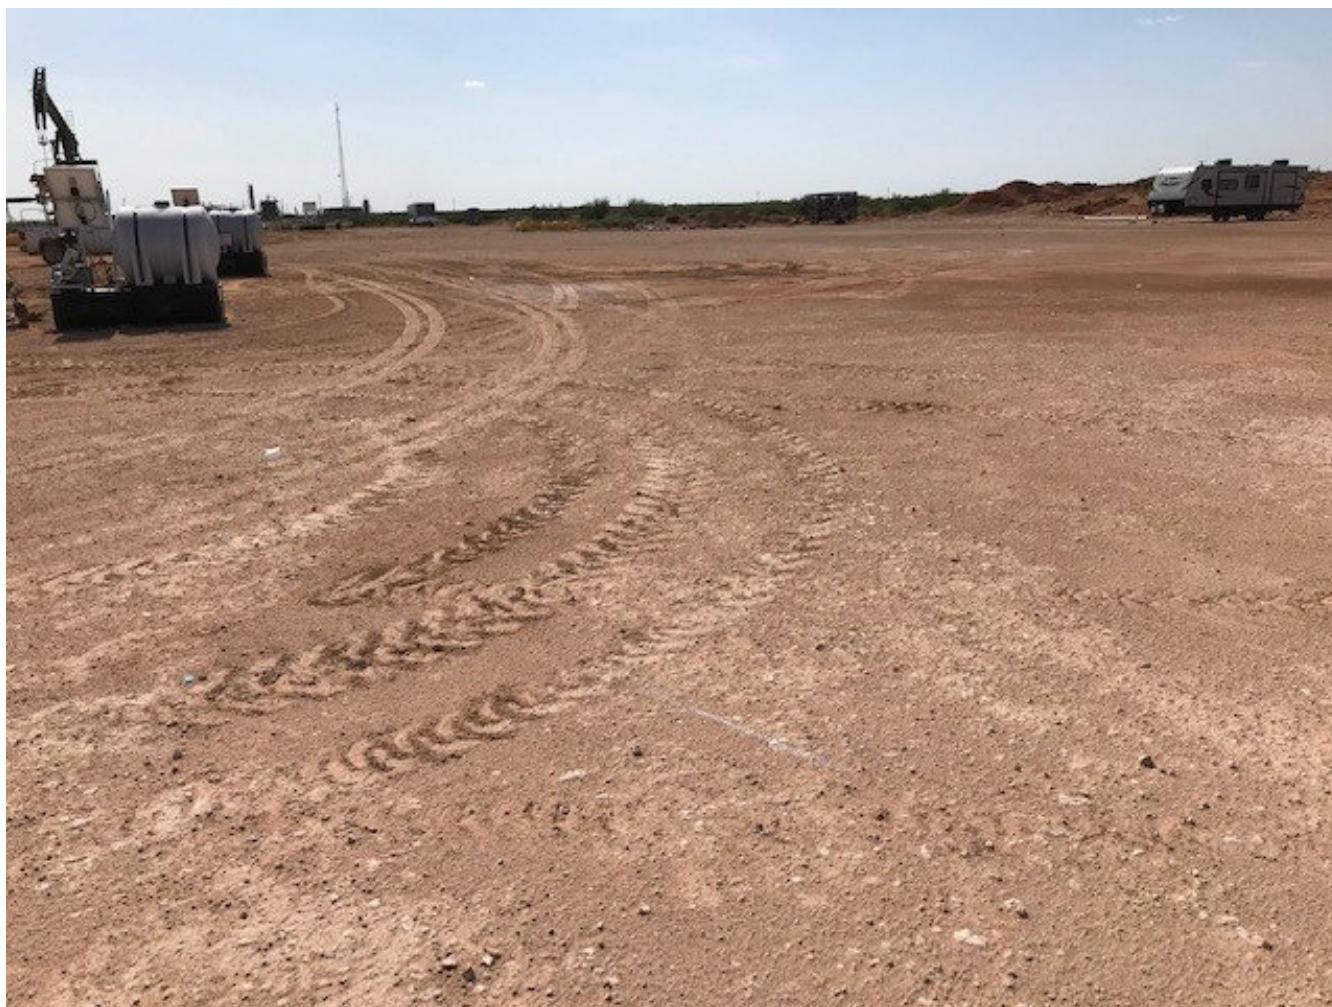
On June 17, 2019, LTE personnel was at the Site to evaluate the release extent based on information provided on the Form C-141 and visual observations. LTE personnel collected eight preliminary soil samples (SS01 through SS08) within the release extent at a depth of approximately 0.5 feet bgs to assess for the presence or absence of soil impacts. Soil was field screened for volatile aromatic hydrocarbons and chloride utilizing a calibrated photo-ionization detector (PID) and Hach® chloride QuanTab® test strips, respectively. The release extent and preliminary soil sample locations were mapped utilizing a handheld Global Positioning System (GPS) unit and are depicted on Figure 2.

**Eastern view of release area during site assessment activities.**

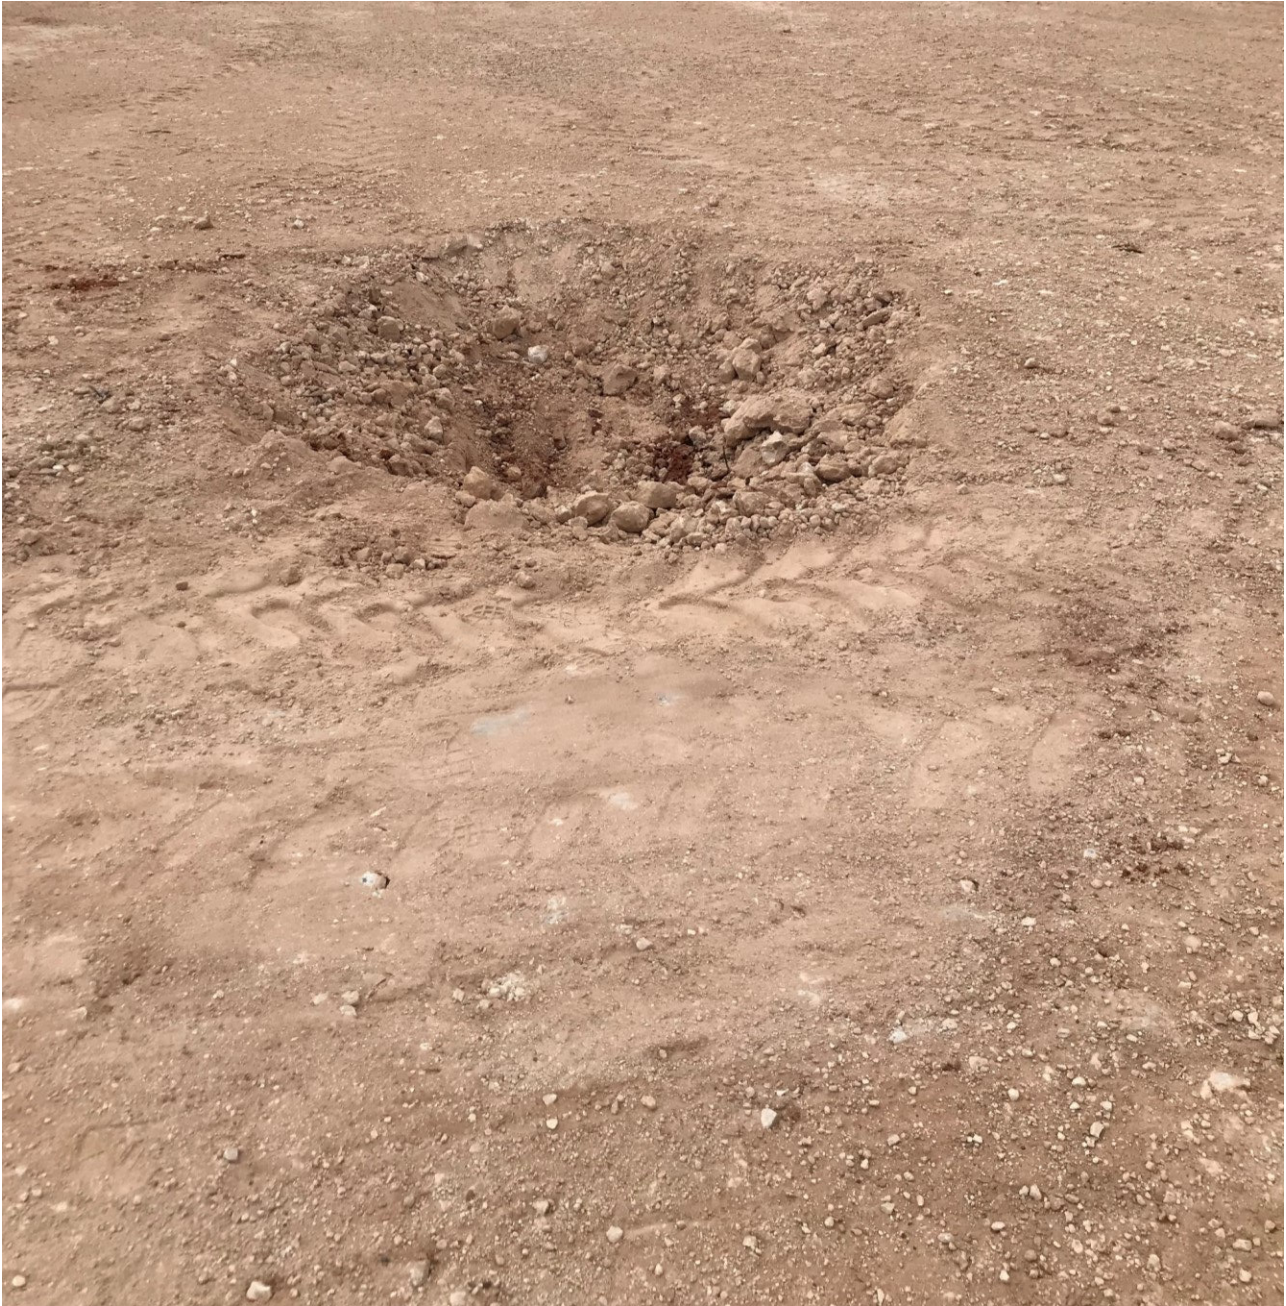
On September 5, 2019, LTE personnel remained on-site to oversee excavation of impacted soil as indicated by visual observations, field screening activities, and laboratory analytical results for preliminary soil sample SS06. To direct excavation activities, LTE screened soil for volatile aromatic hydrocarbons and chloride. Following removal of impacted soil, LTE collected 5-point composite samples every 200 square feet from the sidewalls and floor of the excavation. The 5-point composite sample was collected by depositing five aliquots of soil into a 1-gallon, resealable plastic bag and homogenizing the sample by thoroughly mixing. Based on the shallow depth of the excavation, sample FS01 is representative of the of the sidewalls and floor of the excavation. Composite soil sample FS01 was collected from the floor of the excavation at a depth of approximately 1 foot bgs. The excavation soil sample was collected, handled, and analyzed as described above. The excavation extent and excavation soil sample location are depicted on Figure 4.

The final excavation extent measured approximately 120 square feet in area. A total of approximately 5 cubic yards of impacted soil were removed from the excavation. The impacted soil was transported and properly disposed of at the R360 landfill facility located in Hobbs, New Mexico.

**Eastern view of final excavation extent during confirmation soil sampling activities.**

Initial response efforts and excavation of impacted soil have mitigated impacts at this site. XTO requests no further action for RP Number 1RP-5568. Upon approval of this closure request, XTO will backfill the excavation with material purchased locally and recontour the Site to match pre-existing site conditions. An updated Form C-141 is included as Attachment 1.
