**RE: Closure Request  
Big Eddy Unit #158  
Remediation Permit Number 2RP-2631 and 2RP-2662  
Eddy County, New Mexico**

LT Environmental, Inc. (LTE), on behalf of XTO Energy, Inc. (XTO), presents the following letter report detailing the excavation of impacted soil and confirmation soil sampling activities at the Big Eddy Unit (BEU) #158 (Site) in Unit J, Section 4, Township 22 South, Range 28 East, in Eddy County, New Mexico (Figure 1). The purpose of the excavation activities was to address impacts to soil after two separate events caused releases of crude oil and produced water in the tank battery containment area.

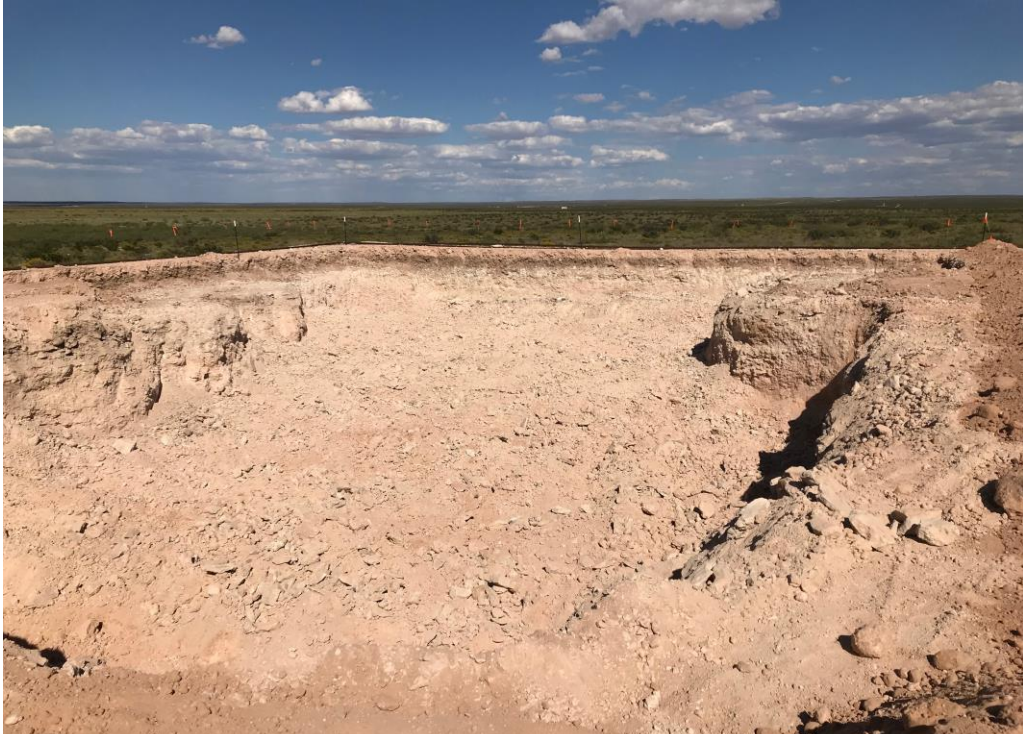
**Photograph 1:** View east of excavation.

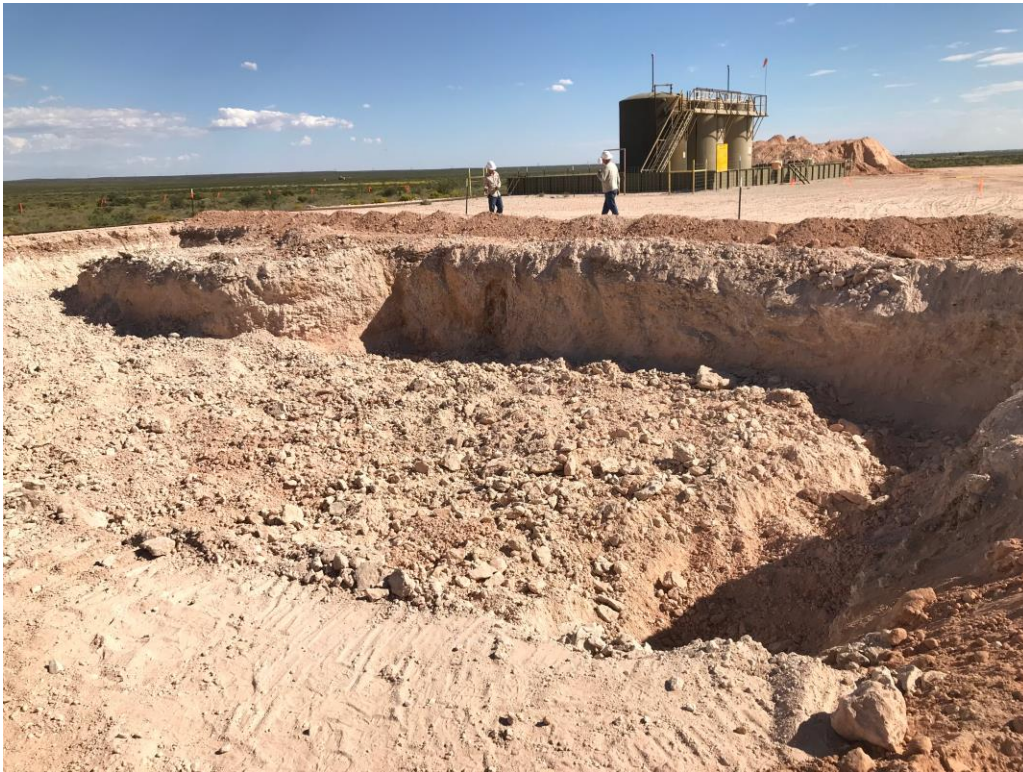
**Photograph 2:** View southeast of excavation and new tank battery.
