Vertex Project #: 19E-00614-008

Spill Closure Report: Queenie 15 Federal #001H (Section 14, Township 20 South, Range 32 East)
API: 30-025-40230
County: Lea
Incident Report: 1RP-5563

Prepared For: Marathon Oil Permian LLC
4111 South Tidwell Road
Carlsbad, New Mexico 88220

2019 Spill Assessment and Closure
December 2019

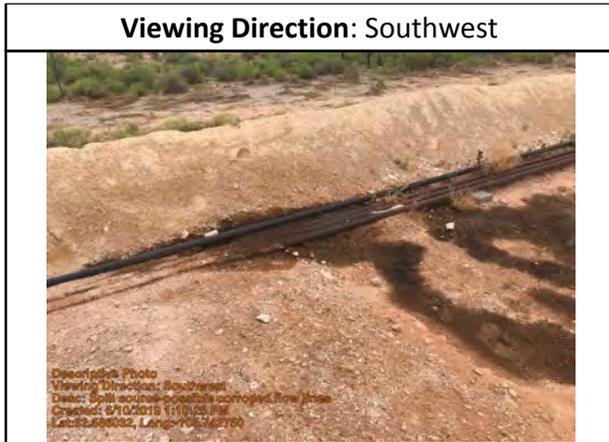
Spill source-possible corroded flow lines

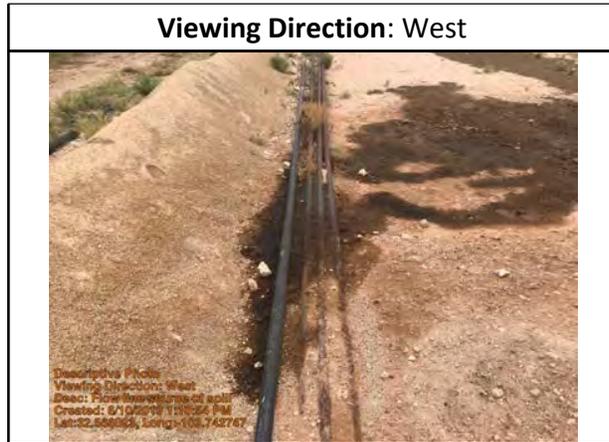
On June 8, 2019, a release occurred at the site due to a pin hole in the line running from the oil tanks to the heater treater. This incident resulted in the release of approximately 7 barrels (bbls) of crude oil onto the south portion of the well pad. No oil was released into undisturbed areas or waterways. Approximately 3 bbls of free fluid were recovered during initial spill clean-up.

Flow line source of spill

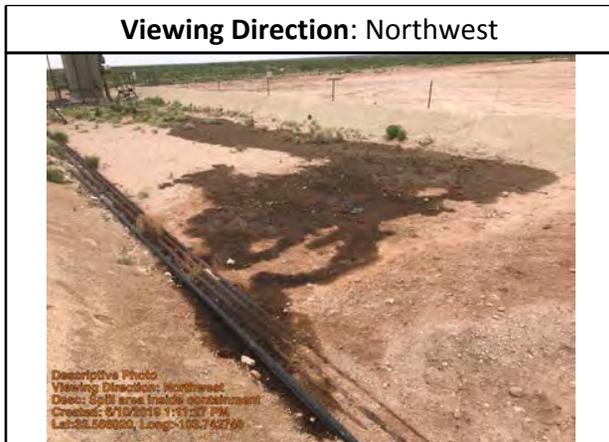
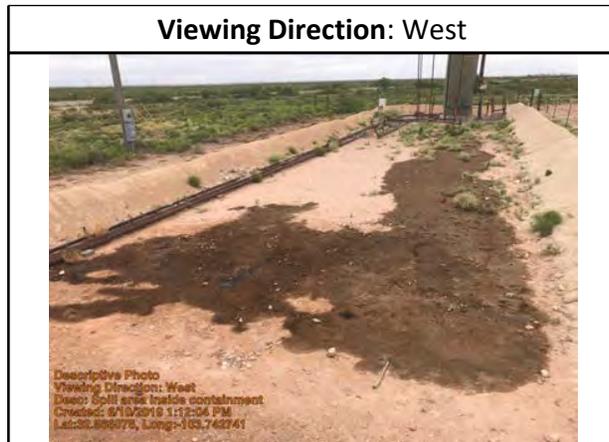
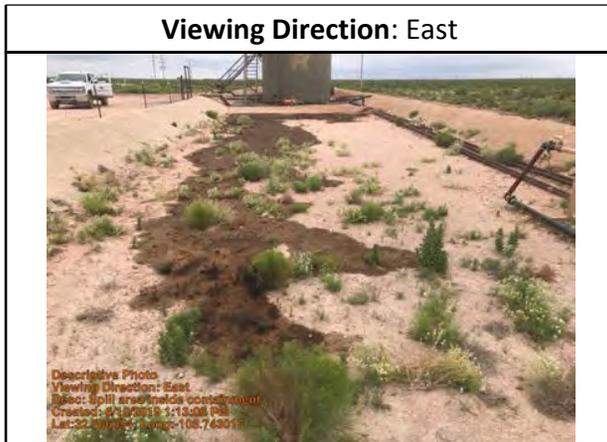
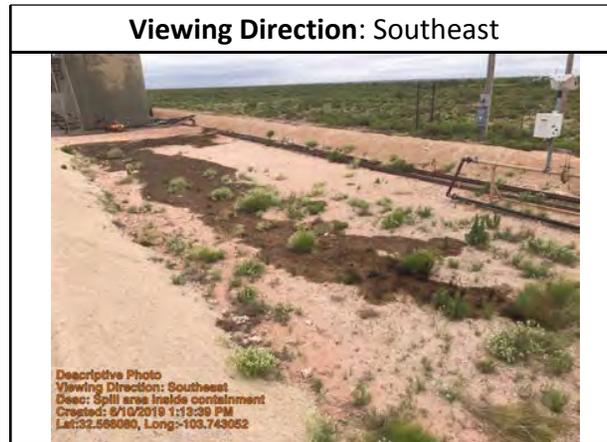
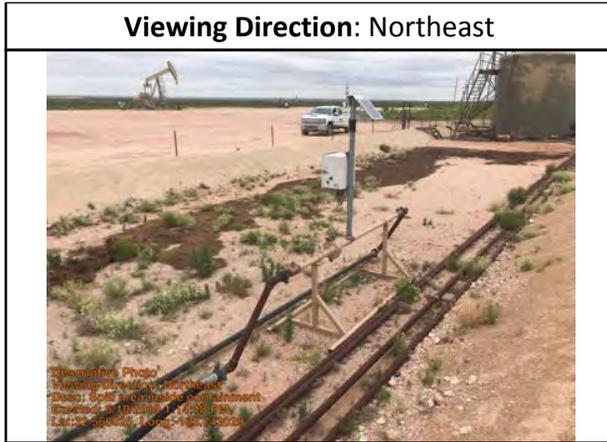
Spill area inside containment

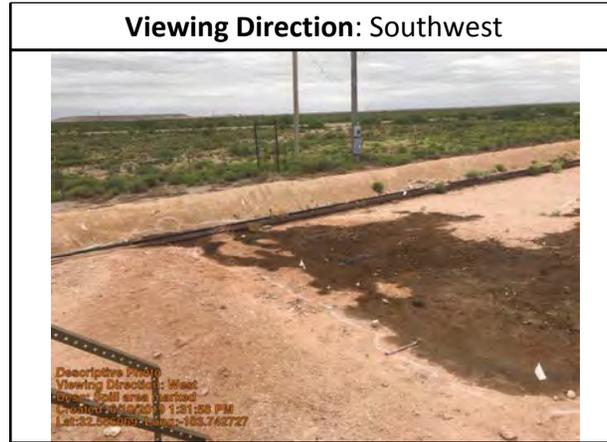
Spill area marked

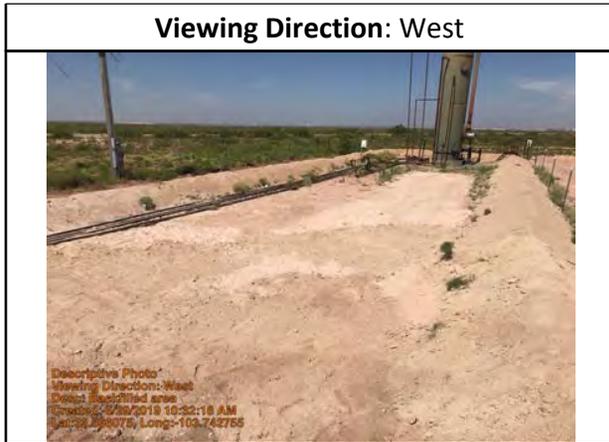
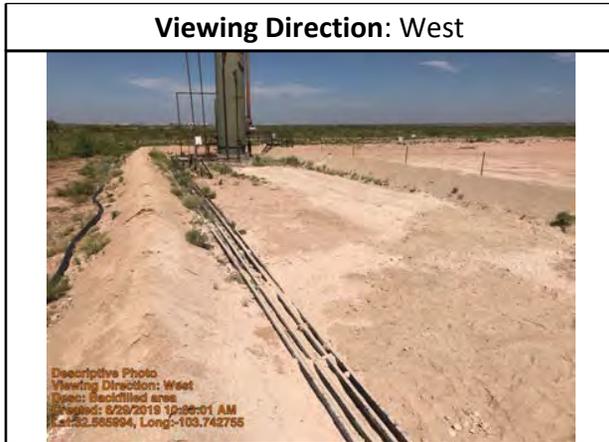
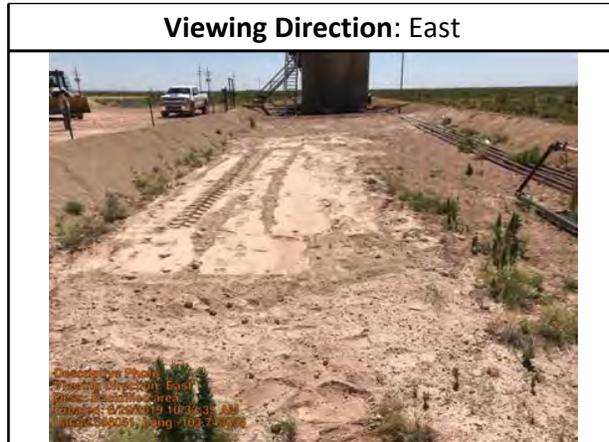
Backfilled area

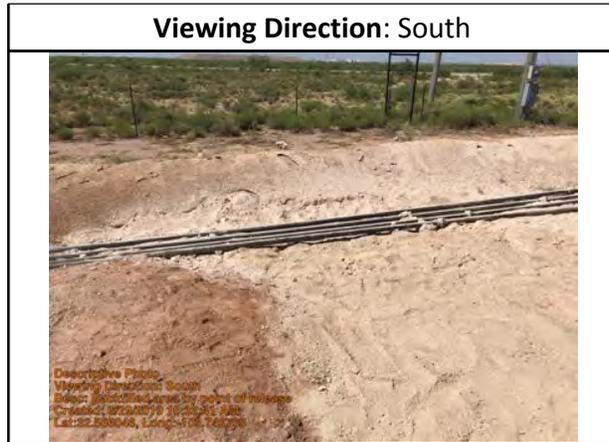
Backfilled area by point of release

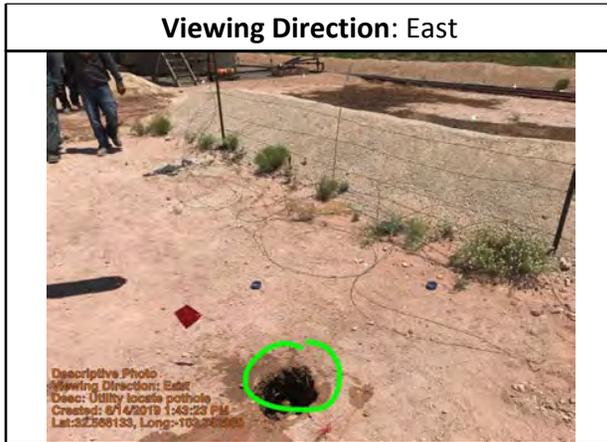
Utility locate pothole Approximately 1-1.5 feet below surface

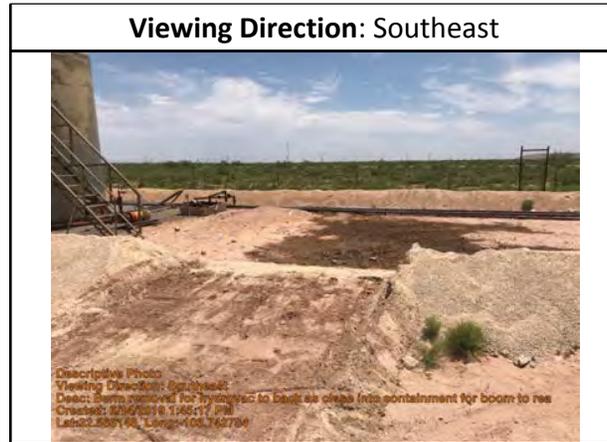
Berm removal for hydrovac to back as close into containment for boom to reach point of release

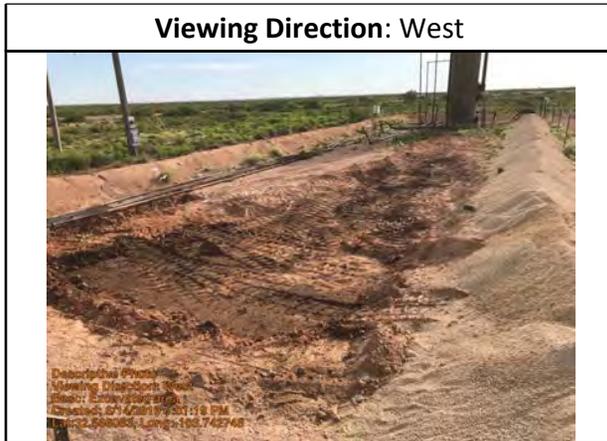
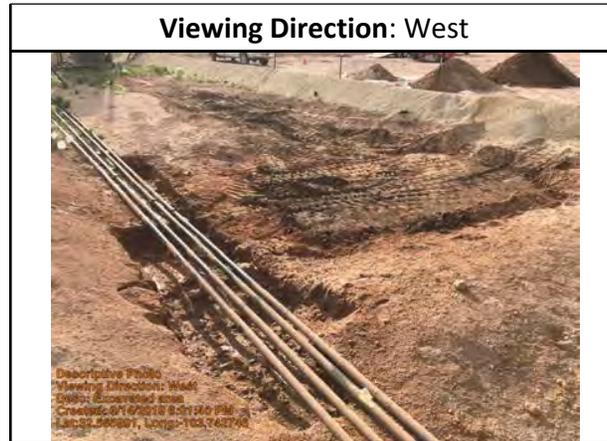
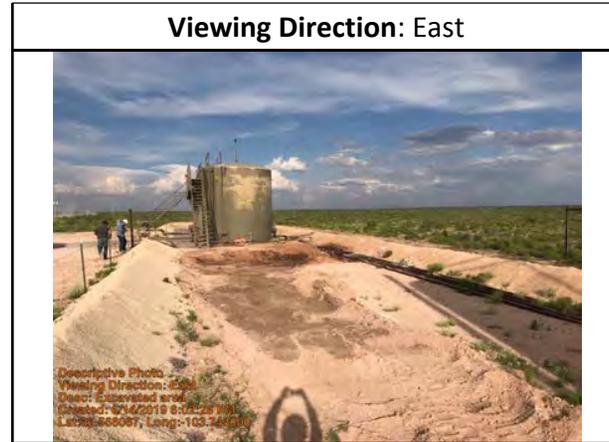
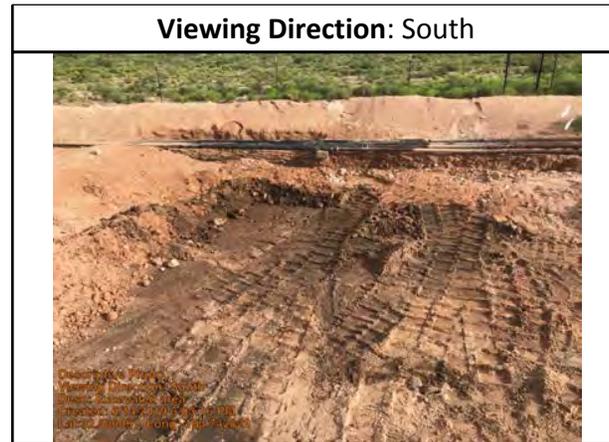
Excavated area

Remediation efforts commenced on June 14, 2019 and were completed by June 29, 2019. Vertex personnel supervised the excavation of impacted soils. Field screening was conducted on a total of five sample points and consisted of analysis using a Photo Ionization Detector (volatile hydrocarbons), Dextsil Petroflag using EPA SW-846 Method 9074 (extractable hydrocarbons) and Quantabs (chlorides). Field screening results were used to differentiate areas requiring further remediation from those areas showing concentrations below determined closure criteria levels. Soils were removed to depths between 0.25 to 1 feet bgs from within the spill footprint. Impacted soil was transported by a licensed waste hauler and disposed of at an approved waste management facility. Field screening results are presented in Attachment 5, as well as in the DFRs in Attachment 4.

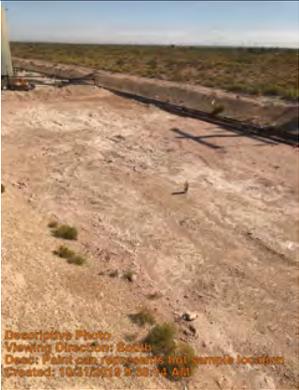
Viewing Direction: South

Paint can represents hot sample location

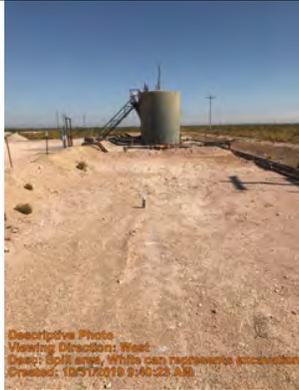
Viewing Direction: West

Spill area, White can represents excavation location

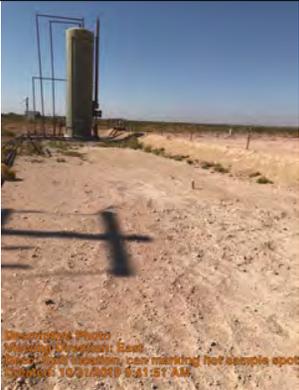
Viewing Direction: East

Spill location, can marking hot sample spot

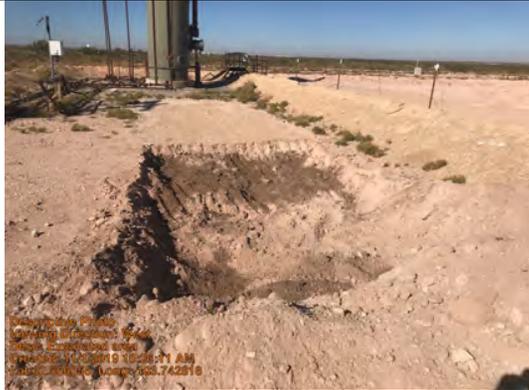
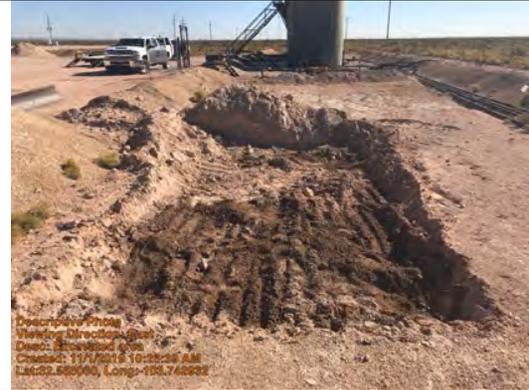
Excavated area

On November 1, 2019, Vertex personnel returned to site to excavate additional soil in the vicinity of sample point TP 19-02, using field screening procedures to guide remediation to a final depth of 1 ft bgs. A confirmation sample was collected from the area of additional remediation and submitted to Xenco Laboratories for analysis using the methods outlined above. The laboratory data report showed TPH levels below the closure criteria for a site with depth to

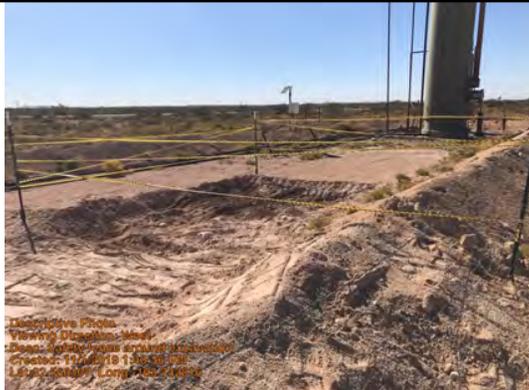
Safety fence around excavation
