**RE: 2019 Annual Groundwater Report  
Rice Operating Company – BD SWD System  
BD Santa Rita EOL Release Site (AP-58): UL/A, Sec. 27, T22S, R37E**

## **BD SANTA RITA EOL RELEASE**

AP-58

### BD Santa Rita EOL (AP-58)

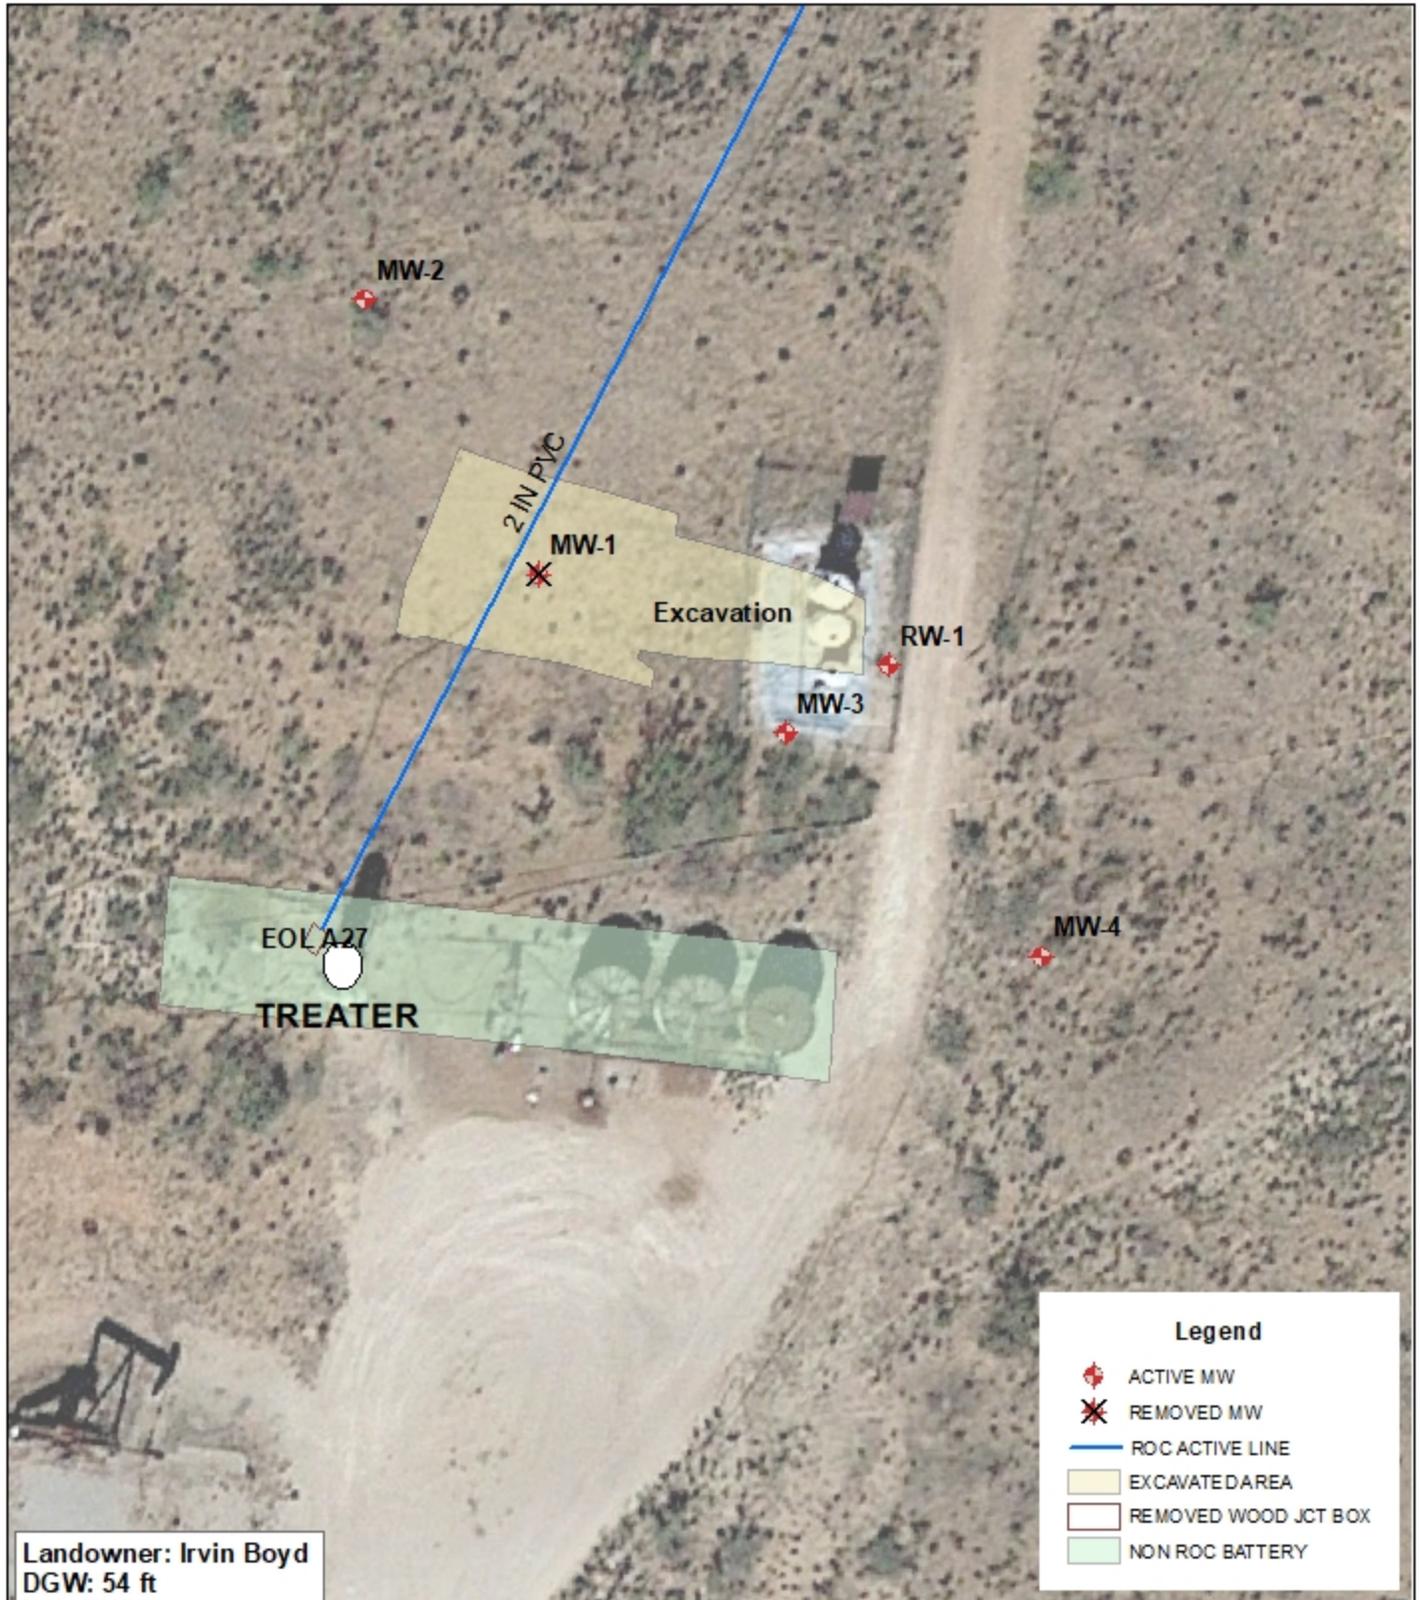
# Site Map

Landowner: Irvin Boyd  
DGW: 54 ft

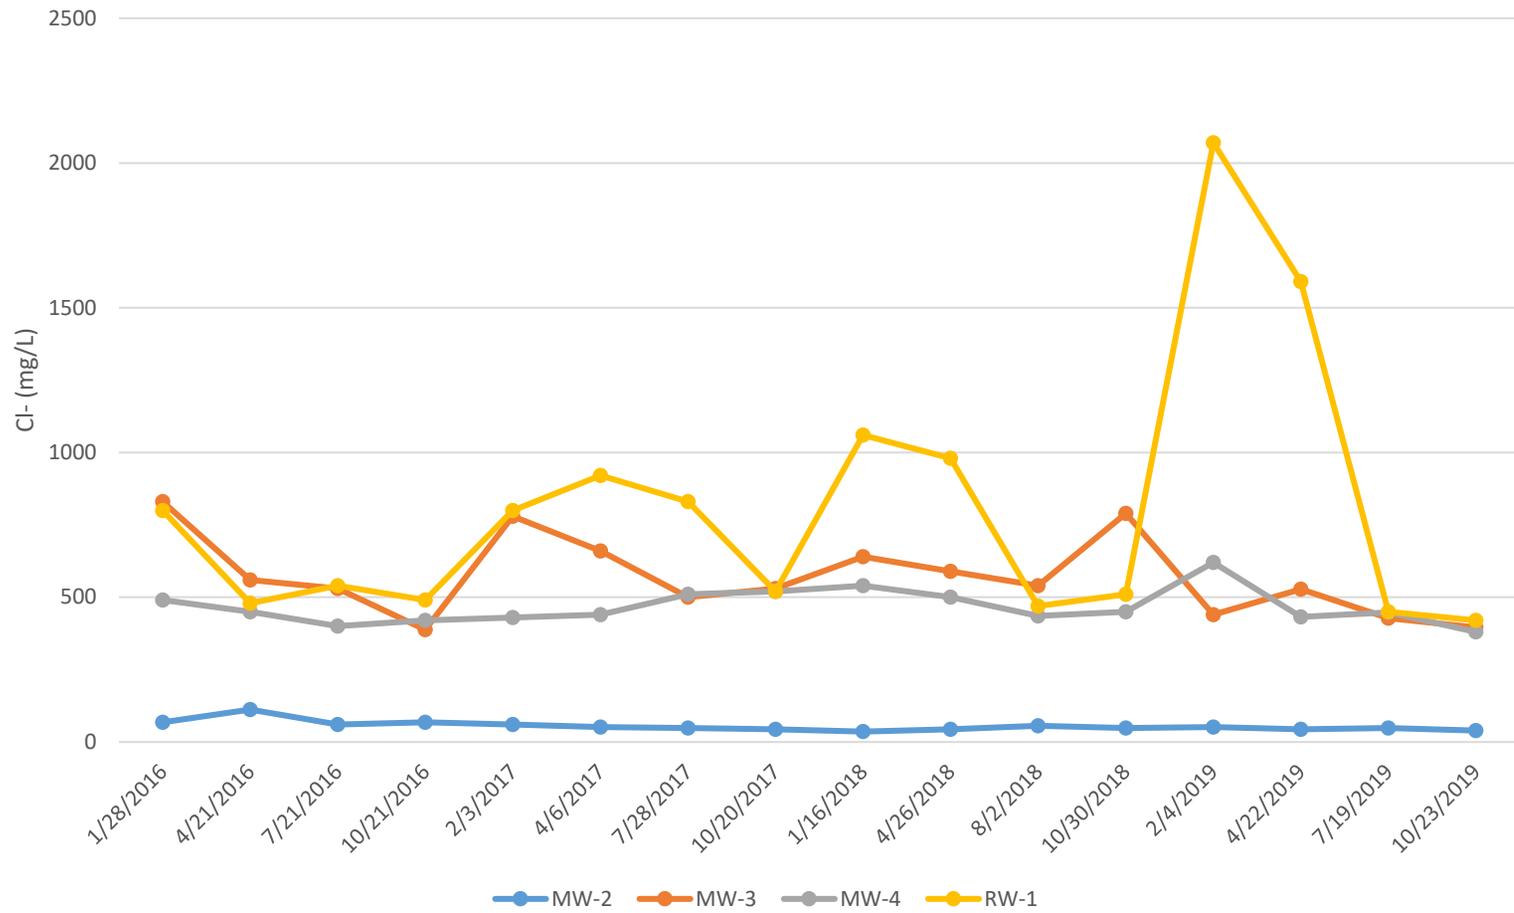
Groundwater recovery began on June 22<sup>nd</sup>, 2010 from RW-1. Since that time, approximately 53,651 barrels of groundwater have been removed (6,040 barrels were removed in 2019). Based on the most recent sampling event, this equates to approximately 3,583 Kg of chlorides removed from the site (403 Kg were removed in 2019). Since pumping efforts began, quarterly groundwater sampling results for chloride have decreased in the down gradient wells (RW-1,

MW-3, and MW-4). This indicates that the pumping program at the site has been effective in reducing the chloride load in the groundwater.

Due to the current climate, and in the interest of safety, ROC proposes to reduce groundwater monitoring from quarterly to semi-annually beginning this year. In addition, ROC is proposing to suspend groundwater recovery for this year. These proposals are only temporary and regularly scheduled groundwater monitoring and recovery will commence as soon as possible.
