**RE: 2019 Annual Groundwater Report
Rice Operating Company – BD SWD System
BD Jct. N-20 (1R426-215): UL/N, Sec. 20, T21S, R37E**

**BD Jct. N-20 (1R426-215)
Unit N, Section 20, T21S, R37E**

BD Jct. N-20 (1R426-215)

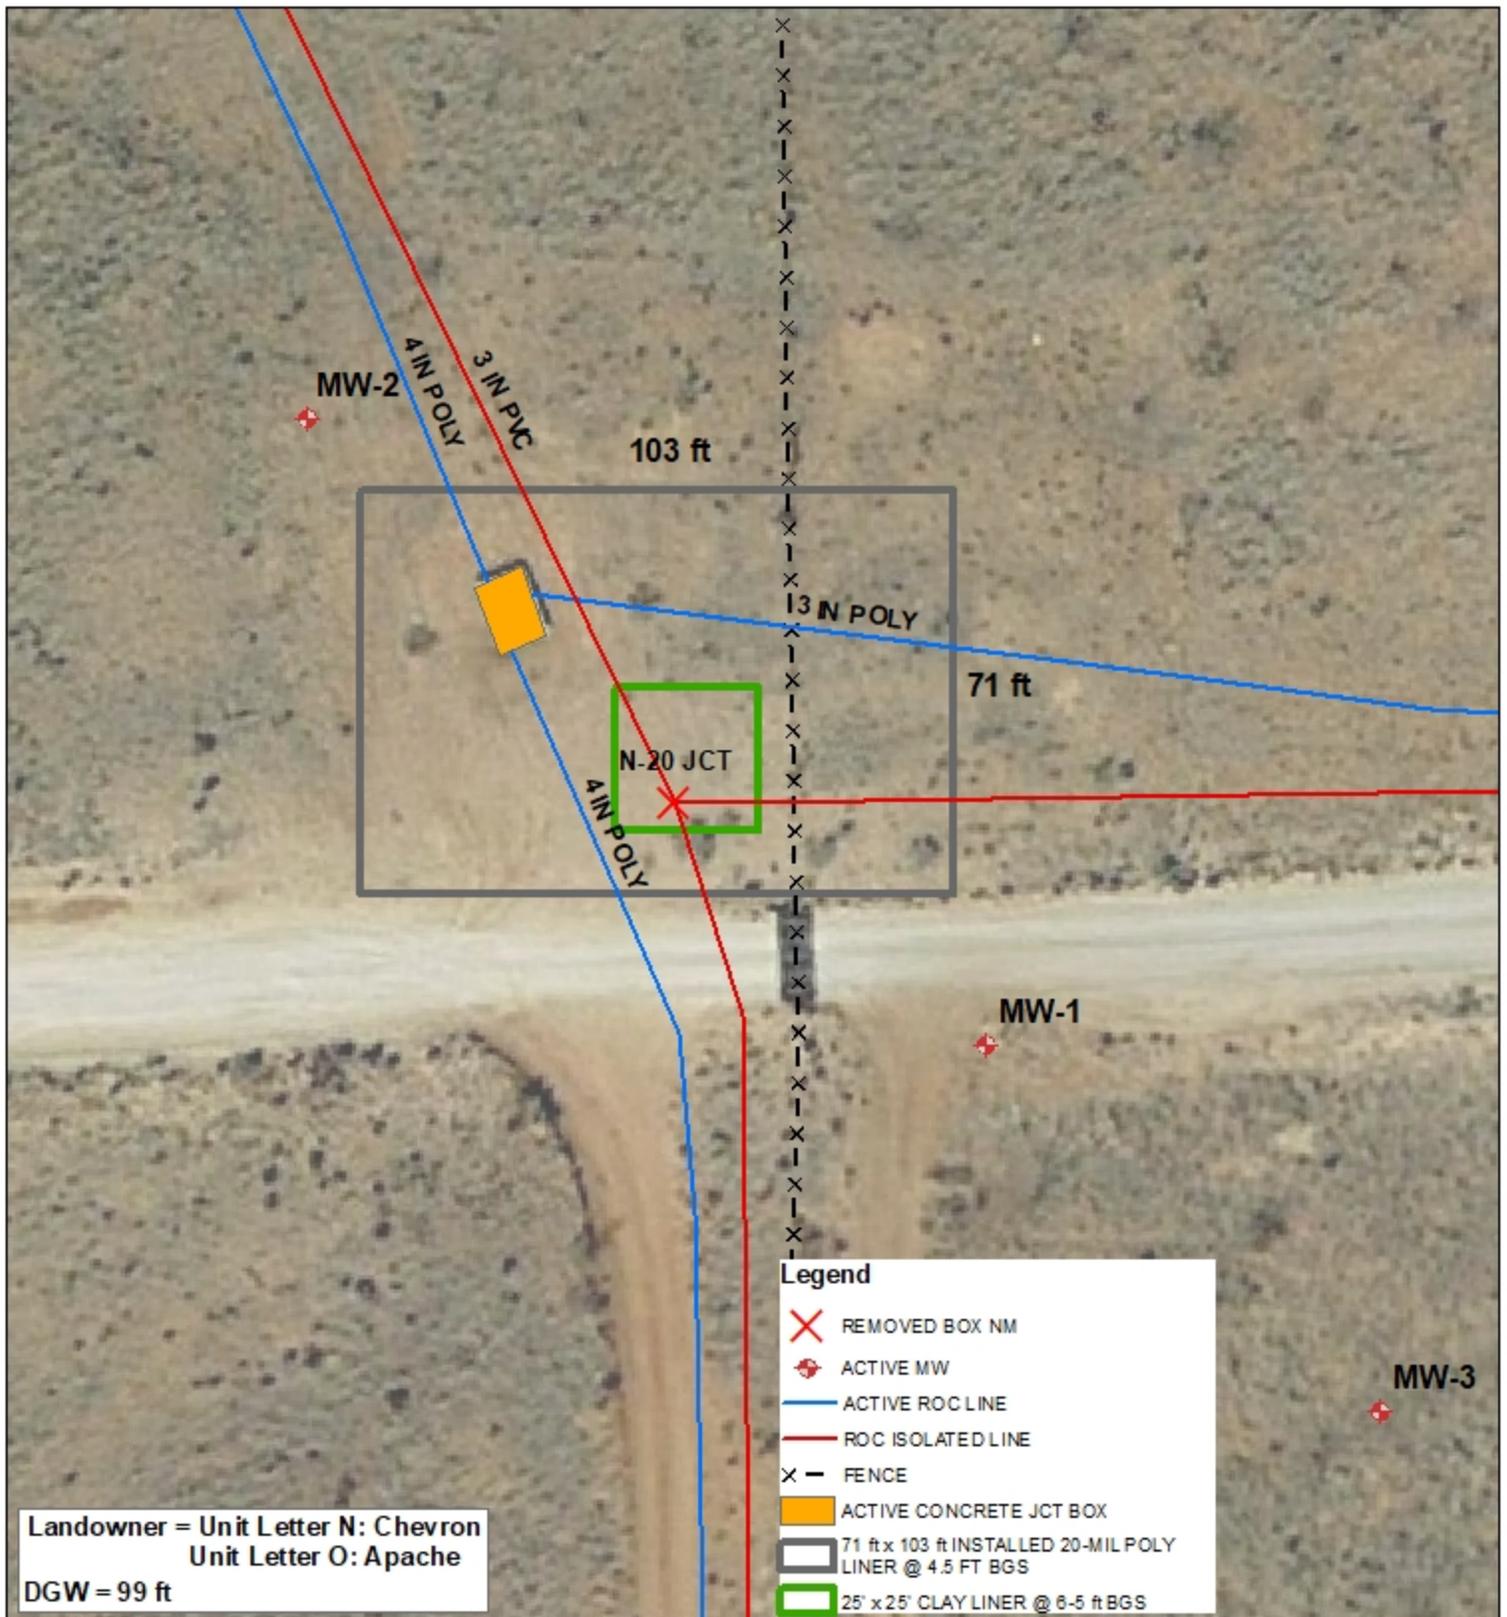
Site Map

Landowner = Unit Letter N: Chevron
 Unit Letter O: Apache
 DGW = 99 ft

- REMOVED BOX NM
- ACTIVE MW
- ACTIVE ROC LINE
- ROCK ISOLATED LINE
- FENCE
- ACTIVE CONCRETE JCT BOX
- 71 ft x 103 ft INSTALLED 20-MIL POLY LINER @ 4.5 FT BGS
- 25' x 25' CLAY LINER @ 6-5 ft BGS

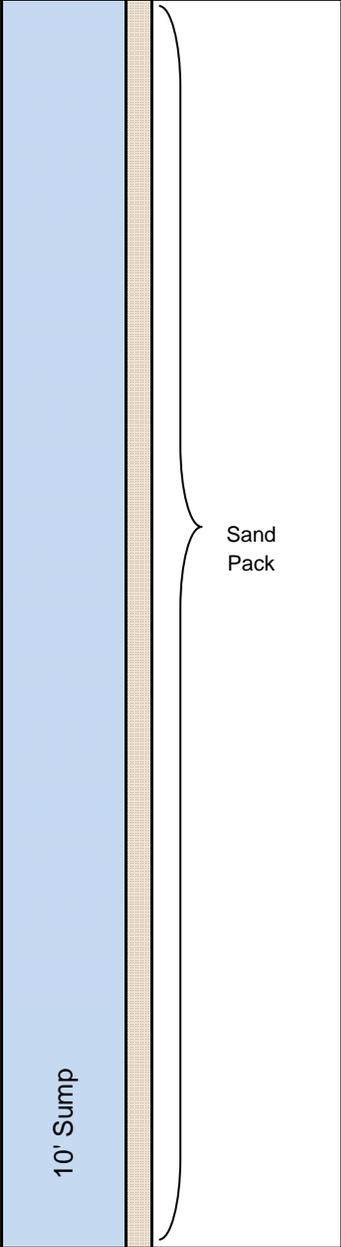
Depth (feet)	Chloride field tests	LAB	PID	Description	Lithology	Well Construction
105 ft				Brown Fine Sand, Wet from Mudding Up, No Odor

110 ft						
115 ft						
120 ft						
125 ft						
130 ft						
135 ft						
140 ft						
				(143'-145') Red Bed, Wet from Mudding Up, No Odor		
145 ft

Logger:	Nick Kopiasz		
Driller:	HCI Drilling		
Drilling Method:	Air/Mud Rotary		
Start Date:	11/15/2019		
End Date:	11/15/2019		
Project Name: BD Jct. N-20		Well ID: MW-2	
Project Consultant: Tasman

Comments: Located approximately 100 ft northwest of the former junction box. Soil samples were collected from drill cuttings at specified intervals.

TD = 113 ft GW = 99 ft

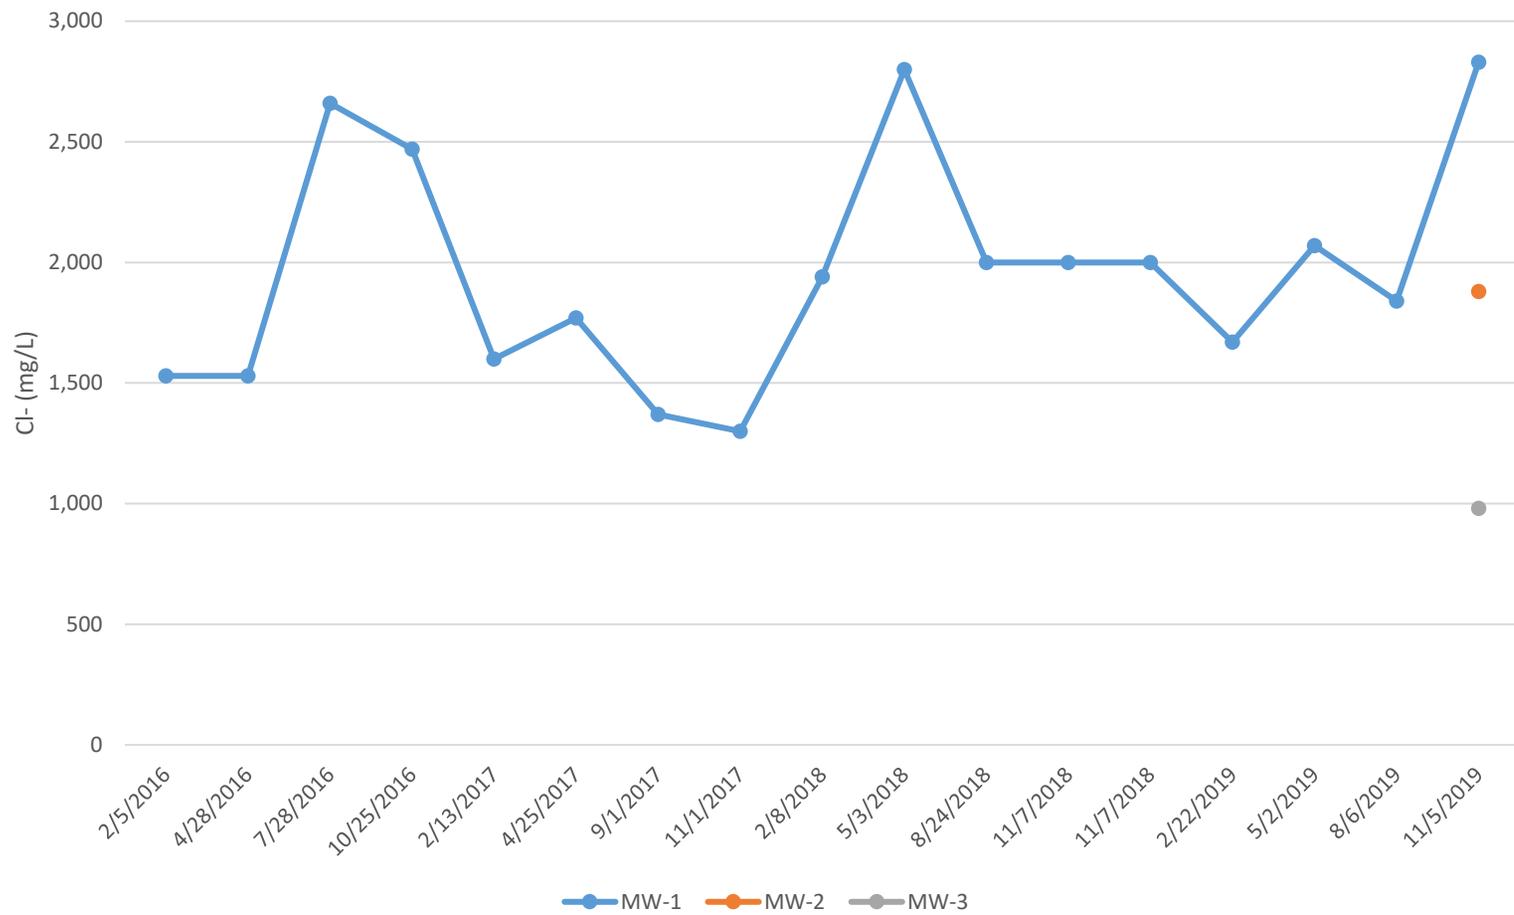
MW	Depth to Water	Total Depth	Well Volume	Volume Purged	Sample Date	Cl	TDS	Benzene	Toluene	Ethyl Benzene	Total Xylenes	Sulfate	Comments
1	100.09	146.9	30.4	100	6/22/2015	640	2,600	<0.001	<0.001	<0.001	<0.003	240	Clear No odor
1	100.23	146.9	30.34	100	8/7/2015	1,100	2,950	<0.001	<0.001	<0.001	<0.003	112	Clear No odor
1	100.22	146.9	30.34	100	10/29/2015	1,260	3,740	<0.001	<0.001	<0.001	<0.003	94	Clear No odor
1	100.14	146.9	30.4	100	2/5/2016	1,530	2,710	<0.001	<0.001	<0.001	<0.003	85	Clear No odor
1	100.14	146.9	30.4	100	4/28/2016	1,530	3,050	<0.001	<0.001	<0.001	<0.003	240	Clear No odor
1	100.21	146.9	30	100	7/28/2016	2,660	5,220	<0.001	<0.001	<0.001	<0.003	16	Clear No odor
1	100.07	146.9	30	100	10/25/2016	2,470	6,460	<0.001	<0.001	<0.001	<0.003	18	Clear No odor
1	100.04	146.9	30.5	100	2/13/2017	1,600	2,970	<0.001	<0.001	<0.001	<0.003	38	Clear No odor
1	99.95	146.9	30.5	100	4/25/2017	1,770	3,160	<0.001	<0.001	<0.001	<0.003	67	Clear No odor

1	99.94	146.9	30.5	100	9/1/2017	1,370	3,170	<0.001	<0.001	<0.001	<0.003	198	Clear No odor
1	99.93	146.9	30.5	100	11/1/2017	1,300	2,780	<0.001	<0.001	<0.001	<0.003	272	Clear No odor
1	99.94	146.9	30.5	100	2/8/2018	1,940	3,310	<0.001	<0.001	<0.001	<0.003	119	Clear No odor
1	100.02	146.9	30.5	100	5/3/2018	2,800	4,850	<0.001	<0.001	<0.001	<0.003	110	Clear No odor
1	100.03	146.9	30.5	100	8/24/2018	2,000	5,040	<0.001	<0.001	<0.001	<0.003	107	Clear No odor
1	100.01	146.9	30.5	100	11/7/2018	2,000	3,510	<0.001	<0.001	<0.001	<0.003	110	Clear No odor
1	100.02	146.9	30.5	100	2/22/2019	1,670	2,740	<0.001	<0.001	<0.001	<0.003	140	Clear No odor
1	100.03	146.9	30.5	100	5/2/2019	2,070	3,370	<0.001	<0.001	<0.001	<0.003	107	Clear No odor
1	100.01	146.9	30.5	100	8/6/2019	1,840	4,240	<0.001	<0.001	<0.001	<0.003	111	Clear No odor
1	100.09	146.9	30	100	11/5/2019	2,830	5,240	<0.001	<0.001	<0.001	<0.003	127	Clear No odor
