Inspection Report
Loco Hills Water Disposal Facility (Waypoint #19)
Eddy County, NM

Inspection Date: November 2, 1998

Facility Description: Commercial facility for produced water disposal.

**Compliance Evaluation Inspection Narrative
Loco Hills Water Disposal Facility (Waypoint #19)
Eddy County, NM**

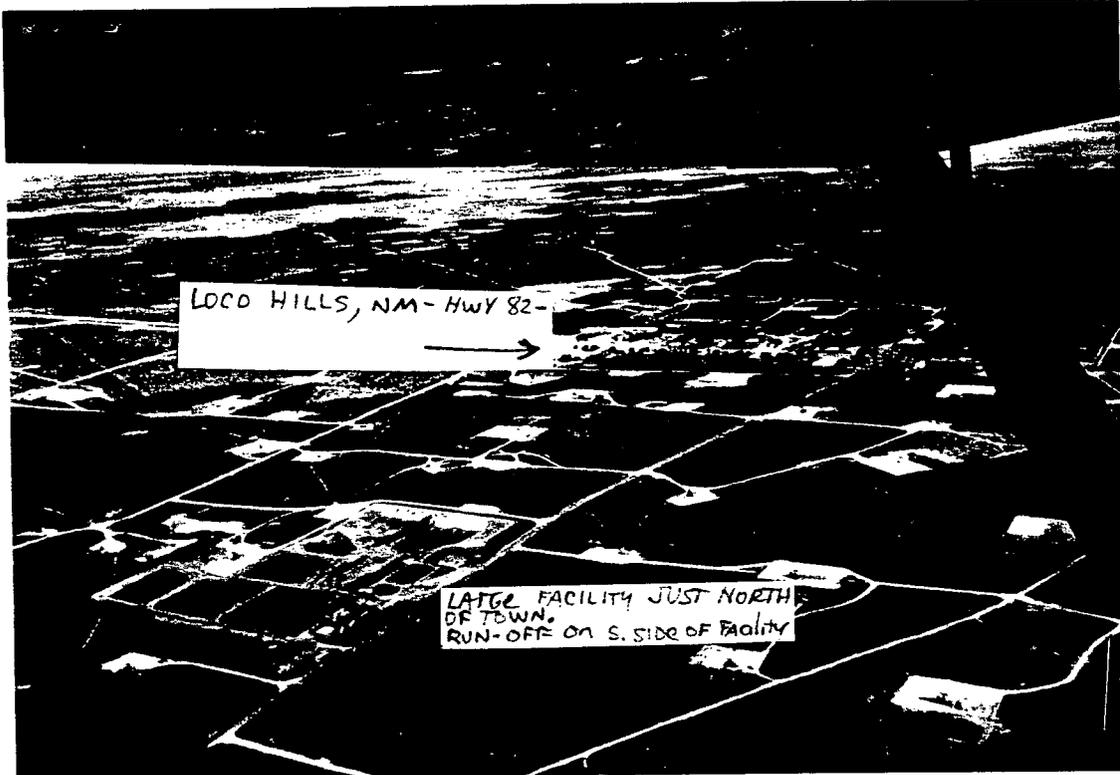
Photo Number: 1 Photographer: Greg Stover, FWS
Location: Loco Hills Water Disposal
Subject: Aerial view of facility
City/County: Loco Hills/Eddy County State: NM
Date: 09/17/98 Time: unknown Weather: partly cloudy

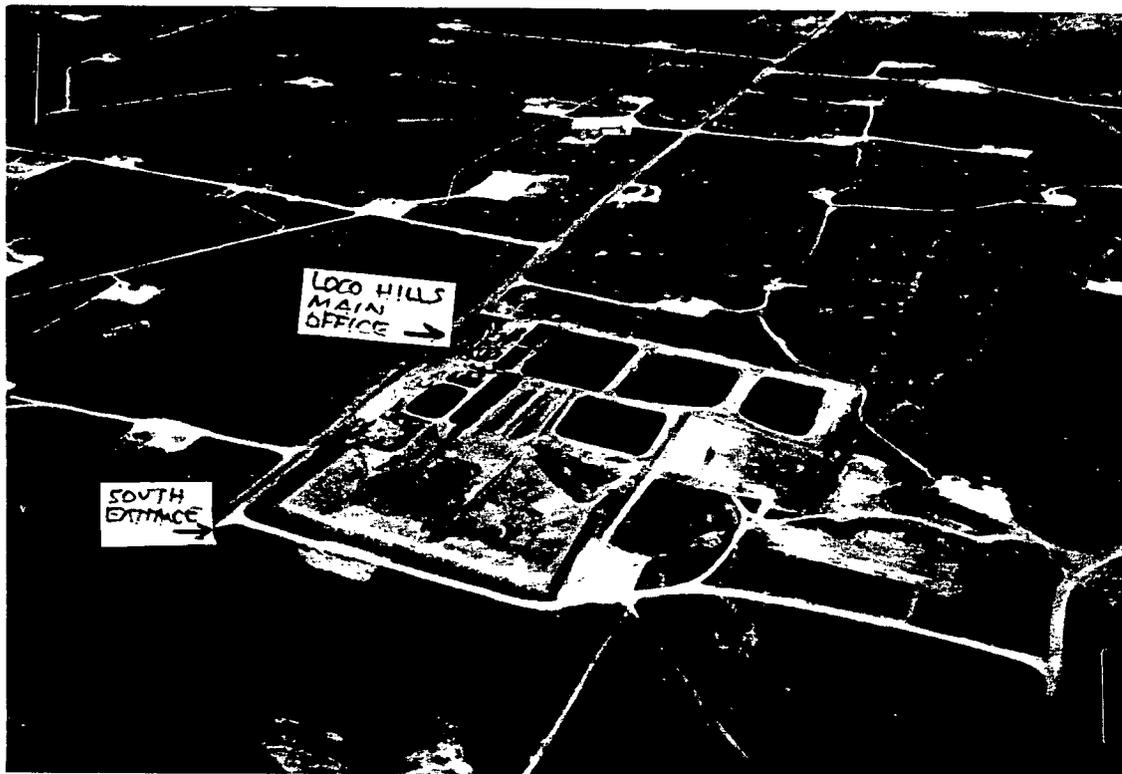
Photo Number: 2 Photographer: Greg Stover, FWS
Location: Loco Hills Water Disposal
Subject: Aerial view of facility
City/County: Loco Hills/Eddy County State: NM
Date: 09/17/98 Time: unknown Weather: partly cloudy

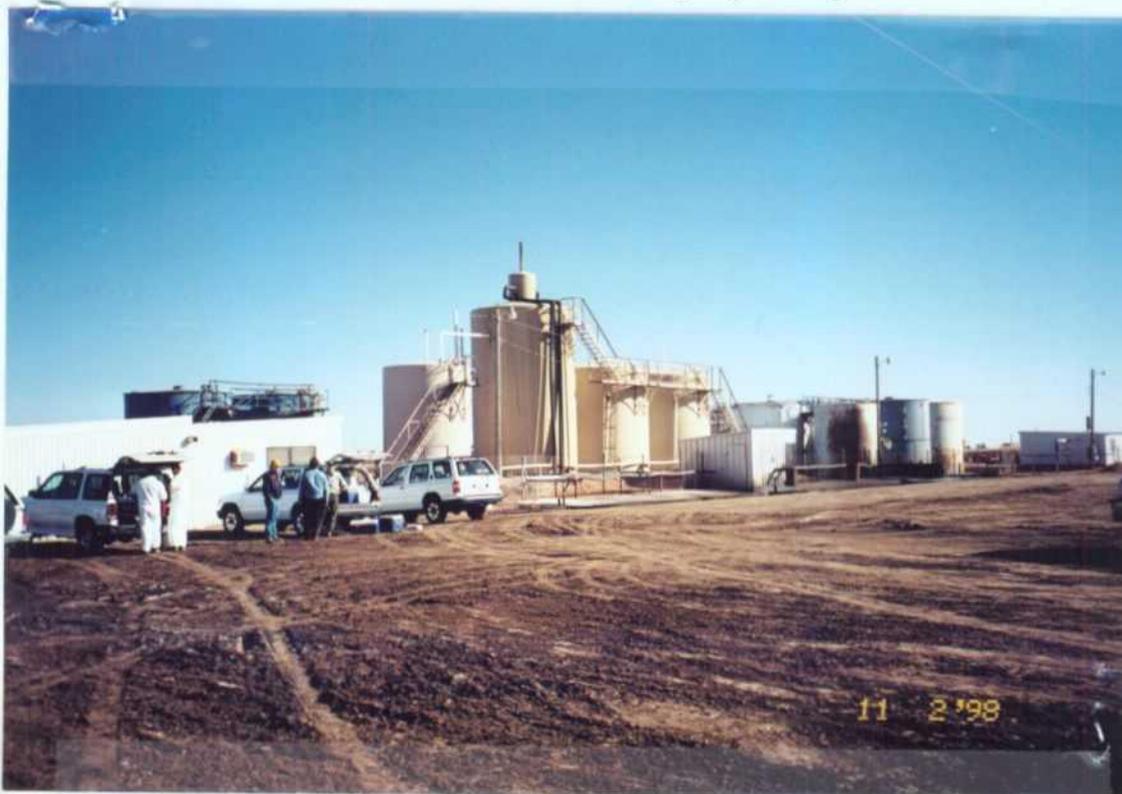
Photo Number: 3 Photographer: Melissa Smith
Location: Loco Hills Water Disposal
Subject: Front of facility, unloading area, and receiving tanks
City/County: Loco Hills/Eddie County State: NM
Date: 11/02/98 Time: am Weather: cool, sunny

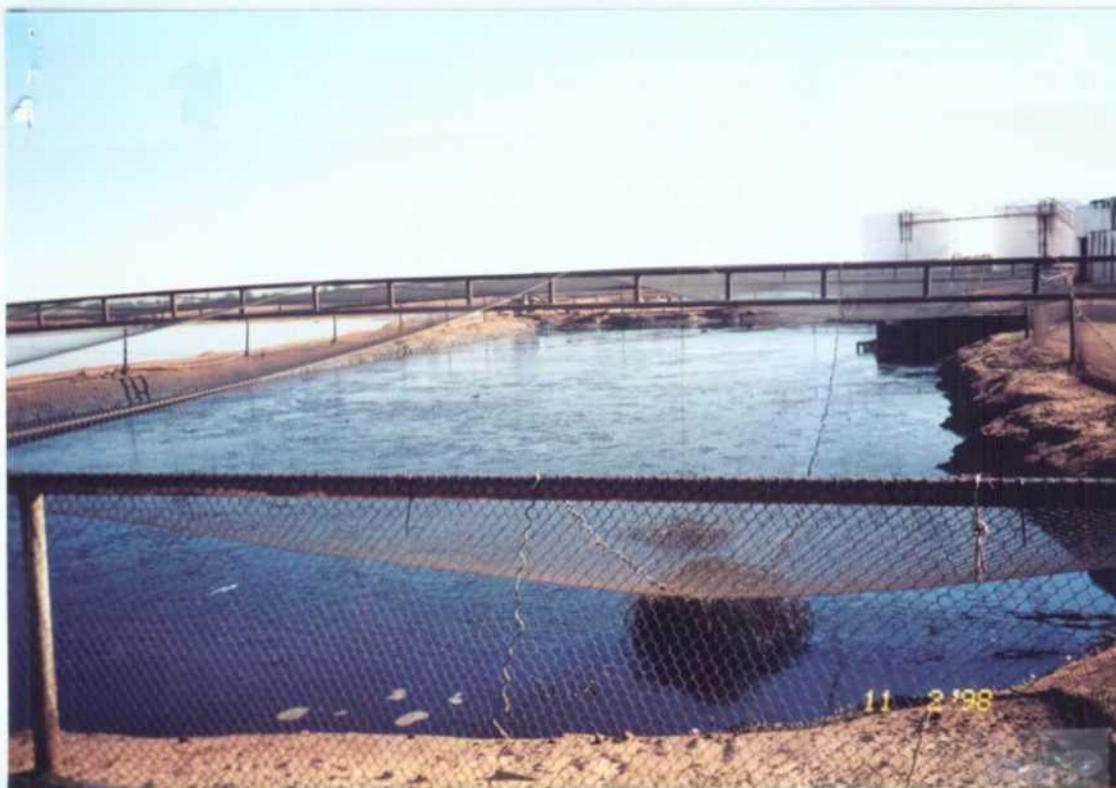
Photo Number: 4 Photographer: Melissa Smith
Location: Loco Hills Water Disposal
Subject: Skim pit - not currently in use
City/County: Loco Hills/Eddie County State: NM
Date: 11/02/98 Time: am Weather: cool, sunny

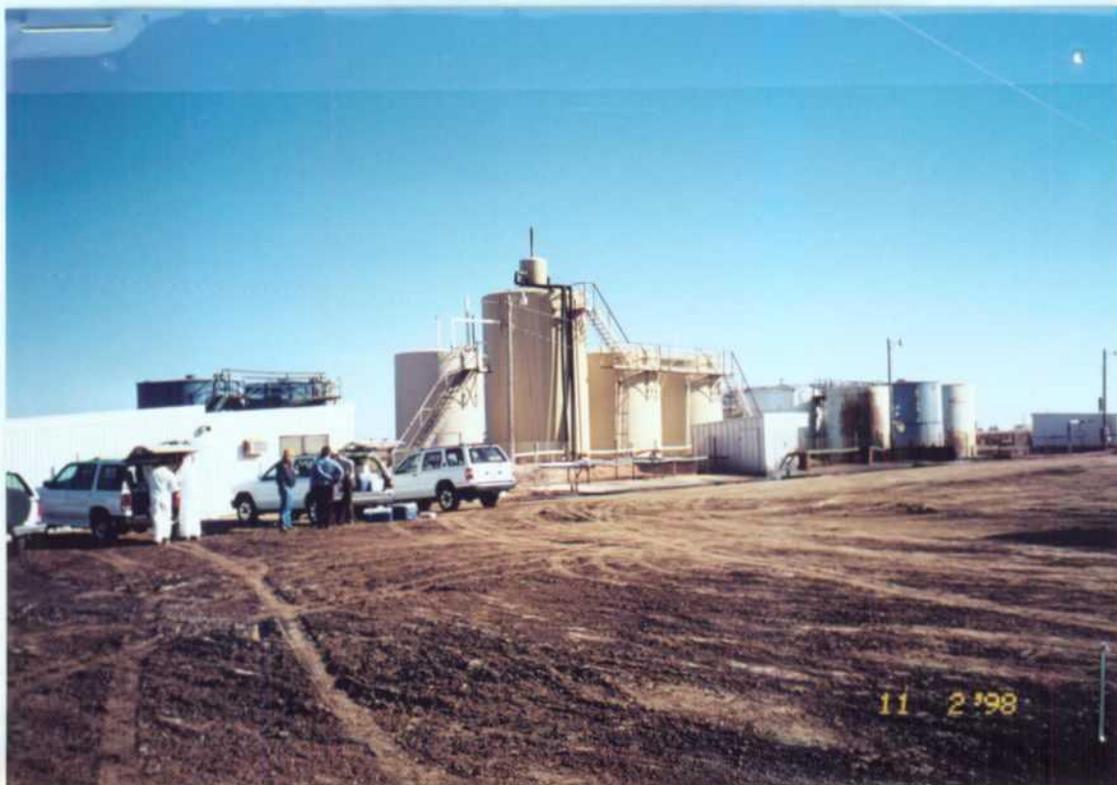
Photo Number: 1 Photographer: Melissa Smith
Location: Loco Hills Water Disposal
Subject: Front of facility, unloading area, and receiving tanks
City/County: Loco Hills/Eddie County State: NM
Date: 11/02/98 Time: am Weather: cool, sunny

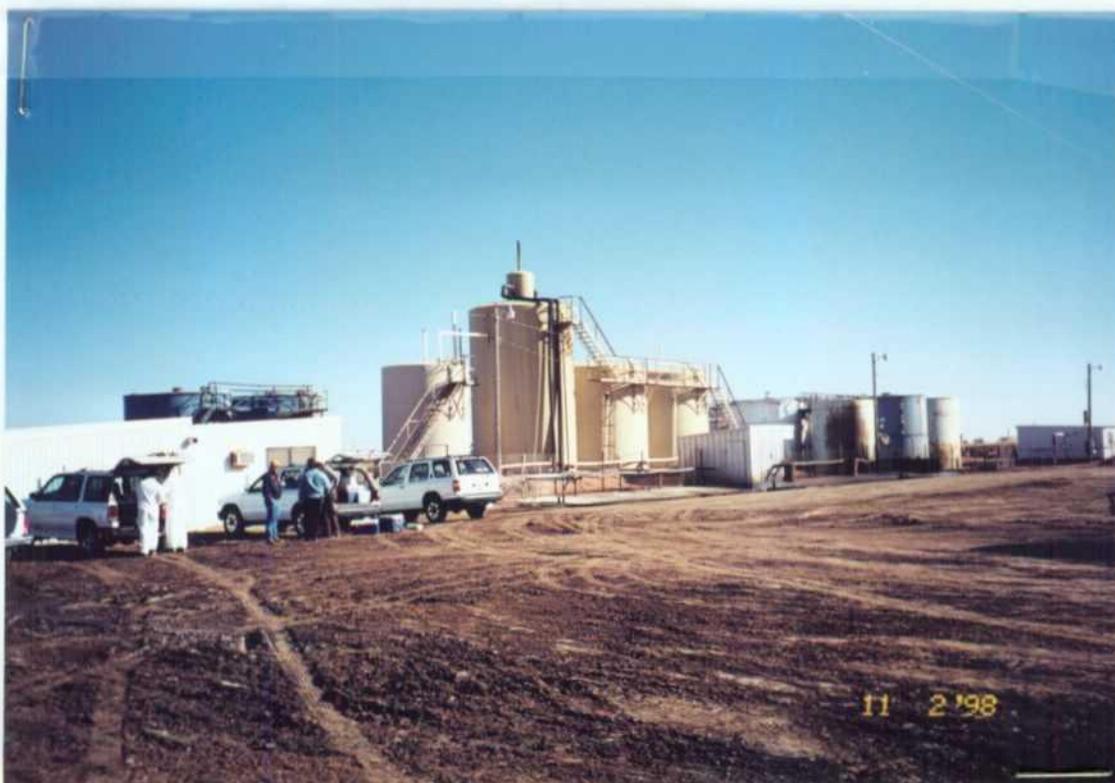
Photo Number: 2 Photographer: Melissa Smith
Location: Loco Hills Water Disposal
Subject: Front of facility, unloading area, and receiving tanks
City/County: Loco Hills/Eddie County State: NM
Date: 11/02/98 Time: am Weather: cool, sunny

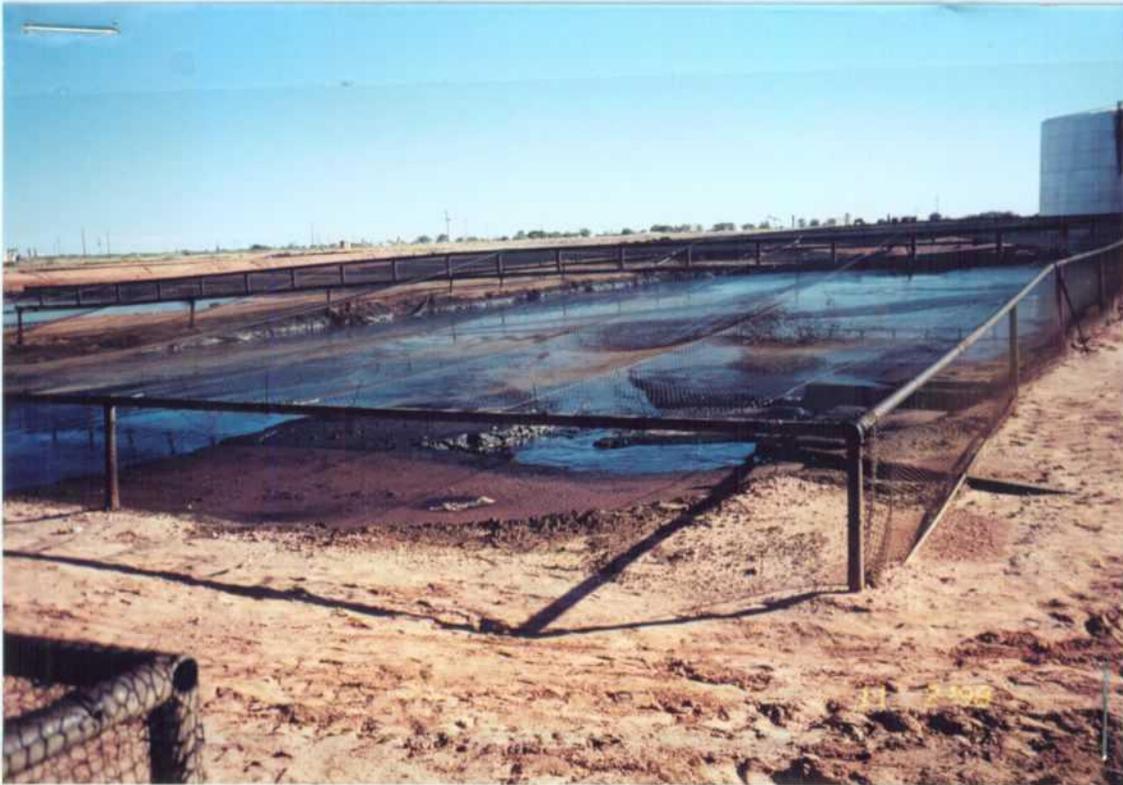
Photo Number: 5 Photographer: Melissa Smith
Location: Loco Hills Water Disposal
Subject: Skim pit - in use
City/County: Loco Hills/Eddie County State: NM
Date: 11/02/98 Time: am Weather: cool, sunny

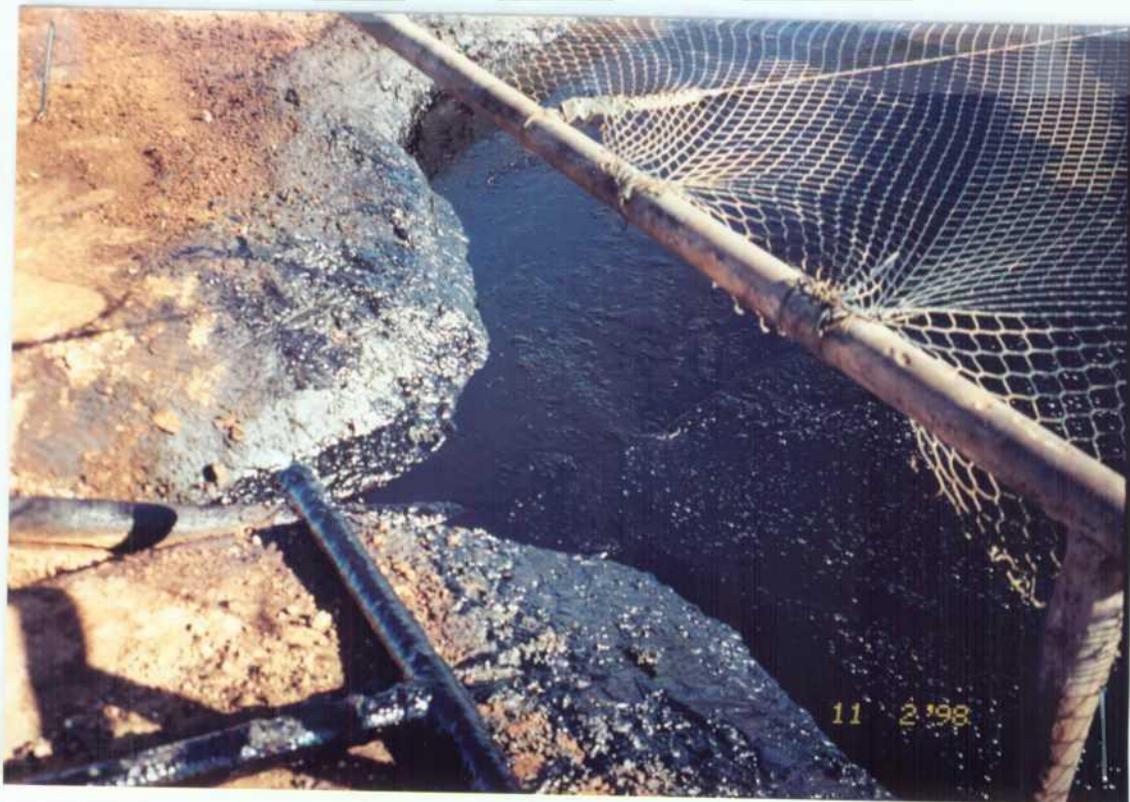
Photo Number: 6 Photographer: Melissa Smith
Location: Loco Hills Water Disposal
Subject: Oil being removed from skim pit
City/County: Loco Hills/Eddie County State: NM
Date: 11/02/98 Time: am Weather: cool, sunny

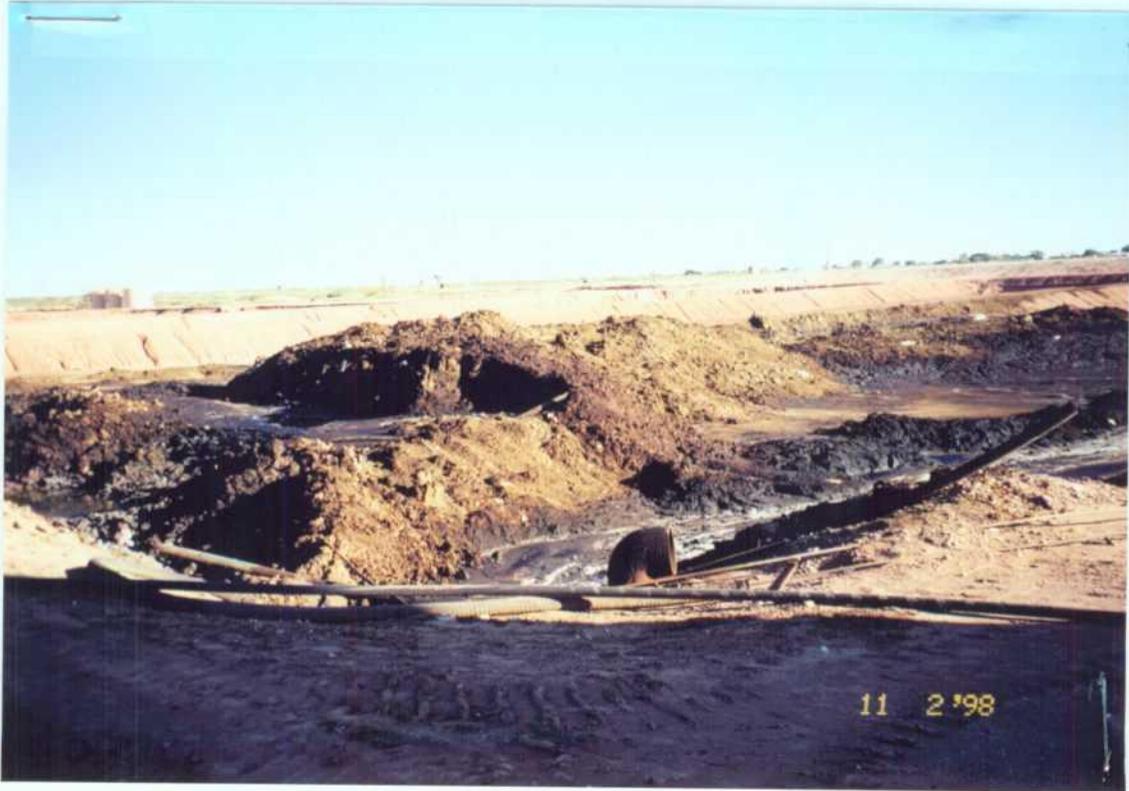
Photo Number: 7 Photographer: Melissa Smith
Location: Loco Hills Water Disposal
Subject: Solids from skim pits
City/County: Loco Hills/Eddie County State: NM
Date: 11/02/98 Time: am Weather: cool, sunny

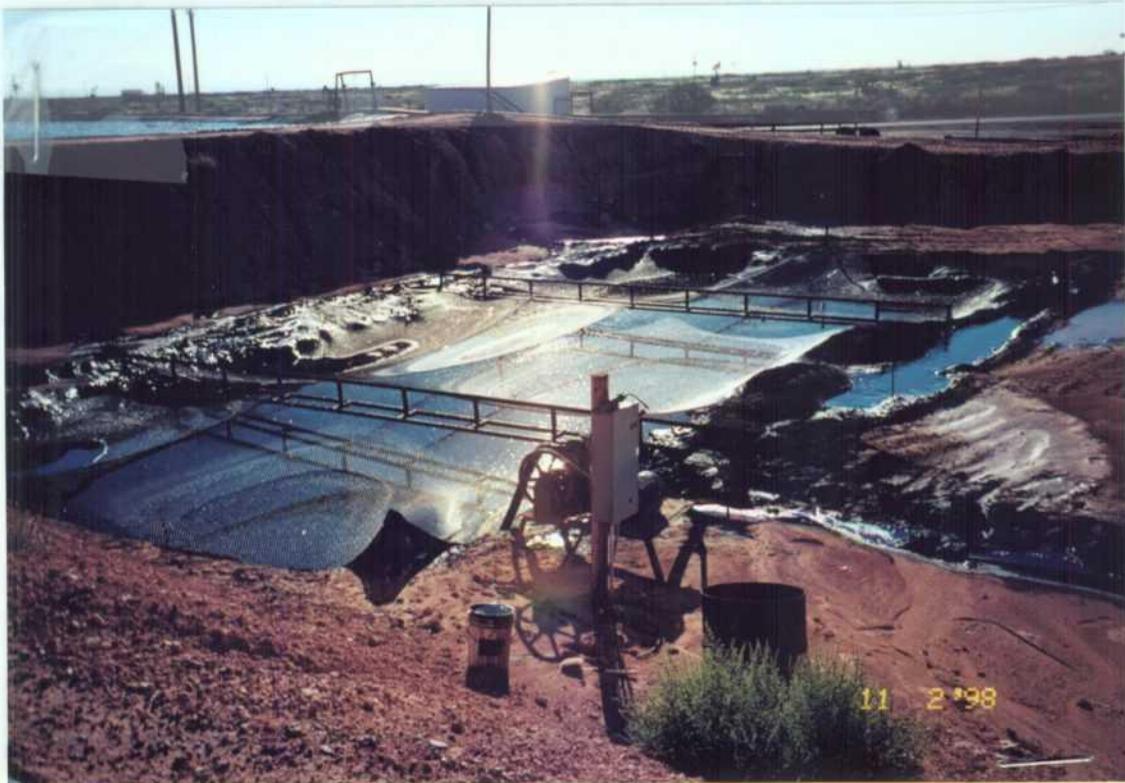
Photo Number: 8 Photographer: Melissa Smith
Location: Loco Hills Water Disposal
Subject: Overflow/spill pit with netting
City/County: Loco Hills/Eddie County State: NM
Date: 11/02/98 Time: am Weather: cool, sunny

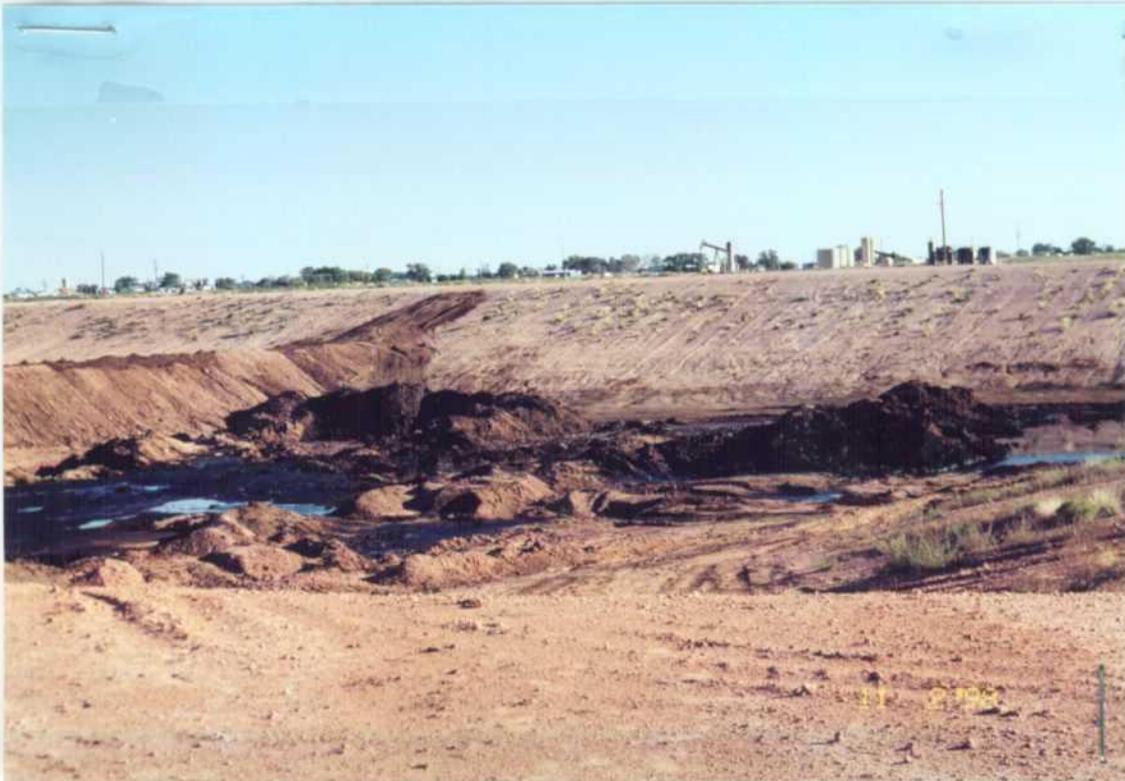
Photo Number: 9 Photographer: Melissa Smith
Location: Loco Hills Water Disposal
Subject: Landfarming of solids
City/County: Loco Hills/Eddie County State: NM
Date: 11/02/98 Time: am Weather: cool, sunny

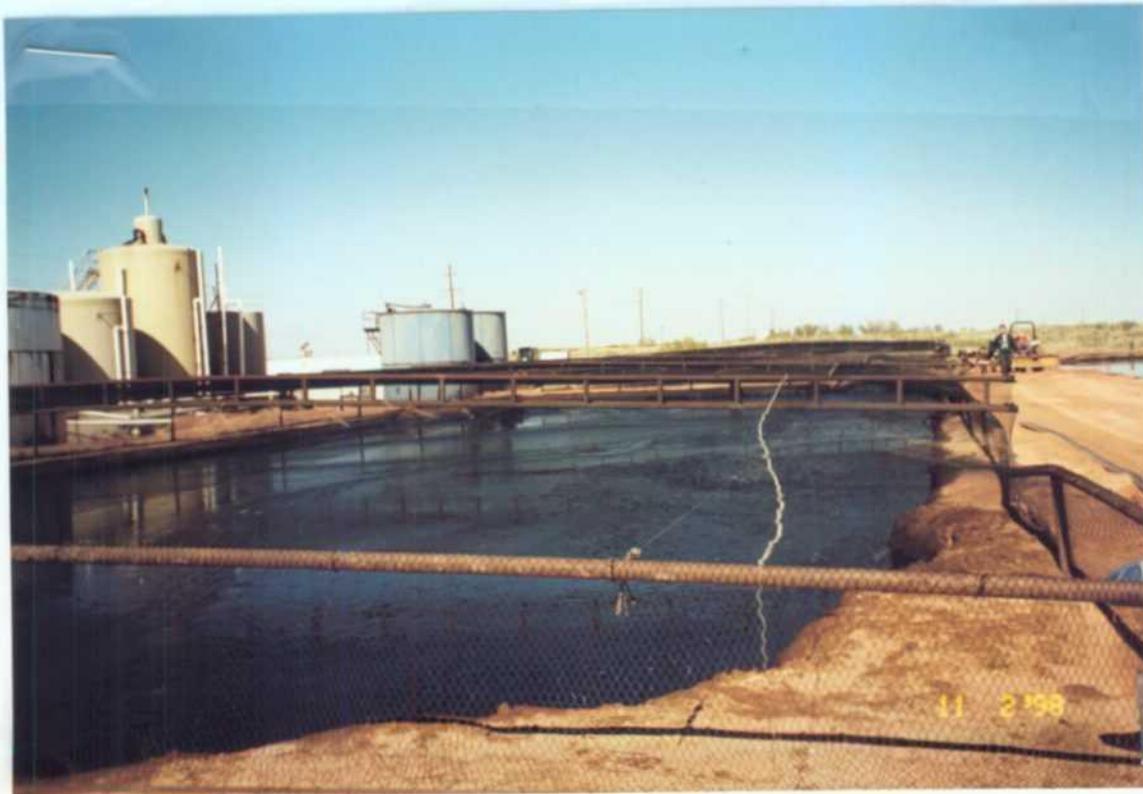
Photo Number: 1 Photographer: T. Reeves
Location: Loco Hills Water Disposal Facility (WP19)
Subject: First separation pond (skim pit), looking north.
City/County: Loco Hills/Eddy County State: NM
Date: 11/02/98 Time: am Weather: sunny, cool

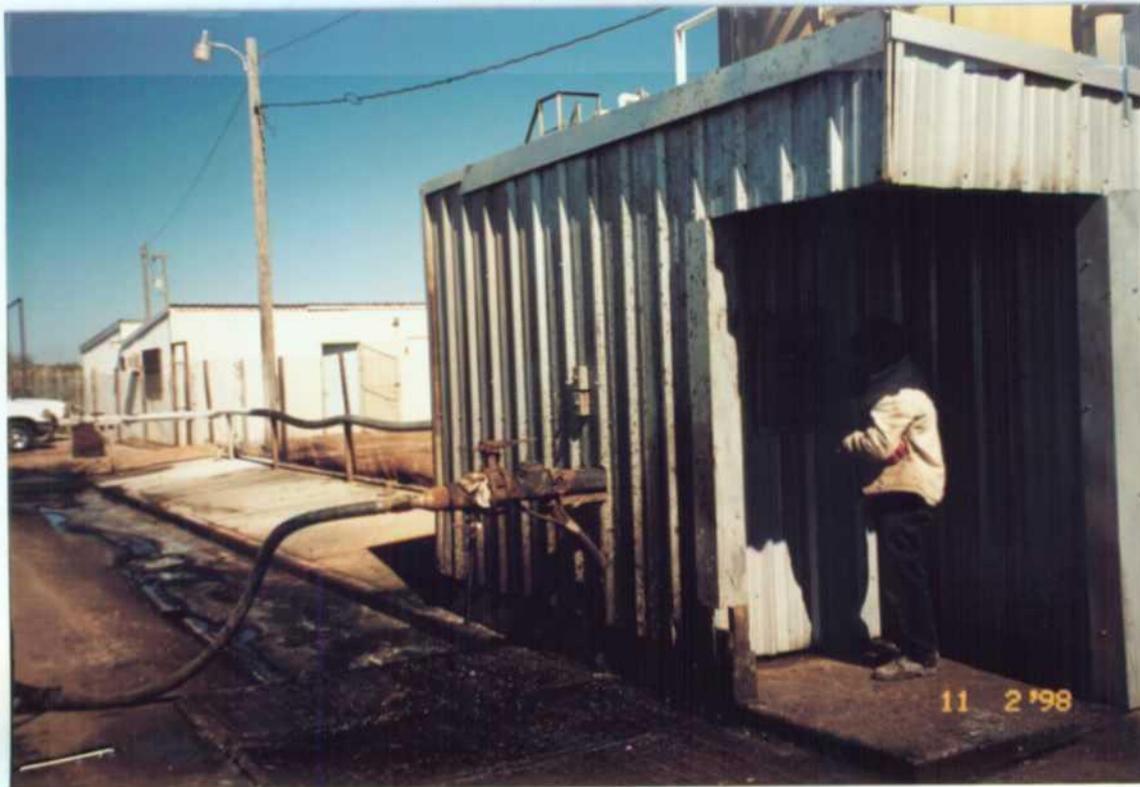
Photo Number: 2 Photographer: T. Reeves
Location: Loco Hills Water Disposal Facility (WP19)
Subject: Off loading of produced water, looking northeast.
City/County: Loco Hills/Eddy County State: NM
Date: 11/02/98 Time: am Weather: sunny, cool

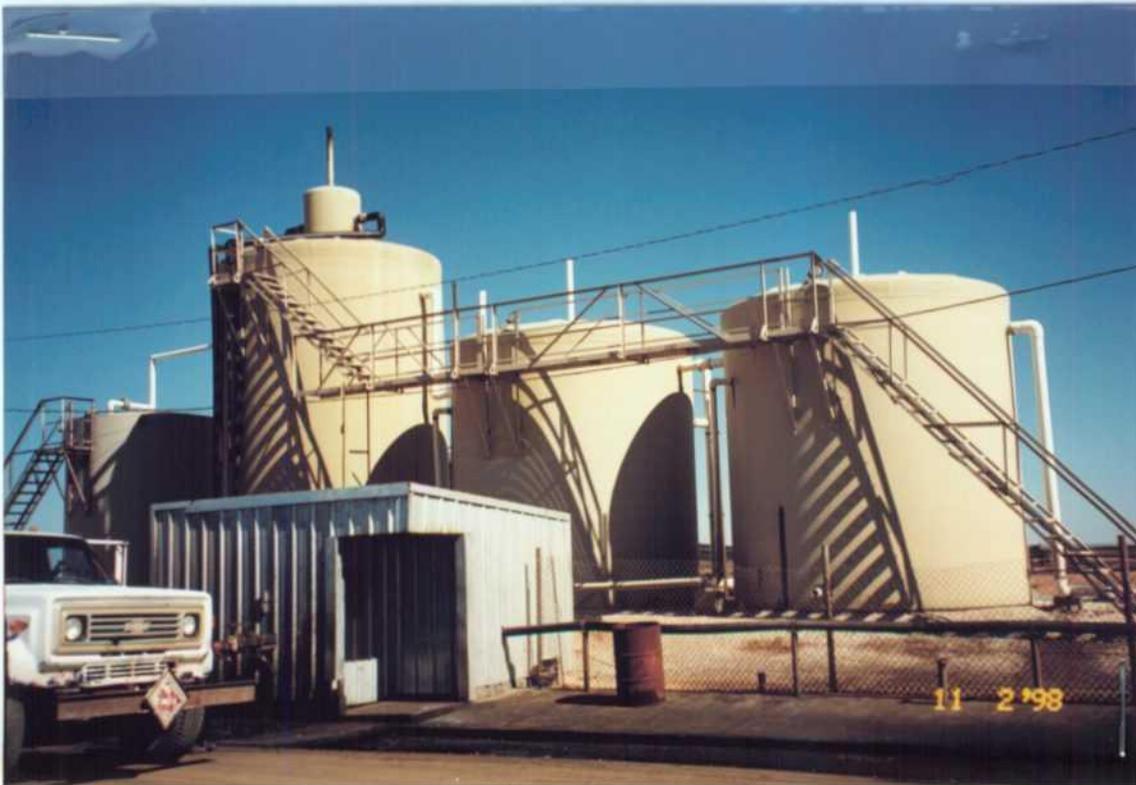
Photo Number: 3 Photographer: T. Reeves
Location: Loco Hills Water Disposal Facility (WP19)
Subject: Receiving tanks, looking east.
City/County: Loco Hills/Eddy County State: NM
Date: 11/02/98 Time: am Weather: sunny, cool

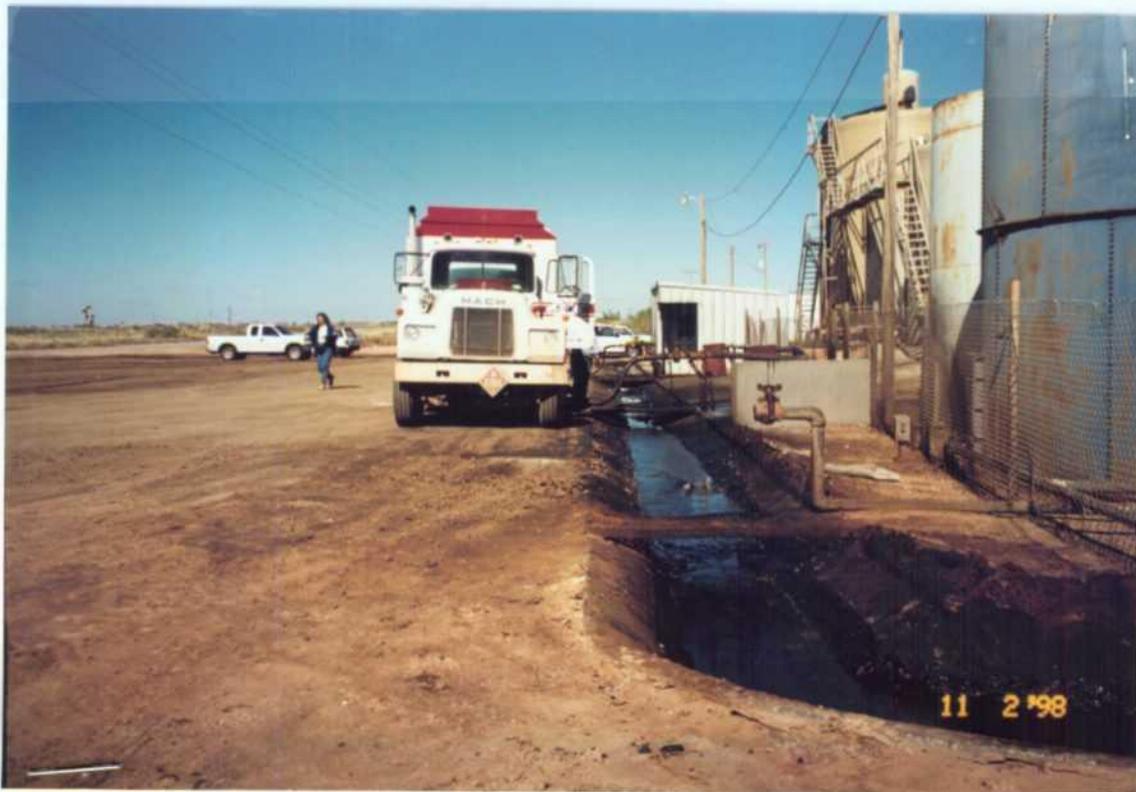
Photo Number: 4 Photographer: T. Reeves
Location: Loco Hills Water Disposal Facility (WP19)
Subject: Containment trench at off loading area, looking north.
City/County: Loco Hills/Eddy County State: NM
Date: 11/02/98 Time: am Weather: sunny, cool

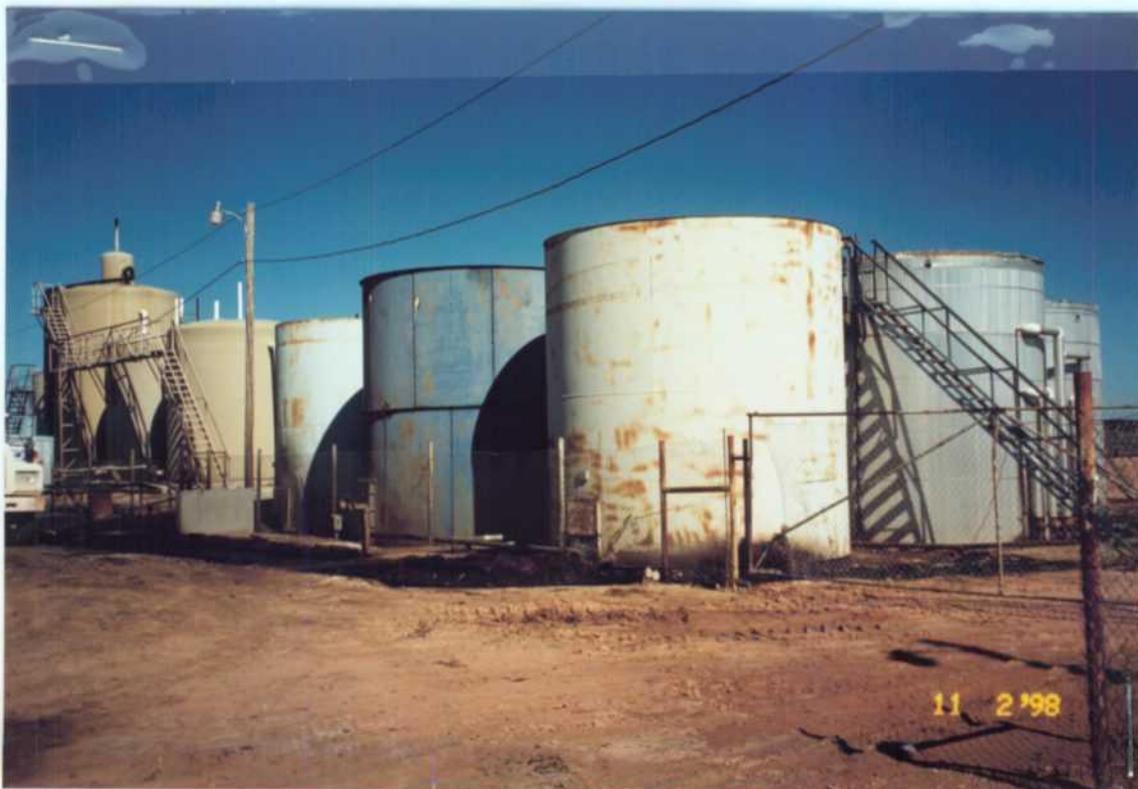
Photo Number: 5 Photographer: T. Reeves
Location: Loco Hills Water Disposal Facility (WP19)
Subject: Recovered oil tank battery.
City/County: Loco Hills/Eddy County State: NM
Date: 11/02/98 Time: am Weather: sunny, cool

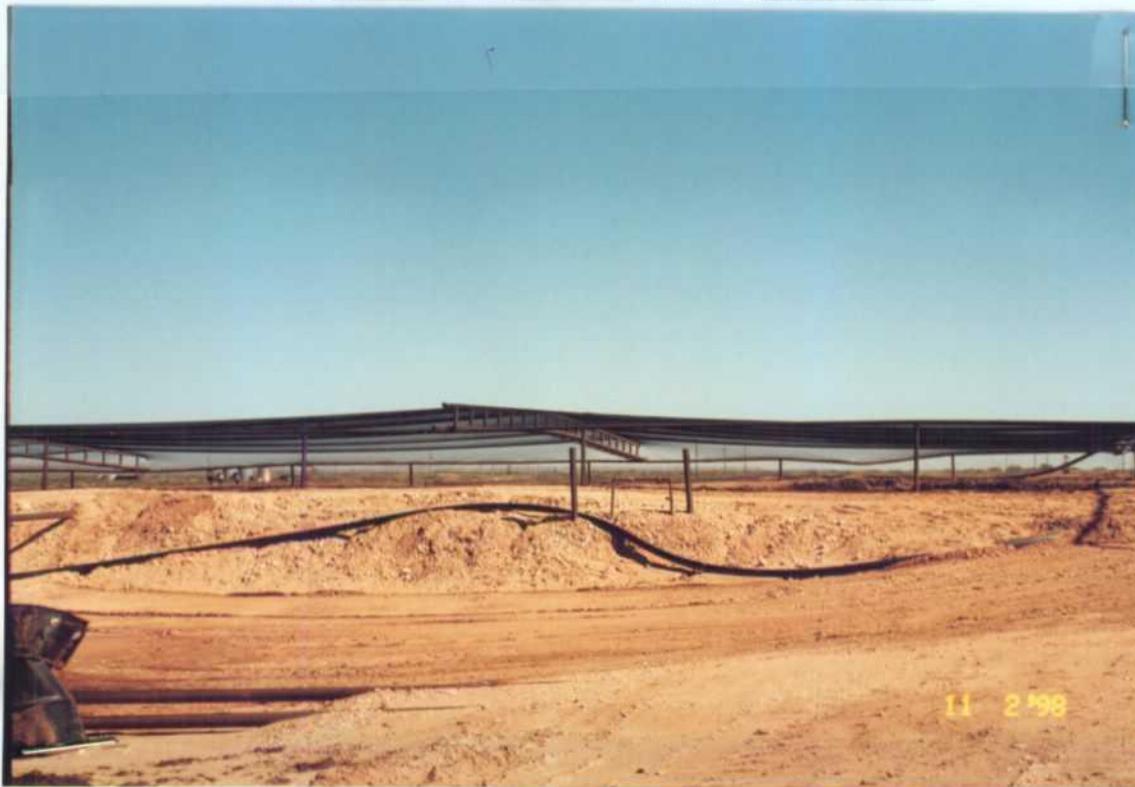
Photo Number: 6 Photographer: T. Reeves
Location: Loco Hills Water Disposal Facility (WP19)
Subject: Netting on settling/skim pond.
City/County: Loco Hills/Eddy County State: NM
Date: 11/02/98 Time: am Weather: sunny, cool

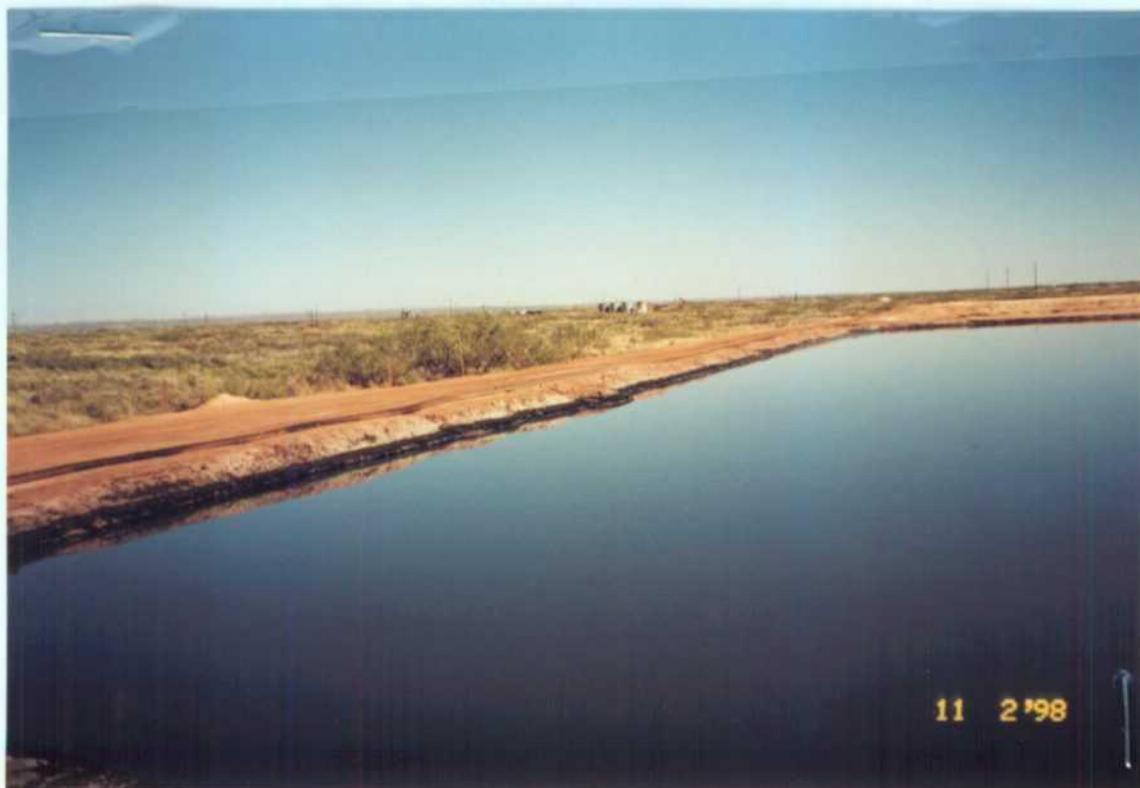
- Some oil staining around bank of first evaporation pit.
- Solids pit and landfarming area contained soil saturated with oil and some small pools of oily liquid.

Photo Number: 7 Photographer: T. Reeves
Location: Loco Hills Water Disposal Facility (WP19)
Subject: Oil and FeS staining on bank of evaporation pond.
City/County: Loco Hills/Eddy County State: NM
Date: 11/02/98 Time: am Weather: sunny, cool
