**Inspection Report
Controlled Recovery Inc. (Waypoint #61)
Lea County, NM**

Inspection Date: November 3, 1998

Facility Name: Controlled Recovery Inc. (CRI)

Facility Description: Commercial facility for oil field waste disposal.

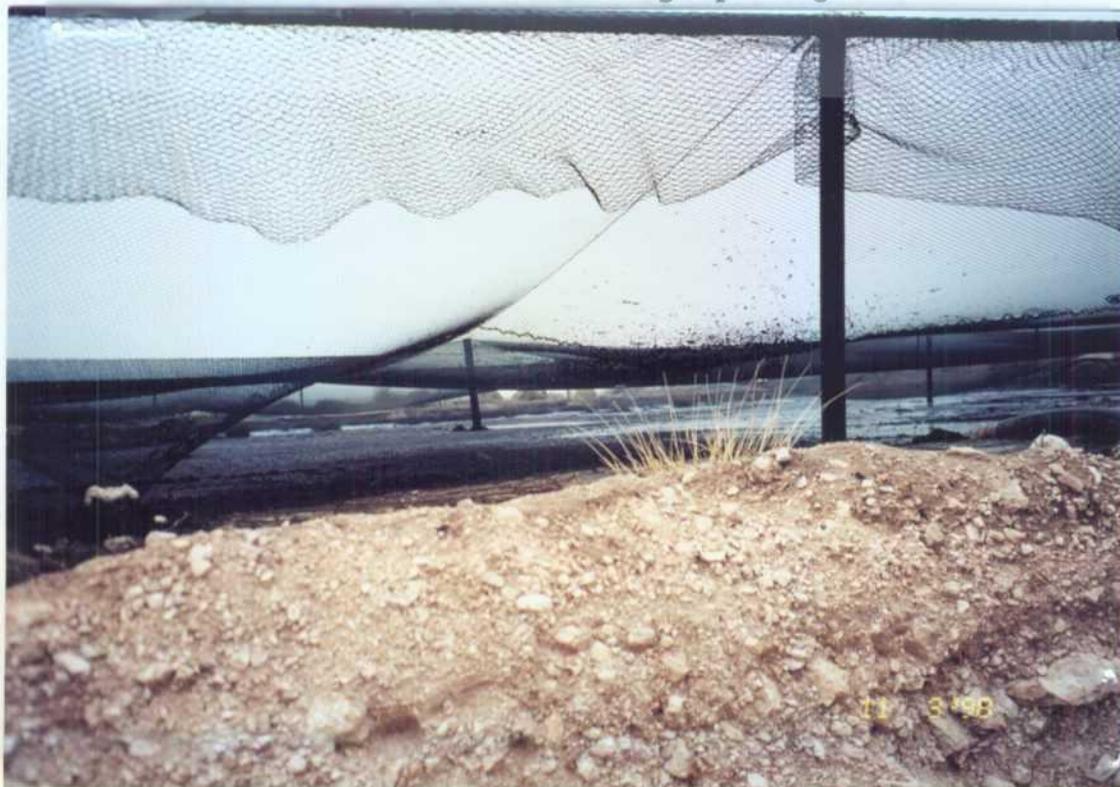
Photo Number: 1 Photographer: Melissa Smith
Location: Controlled Recovery Inc.
Subject: Netted and lined pit for excess storage
City/County: Lea County State: NM
Date: 11/03/98 Time: am Weather: cloudy, cool

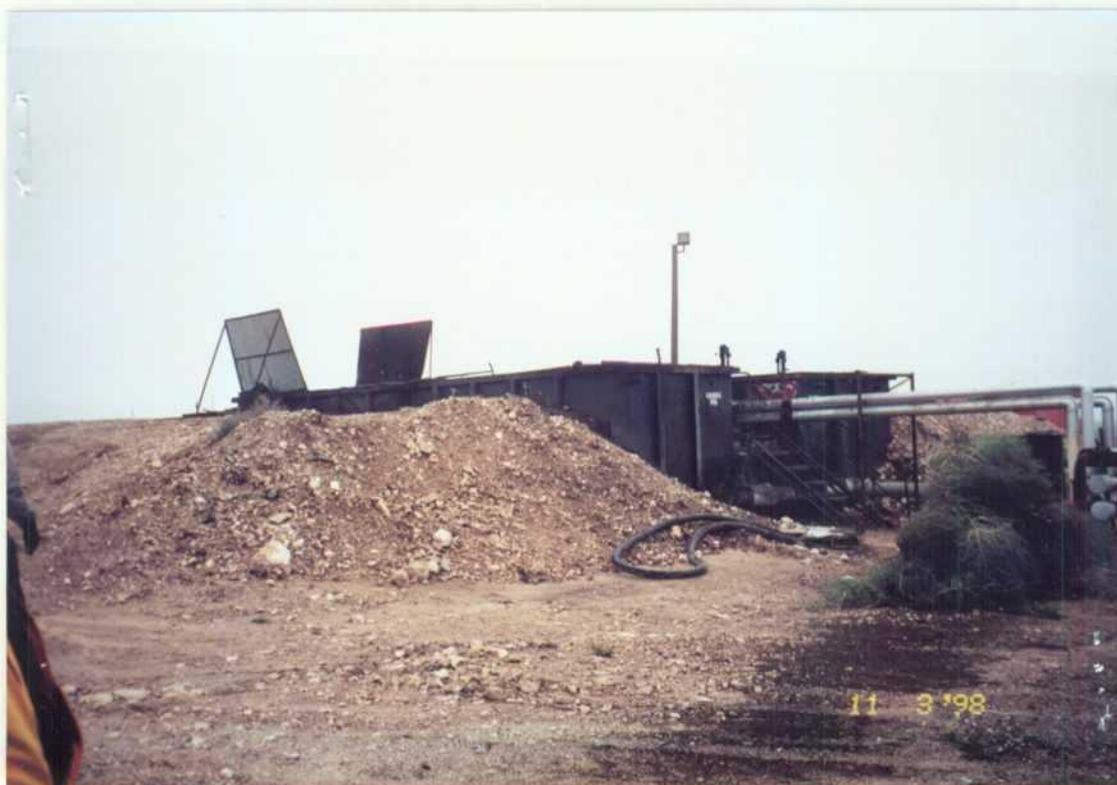
Photo Number: 2 Photographer: Melissa Smith
Location: Controlled Recovery Inc.
Subject: Receiving tanks for treatment process
City/County: Lea County State: NM
Date: 11/03/98 Time: am Weather: cloudy, cool

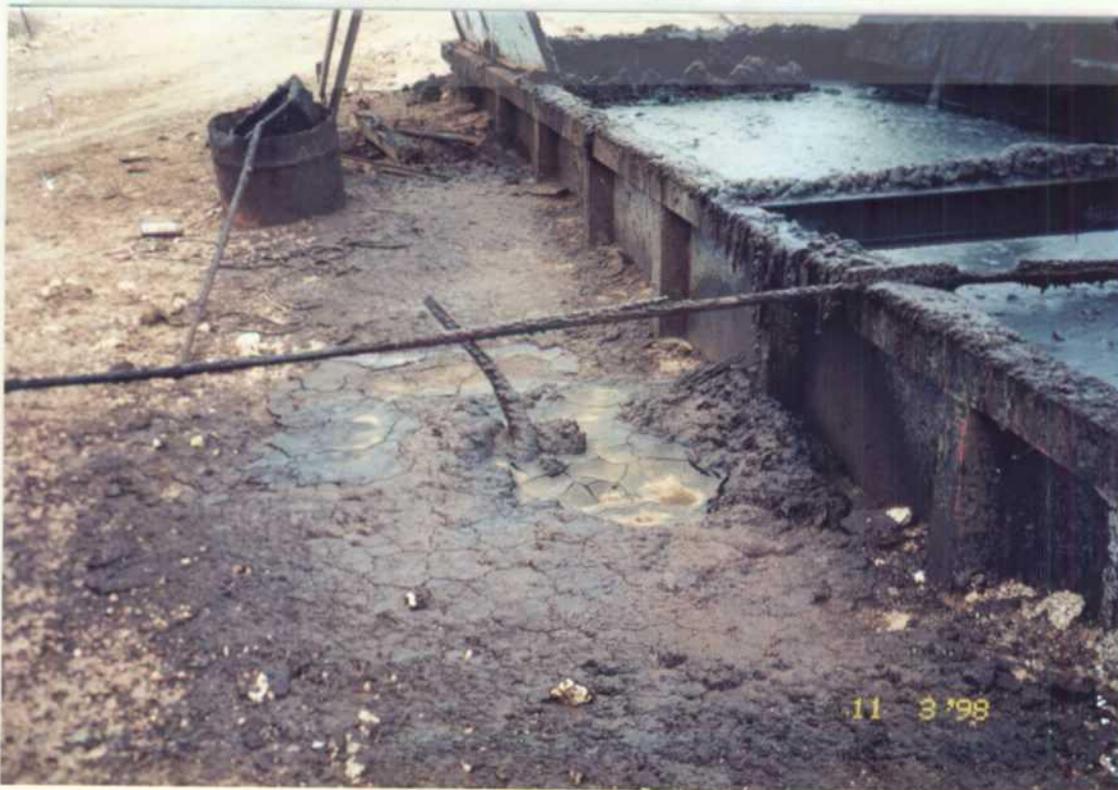
Photo Number: 3 Photographer: Melissa Smith
Location: Controlled Recovery Inc.
Subject: Receiving tank for treatment process
City/County: Lea County State: NM
Date: 11/03/98 Time: am Weather: cloudy, cool

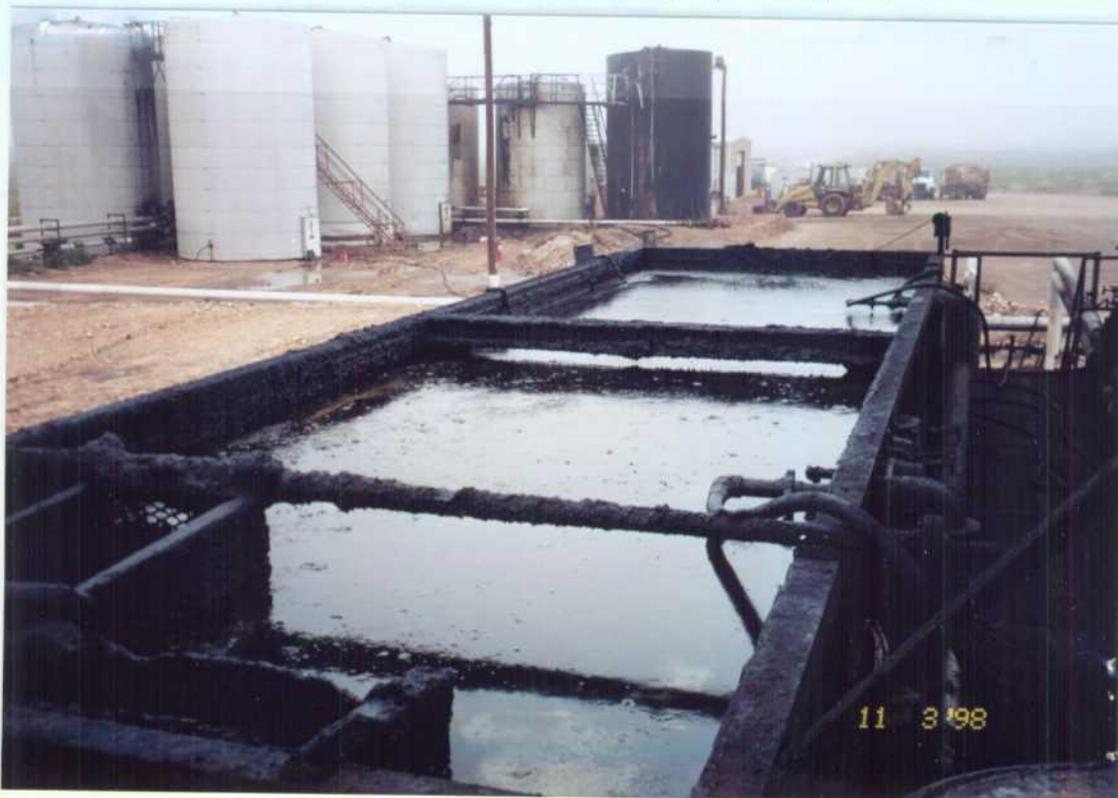
Photo Number: 4 Photographer: Melissa Smith
Location: Controlled Recovery Inc.
Subject: Receiving tank for treatment process
City/County: Lea County State: NM
Date: 11/03/98 Time: am Weather: cloudy, cool

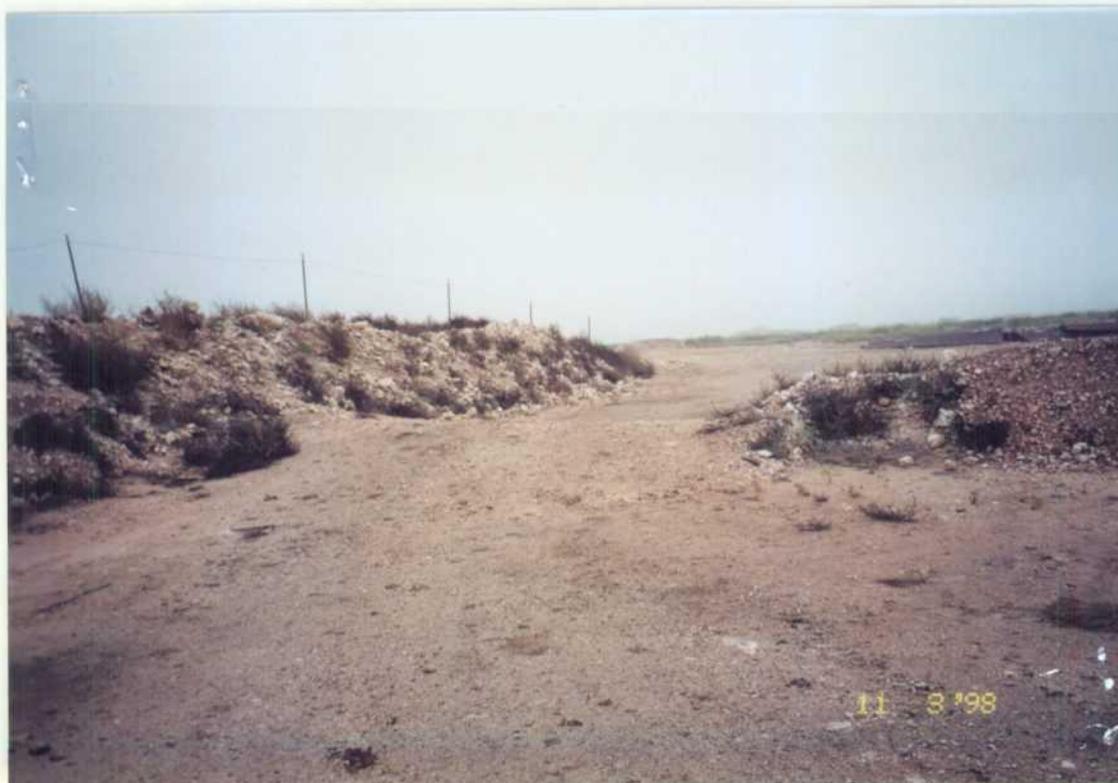
- Inadequate berm around treatment tanks.
- Less than 2 feet of freeboard in receiving pits and excess storage pit located in the treating plant.
- Skim pits and drilling mud pits are heavily covered with oil and there is insufficient migratory bird deterrent as mortality was discovered during the inspection.
- Lining of one of the skim pits appears to be compromised.
- Drilling mud pits are heavily saturated with oil and are not lined.

Photo Number: 6 Photographer: Melissa Smith
Location: Controlled Recovery Inc.
Subject: Low point in berm around treatment tanks
City/County: Lea County State: NM
Date: 11/03/98 Time: am Weather: cloudy, cool

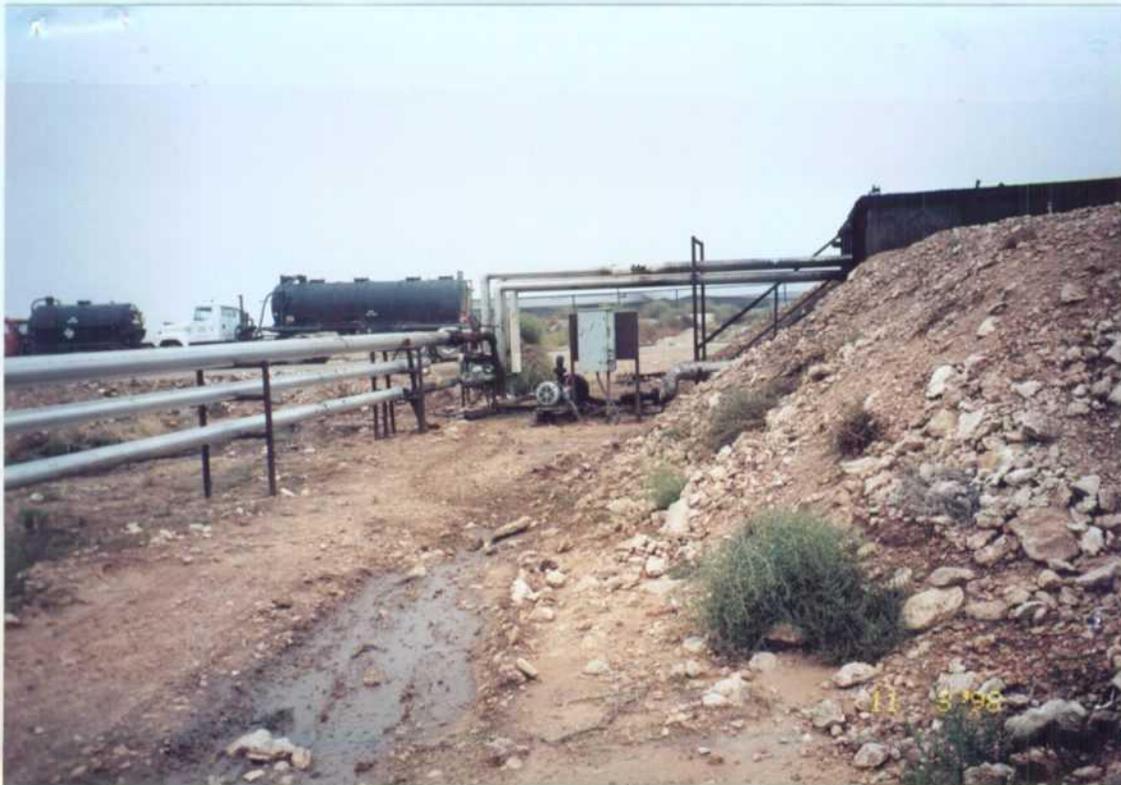
Photo Number: 7 Photographer: Melissa Smith
Location: Controlled Recovery Inc.
Subject: Pump in berm opening from receiving tanks to treatment tanks
City/County: Lea County State: NM
Date: 11/03/98 Time: am Weather: cloudy, cool

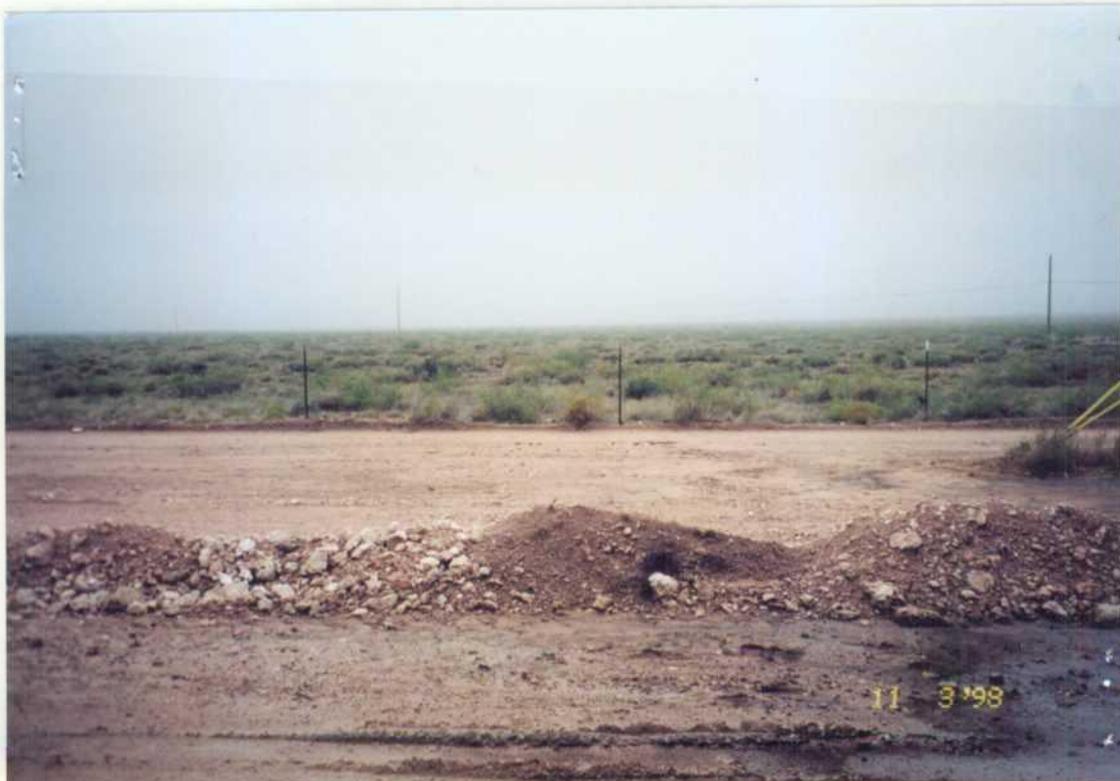
Photo Number: 8 Photographer: Melissa Smith
Location: Controlled Recovery Inc.
Subject: Berm around treatment tanks, and pasture beyond fence
City/County: Lea County State: NM
Date: 11/03/98 Time: am Weather: cloudy, cool

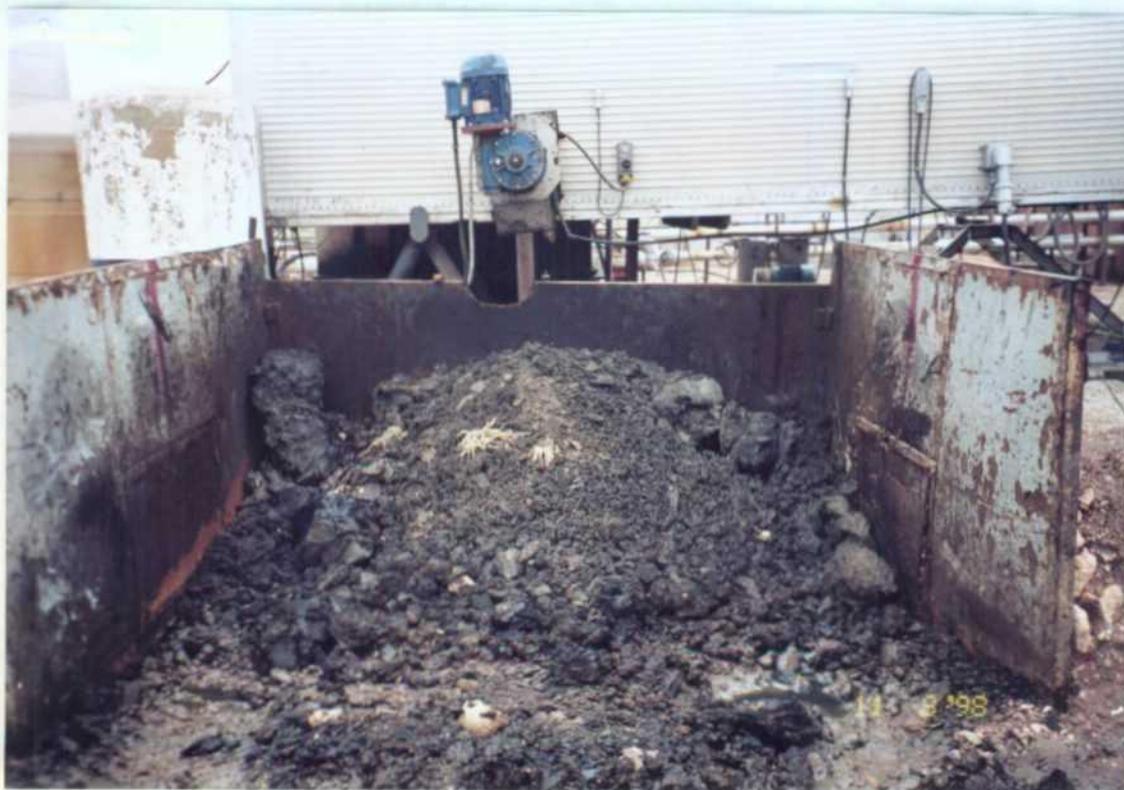
Photo Number: 9 Photographer: Melissa Smith
Location: Controlled Recovery Inc.
Subject: Solids from centrifuge
City/County: Lea County State: NM
Date: 11/03/98 Time: am Weather: cloudy, cool

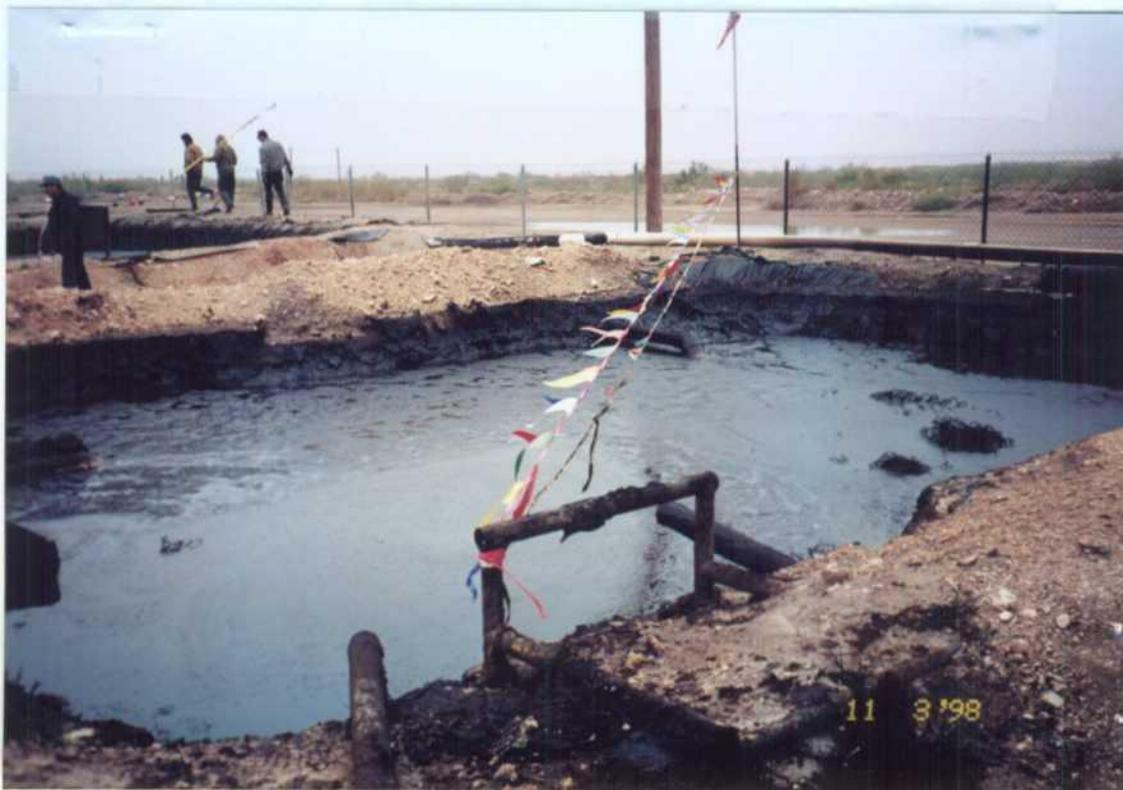
Photo Number: 11 Photographer: Melissa Smith
Location: Controlled Recovery Inc.
Subject: First skim pit for produced water
City/County: Lea County State: NM
Date: 11/03/98 Time: am Weather: cloudy, cool

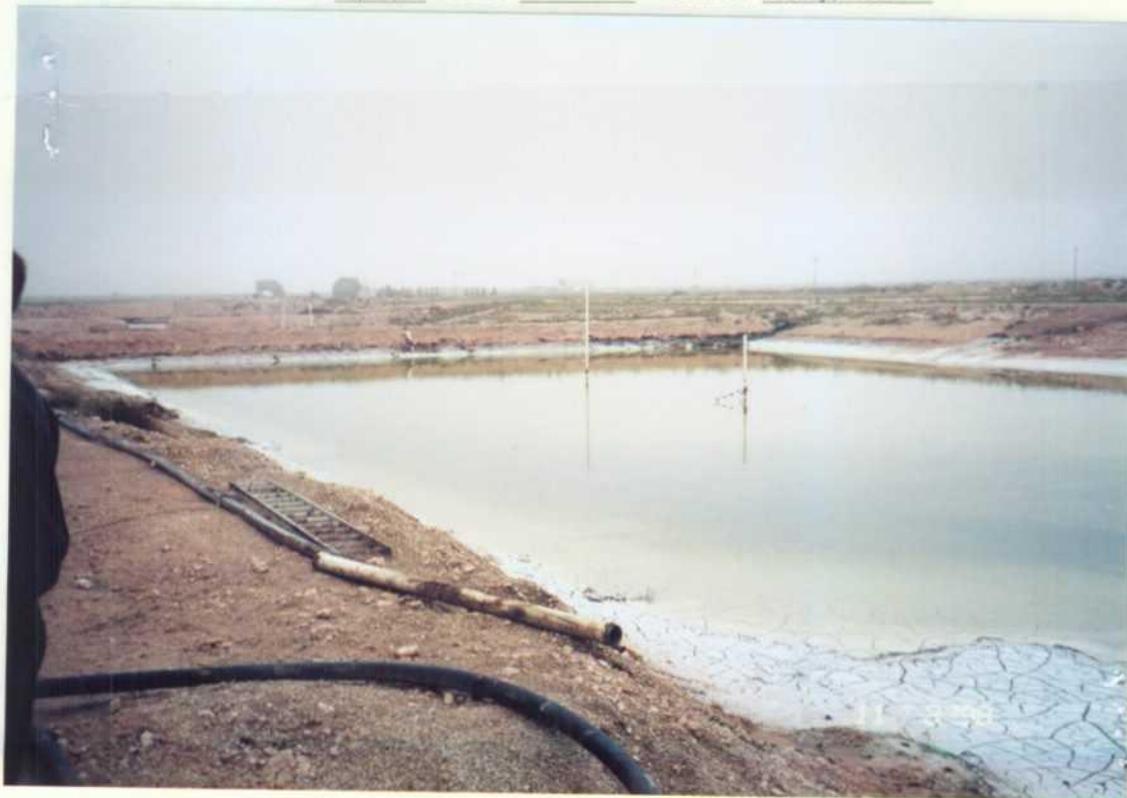
Photo Number: 12 Photographer: Melissa Smith
Location: Controlled Recovery Inc.
Subject: Final evaporation pit for produced water
City/County: Lea County State: NM
Date: 11/03/98 Time: am Weather: cloudy, cool

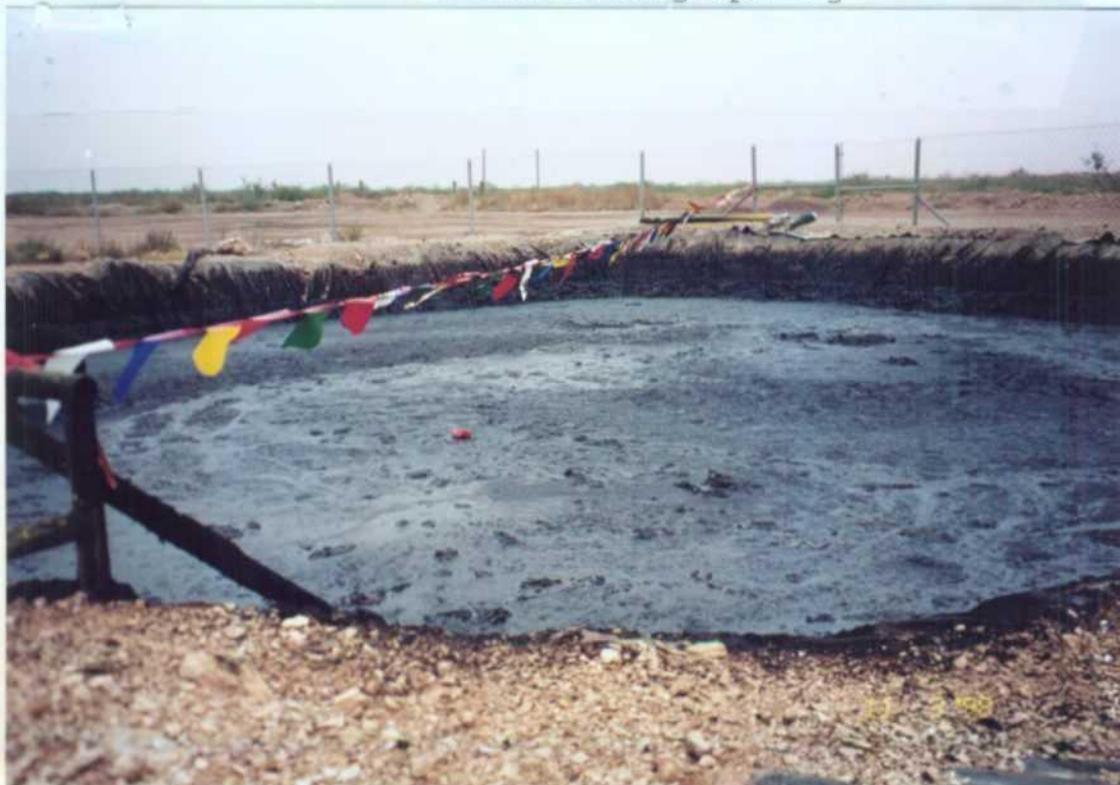
Photo Number: 13 Photographer: Melissa Smith
Location: Controlled Recovery Inc.
Subject: Second skim pit for produced water
City/County: Lea County State: NM
Date: 11/03/98 Time: am Weather: cloudy, cool

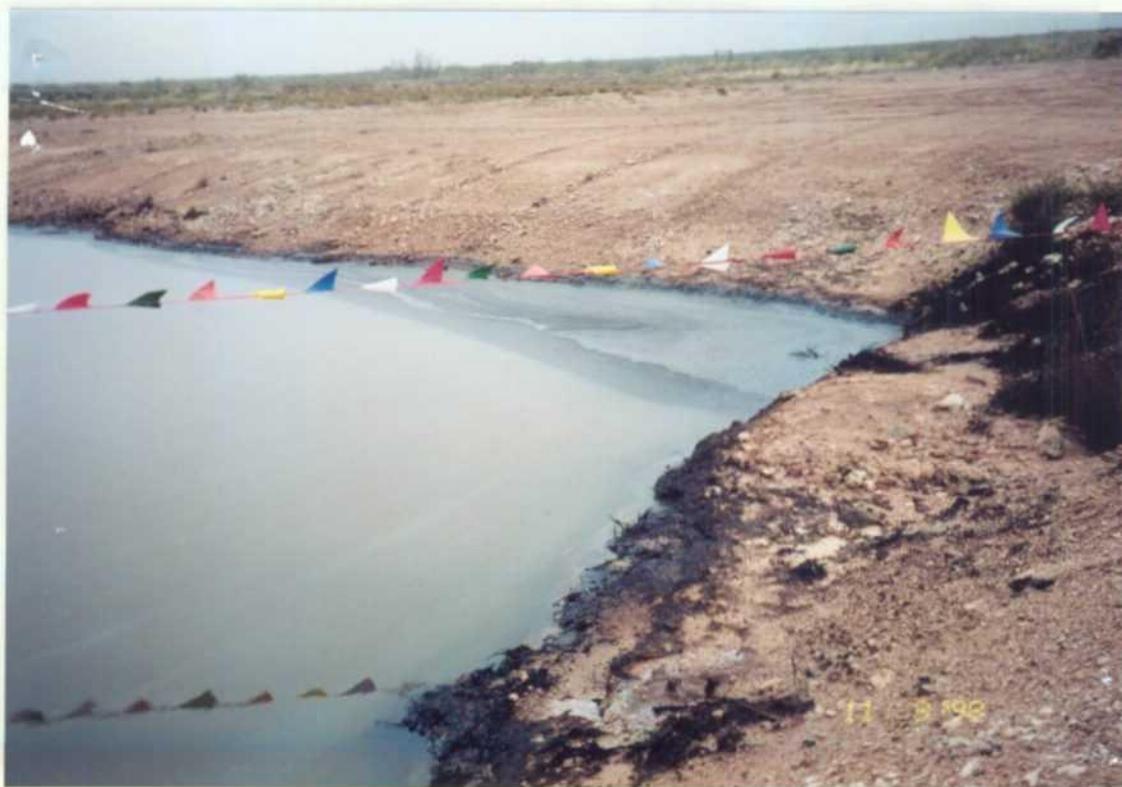
Photo Number: 14 Photographer: Melissa Smith
Location: Controlled Recovery Inc.
Subject: Third skim pit for produced water
City/County: Lea County State: NM
Date: 11/03/98 Time: am Weather: cloudy, cool

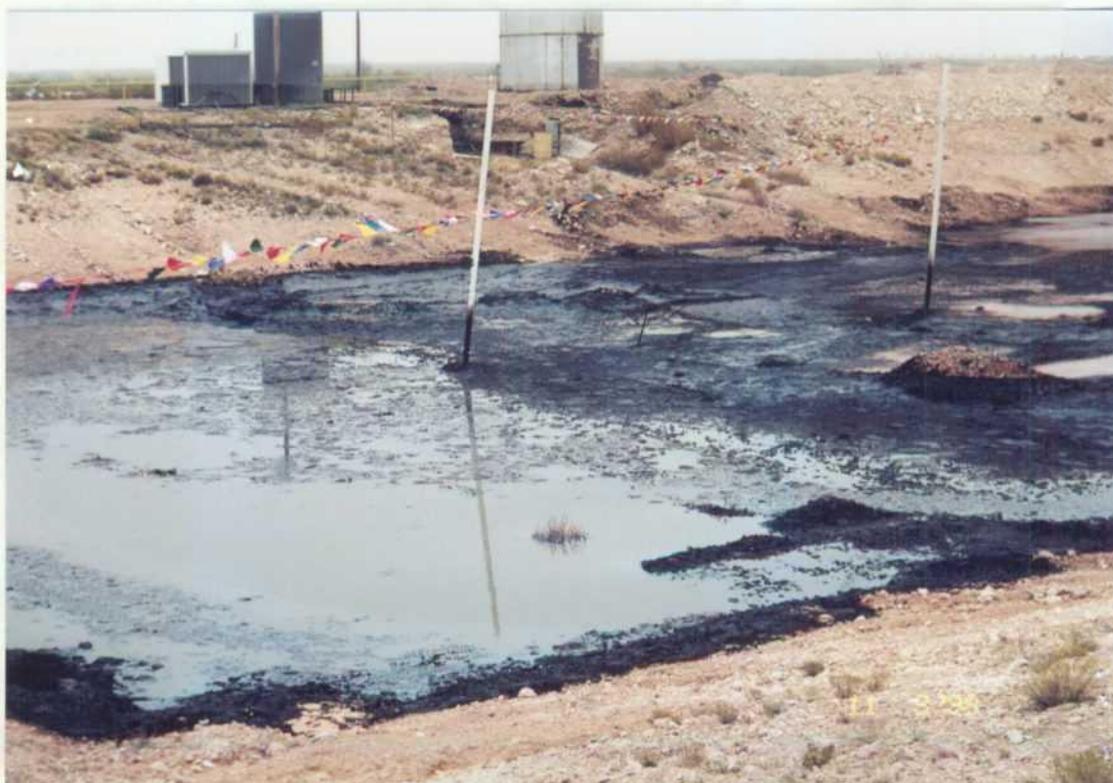
Photo Number: 16 Photographer: Melissa Smith
Location: Controlled Recovery Inc.
Subject: Pit for drilling muds
City/County: Lea County State: NM
Date: 11/03/98 Time: am Weather: cloudy, cool

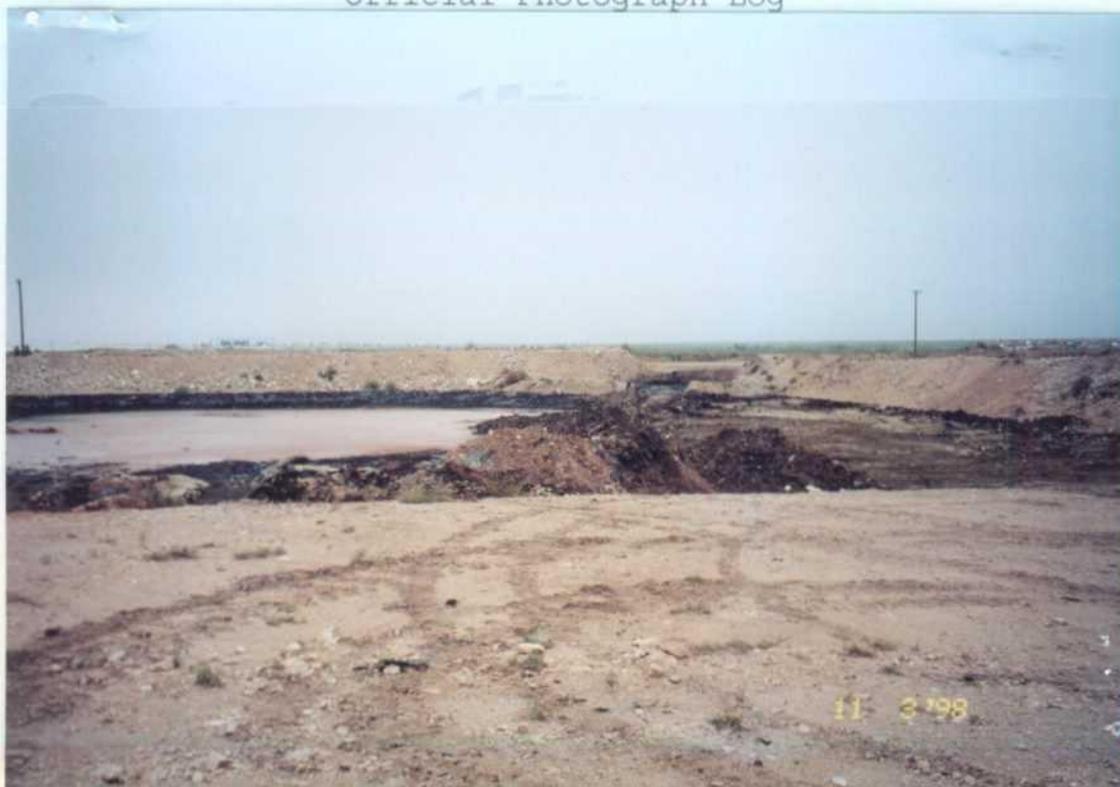
Photo Number: 17 Photographer: Melissa Smith
Location: Controlled Recovery Inc.
Subject: Pit for drilling muds
City/County: Lea County State: NM
Date: 11/03/98 Time: am Weather: cloudy, cool

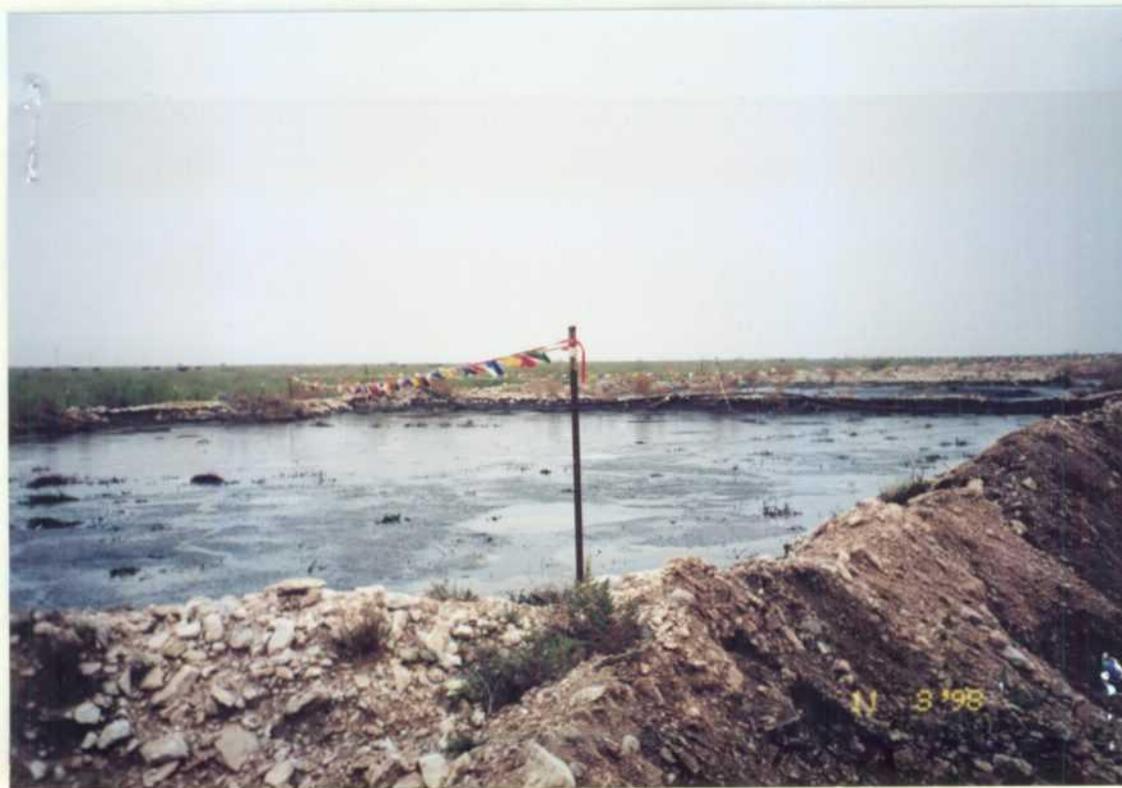
Photo Number: 18 Photographer: Melissa Smith
Location: Controlled Recovery Inc.
Subject: Drying pit for oil based drilling muds
City/County: Lea County State: NM
Date: 11/03/98 Time: am Weather: cloudy, cool

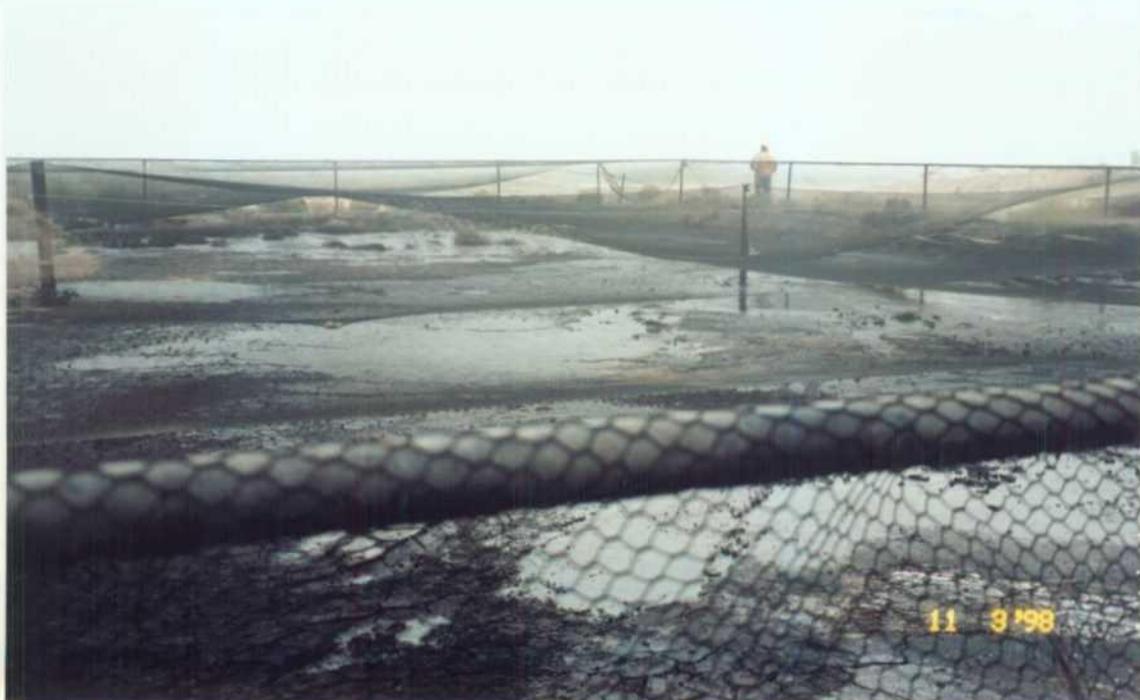
Photo Number: 1 Photographer: T. Reeves, SAIC
Location: Controlled Recovery Inc.
Subject: Backup secondary pit for tank bottoms, looking N
City/County: Lea County State: NM
Date: 11/03/98 Time: am Weather: cloudy, cool

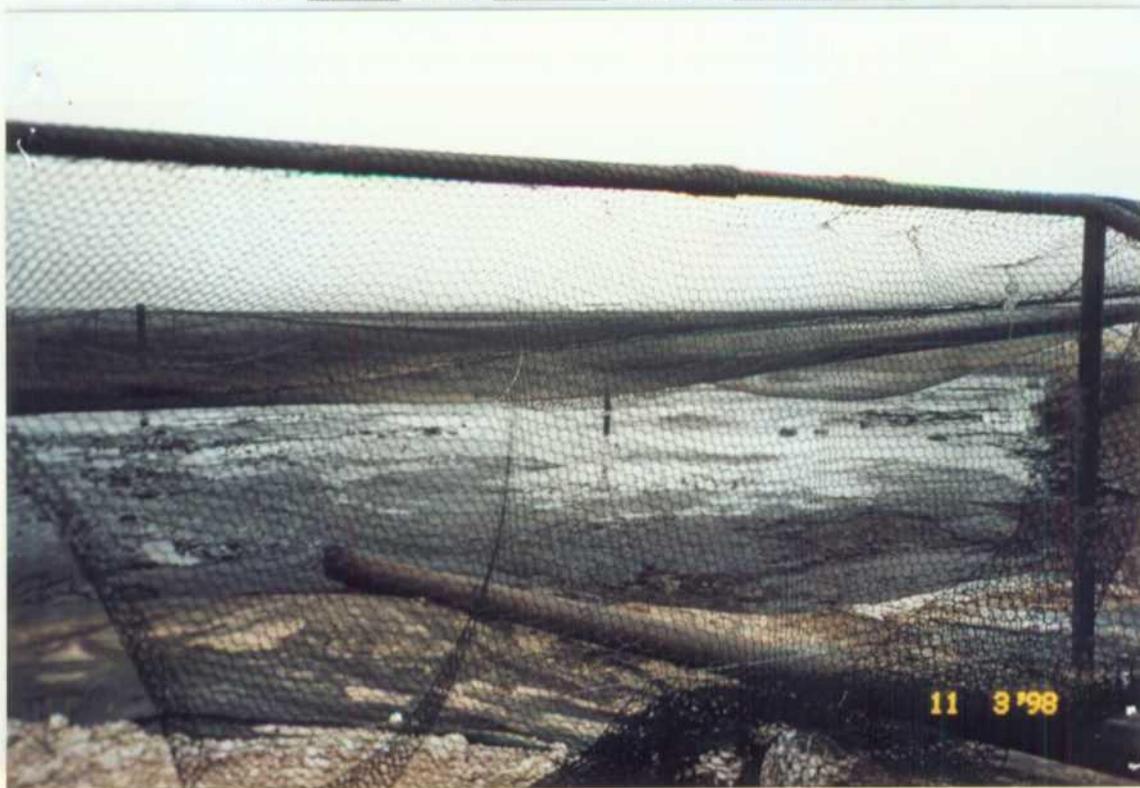
Photo Number: 2 Photographer: T. Reeves, SAIC
Location: Controlled Recovery Inc.
Subject: Backup secondary pit for tank bottoms, looking NW
City/County: Lea County State: NM
Date: 11/03/98 Time: am Weather: cloudy, cool

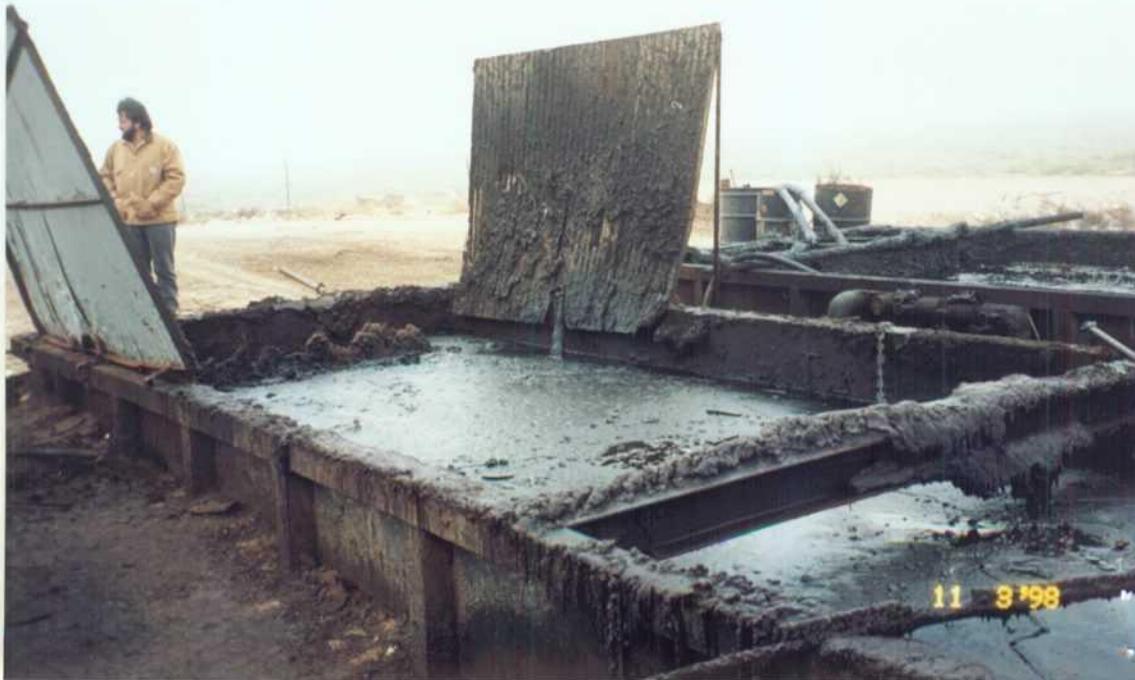
Photo Number: 3 Photographer: T. Reeves, SAIC
Location: Controlled Recovery Inc.
Subject: Heated receiving tanks for tank bottoms
City/County: Lea County State: NM
Date: 11/03/98 Time: am Weather: cloudy, cool

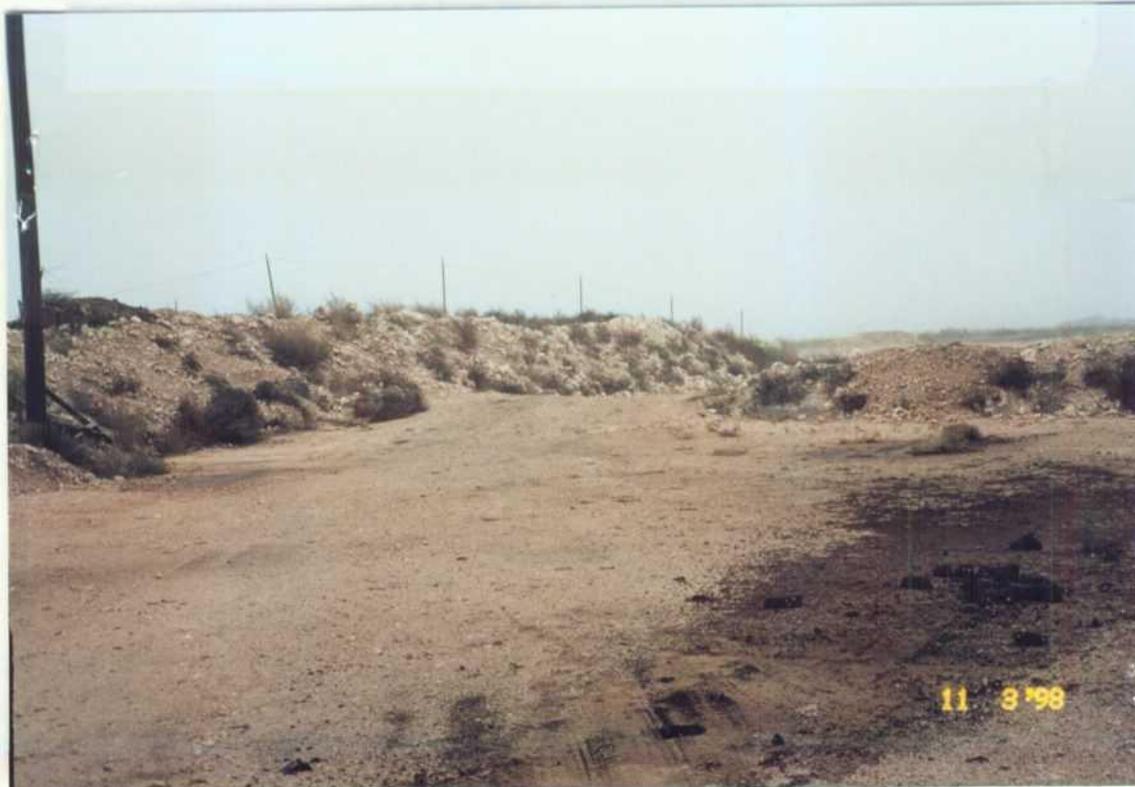
Photo Number: 4 Photographer: T. Reeves, SAIC
Location: Controlled Recovery Inc.
Subject: Low spot in berm used as a road or driveway
City/County: Lea County State: NM
Date: 11/03/98 Time: am Weather: cloudy, cool

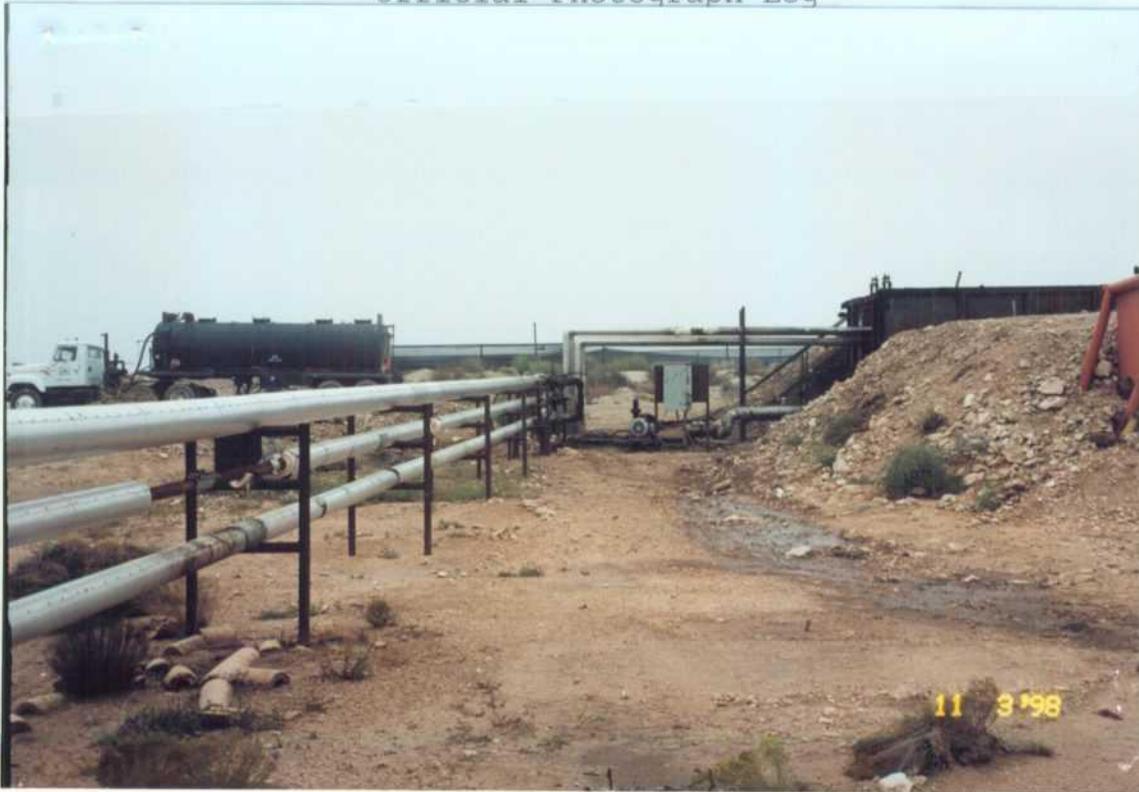
Photo Number: 5 Photographer: T. Reeves, SAIC
Location: Controlled Recovery Inc.
Subject: No berm beneath piping
City/County: Lea County State: NM
Date: 11/03/98 Time: am Weather: cloudy, cool

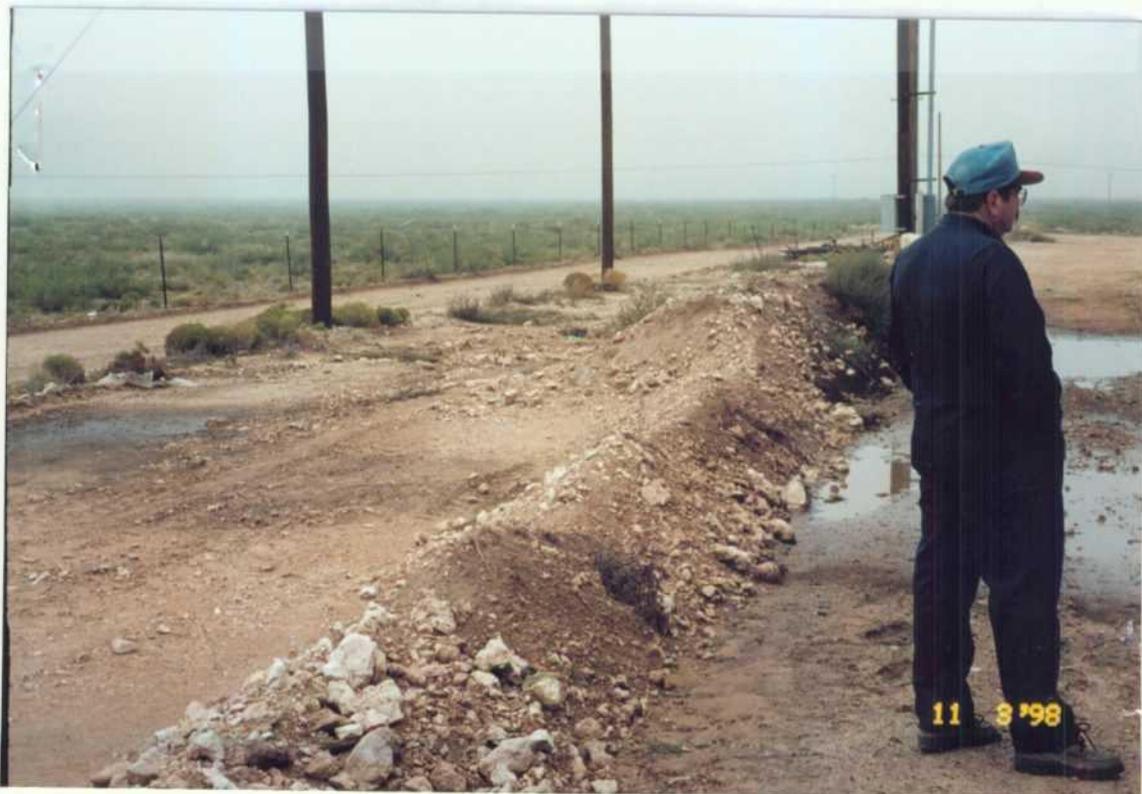
Photo Number: 6 Photographer: T. Reeves, SAIC
Location: Controlled Recovery Inc.
Subject: Low berm at east side of tank battery
City/County: Lea County State: NM
Date: 11/03/98 Time: am Weather: cloudy, cool

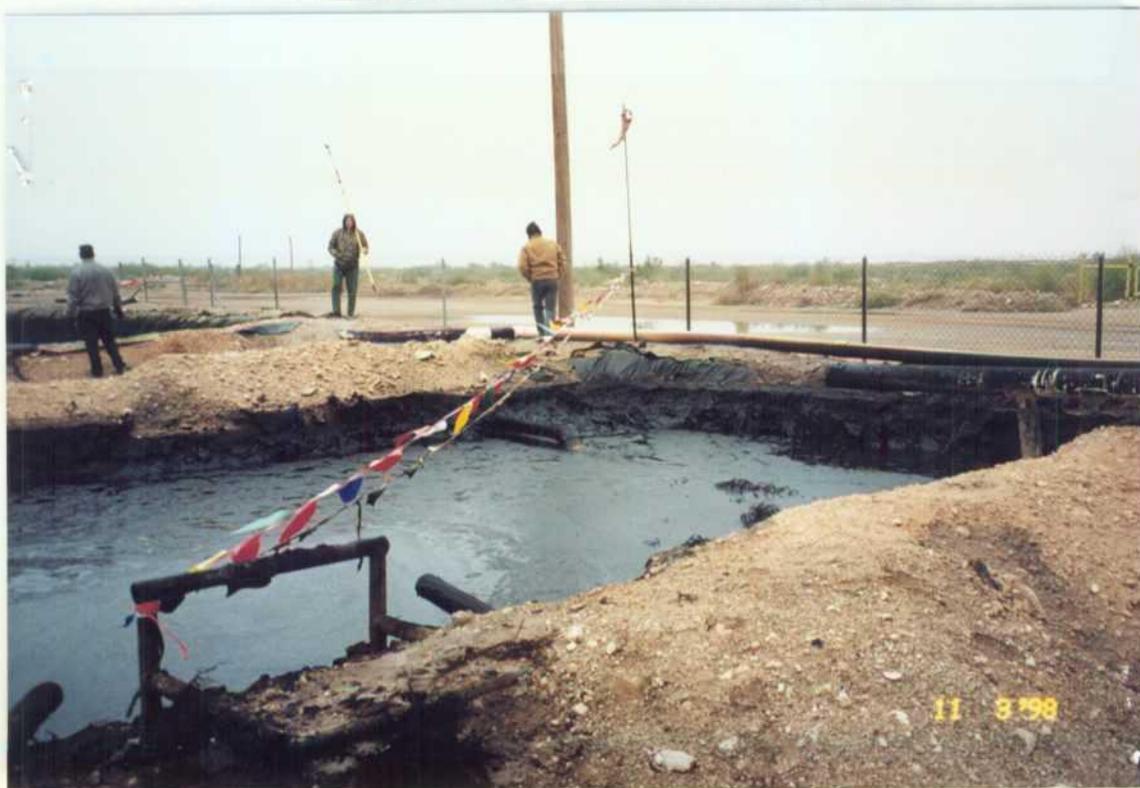
Photo Number: 8 Photographer: T. Reeves, SAIC
Location: Controlled Recovery Inc.
Subject: First produced water pit for settling
City/County: Lea County State: NM
Date: 11/03/98 Time: am Weather: cloudy, cool

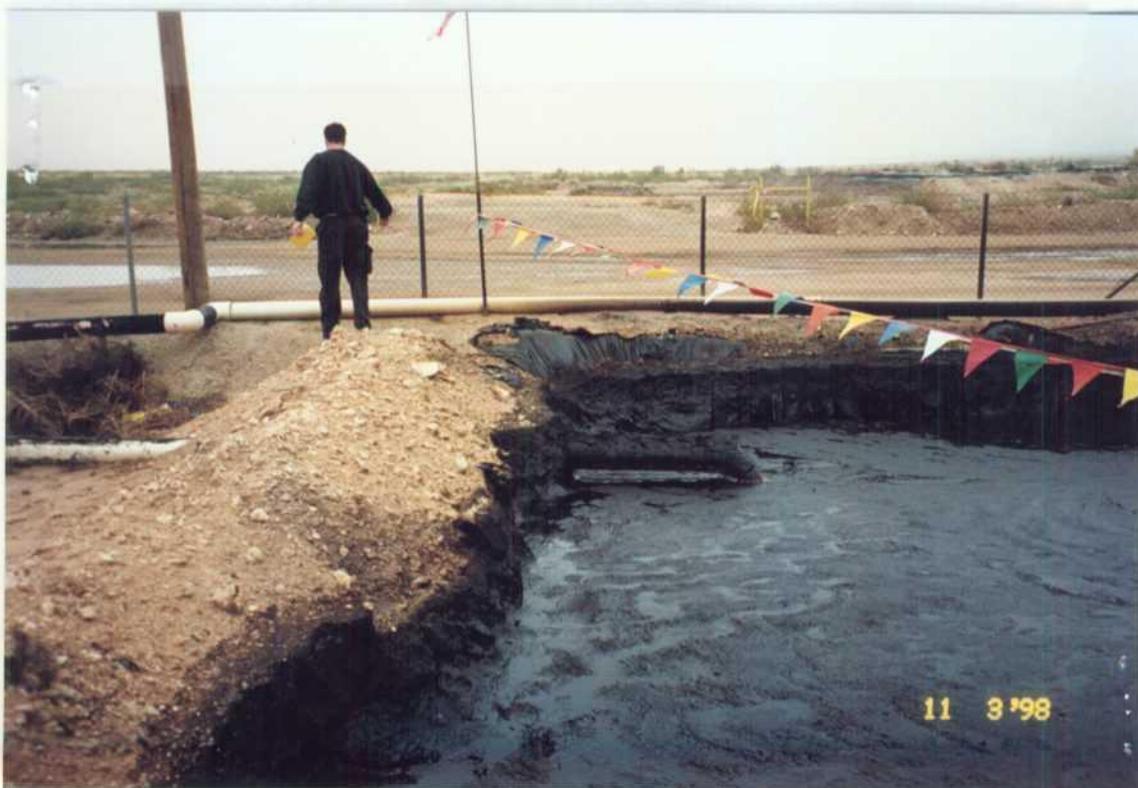
Photo Number: 10 Photographer: T. Reeves, SAIC
Location: Controlled Recovery Inc.
Subject: Torn liner on 1st produced water pit (see photo 8)
City/County: Lea County State: NM
Date: 11/03/98 Time: am Weather: cloudy, cool

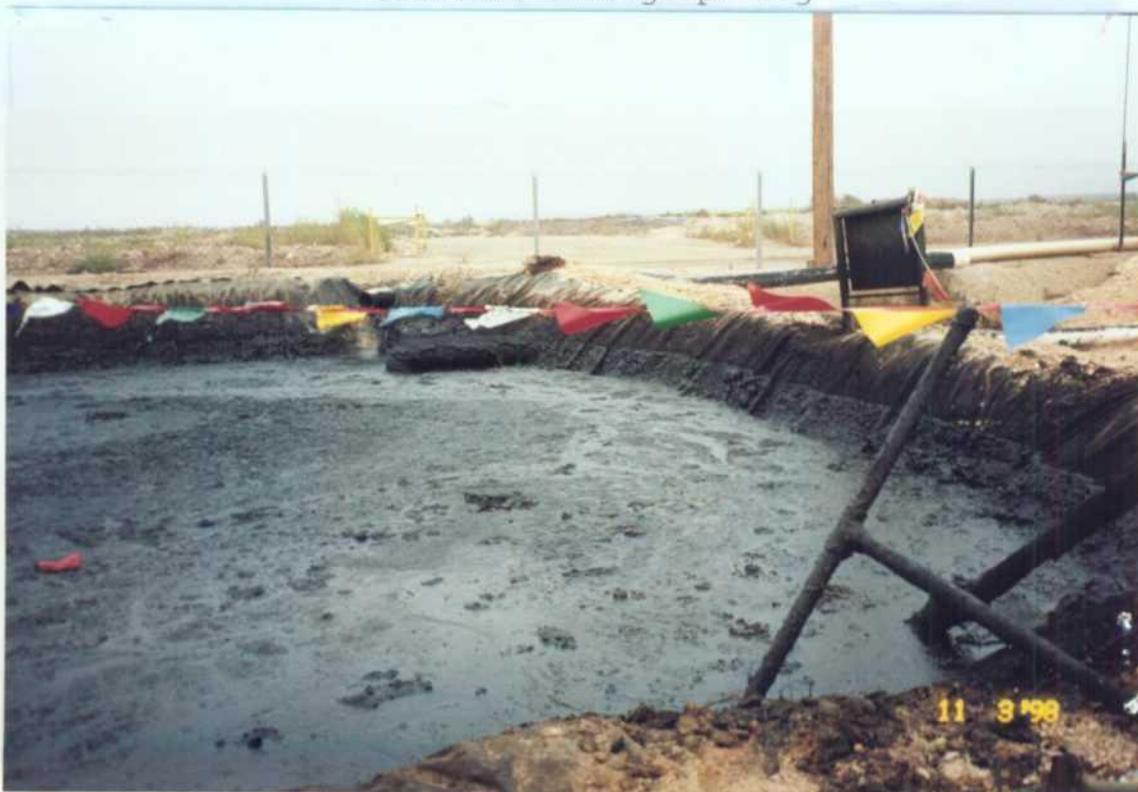
Photo Number: 11 Photographer: T. Reeves, SAIC
Location: Controlled Recovery Inc.
Subject: Second settling pit for produced water
City/County: Lea County State: NM
Date: 11/03/98 Time: am Weather: cloudy, cool
