**Inspection Report
Controlled Recovery Inc. (Waypoint #61)
Lea County, NM**

Inspection Date: November 3, 1998

Facility Name: Controlled Recovery Inc. (CRI)

Facility Description: Commercial facility for oil field waste disposal.

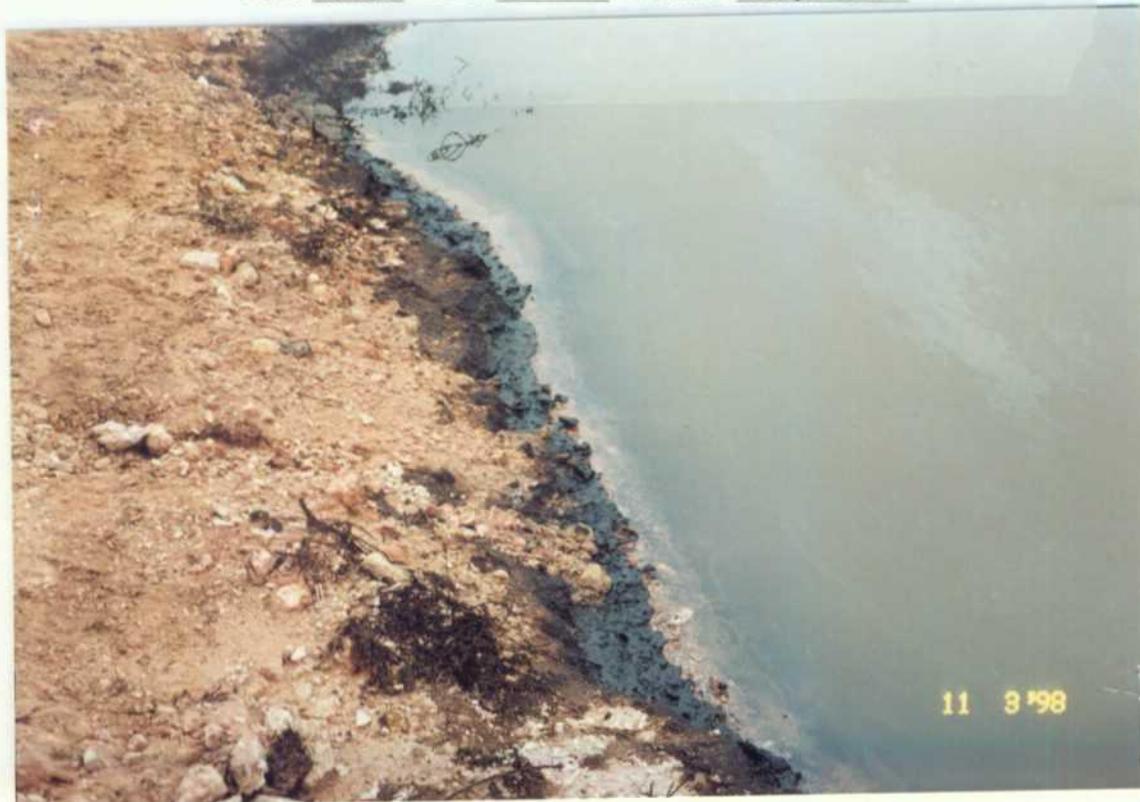
Photo Number: 12 Photographer: T. Reeves, SAIC
Location: Controlled Recovery Inc.
Subject: Oil on bank edge of 1st evaporation pond for produced water
City/County: Lea County State: NM
Date: 11/03/98 Time: am Weather: cloudy, cool

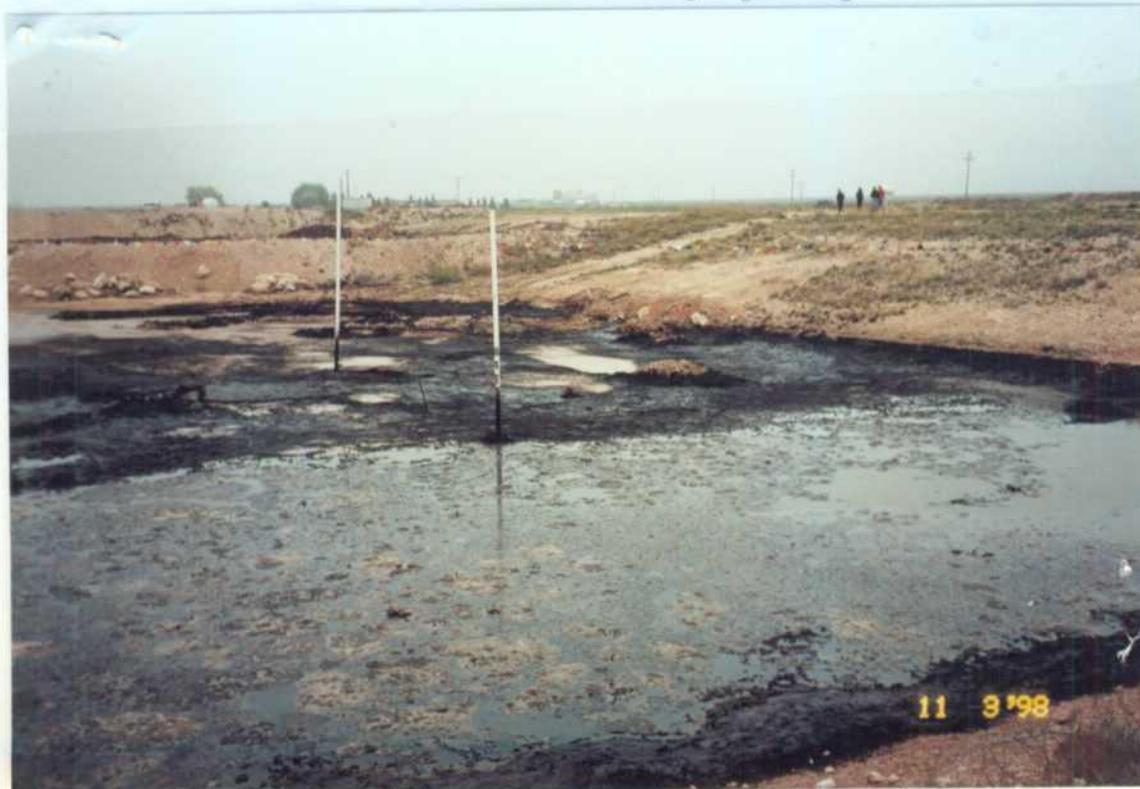
Photo Number: 1 Photographer: T. Reeves, SAIC
Location: Controlled Recovery Inc.
Subject: Pit for drilling muds
City/County: Lea County State: NM
Date: 11/03/98 Time: am Weather: cloudy, cool

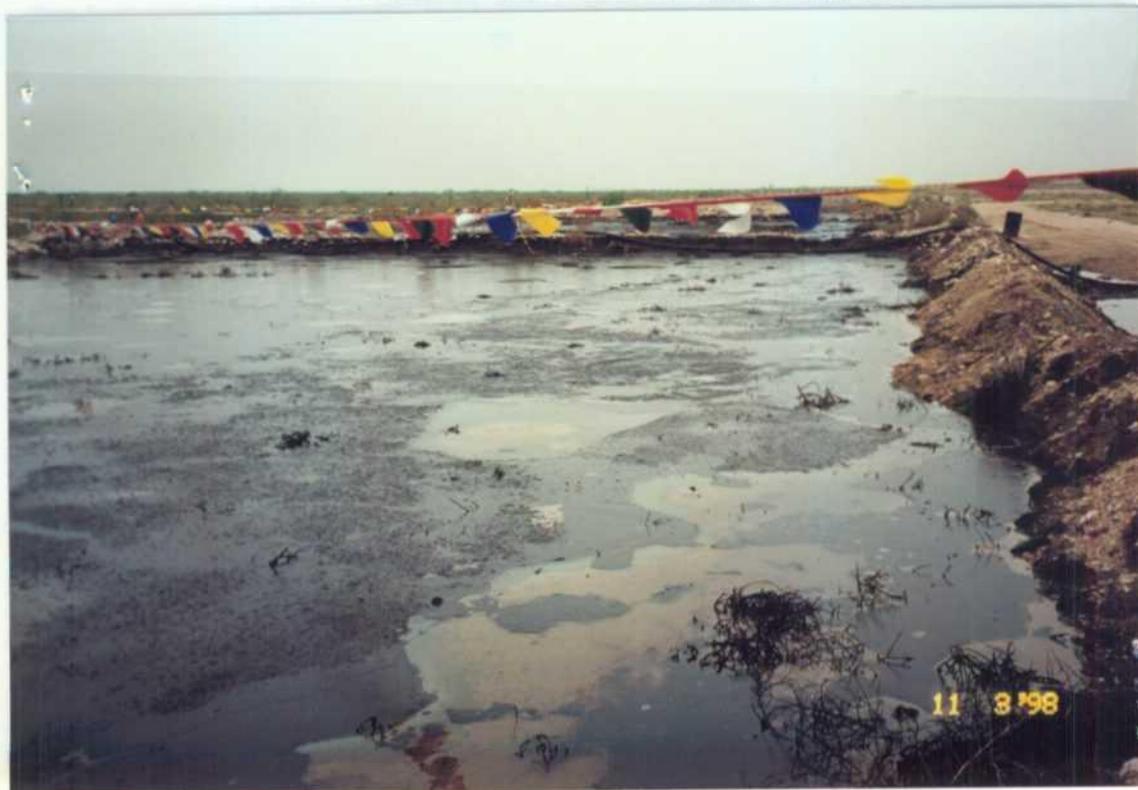
Photo Number: 2 Photographer: T. Reeves, SAIC
Location: Controlled Recovery Inc.
Subject: SW pit for drilling muds
City/County: Lea County State: NM
Date: 11/03/98 Time: am Weather: cloudy, cool

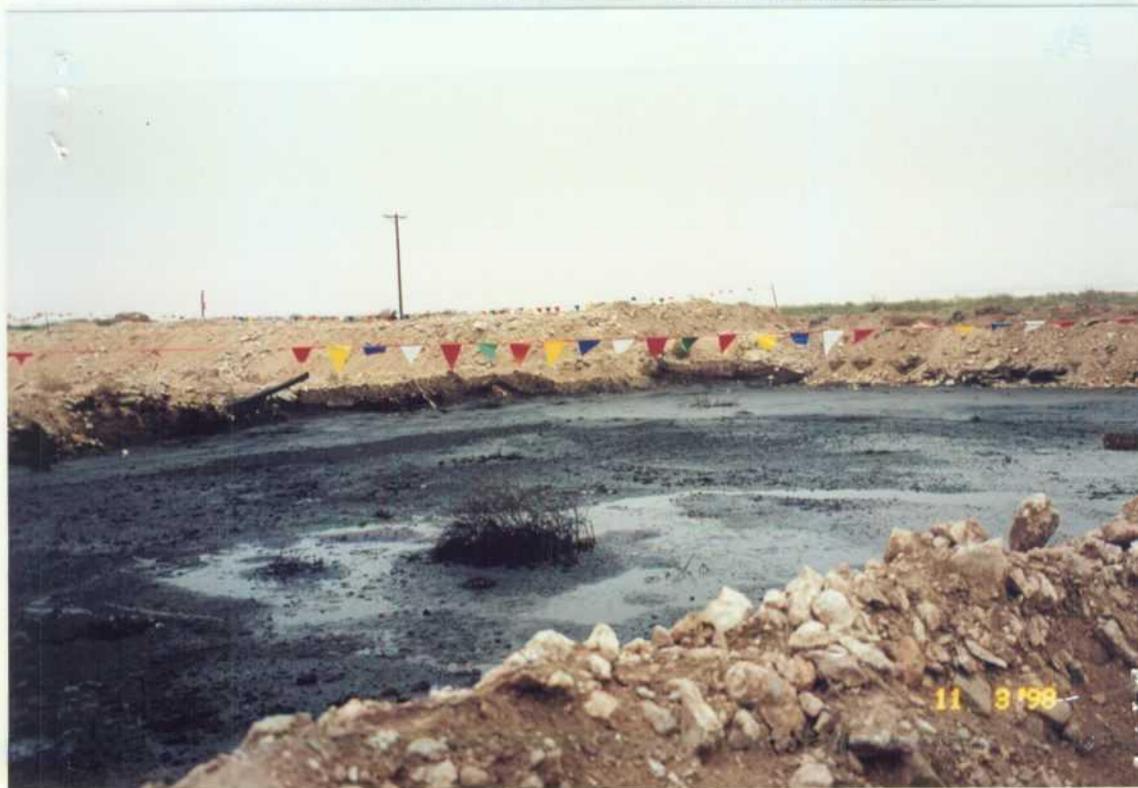
Photo Number: 4 Photographer: T. Reeves, SAIC
Location: Controlled Recovery Inc.
Subject: East of evaporation pits, partially dried out pit of drilling mud
City/County: Lea County State: NM
Date: 11/03/98 Time: am Weather: cloudy, cool

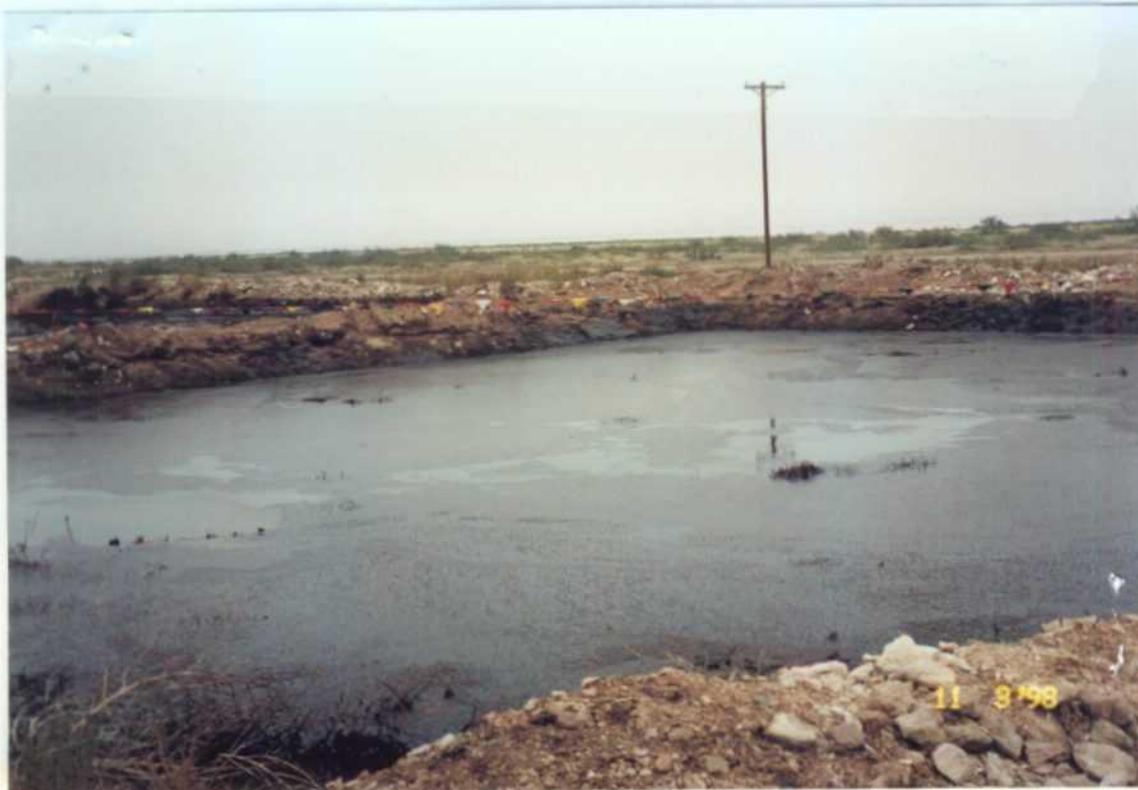
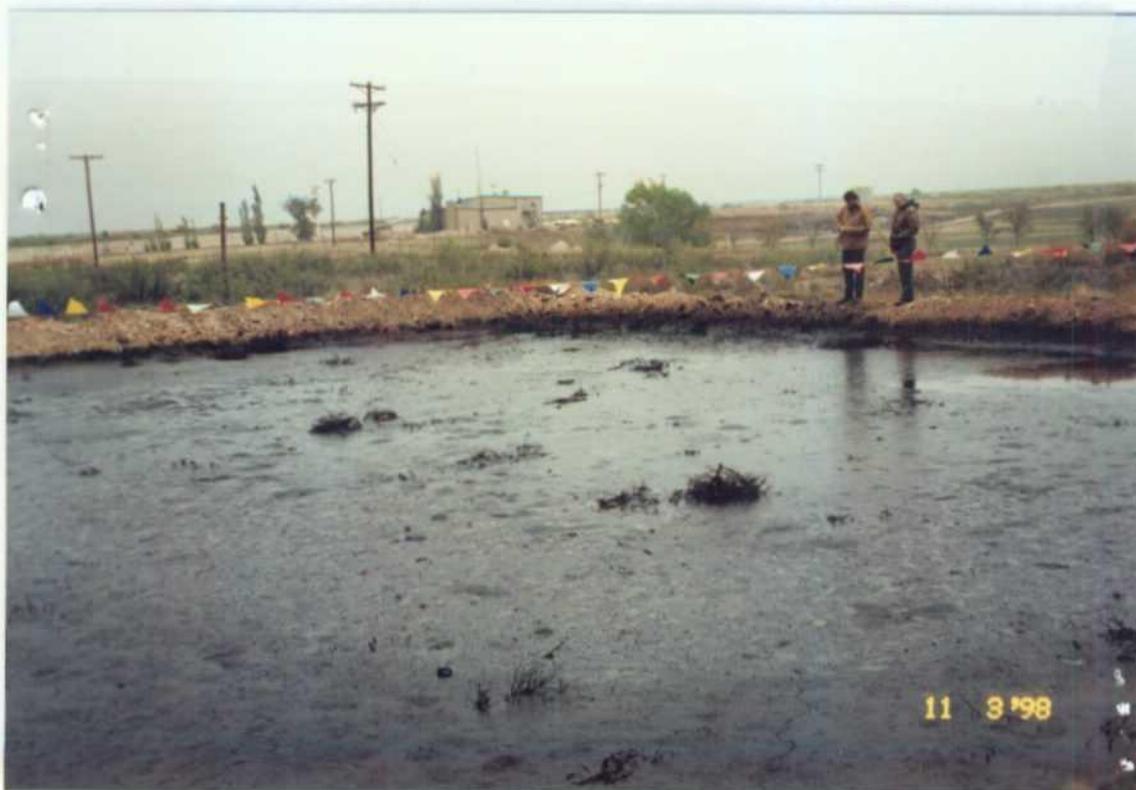
Photo Number: 5 Photographer: T. Reeves, SAIC
Location: Controlled Recovery Inc.
Subject: Additional pit for drilling muds
City/County: Lea County State: NM
Date: 11/03/98 Time: am Weather: cloudy, cool
