HIP - 17

**GENERAL
CORRESPONDENCE**

**Subject: Approval for Minor Discharge of Hydrostatic Test Water
from New Pipe into Lined Pond in McKinley County, New
México**

Characterization of Hydrostatic Test Waters

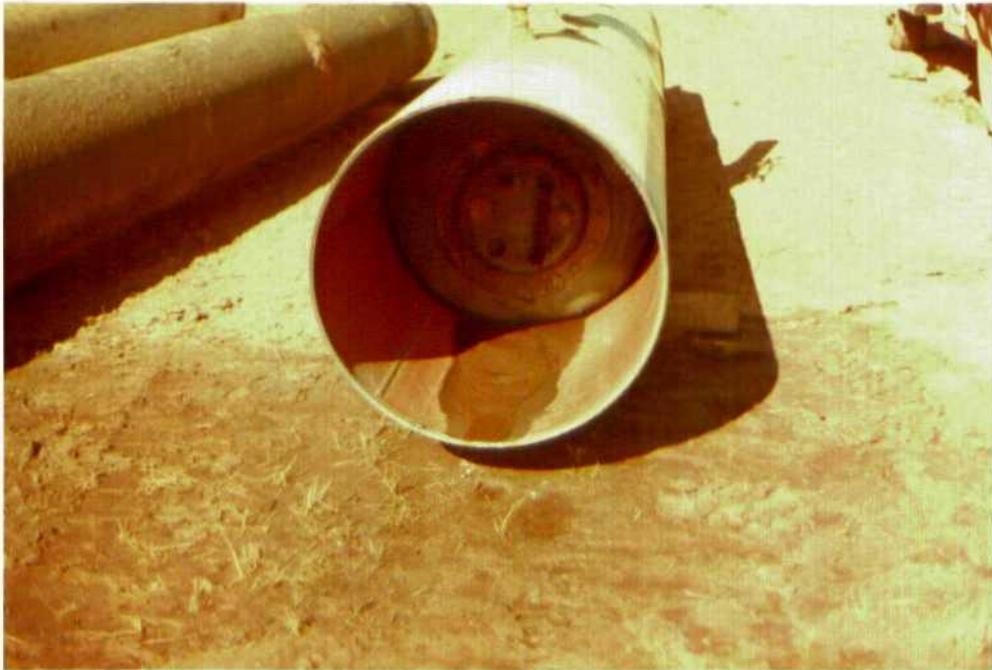
Photograph No. 1

Showing the end of the 36-inch pipeline with a squeegee pig. The debris shown in the pipeline accumulated in front of the pig as it moved down the pipeline.

The 7,700 foot pipeline was filled at Station 2127 + 62' (Section 27 TWS. 14-N, Range 14-W NMPM). See Figure 1 in map pocket. As water filled the line a squeegee fill pig was pushed toward the other end of the line. Some of the debris left in the line during construction mixed with the water and accumulated ahead of the pig as shown in Photograph No. 1. By the time the fill pig reached the end of the line a relatively small quantity of sediment had accumulated. The discharge was red in color indicating the majority of the sediment was probably iron oxide from the pipeline cutting and welding operation and some orange-red paint overspray used for coating the interior of the pipe. A small amount of solids and water discharged during this initial filling of the line was deposited in the pipeline ditch and buried. The pipeline was

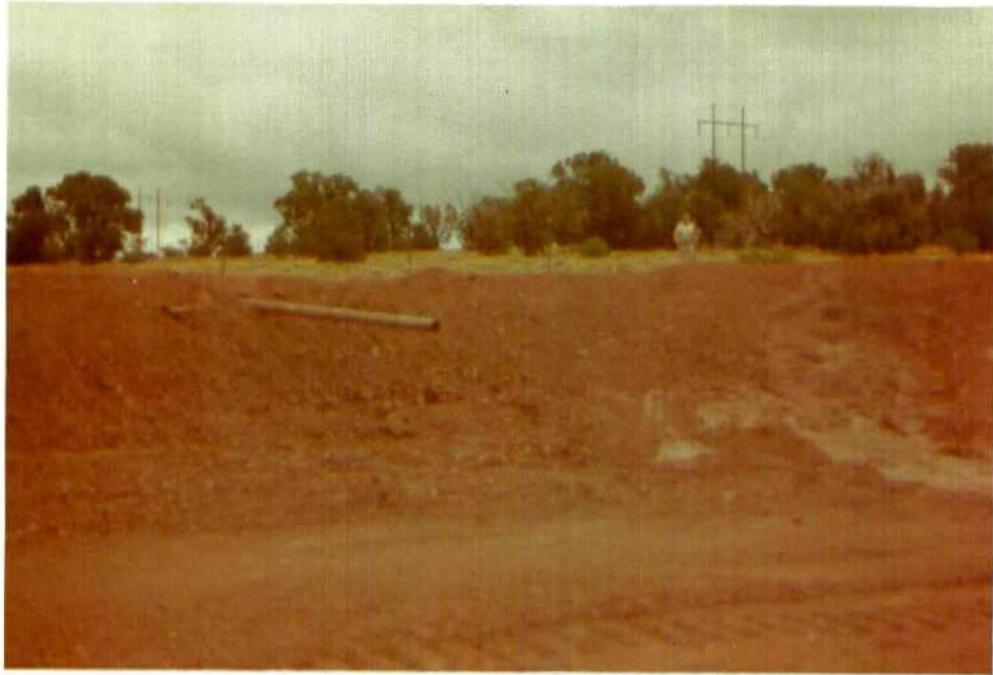
Photograph No. 2

Showing the six-inch discharge pipe into the earthen holding pond. After discharging all the water in the pipeline into the pond the maximum depth measured was three feet.

The earthen pond which was used to contain the discharge water filled to an estimated depth of three feet. It was allowed to dry by evaporation and infiltration. Once dry, the pond was graded to the approximate original contour and reseeded with native vegetation.

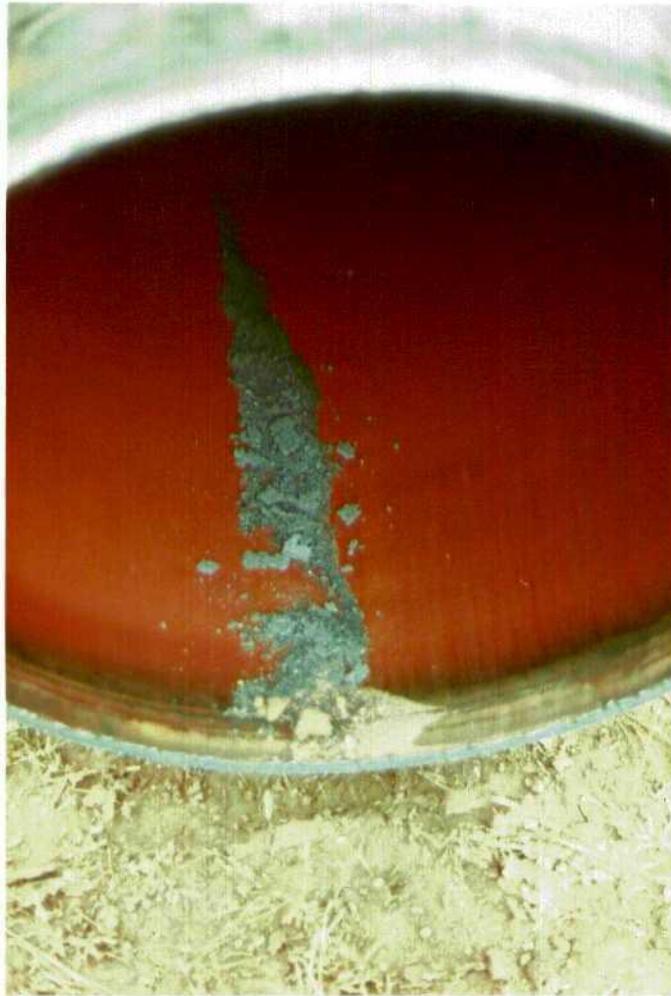
Photograph No. 3

Showing the end of the 36-inch pipeline where welding and cutting residue has accumulated. This residue is readily filtered by the soil and poses no significant environmental problem.
