CONCERNS AND REQUEST  
FOR FURTHER DATA ACQUISITION  
EAST LEE ACRES LANDFILL

*February 6, 1986*

*Giant Industries, Inc.  
7227 North 16th Street  
Phoenix, Arizona 85020*

*Geoscience Consultants, Ltd.  
500 Copper Avenue, NW  
Suite 325  
Albuquerque, New Mexico 87102*

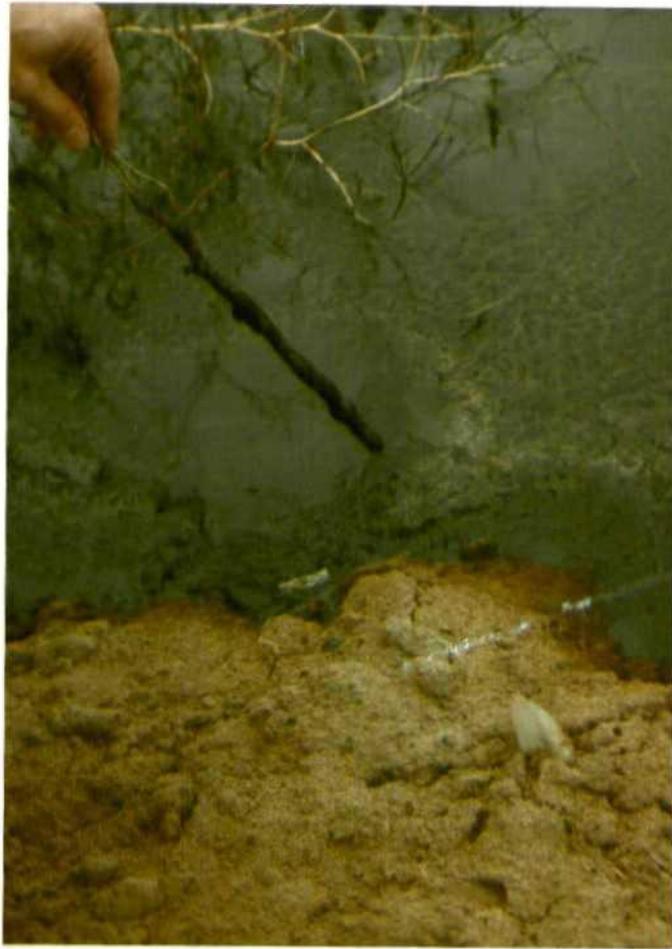
Figure 2-5 Photograph of edge of impoundment at East Lee Acres showing petroleum product sludge floating on surface 3/12/85.

At the time of our initial inspection (March 12, 1985), the liquid in the impoundment appeared to consist of several phases of liquid and semisolid petroleum wastes. Figure 2-5 shows the sticky, sludge-like material that floats on top of much of the impoundment and is from 0 to 4" thick. This material consists of heavy ends (asphaltic) of petroleum hydrocarbons similar to sludges that may form in tank bottoms or in an API separator. The impoundment also contains some paraffin-like, yellow-orange compounds. The bulk of the material is aqueous with a slight oil cut.

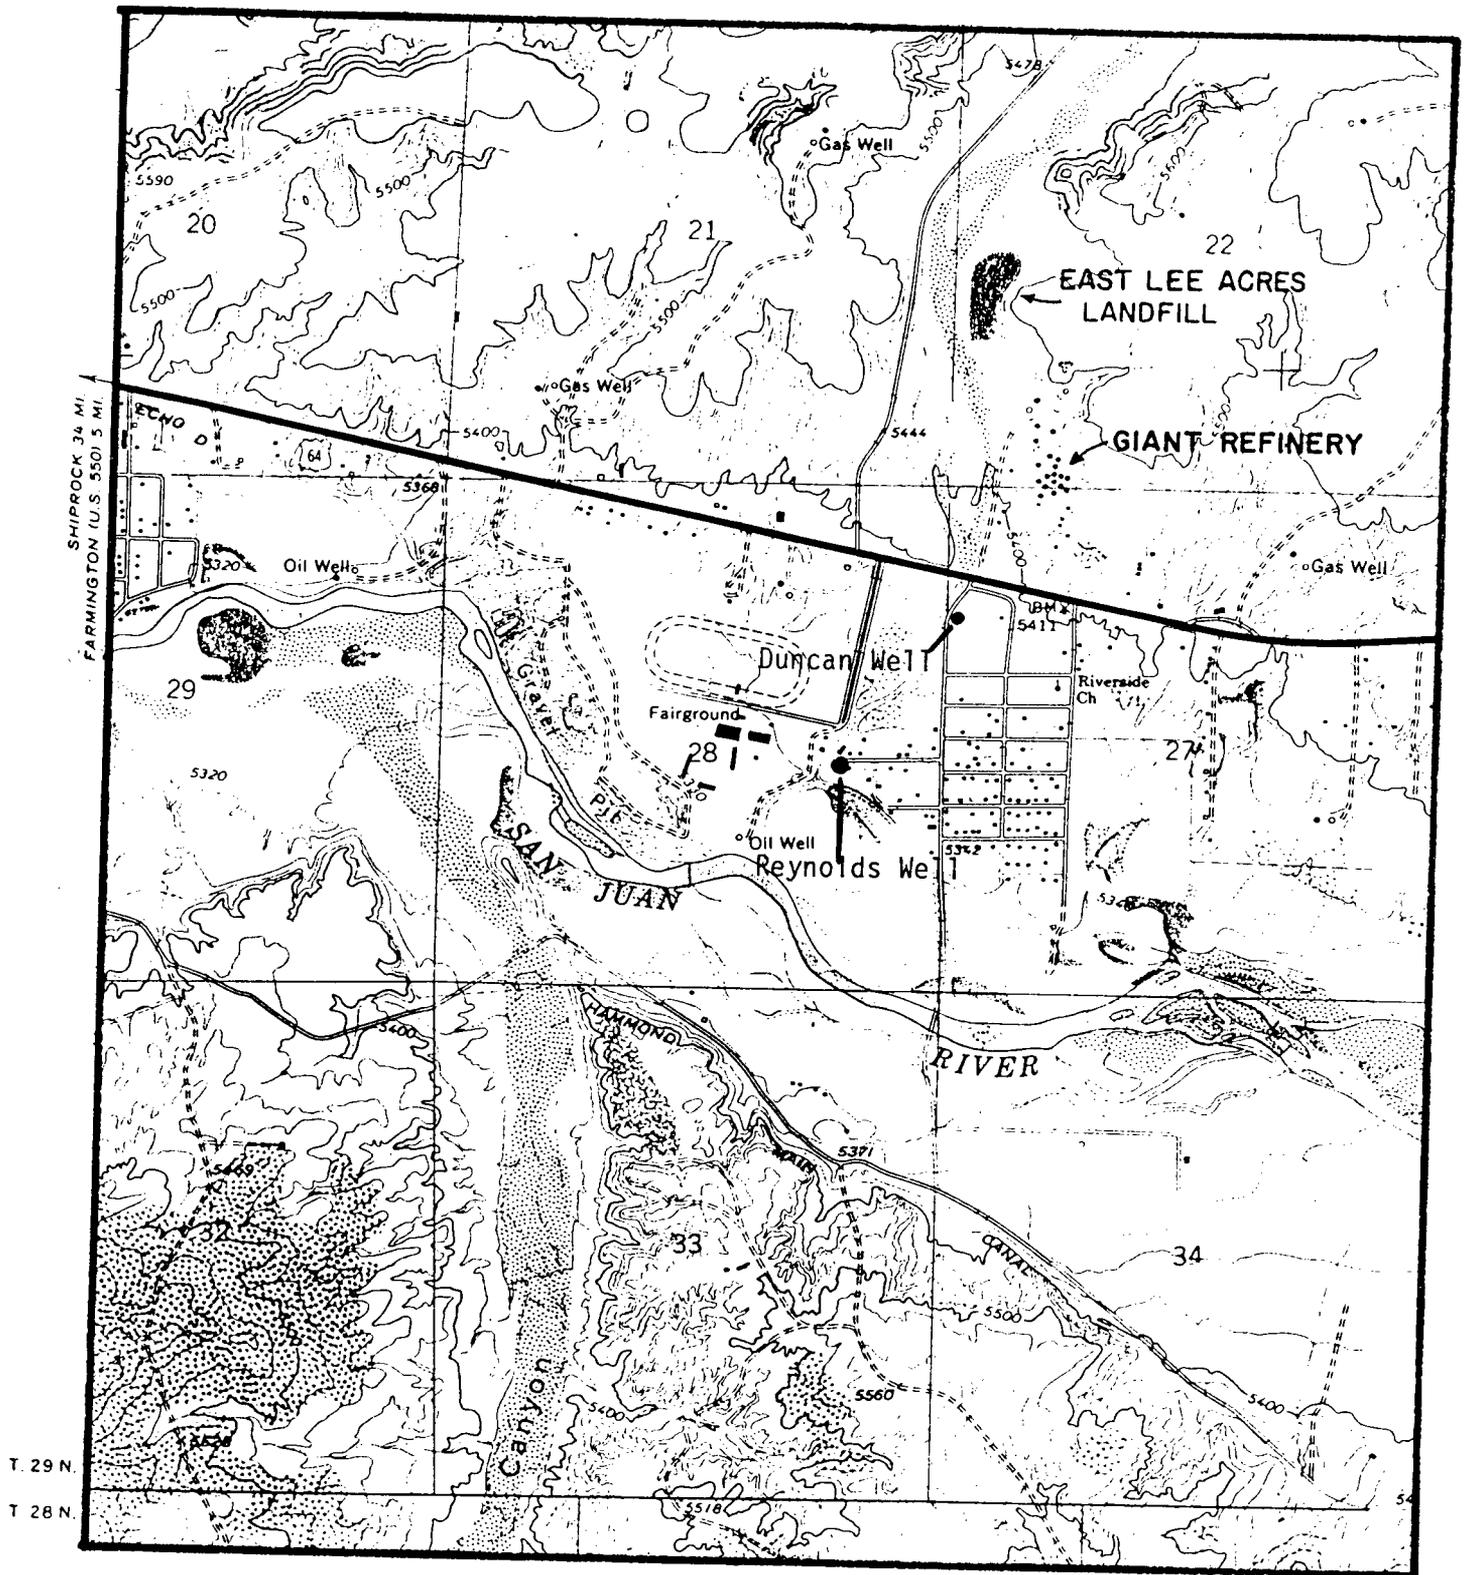
Figure 3-1 Location of Wells Sampled by NMEID

NMEID has sampled several downgradient domestic wells on the south side of the road to attempt to assess if gross ground water contamination has resulted from the impoundments. Location of these wells is plotted on Figure 3-1. The results of these analyses are included as Table 3-3. A comparison between the results of these analyses and the constituents in the impoundments shows that some of the same compounds were detected although not in similar proportions. Since the halogenated organics (Table 3-3) found in the Reynolds well (Figure 3-1) samples are common contaminants of ground water in light industrial areas, and no information on the hydrologic relationship between these sample locations and the ground water beneath the impoundment has been established, it is likely that the impoundments are the source of the observed contamination in the wells.

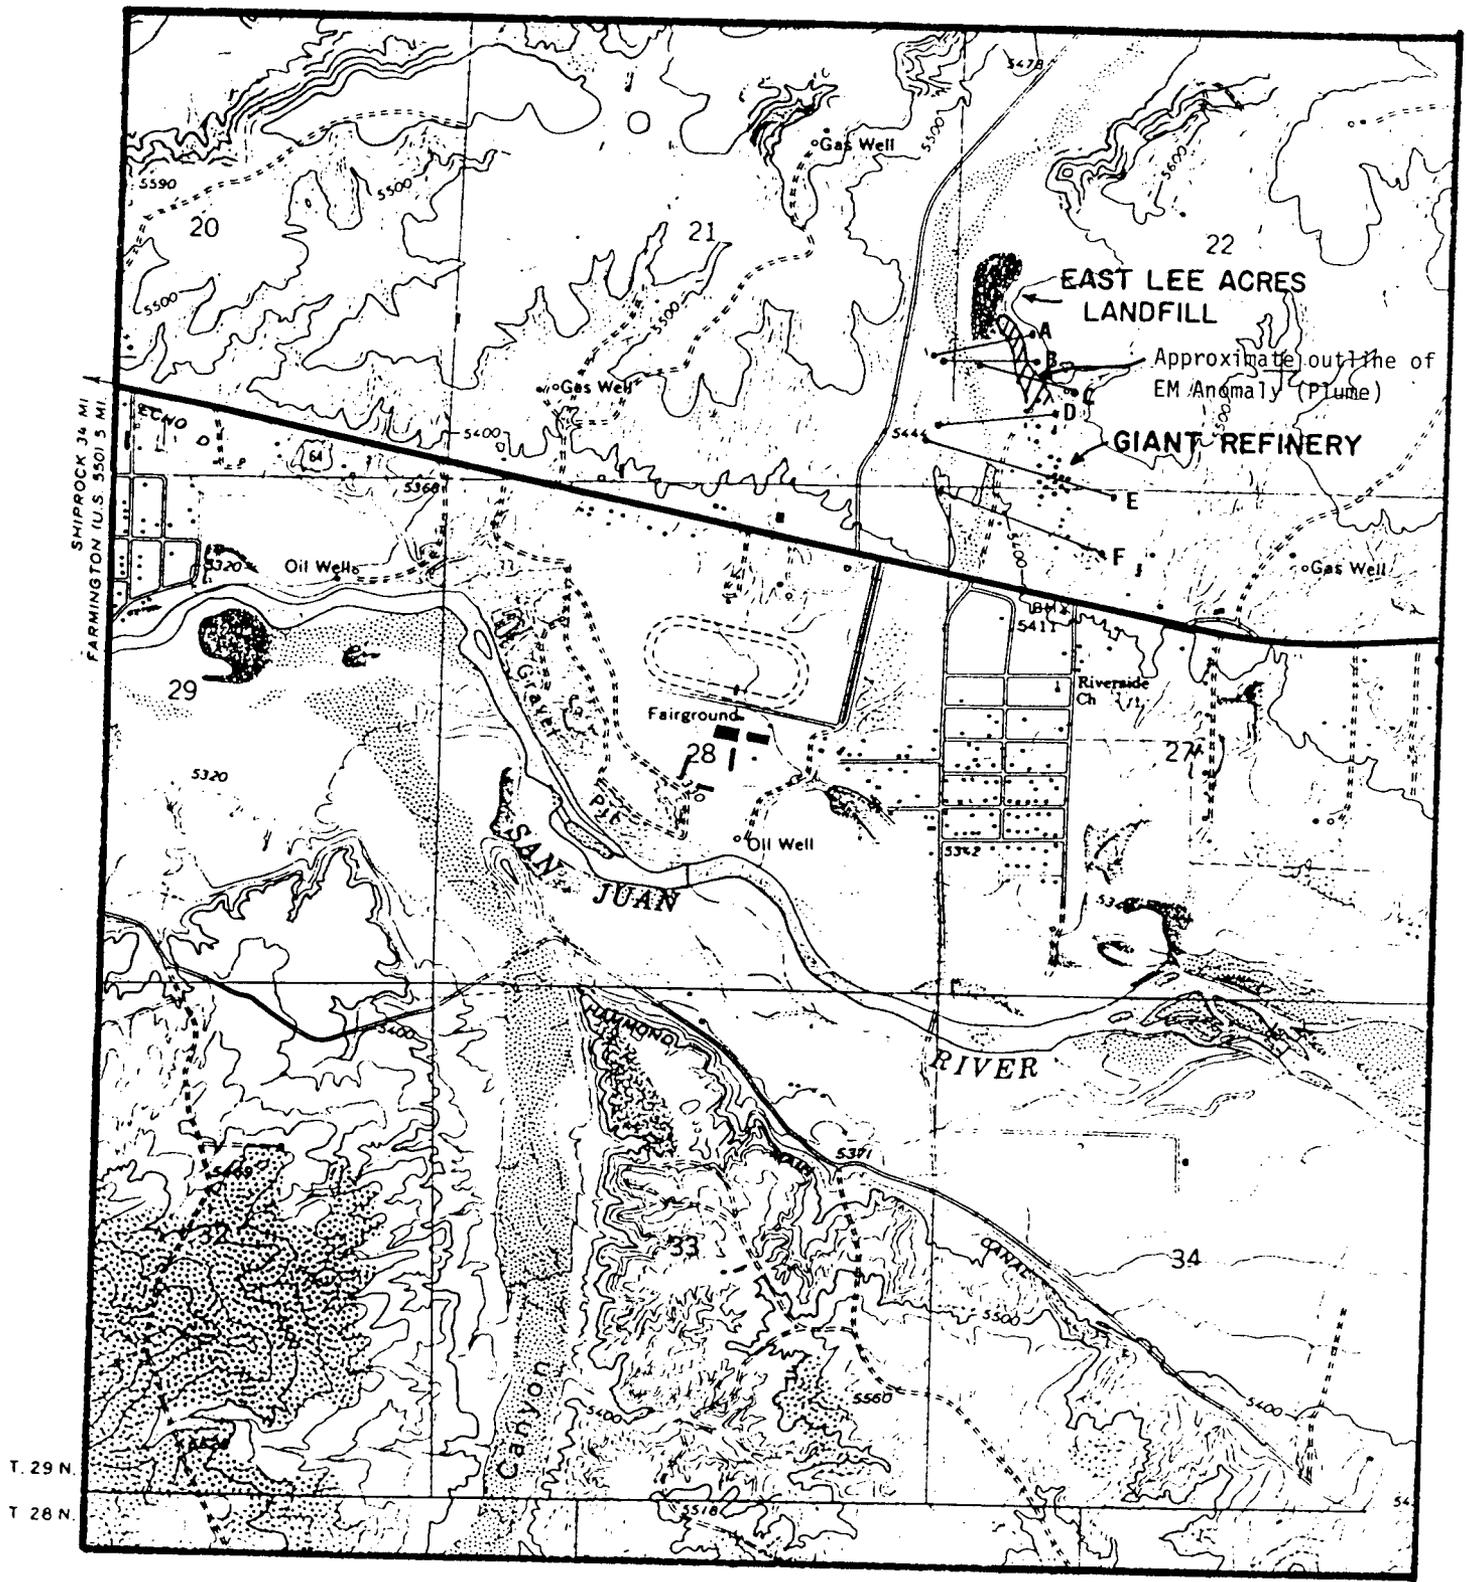
Figure 3-2 Preliminary EM Survey of The East Lee Acres Site

On October 23-24, 1985, GCL personnel accompanied NMEID on an electromagnetic-induction (EM) survey of the arroyo which drains the landfill area, where the arroyo crosses Giant property (Figure 3-2). A total of 6 EM lines were run, labeled A through F on Figure 3-2.

Lines A, B and C revealed anomalously high ground-water conductance along the east side of the arroyo. Results of lines D, E and F were

EM Survey Transects are represented as lines labeled A-F  
 Approximate Outline of EM Anomaly (plume) shown as hatched area

ambiguous due to the presence of tanks, underground lines, fences and buildings. The anomalies seen in lines A, B and C were consistent with values observed in lines nearer the landfill, indicating that a plume of contaminated ground water exists along the eastern side of the arroyo. The approximate location of the inferred contaminant plume is shown on Figure 3-2.

Because of the presence of numerous surface and buried metallic objects on the Giant site, it is unlikely that an EM survey could accurately define potential subsurface anomalies. The results of the EM survey should be used to plan a drilling program in order to directly sample ground water in the arroyo. This recommendation is discussed in section 4.0.

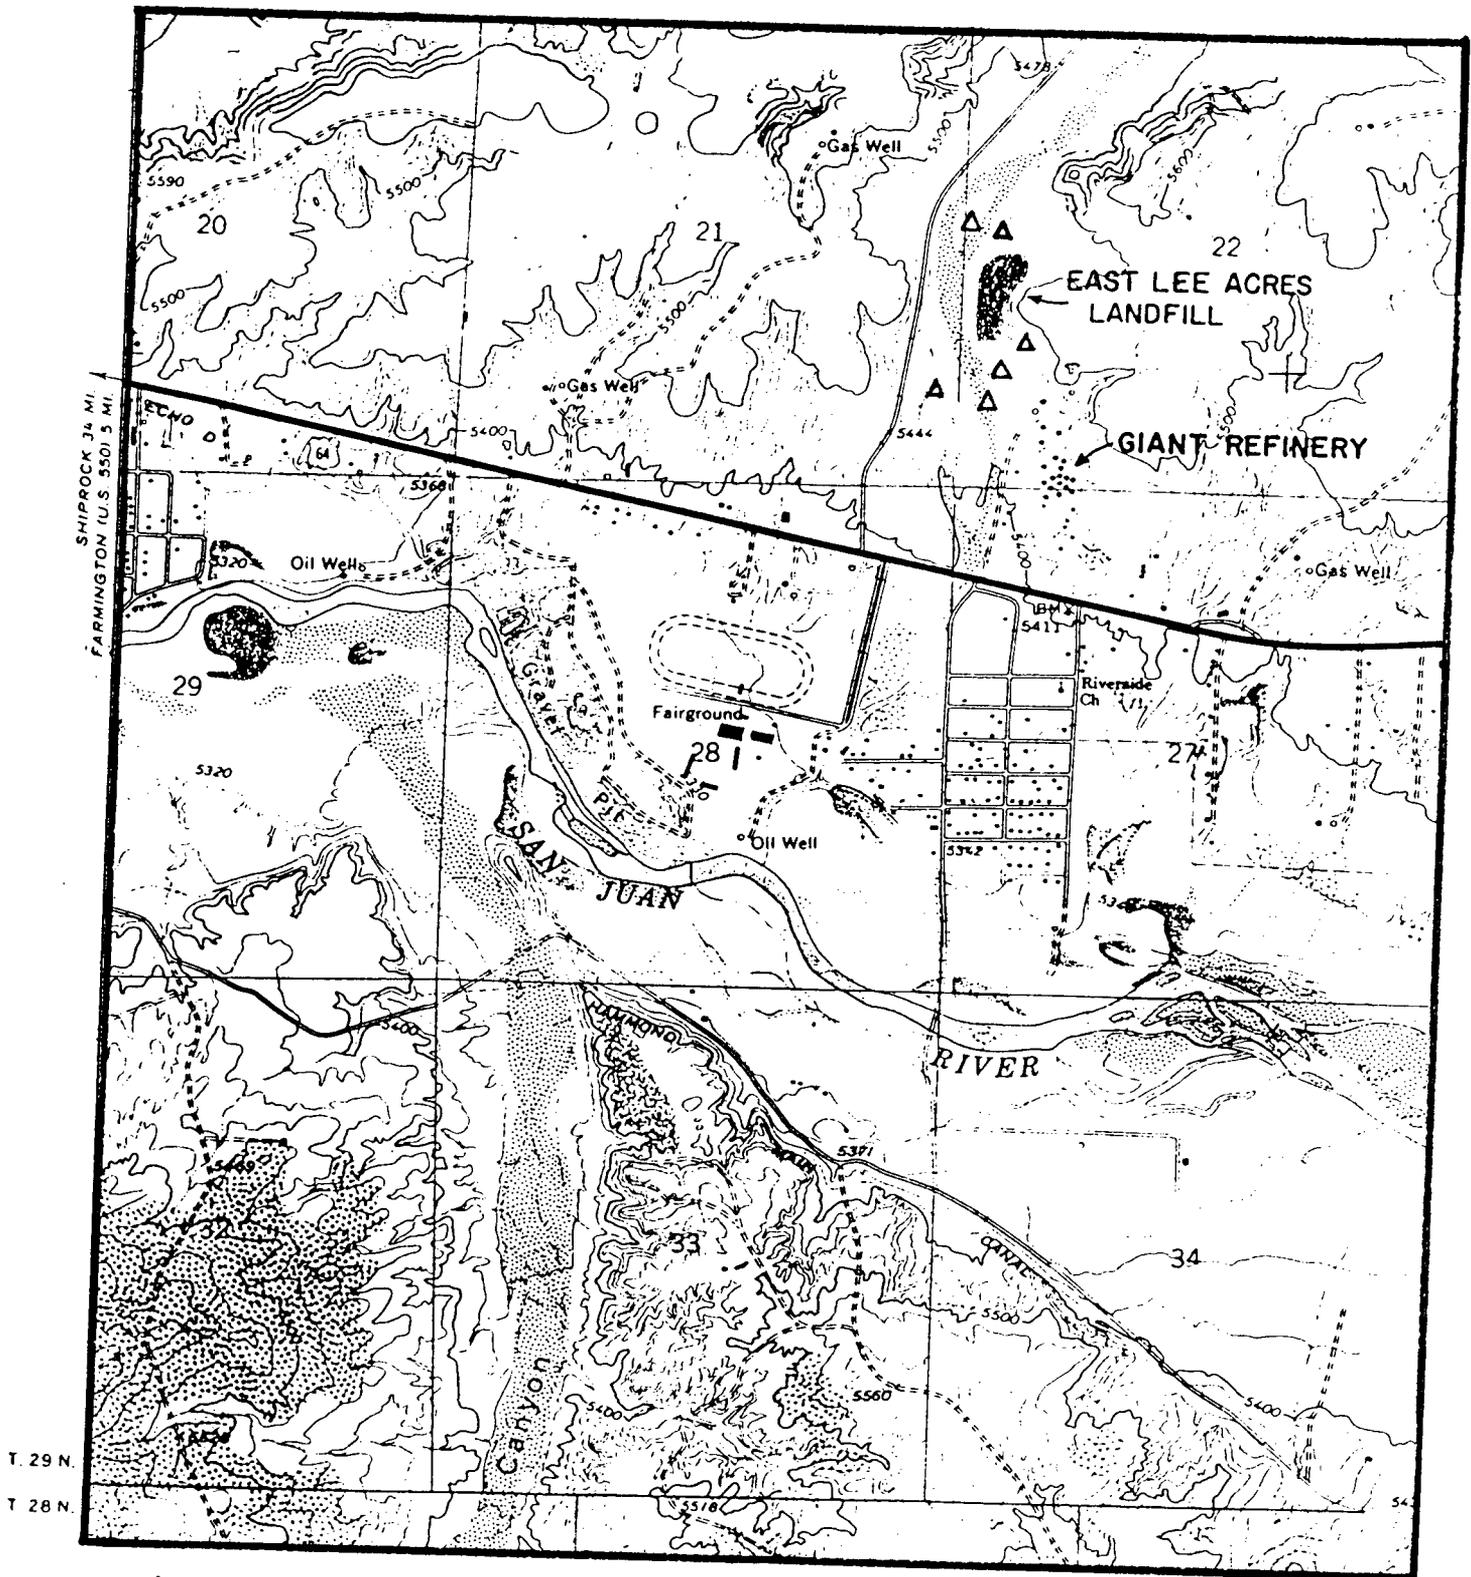
Figure 4-1 Potential Locations for Proposed Monitor Wells

The aqueous nature of the waste, the location of the impoundment, construction techniques and the apparently permeable berm and bottom materials indicate that substantial subsurface seepage may be occurring into the shallow alluvium in the valley where the landfill is located. The silty/sand nature of the sediments and the hydraulic head difference between the refinery area and the impoundment create the potential for a plume of ground water contamination to migrate from the landfill area to the refinery area. Since the wastes in the impoundment contain petroleum products, any ground water contamination that results from landfill leachate could, at some point in the future, be attributed incorrectly to Giant's activities.

To assess the extent of the potential for a problem, it will be necessary to examine the ground water hydrology of the small valley in which the landfill and refinery are located and to determine the best locations to install monitoring points upgradient and downgradient from the impoundments (upgradient from the refinery boundary). In order to determine whether ground water contamination has occurred due to the disposal of unknown quantities of unknown wastes at East Lee Acres, it will be necessary to install a ground water monitoring network in the vicinity of the impoundments. The design for this network should be based on a thorough analysis of all available hydrogeologic and EM survey data.

Giant believes that the installation of such a network represents the only prudent and reasonable course of action for the owner/operator of the East Lee Acres Landfill. Giant must be assured that any potential contaminants from the impoundments not be allowed to migrate downgradient beneath their facility. The precise location and number of wells required for an accurate assessment of ground water contamination must await a detailed hydrogeologic study; however, based on the results of the EM survey and other available data, a system similar to that proposed in Figure 4-1 will be required. Giant hereby requests that the appropriate regulatory agencies and the owners/operators of the impoundments
