**ADDENDUM SITE REMEDIATION CLOSURE REPORT  
HOMCO INTERNATIONAL, INC. LOCATION 151 FACILITY  
FARMINGTON, NEW MEXICO**

*February 14, 1992*

**BUYS AND ASSOCIATES, INC.**

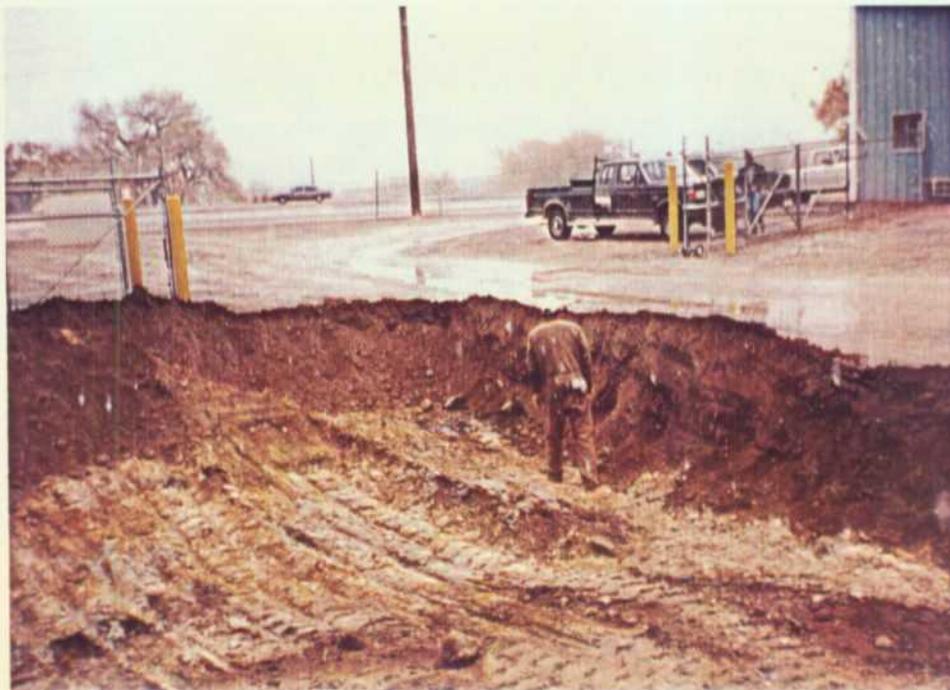
1. View of southwest corner of excavation adjacent to western margin of HFTO building. West wall and southwest corner of this excavation are the furthest extent of the excavation completed in these directions. The total depth of the excavation into the bedrock (light colored material at left in foreground) is also depicted.

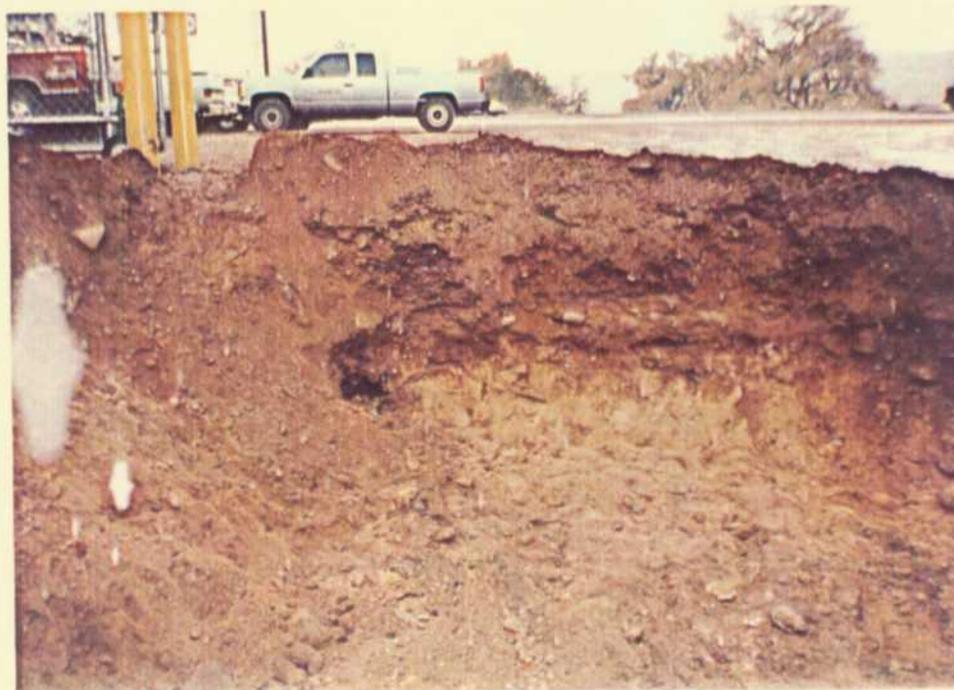
2. Closeup view of southwest corner of excavation adjacent to western margin of HFTO building. Hydrocarbon stain in south wall (left center) is from migration of contaminants from sump inside HFTO building. Hydrocarbon visible in the south wall were excavated and disposed after fence (top left) was dismantled. Unstained sidewall (to right of hydrocarbon stain) is furthest extent of excavation to southwest.

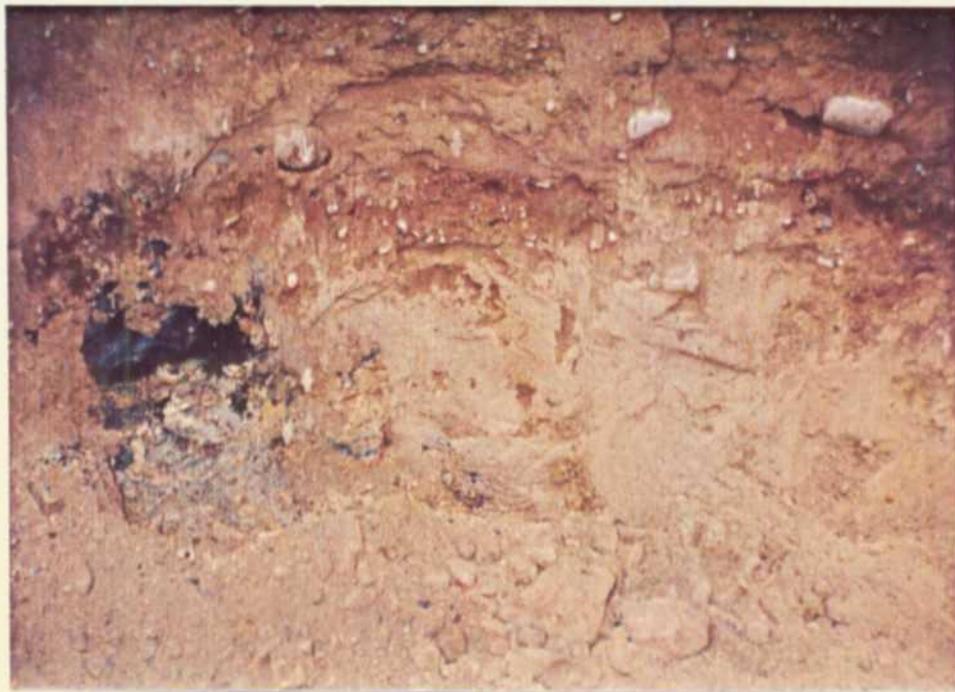
3. Closeup view of hydrocarbon stained soils ( in south wall of excavation adjacent to western margin of HFTO building) depicted in photograph 2.

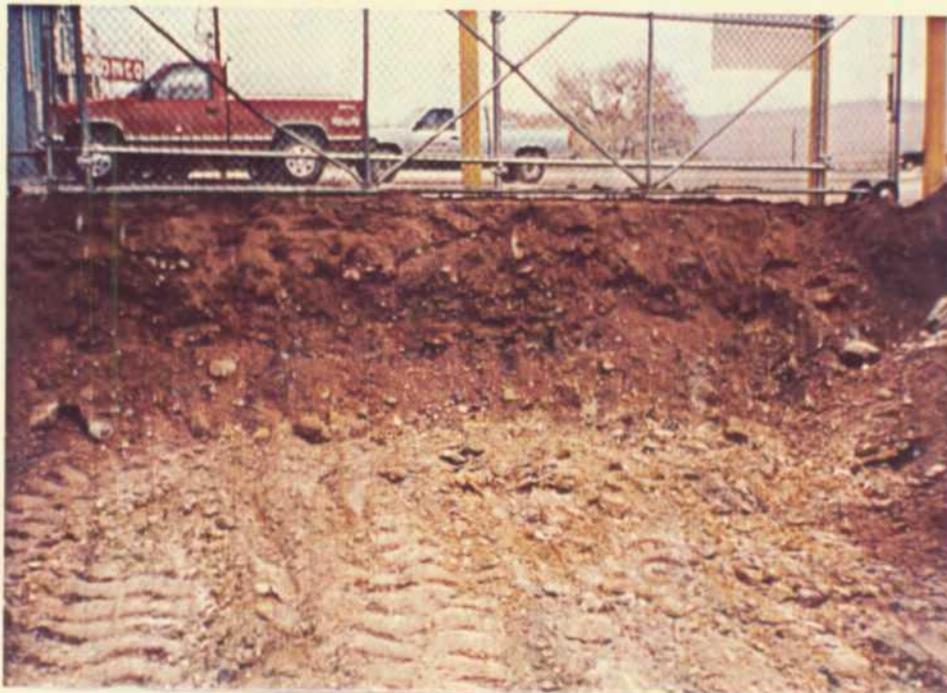
4. View of south wall of excavation adjacent to western margin of HFTO building. Hydrocarbon-stained materials are visible in this sidewall. Excavation was extended to south to remove these stained materials after the fence was dismantled.

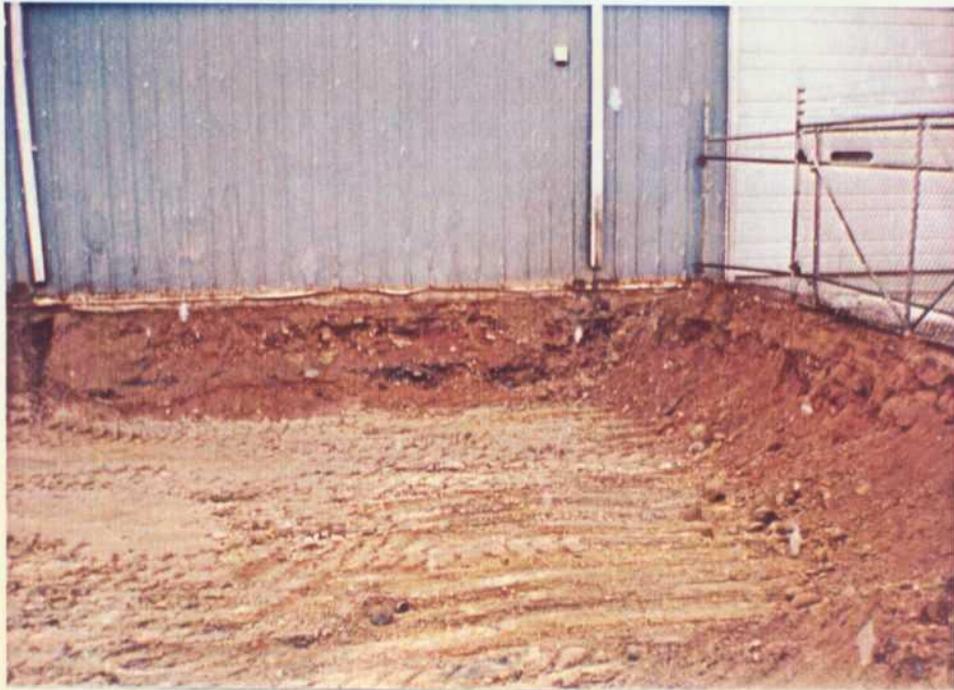
5. View of southeast corner of excavation adjacent to western margin of HFTO building. Petroleum hydrocarbon contaminants visible in the east wall occur in soils beneath the building foundation. These contaminants migrated from the indoor sump located on the other side of the wall. The east wall was not excavated any further to avoid damage to the building foundation.

The source of petroleum hydrocarbons in the soil was the leaking indoor sump located in the northern margin of the original HFTO building. The existence of the petroleum hydrocarbon-contaminated material excavated from north of the fence was anticipated in the work plans. The migration of petroleum hydrocarbon contaminants south of the fence was not originally expected. OVM responses within stained material that was excavated ranged from 56 to 105 ppm. OVM responses within the completed excavation ranged from 0 to 5 ppm (Figure 4-2). Contaminated soils on the east wall of the excavation (beneath the HFTO building) were left in place (Photograph A-5).

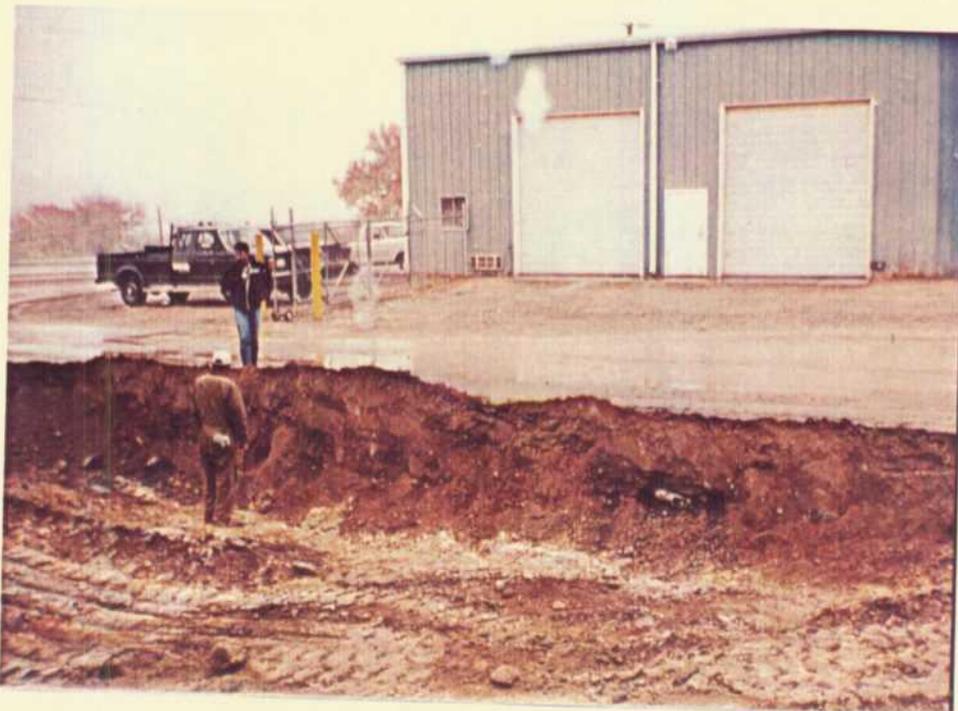
6. View of west wall of excavation adjacent to western margin of the HFTO building. The drain line and leach field that trend to the southwest from the HFTO building are visible in the west wall.

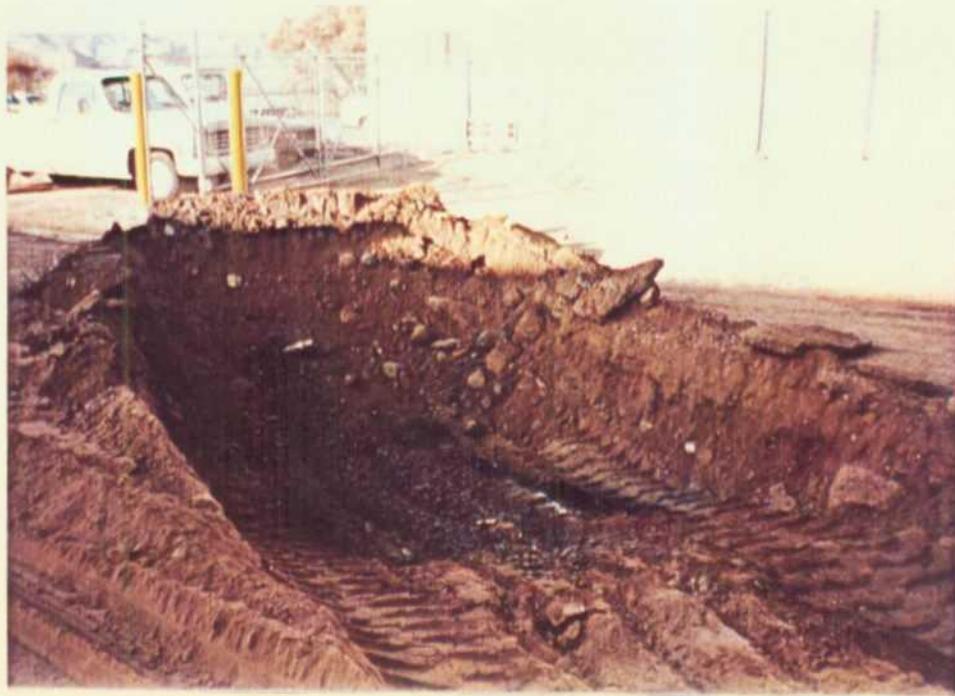
7. Excavation of drain line and leach field that extend to southwest from the HFTO building. Note black hydrocarbon stain in leach field gravels and adjacent soils.

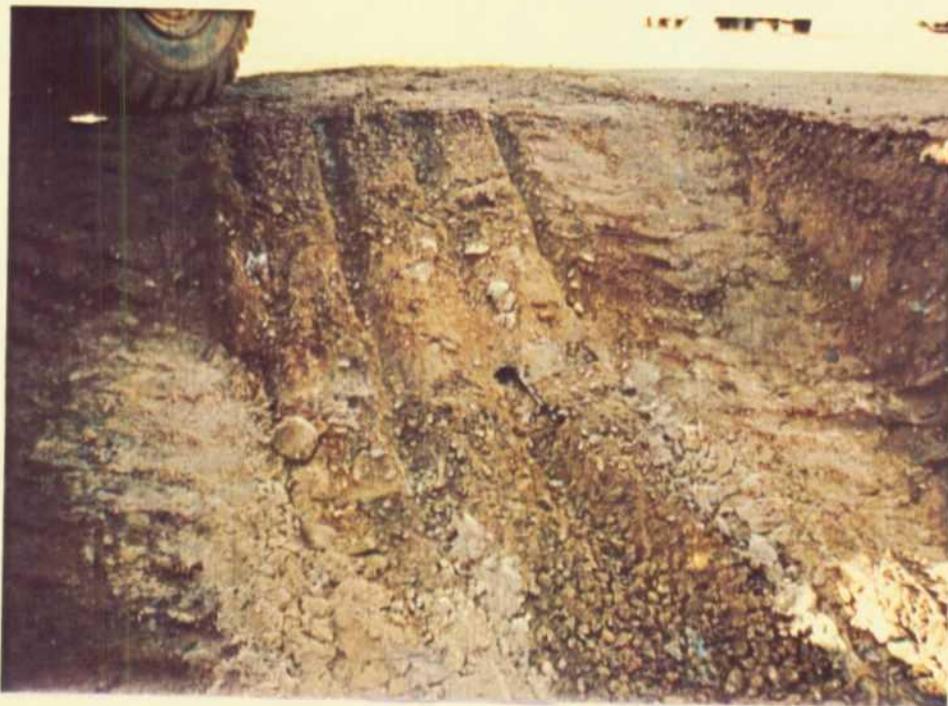
8. Excavation of drain line and leach field that extend to southwest from the HFTO building and past the facility fence. Leach field gravels visible in the foreground do not exhibit extensive hydrocarbon staining. Analytical results of sample collected from these materials exceeded NMOCD action levels; leach field was subsequently removed.

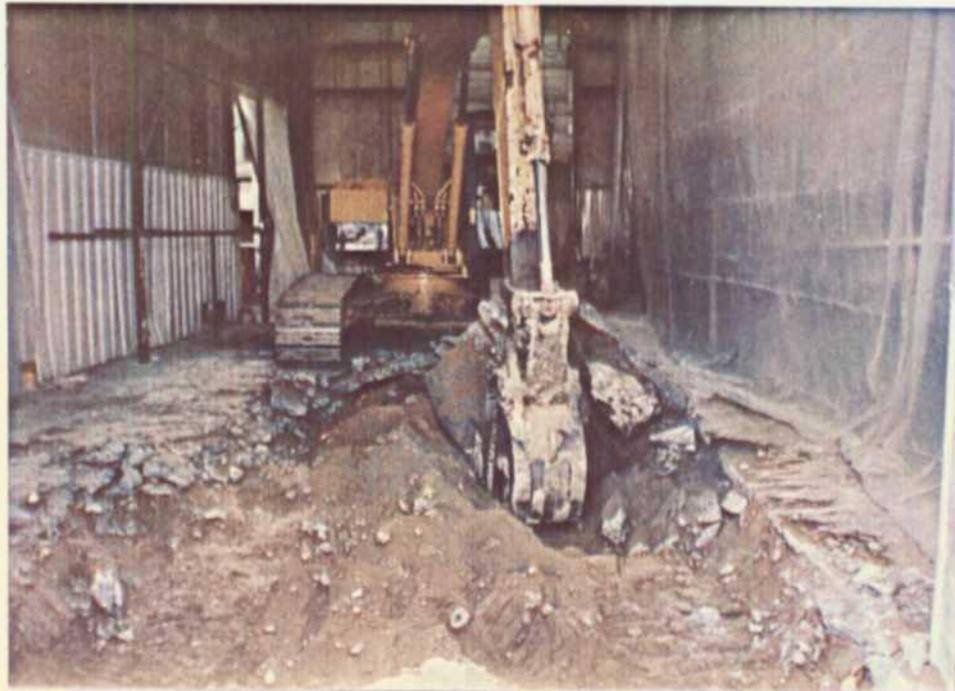
9. Removal of concrete and excavation of soils inside northern margin of HFTO building. Note plastic walls (at left and right) constructed to minimize migration of dust and odors into other portion of the building.

Prior to conducting operations inside the northern margin of the HFTO building, temporary plastic walls were constructed (Photograph A-9) to minimize the amount of dust and fumes that would impact the building interior. The concrete floor surrounding the leaking indoor sump (in the northern margin of the HFTO building, Figure 4-3) was cut with a concrete saw on October 31, 1991. In addition, holes were drilled at regular intervals into the floor with a jack hammer to facilitate removal of the concrete. The foundation footings beneath the overhead door on the western margin of the building (Figure 4-3) were also cut.

The concrete, sump and all piping were excavated, transported and disposed on November 4, 1991 (Photograph A-9). The excavation was 55-foot long, 20-foot wide and 5 to 6 foot deep (Figure 4-3). The north, south and east walls of this excavation displayed petroleum hydrocarbon-stained soils (Photographs A-10 and A-11). The west wall was extended into the excavation along the western margin of the HFTO building (Section 4.1.4.1). A total of 250 yds<sup>3</sup> of material was removed from this excavation, 200 yds<sup>3</sup> of petroleum hydrocarbon-contaminated soils and 50 yds<sup>3</sup> of concrete.

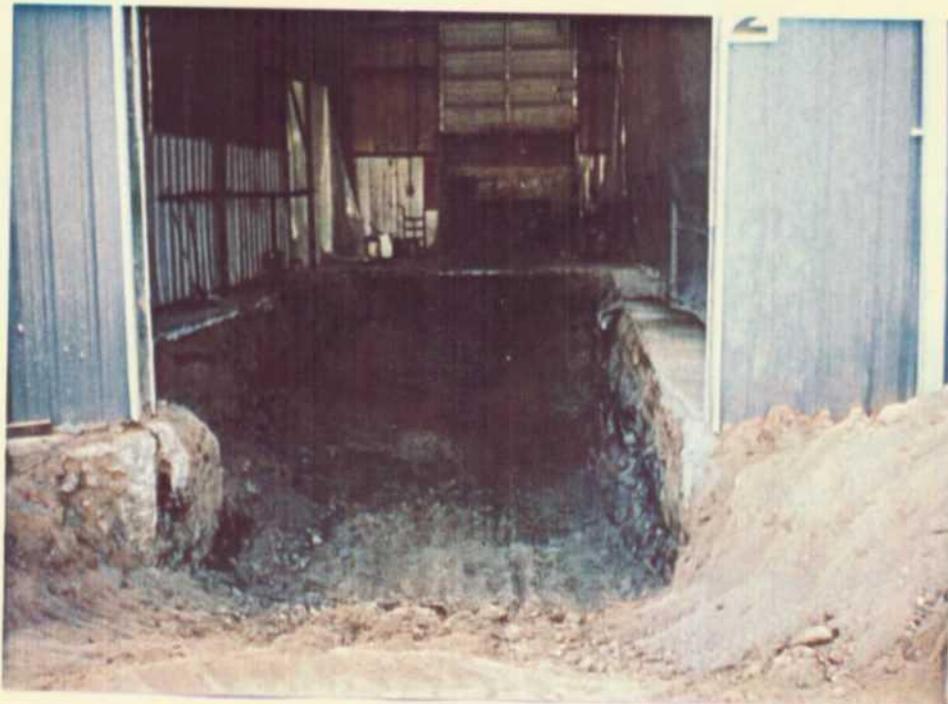
10. View of completed excavation inside northern margin of HFTO building.

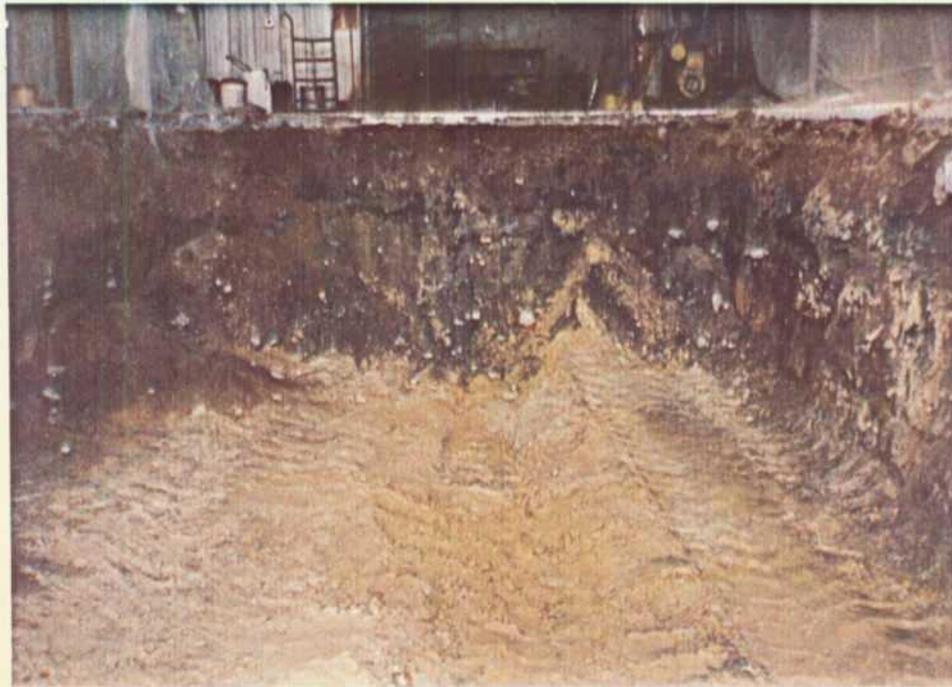
11. Close up view of completed excavation inside northern margin of HFTO building. Note the hydrocarbon stained soils present in the sidewalls, The excavation was not extended further to avoid damage to the building foundation.

The source of petroleum hydrocarbons in the soil was the cracked indoor sump. None of the soils contained sludges or were saturated with petroleum hydrocarbons. An OVM response measured within the completed excavation was 0 ppm (Figure 4-3). Contaminated soils on the north, south and east walls of the excavation (beneath the HFTO building) were left in place because further excavation would have threatened the structural integrity of the building (Photographs A-10 and A-11).

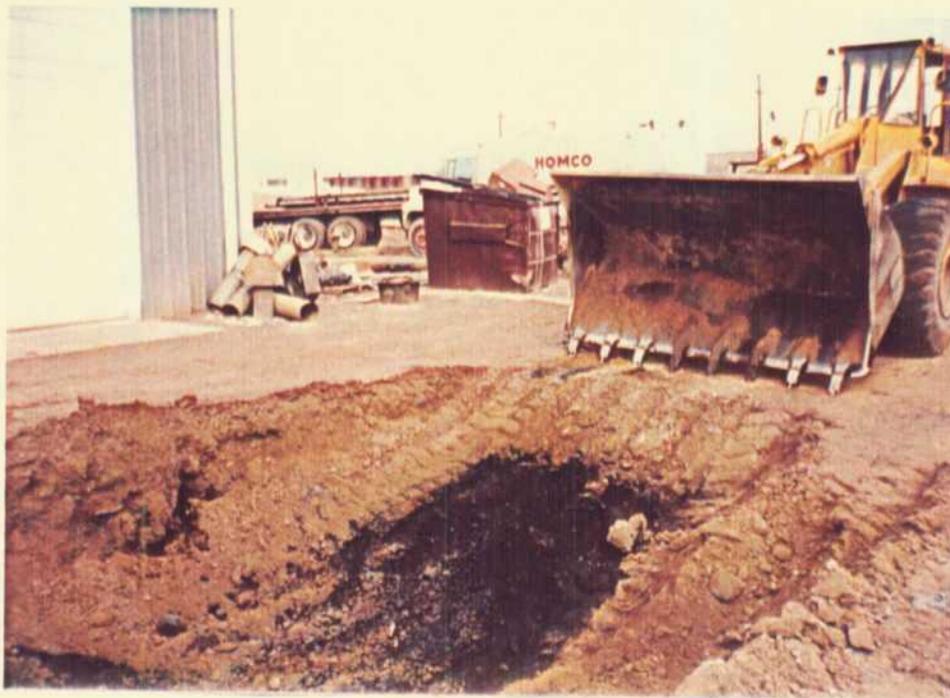
12. Excavation of leach field directly in front of HWS building. Leach field gravels and adjacent soils are saturated with petroleum hydrocarbons. This leach field is the source of contaminants for the bedrock plume.

The source of petroleum hydrocarbons in the bedrock was the drain line and leach field excavated east of the HWS building (Photographs A-12, A-13 and A-21). The occurrence of this plume was not originally expected. OVM responses within the bedrock plume left in place beneath the concrete cap (Photograph A-24) ranged from 89 to 1028 ppm (Figures 4-2 and 4-4). One OVM response measured within materials left in place beneath the HWS building was 175 ppm (Figure 4-2). A small area of slightly stained soils left in place above the bedrock plume and beneath the concrete cap yielded an OVM response of 220 ppm (Figure 4-2).

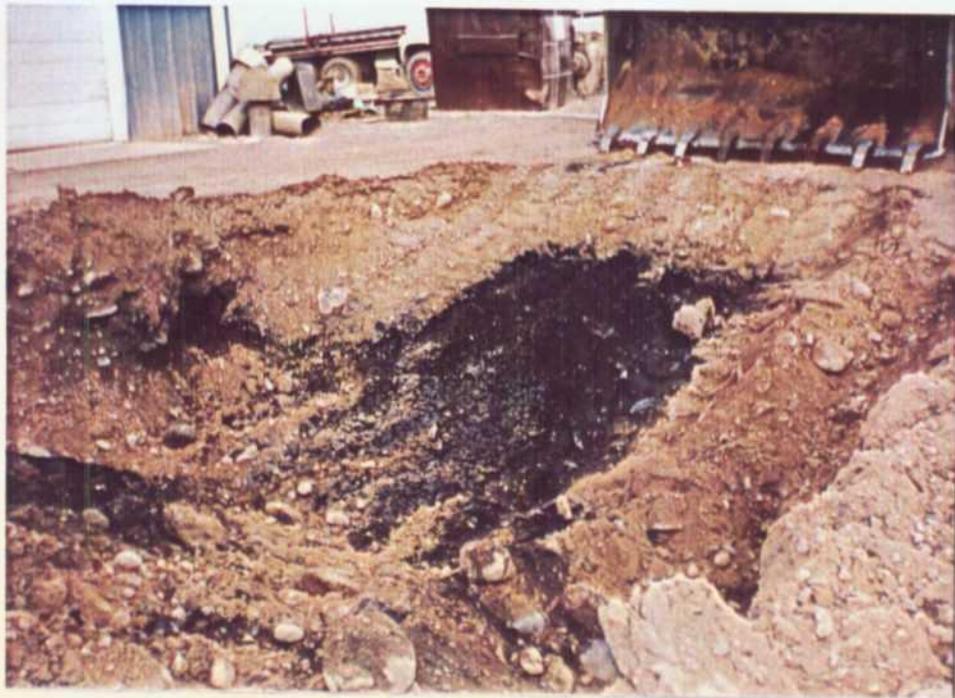
13. Closeup view of leach field (directly in front of HWS building) depicted in photograph 12.

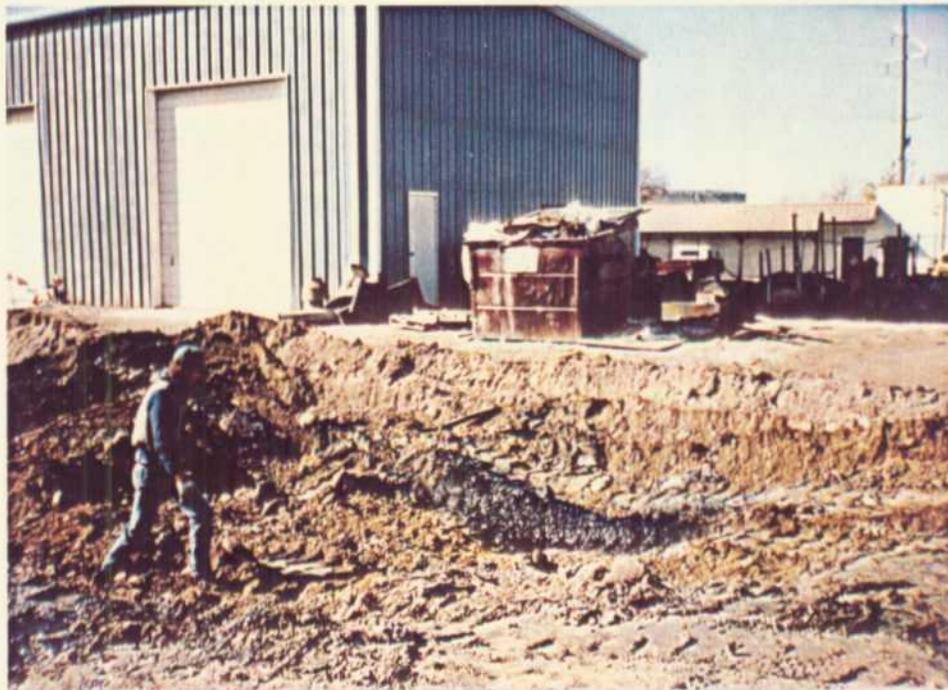
14. Excavation of leach field extending to the north from the front of the HWS building. Leach field gravels and adjacent soils are saturated with petroleum hydrocarbon contaminants.

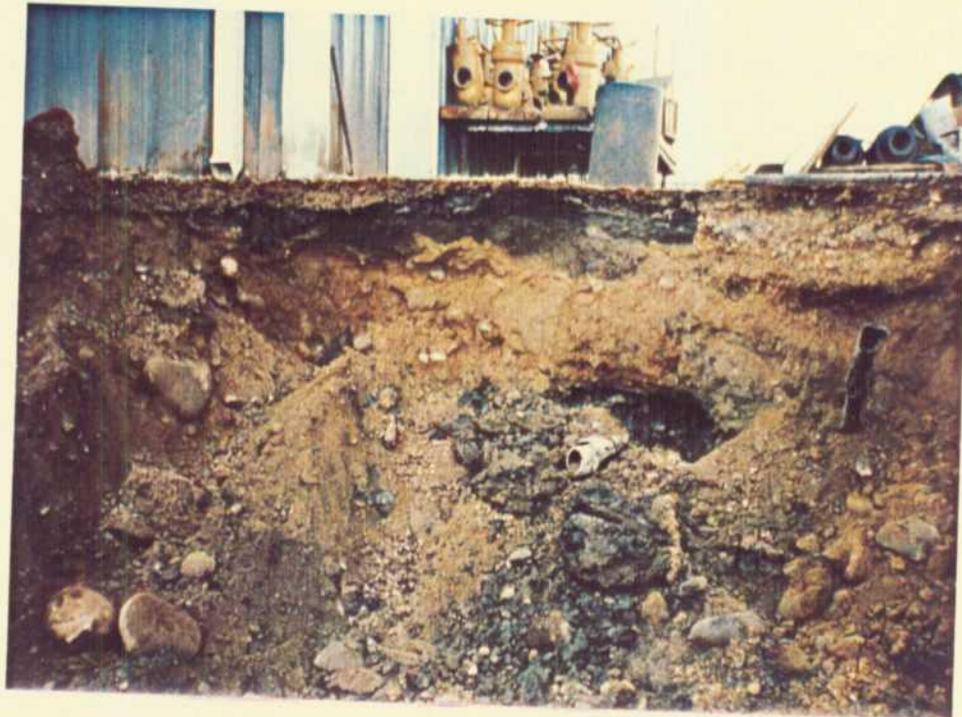
16. View of drain line and leach field that trend in east-west direction along northern margin of HWS building. Surficial soil is stained black from spillage of used oil.

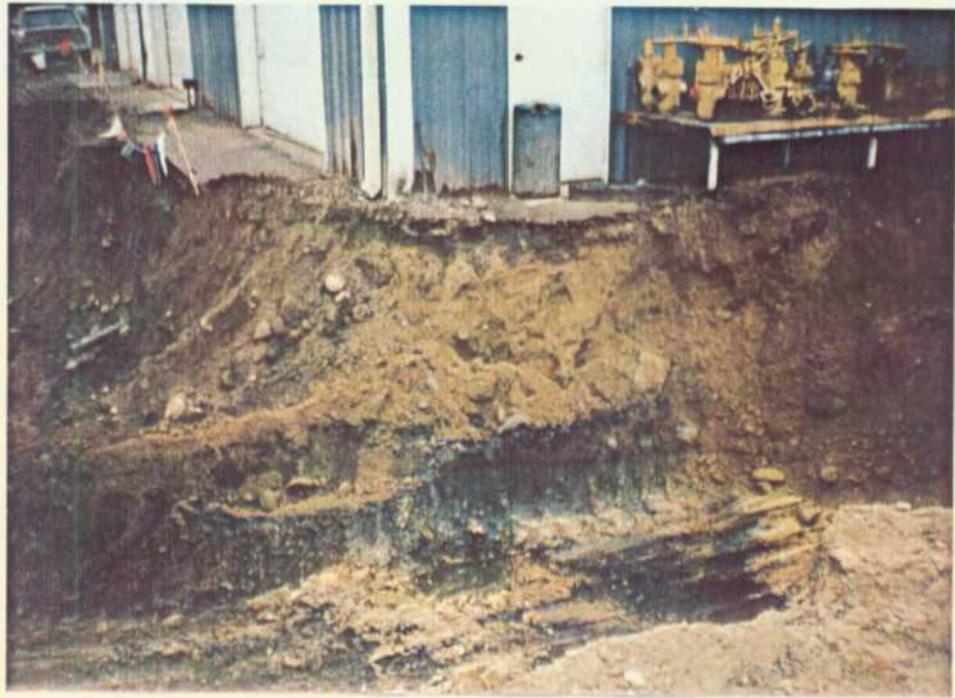
17. Excavation of leach field that trends east-west along northern margin of HFTO building.

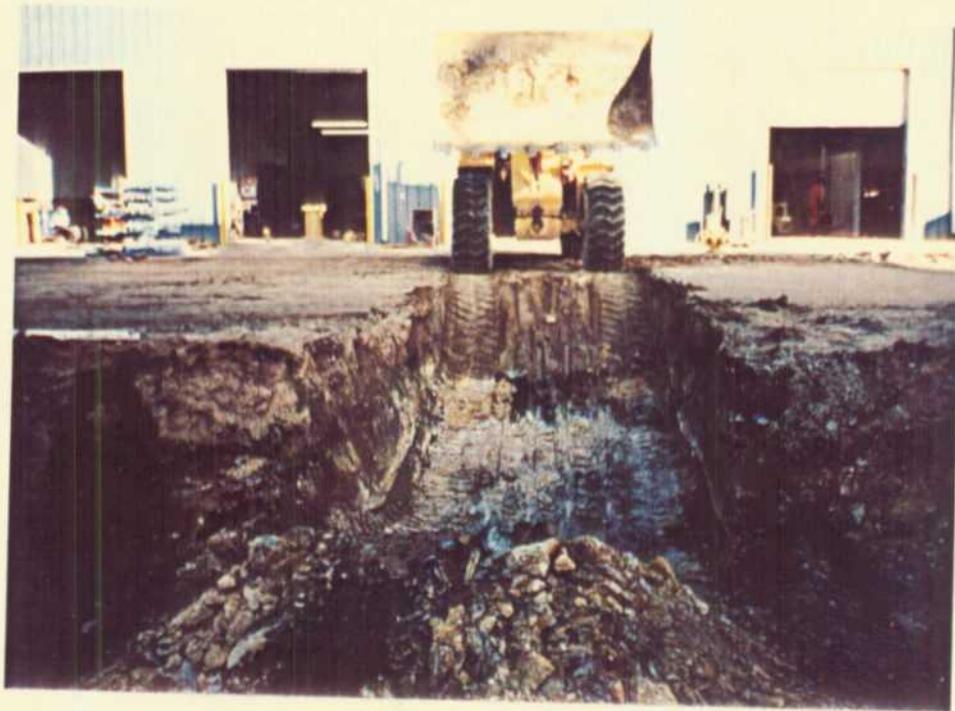
18. Excavation of drain line and leach field that trend eastward from HWS building towards HFTO building.

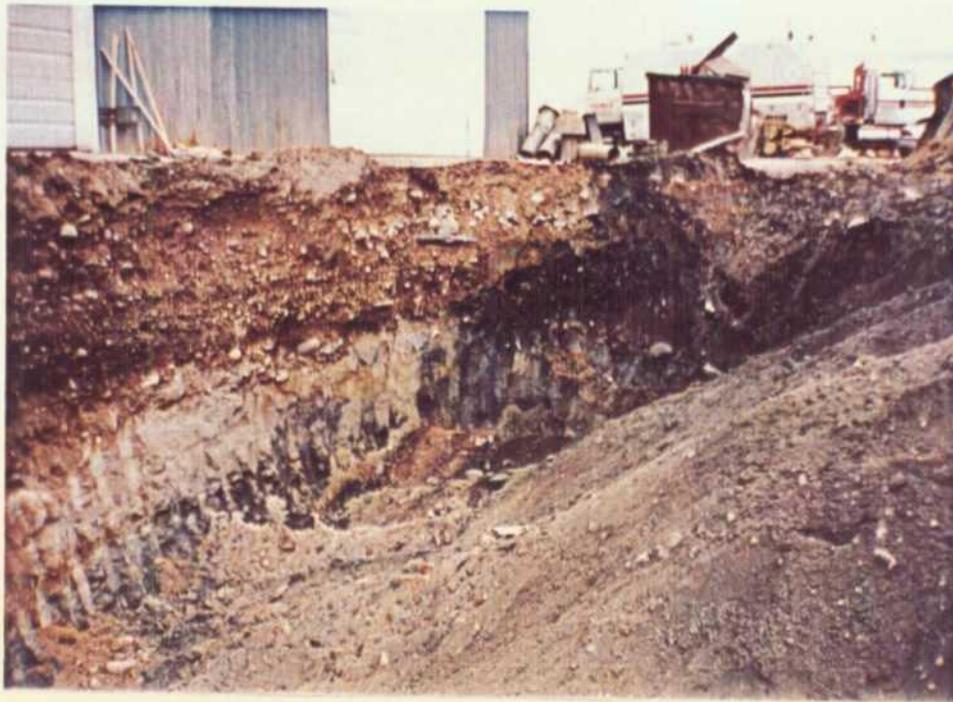
21. View to northwest of excavation for bedrock plume. Overlying leach field was source of petroleum hydrocarbon contaminants for this plume.

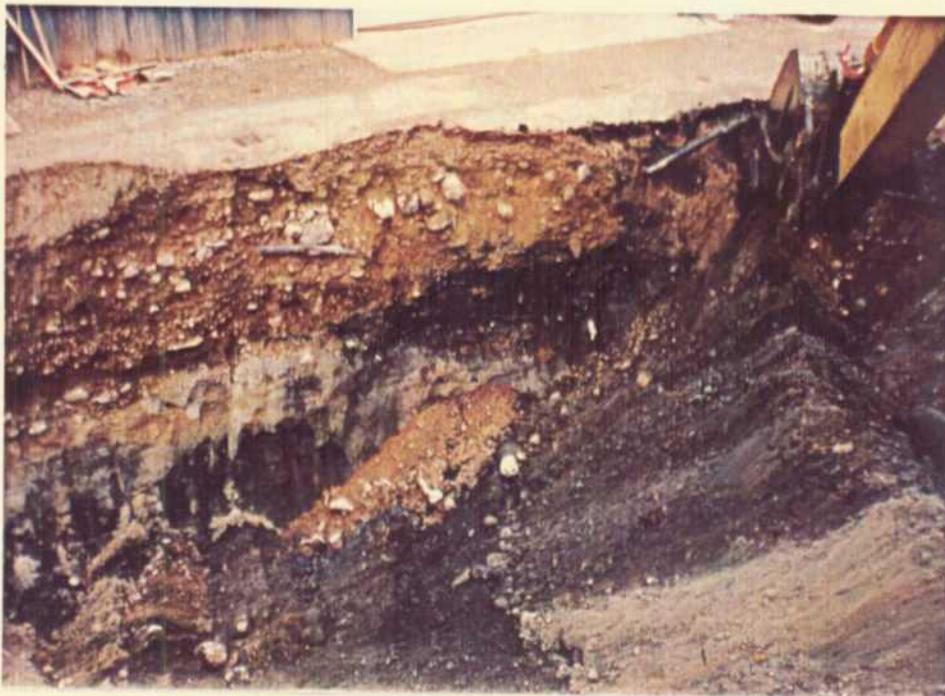
22. Closeup view of bedrock plume and overlying leach field.

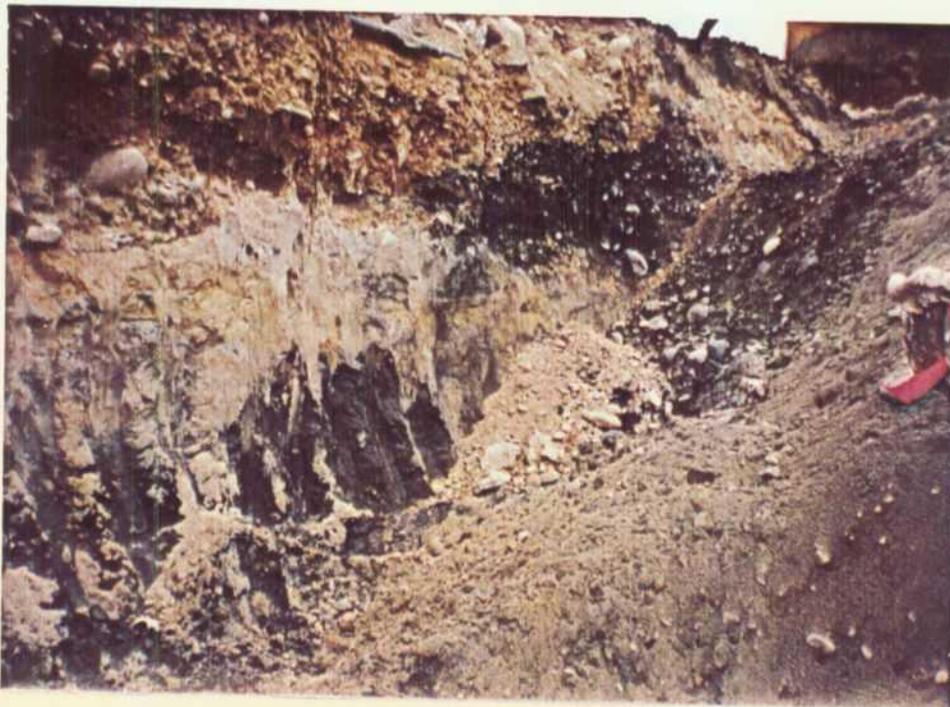
23. Closeup view of bedrock plume and overlying leach field.

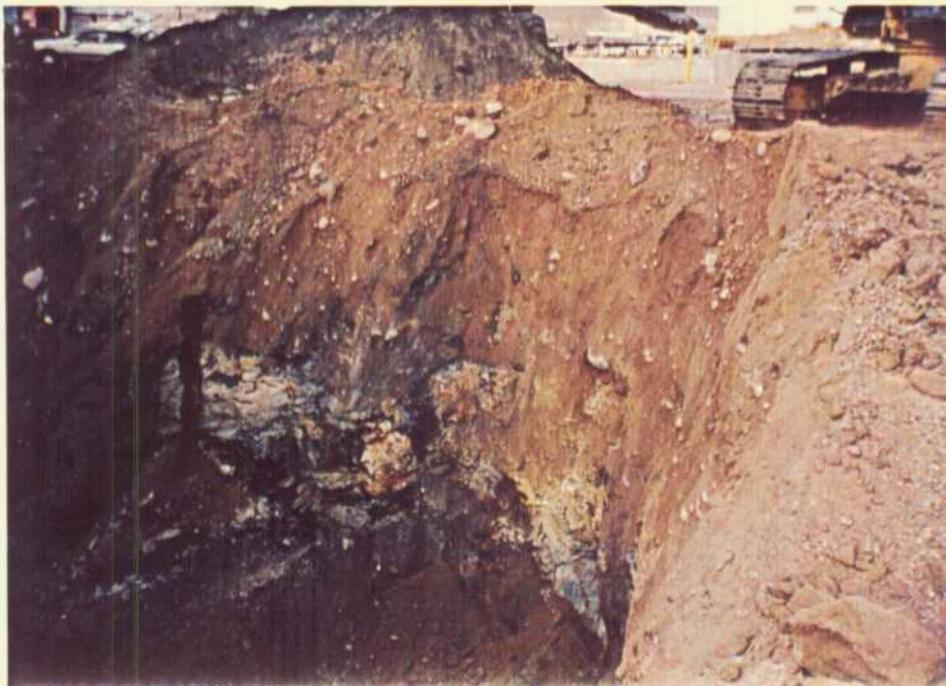
24. View of north wall of completed excavation for southern margin of bedrock plume. The petroleum hydrocarbon contaminants visible in the north wall were sampled for Sample #9111041200. These contaminants were left in place and capped with concrete.

9111041200	5	Southern margin of plume in bedrock composited from 8' to 18'.	Characterize plume in bedrock.	OVM= 89-842 ppm; stained black, strong hydrocarbon odor.
9111041430	6	Floor of excavation beneath indoor sump removed from Operations Building.	Verify floor of excavation.	OVM= 0 ppm; no stains or odors.
9111071315	7	Floor of excavation (18') for plume in bedrock.	Verify vertical extent of plume in bedrock.	OVM= 9.8 ppm; No stains or odors.

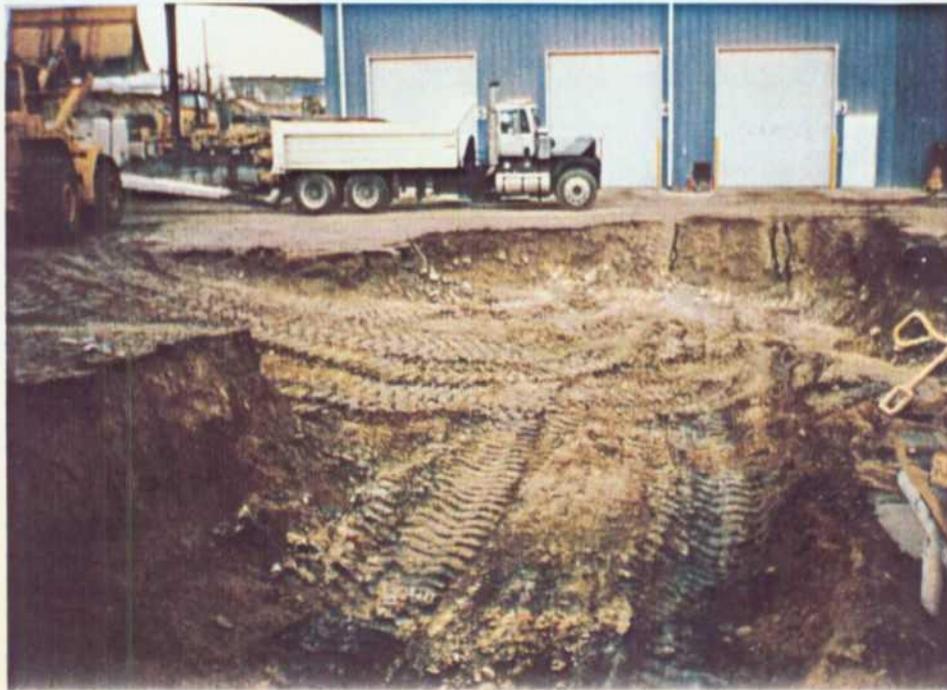
25. View of northeast margin of completed excavation for shallow drain lines and leach fields originating from HWS building.

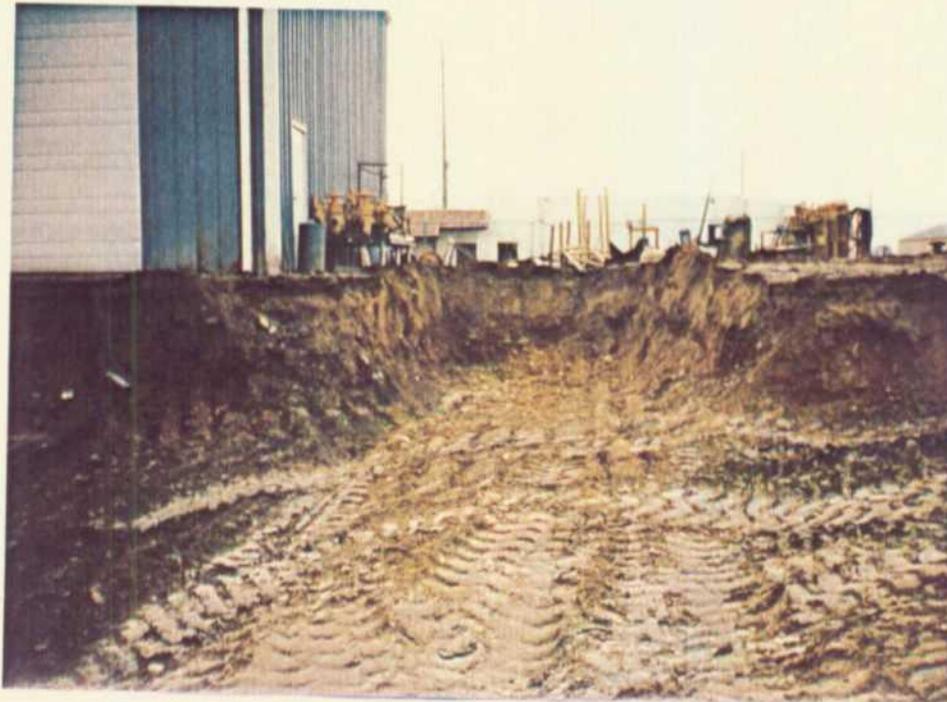
26. View of northwest margin of completed excavation for shallow drain lines and leach fields originating from HWS building

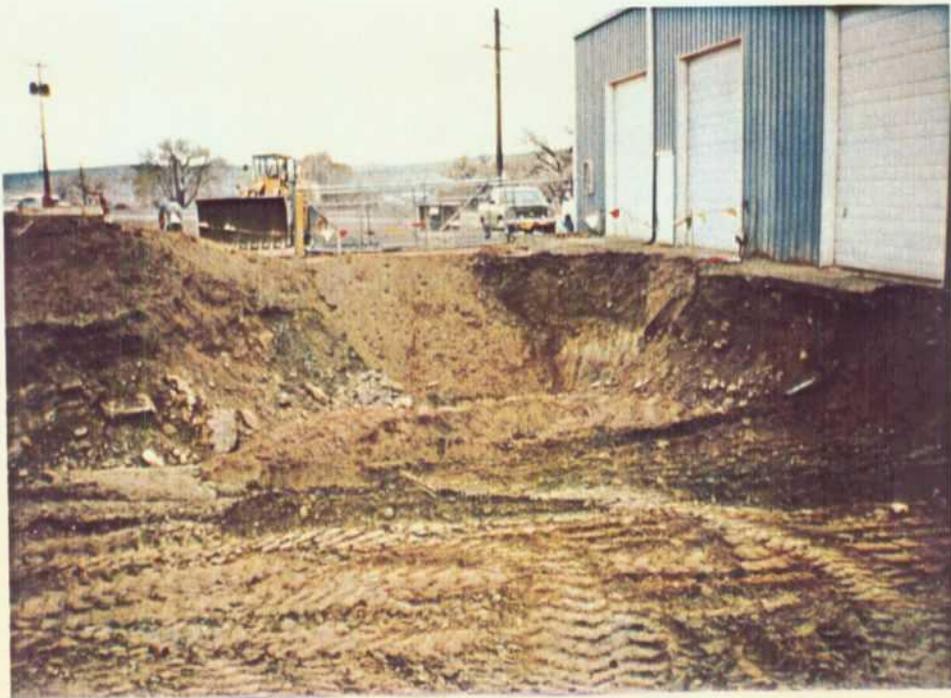
27. View to south of completed excavation for shallow drain lines and leach fields originating from HWS building.

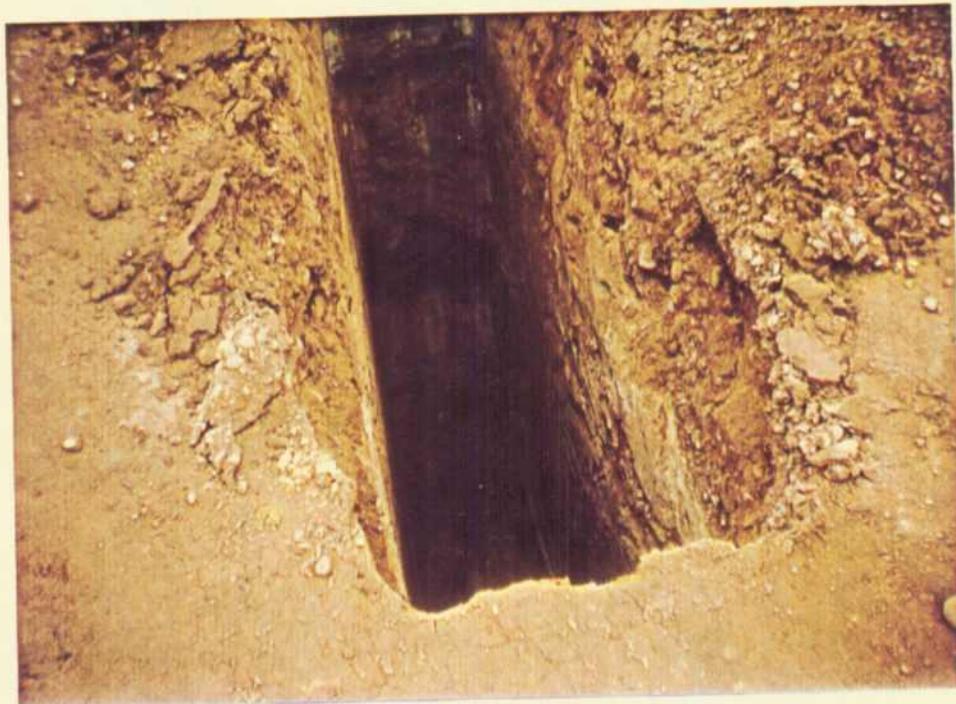
28. View into exploratory trench excavated south of the gateway. Note absence of hydrocarbon stain on sidewalls of trench.

The second and third exploratory trenches were excavated on November 21, 1991. The second trench was dug approximately 40 foot south of the gateway (Figure 4-1). This location is approximately 10 foot south of the excavations for the drain lines originating from the HWS building. The trench was excavated to a depth of approximately 12 foot. It was dug to verify that petroleum hydrocarbon contaminants had not migrated south of the excavations. No hydrocarbon stains or odors were noted at any level within the trench (Photograph A-28). The OVM response measured within sandstone at the bottom of the excavation was 0 ppm (Figure 4-2).

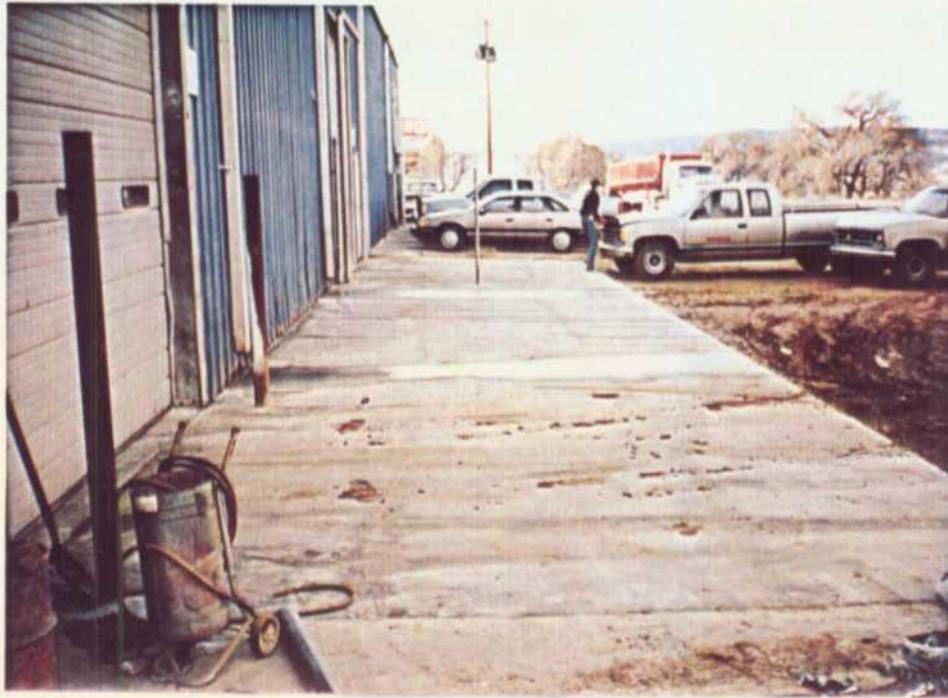
29. View to south of replacement concrete pads installed along western margin of HFTO building.

The concrete pads adjacent to the HFTO building and north of the facility fence were replaced with new steel-reinforced concrete pads (Photograph A-29) poured on November 7, 1991 (Figure 4-5). A segment of the concrete pad south of the facility fence was also replaced. This segment was cracked and replaced at the request of local HOMCO management. All concrete poured adjacent to the HFTO building was tied into the building foundation with rebar.

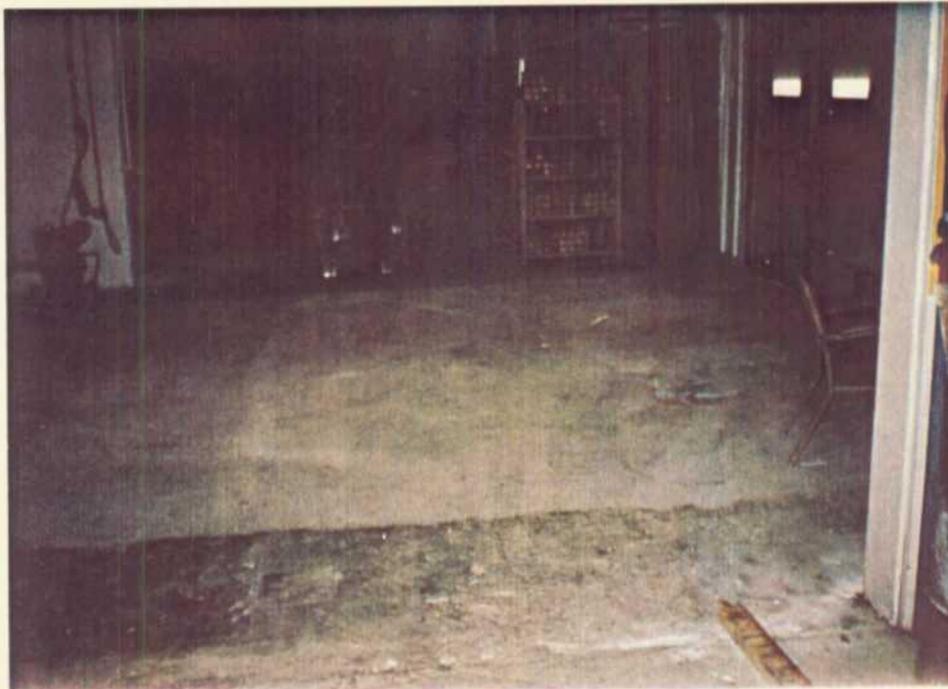
30. View of replacement concrete floor installed inside HFTO building.

A floor drain was installed on November 7, 1991 to replace the sump that had been removed. The drain is plumbed into the oil/water separator. A steel-reinforced concrete floor (Photograph A-30) was poured on November 7, 1991. The north, east and south sides of the new concrete floor were tied into the pre-existing concrete floor with steel rebar. The new floor was sealed after the concrete had sufficiently cured. In addition, the joints between the old and new floors were also sealed to retard fluid migration.

The new concrete floor constructed inside the HOMCO Fishing Tool Operations building was sealed to retard fluid migration. The quality of the seal will diminish with use. Periodic inspection of the floor by local management is recommended to monitor the quality of the seal. Local management was provided with floor sealer for future use.

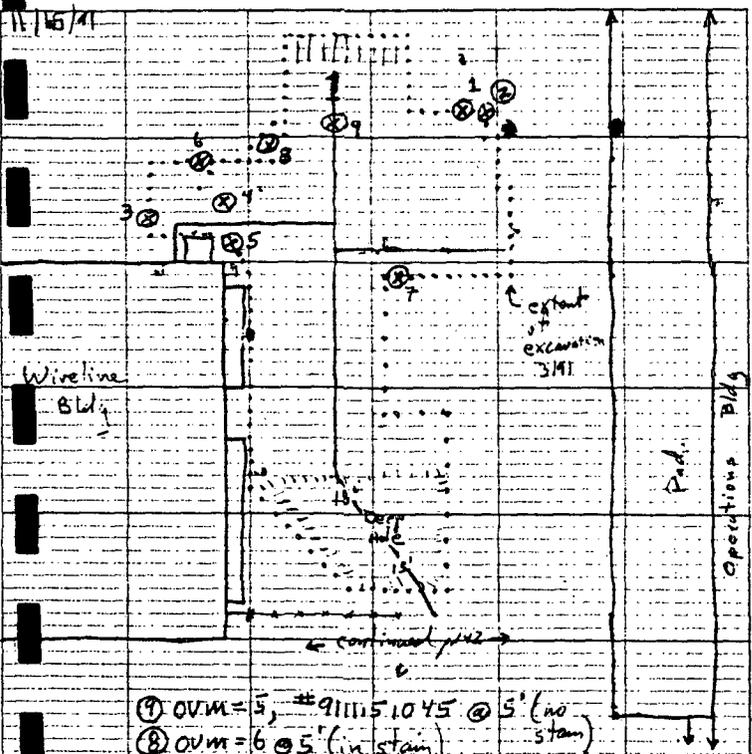
- ① OVM = 5, #911151045 @ 5' (no stain)
- ② OVM = 6 @ 5' (in stain)
- ③ OVM = 220 (in stain)
- ④ OVM = 4; #911150945 (no stain)
- ⑤ OVM = 175 (in stain)
- ⑥ OVM = 45 @ 5'
- ⑦ OVM = 9 (in stain)
- ⑧ #911150815 (in stain)
- ⑨ OVM = 3.8 (in stain) Final Excavation
