**GW - 158**

**INSPECTIONS &  
DATA**

**Re:** Knight Oil Tools (GW-158)  
Farmington, San Juan County, NM  
Discharge Permit – Renewal Conditions

## SITE INSPECTION SHEET

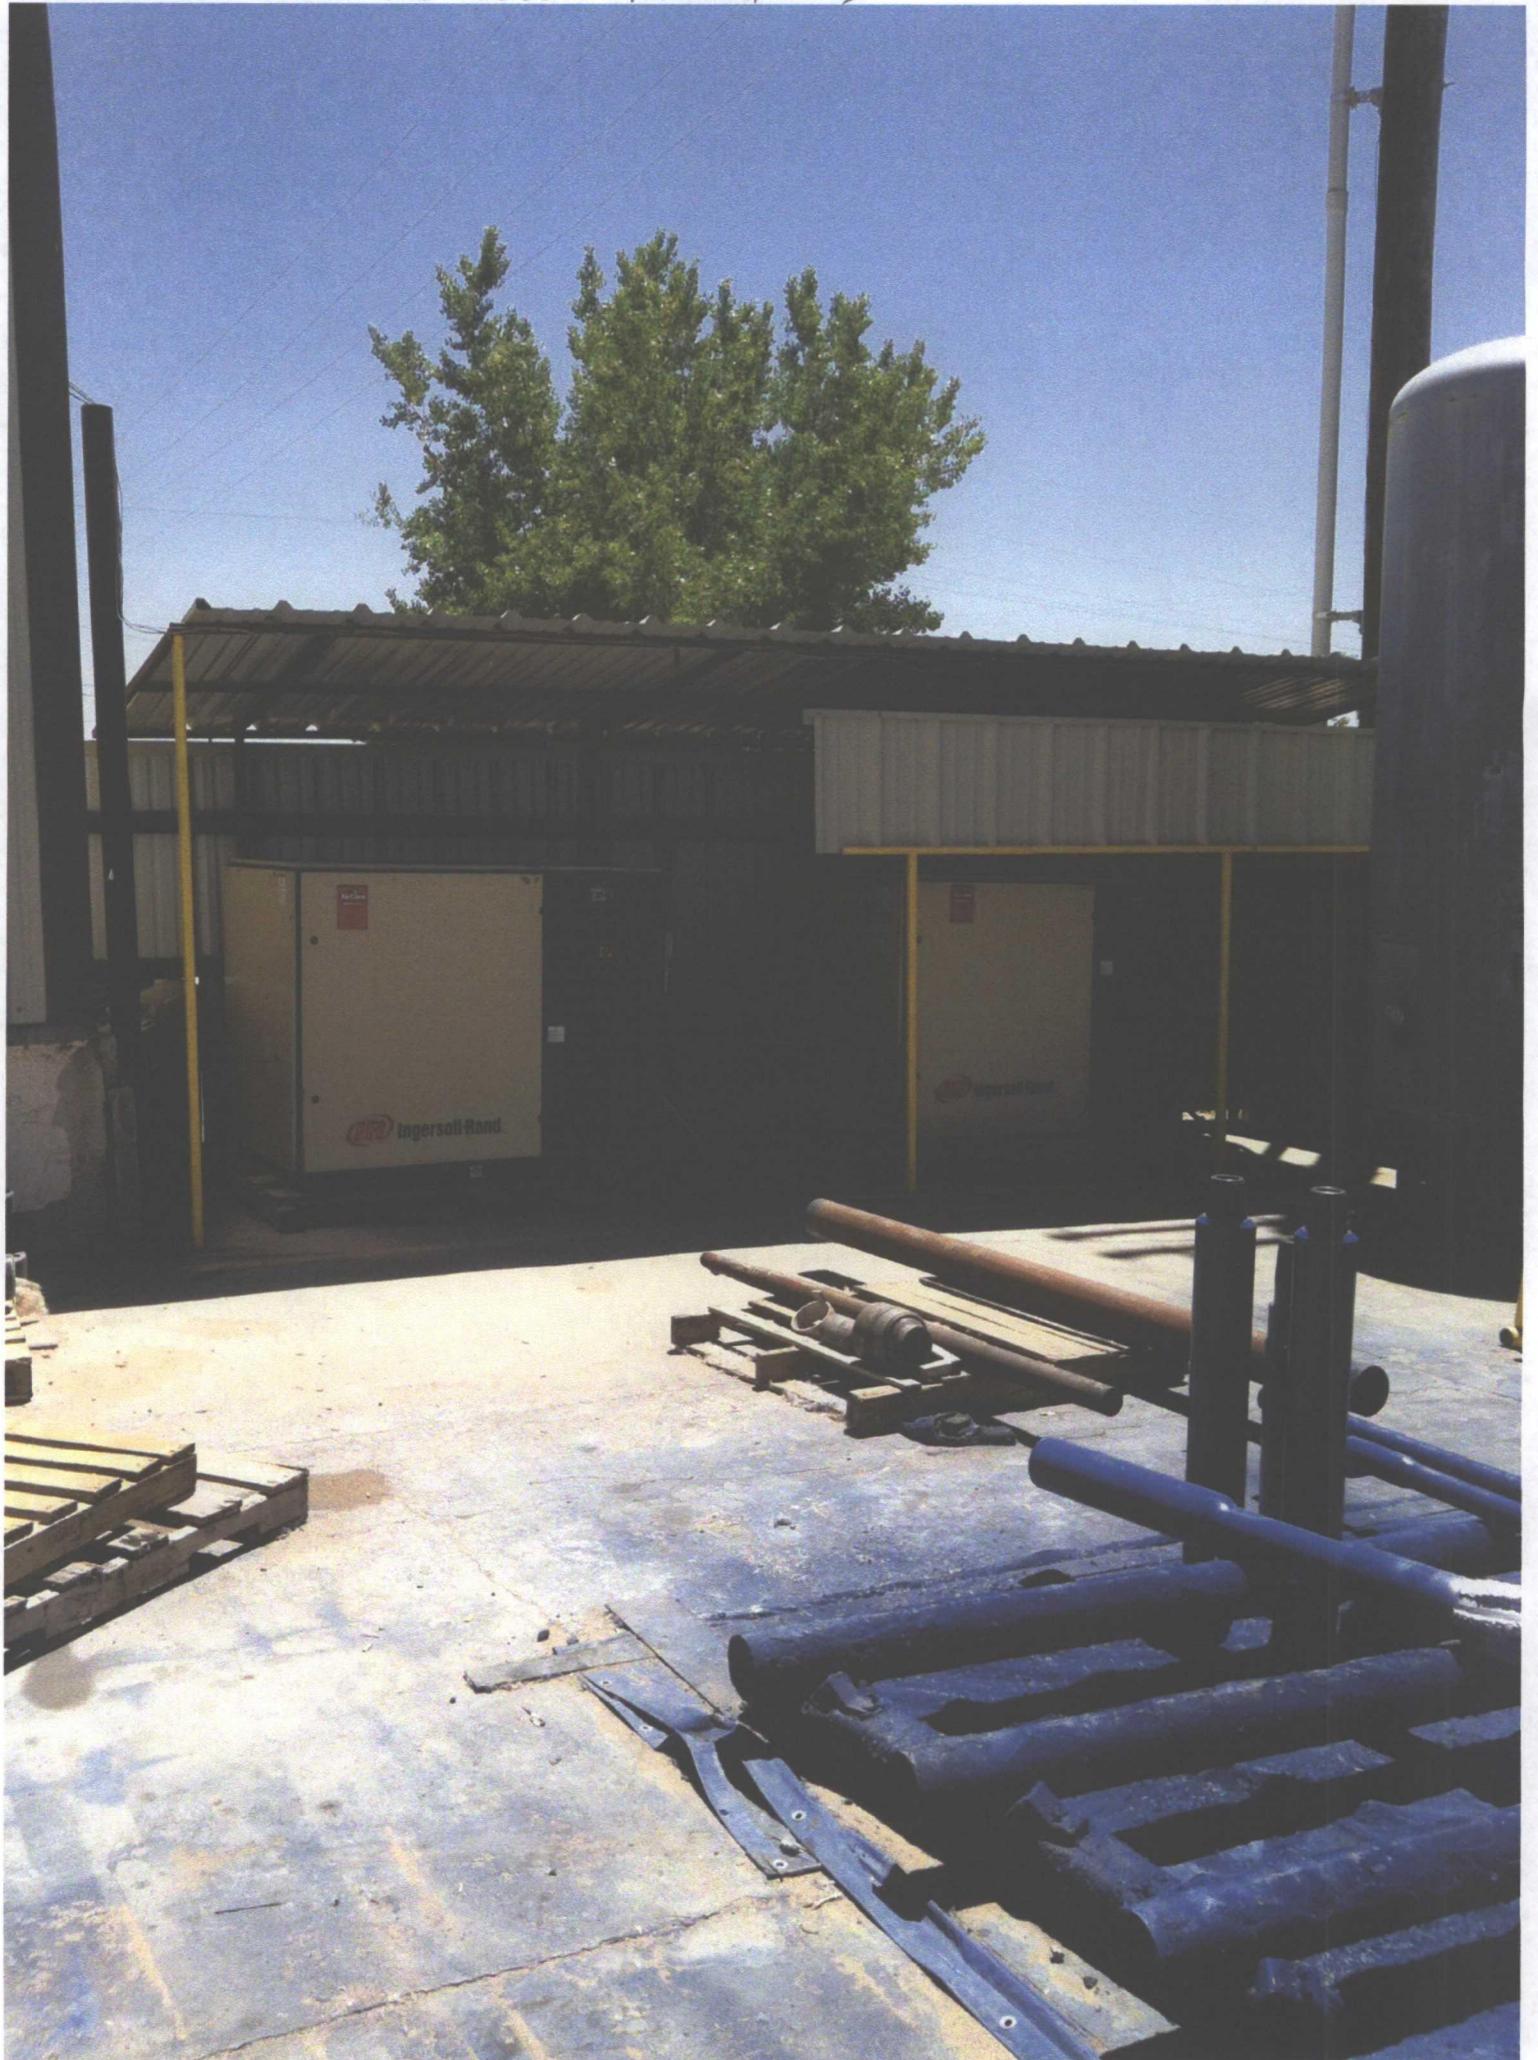
E-mail Attachment 060612 New Compressors

**The stains were remediated, the compressor and drip pan configuration was replaced by new compressor systems with built in containment.**

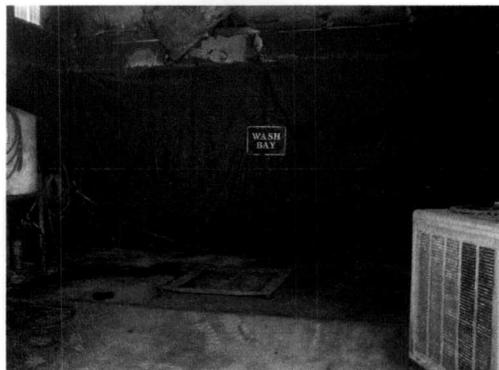
**NMOCD May 4<sup>th</sup>, 2009 letter Section 16. #1: Photo 1 - Wash Bay**

As apparent the Wash Bay remains in the same configuration as before. It does not possess secondary containment. It does not remain full of fluids at any given time as wash waters which enter the sump are conveyed to a closed-loop recycling system.

As depicted in the above photo, Knight intends to utilize this system type at the Farmington facility thereby eliminating the "Below Grade Tank". Wash waters in the above system simply drain through the false floor and are conveyed to the same closed loop system as before.

EDI will provide a schematic of the system upon receipt. A "Closure Plan" for the sump / below grade tank will be submitted for prior approval.

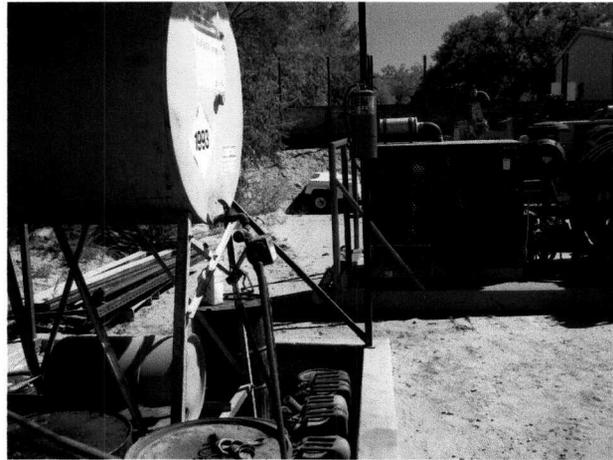
**Section 16 #2: Photo 2 – Saddle Tank placement**

**Fuel Tank in Secondary Containment 09/25/09**

As shown in the above photo the saddle tank was repositioned as to contain the valve and nozzle fittings so possible leaks or failures would remain within containment.

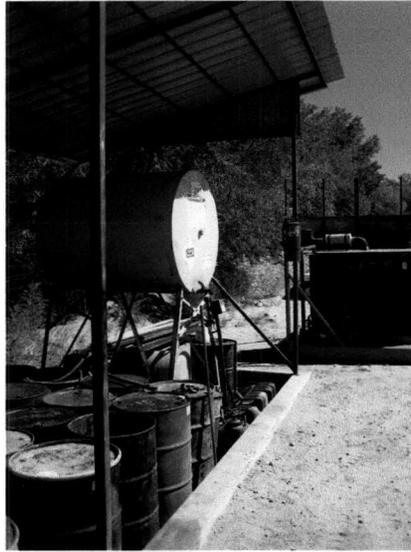
**Section 16 #3: Photo 3 – Missing Bung**

**Drums within Containment 09/25/09**

All drums inspected on the noted date possessed secured bungs. Open drums were observed but were actively in use. Upon activity completion the drums all secured with tops and rings and / or bungs.

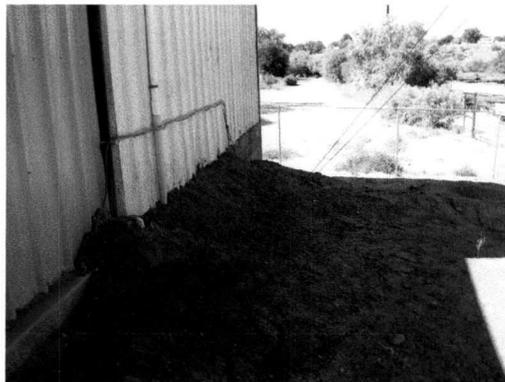
**Section 16 #6: Photo 8 – Staining outside wash bay building**

**Area behind wash bay building; 09/25/09**

As noted in the photo, the stained soils have been removed and replaced with clean fills. Removed soils were placed in drums and are awaiting profile approval.

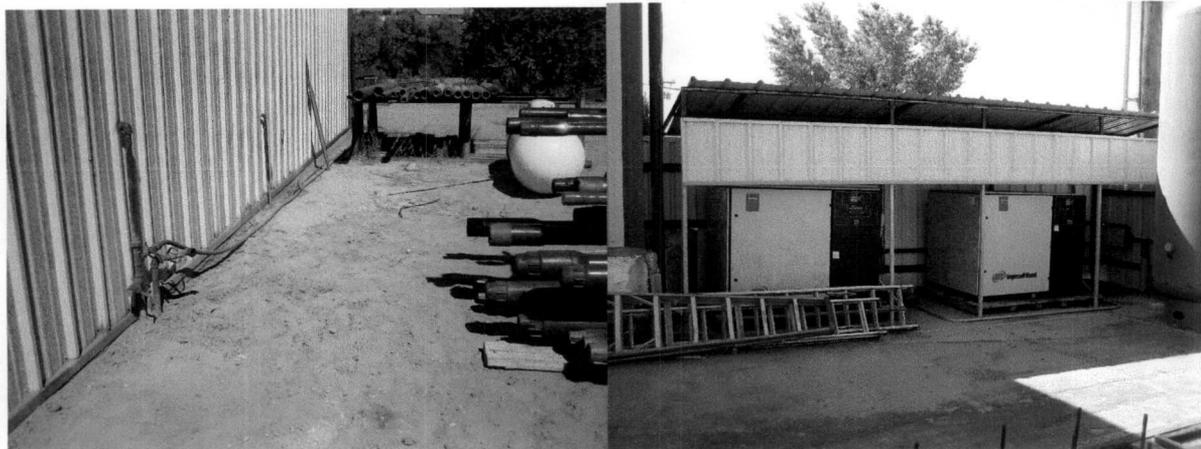
**Section 16. #7: Photo 9 - 10 – Former compressor containment**

**Former Compressor area; 09/25/09**

**New compressors; 09/25/09**

The above photos provide visual confirmation that the former compressor area was remediated and the soils drummed for disposal. The new compressor area lay adjacent to the main shop building on a cement slab. Each unit possesses its own internal secondary containment.

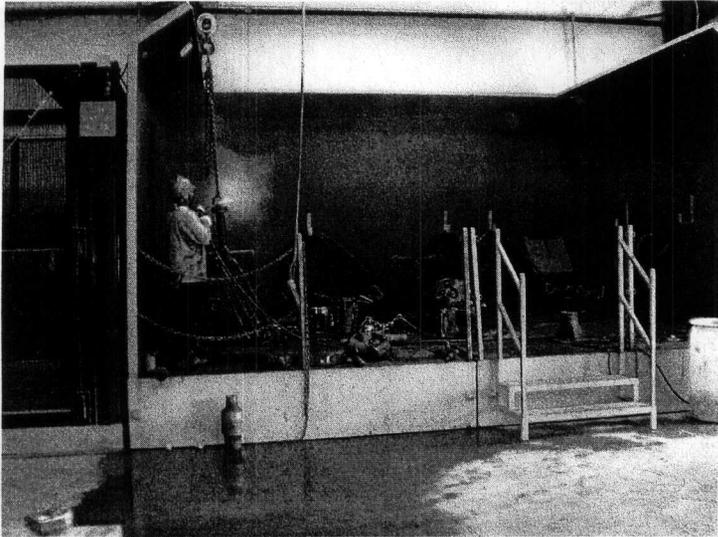
Wash Bay system at the Knight Oil Tools OK City Facility

As depicted in the above photo, Knight intends to utilize this system type at the Farmington facility thereby eliminating the "Below Grade Tank". Wash waters in the above system simply drain through the false floor and are conveyed to the same closed loop system as before.

EDI will provide a schematic of the system upon receipt. A "Closure Plan" for the sump / below grade tank will be submitted for prior approval.

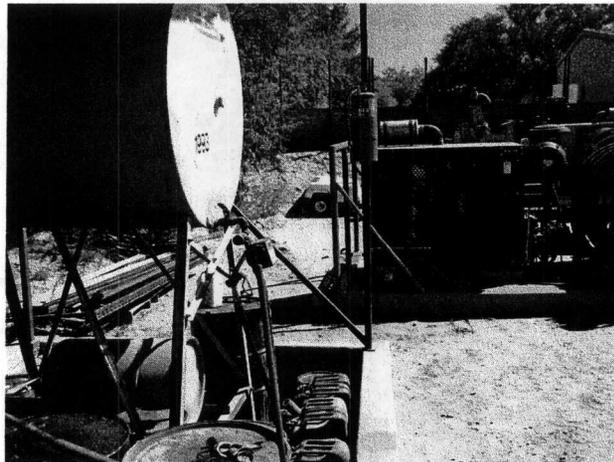
**Section 16 #2: Photo 2 – Saddle Tank placement**

Fuel Tank in Secondary Containment 09/25/09

As shown in the above photo the saddle tank was repositioned as to contain the valve and nozzle fittings so possible leaks or failures would remain within containment.

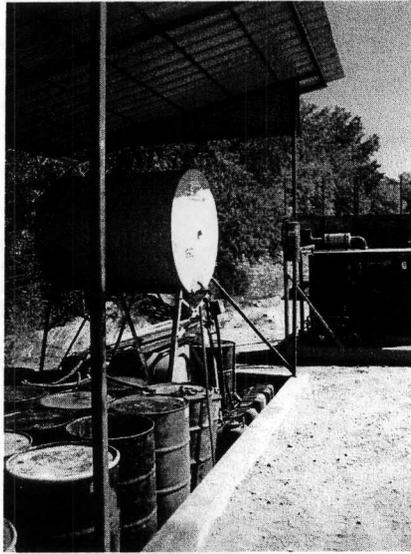
**Section 16 #3: Photo 3 – Missing Bung**

**Drums within Containment 09/25/09**

All drums inspected on the noted date possessed secured bungs. Open drums were observed but were actively in use. Upon activity completion the drums all secured with tops and rings and / or bungs.

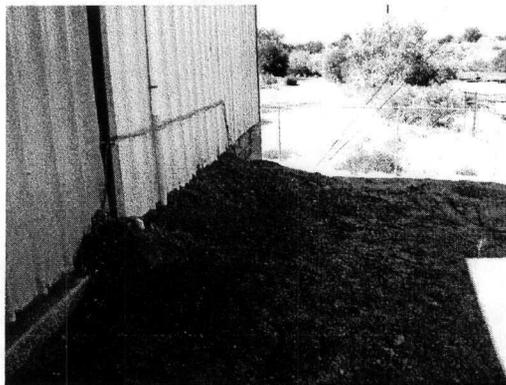
**Section 16 #6: Photo 8 – Staining outside wash bay building**

**Area behind wash bay building; 09/25/09**

As noted in the photo, the stained soils have been removed and replaced with clean fills. Removed soils were placed in drums and are awaiting profile approval.

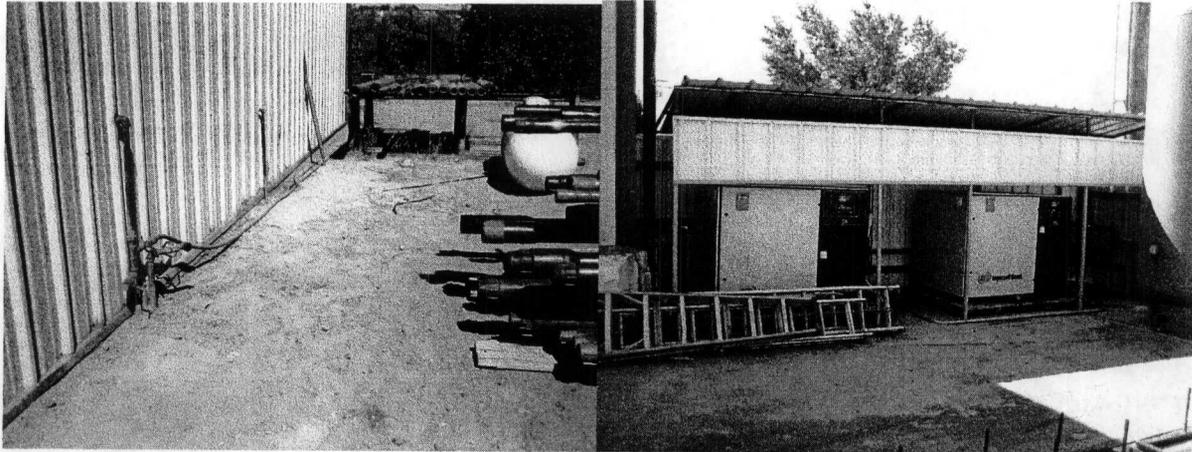
**Section 16. #7: Photo 9 - 10 – Former compressor containment**

**Former Compressor area; 09/25/09**

**New compressors; 09/25/09**

The above photos provide visual confirmation that the former compressor area was remediated and the soils drummed for disposal. The new compressor area lay adjacent to the main shop building on a cement slab. Each unit possesses its own internal secondary containment.

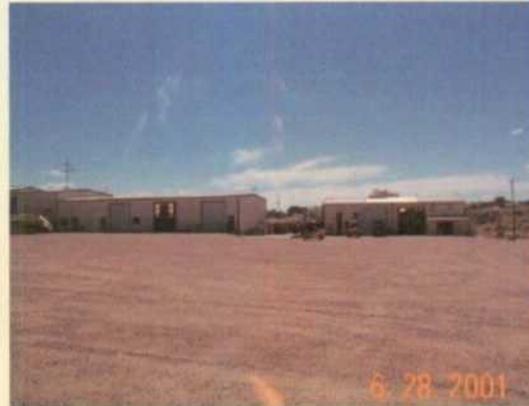
Pic #4 East side of yard looking west.

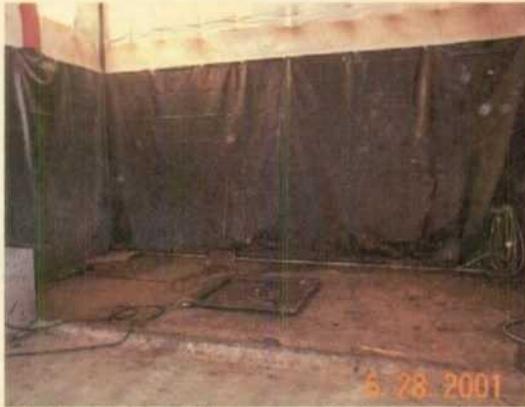
PIC # 2 WASH BAY SUMP - OIL FIELD TOOLS (SINGLE WALL SUMP)

ONE LINE BETWEEN SUMP & RE-CYCLE SYSTEM

SUMP WASTE SLOUSE → SAFETY CLEAN - ALBA.

Pic #2 Tool wash bay area with single wall sump connected to water re-cycle system. Sump waste is disposed of by Safety Clean (Albq).

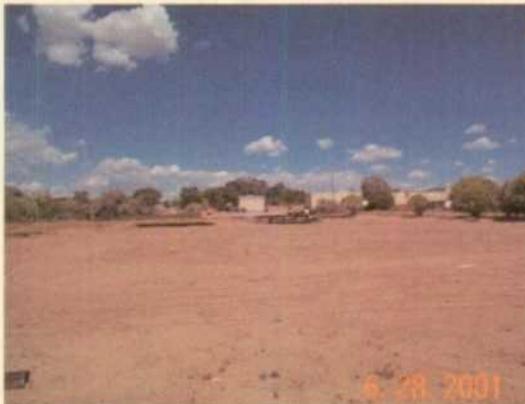
Pic #3 Far West side of yard looking east
